Development of fragility curves for railway embankment and ballast scour due to overtopping flood flow

Ryota Tsubaki¹, Jeremy David Bricker², Koji Ichii³, and Yoshihisa Kawahara³

Abstract. Fragility curves evaluating a risk of railway embankment fill and track ballast scour were developed. To develop fragility curves, two well-documented events of single-track railway washout during floods in Japan were investigated. Type of damage to the railway was categorized into no damage, ballast scour, and embankment scour, in order of damage severity. Railway overtopping water depth for each event was estimated based on well-documented hydrologic and hydraulic analyses. Normal and log-normal fragility curves were developed based on damage probability derived from field records and the estimated overtopping water depth. A combined ballast and embankment scour model was validated by comparing the results of previous studies and the spatial distribution of railway damage type records.

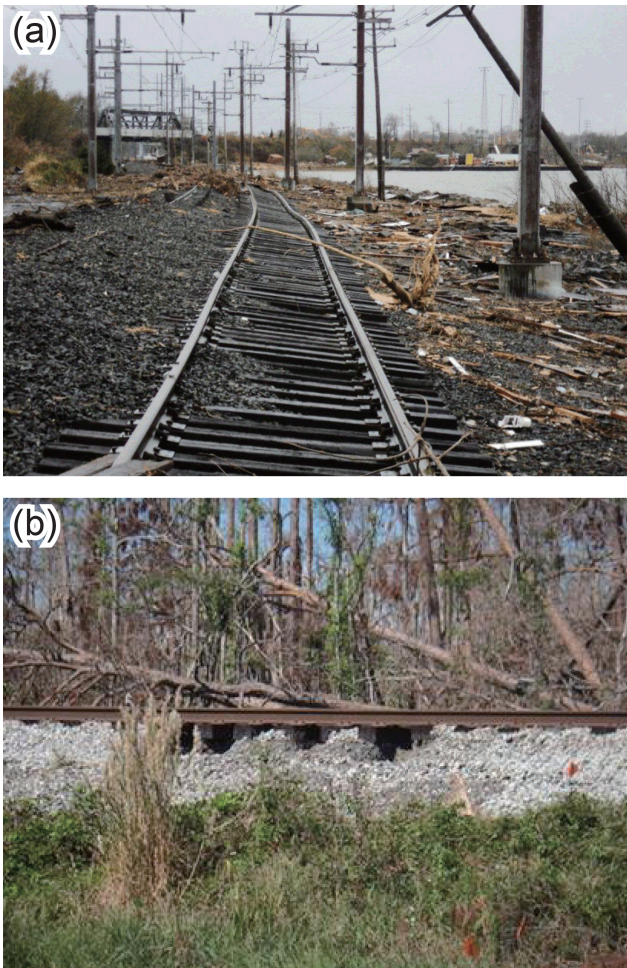
Figure 1. Railway ballast scour failures: (a) New Jersey Transit tracks in New Jersey, USA, after Hurricane Sandy in 2012; (b) CSX railroad tracks in Mississippi, USA, after Hurricane Katrina in 2005 (photo credits: New Jersey Transit, a).

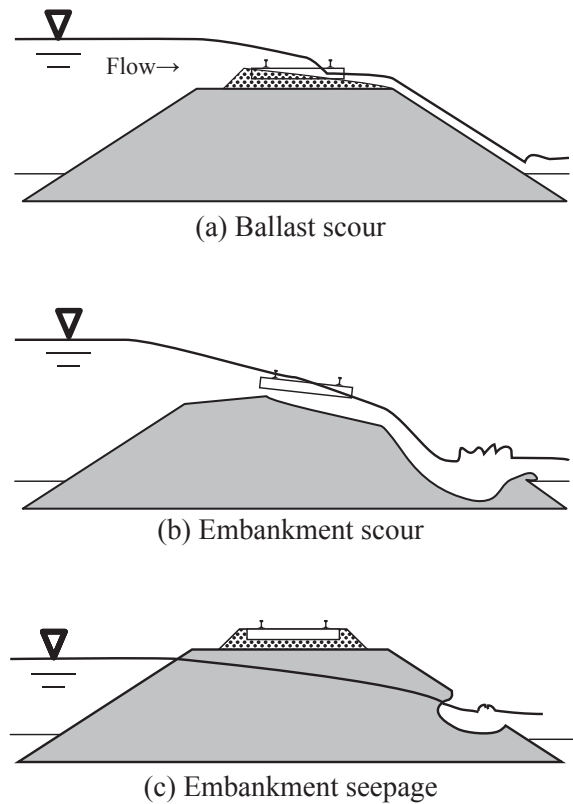
Figure 2. Railway embankment damage types.

ometrically similar to roadway embankments and levees, the structures atop railway embankments are very different from those atop these other embankments, as are the mechanisms by which overtopping can cause damage. As Fig. 2 shows, floods can cause damage to railway embankments via three processes: (a) scour of ballast induced by overtopping, (b) scour of both ballast and embankment fill by overtopping, and (c) piping/seepage failure of embankment fill. Though piping/seepage failure of fill is more likely to occur in high (and wide) embankments, most railway embankments are relatively low, and most observed railway embankment failures appear to have been the result of overtopping-induced scour of embankment fill and/or ballast (Kaneko, 2010; Tsubaki et al., 2012a; Onoda and Hayano, 2015). Ballast scour is a damage mode unique to railway embankments. In the cases of ballast scour only, repair of the ballast layer is relatively straightforward, but in cases of embankment fill scour, repairs can be costly and take a long time. Repair of damage to an embankment is less expensive than repair of damage to bridges and other facilities (see Table 1), but ballast and embankment damage occurs much more frequently than bridge damage. Furthermore, river floods or tsunamis large enough to damage bridges usually also cause extensive flooding which leads very long sections of an embankment to wash out (e.g., Shimozono and Sato, 2016). Therefore, the development of fragility curves for scour of railway ballast and embankments is crucial for the assessment of railway vulnerability and resilience.

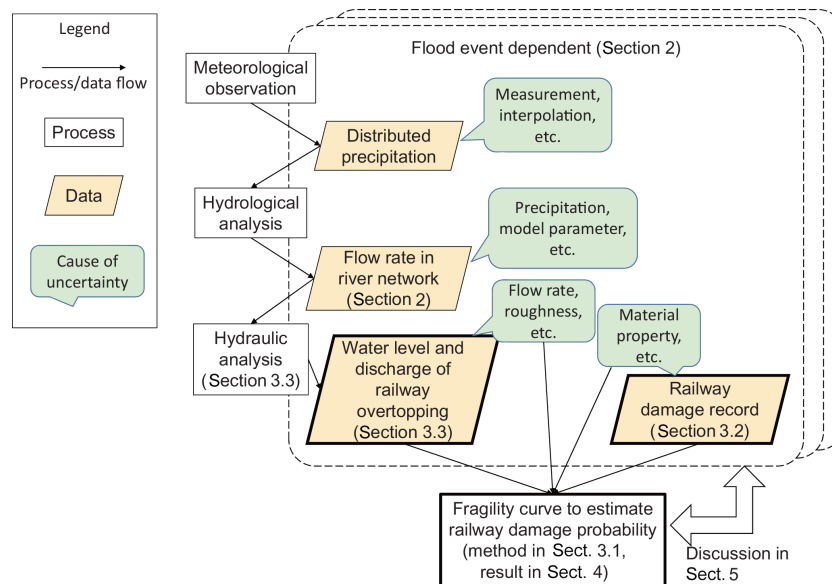
Figure 3. Relationship between processes and data within the structure of this paper.

Figure 3 shows the relationship between the processes and data used in this study. The two flood events for which damage records exist, as well as the estimated flow rates in the river networks during these events, are described in Sect. 2. Section 3 is devoted to the methods used in this study. Fragility curves are introduced in Sect. 3.1. Railway damage recorded for the two flood events is described in Sect. 3.2. The method of hydraulic analysis and uncertainty in the estimated water depth are both described in Sect. 3.3. Based on the results of Sects. 3.2 and 3.3, the fragility curves are developed in Sect. 4. Discussions including the comparison between the estimated damage probability and recorded damage types are reported in Sect. 5. Section 6 highlights the conclusions of this study.

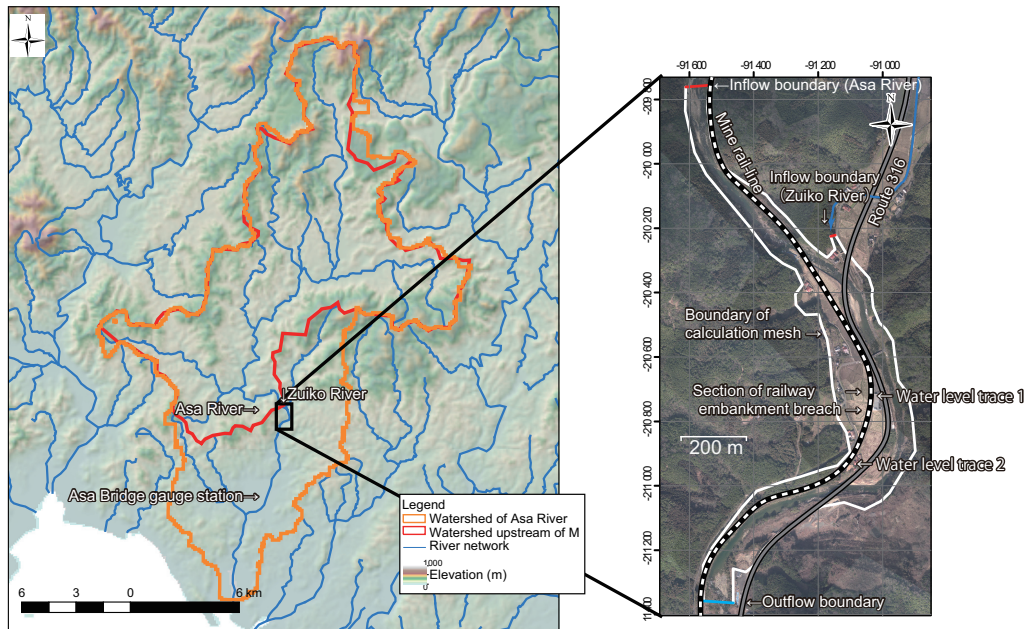
Figure 4. Watershed of the Asa River (left) and aerial photo taken in 2011 of section M (right). (Source: National Land Numerical Information download service, Ministry of Land, Infrastructure, Transport and Tourism, Japan, for digital elevation model, watersheds, and river network.)

In June 2010, a large flood occurred along section M (see Fig. 4) of the Asa River and caused inundation of homes and a factory, as well as washout of a railway embankment (Yamasaki et al., 2010; Tsubaki et al., 2014). The left-hand map in Fig. 4 outlines the watershed upstream of section M of the Asa River in red, while the watershed of the entire reach of the Asa River is outlined in orange. A storage function model, with parameters calibrated to previous major events, was used to calculate an event-dependent model parameter R_{sa} (a saturation criterion to start runoff), which was determined via best fit to the discharge hydrograph measured at the Asa Bridge gauge station (location indicated in the left panel of Fig. 4) based on four error criteria (Ube Construction Office, 2012). The estimated maximum flow rate in the Asa River was $811 \text{ m}^3 \text{ s}^{-1}$ (Ube Construction Office, 2012), while the inflow from the Zuiko River was $110 \text{ m}^3 \text{ s}^{-1}$. Though it is possible that the peak flow in each river would reach their confluence at slightly different times, the same hydrologic model showed that the maximum flow at a point 3 km downstream of the confluence was

Water levels hindcast by the flood simulation are compared with measured water level traces from two locations depicted in the right panel of Fig. 4. Steady flow boundary conditions were used for model inflow and outflow, though the presence of vortices (circulatory flow) over the floodplain and near the riverbanks caused a complex velocity field and prevented perfectly steady flow from forming (Tsubaki and Kawahara, 2013). Due to these fluctuations, modeled water levels were assessed via both 20 min running averages representing each minute of model output, as well as maximum water levels during these same intervals. Flood elevation trace no. 1, on the inner wall of the factory, was measured to be 25.98 m (in Tokyo datum, hereafter). The average modeled flood elevation here was 25.79 m, and the maximum modeled flood elevation at this location was 25.90 m. At location no. 2,

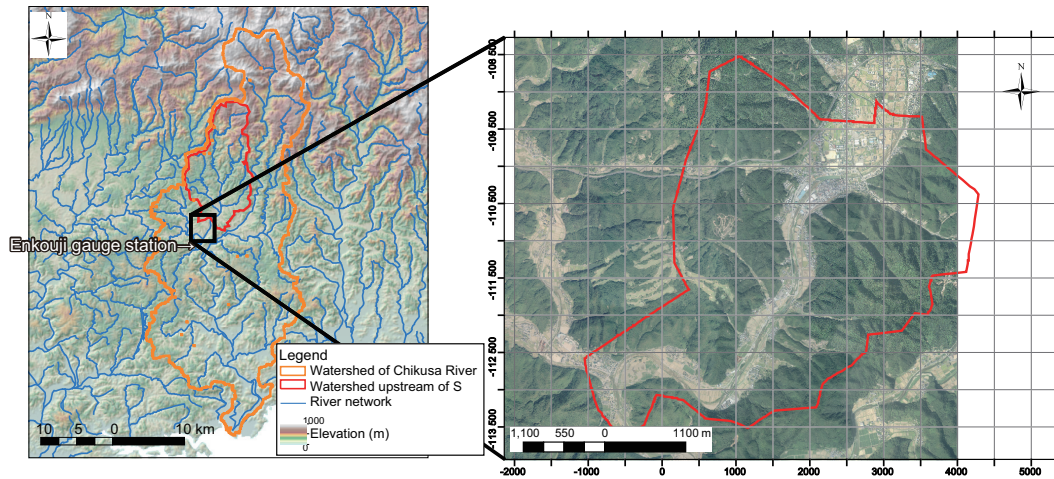
Figure 5. Watershed of Chikusa River (left) and hydraulic flood model domain in section S of Sayo River (right). (Source: National Land Numerical Information download service, Ministry of Land, Infrastructure, Transport and Tourism, Japan, for digital elevation model, watersheds, and river network and Kinki Regional Development Bureau, Ministry of Land, Infrastructure, Transport and Tourism Japan for the aerial photo taken in 2010.)

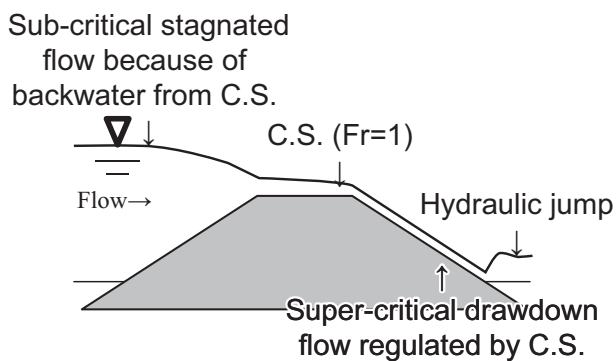
Figure 6. Schematic diagram of one-dimensional flow over embankment. C.S. in figure corresponds to the critical section where the flow is critical.

In this paper, we use upstream flood water level (overtopping surcharge) as a variable explanatory for railway overtopping failures. As schematically depicted in Fig. 6, under the situation of water overtopping an embankment, critical flow occurs on the embankment (C.S. in Fig. 6) and the upstream water level correlates almost directly to the overtopping discharge (Chow, 1959; Dawson et al., 2005; Apel et al., 2009). The upstream water has less velocity head and the surface is relatively flat, whereas the overtopping flow atop the embankment is rapidly varied flow and quite sensitive to small differences and uncertainty in the local elevation of the em-

bankment crest. The flow on the lee side of embankment is supercritical and the water level is regulated by the C.S. The local flow rate over the embankment crest estimated by the embankment-resolving fine-resolution inundation simulation (e.g., Tsubaki and Kawahara, 2013) has non-negligible uncertainty because of high sensitivity to the embankment shape and height represented by the undulation of the calculation grid based on the digital elevation model and land cover data. This is because exchange between kinetic and potential energies is actively occurring in this area (Chow, 1959), leading to a two-dimensionally undulating water surface profile and inhomogeneous velocity distribution (Tsubaki and Kawahara, 2013). For these reasons we use the upstream water level as a hazard level to explain the probability of railway failure.

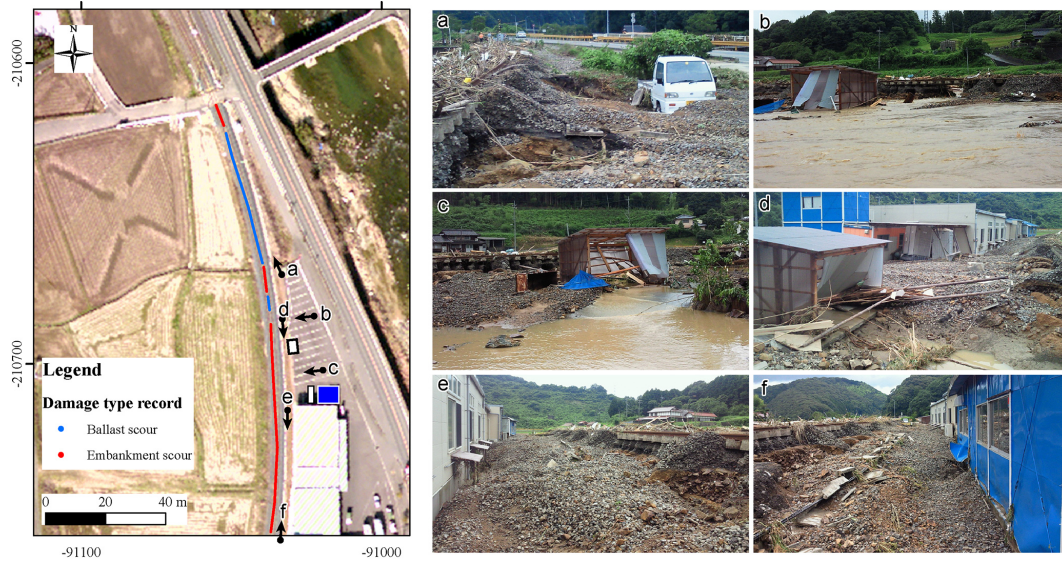
Figure 7. Example of the photos showing the status of the railway ballast–embankment scour just after the flood. Shooting location and direction of each photo are both plotted in the left orthorectified aerial photo taken in February 2012 (photo source: M. Kikunaga).

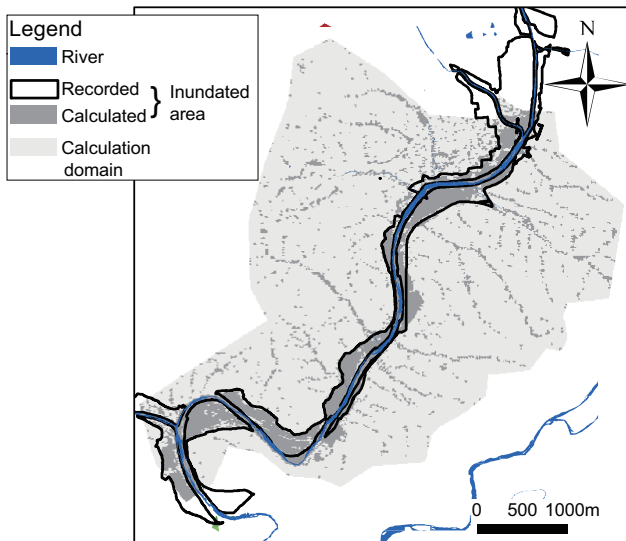
Figure 8. Comparison of calculated and recorded inundation areas (Tsubaki et al., 2012a).

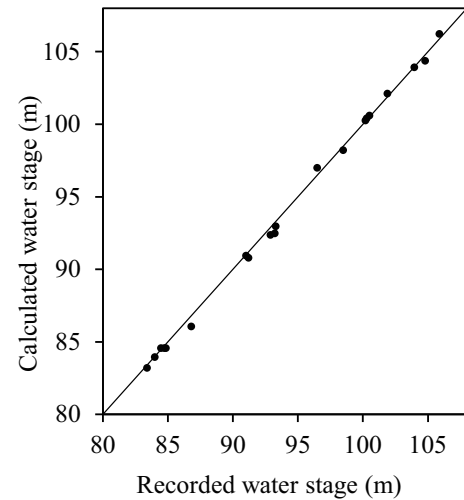
Figure 9. Comparison of calculated and recorded flood stages in Tokyo datum. The straight line shows the perfect-agreement line, i.e., recorded water stage = calculated water stage (Tsubaki et al., 2012a).

cover on the embankment slope. Moreover, there is a difference in the definitions of calculated and recorded water depths, namely the calculated water depth is a cell-averaged quantity but the recorded water depth denotes the local water depth around obstacles; this caused an underestimation of the calculated water depth as reported in Sect. 3.3.2a for the Asa River and shown in Fig. 9 for the Sayo River.

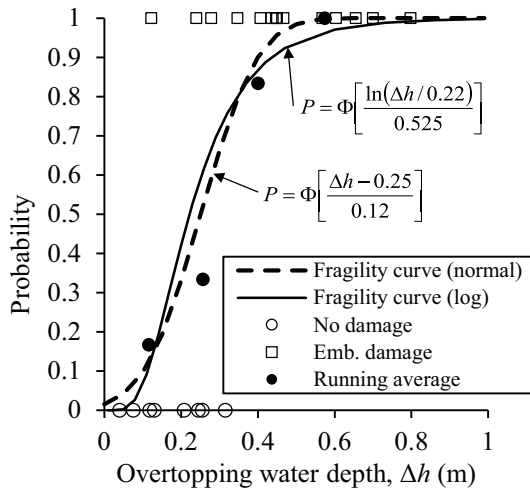
Figure 10. Fragility curves for embankment scour damage described by normal and log-normal distributions.

Figure 10 displays the fragility curves for the embankment scour using the normal distribution (depicted by the dashed line with log-likelihood $\ln(L) = -7.3$) and the log-normal distribution (the solid line with log-likelihood $= -7.9$) resulting from data points at which either no damage (the number of samples was $n = 8$) or embankment scour ($n = 16$) was observed at two flood events. In Fig. 10, open symbols represent individual data points, while filled figures represent overtopping water depth and damage data which have been put through a five-point running average after ordering by overtopping water depth. Though both normal and log-normal distribution models (solid and dashed lines, respectively) represent well the trend of damage probability based on the field record (filled circles), the normal distribution has a slightly better fit.

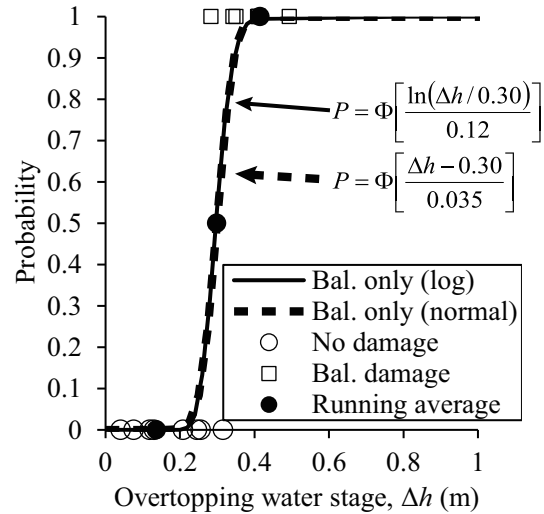
Figure 11. Fragility curves for ballast scour damage described by normal and log-normal distributions.

Figure 11 shows the fragility curves for the ballast scour using the normal distribution (depicted by the dashed line with log-likelihood $= -2.6$) and the log-normal distribution (the solid line with log-likelihood $= -2.6$) resulting from data points at which either no damage (the number of samples was $n = 8$) or ballast scour ($n = 7$) were observed during the two flood events. The normal and log-normal curves were almost identical.

In Fig. 11, the fragility curve for ballast scour has a median overtopping water depth of $\Delta h = 0.30 \text{ m}$, and its variance $\sigma = 0.035 \text{ m}$ is smaller than those of the fragility curves for the embankment scour and combined ballast and embankment scour. It must be kept in mind that the lidar topography used in the flood model has an RMSE on the order of 0.1 m , and the uncertainty in hindcast flood levels was on the order of 0.2 m , so the standard deviation $\sigma = 0.035 \text{ m}$ of the ballast scour model is very small compared with expected uncertainty in the estimated overtopping water level. The experiment of Tsubaki et al. (2012b) showed ballast scour to begin at $q_c = 0.045 \text{ m}^2 \text{ s}^{-1}$, which is an order of magnitude smaller than the median ($q = 0.4 \text{ m}^2 \text{ s}^{-1}$) or lower limit ($q = 0.25 \text{ m}^2 \text{ s}^{-1}$) of the fragility curve for ballast scour shown in Fig. 13. Therefore, it appears the calculated fragility curve for ballast scour in this study may overestimate the condition experimentally evaluated in Tsubaki et al. (2012b). This

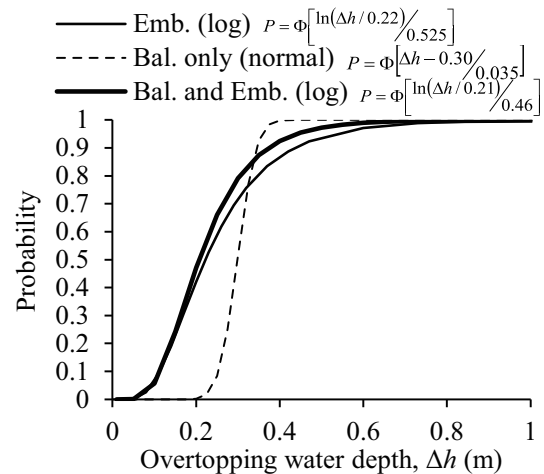
Figure 12. Fragility curves for ballast scour (Bal. only), embankment scour (Emb.), and ballast and embankment scour (Bal. and Emb.).

Figure 12 compares the normal fragility curve for ballast scour (dashed line) and a log-normal curve for the combination of ballast scour and embankment scour (thick line, log-likelihood $= -8.9$). The fragility curve for ballast scour has a larger mean and smaller standard deviation compared with the curve for embankment scour and the curve for combined ballast scour and embankment scour. The damage probability at medium overtopping water depth $0.2 \text{ m} < \Delta h < 0.6 \text{ m}$ for the combined ballast and embankment scour is slightly larger than the probability for embankment scour only.

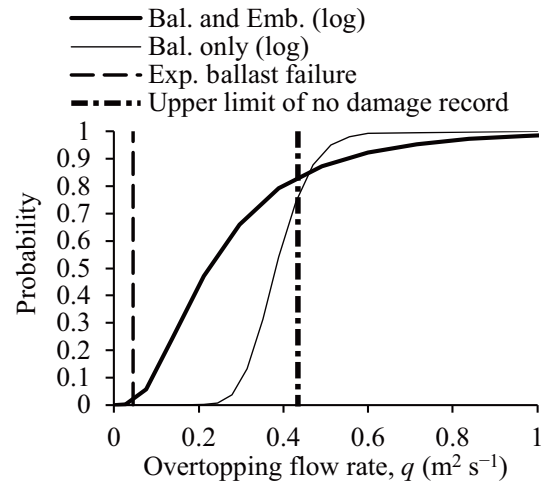
Figure 13. Fragility curve for ballast failure using overtopping flow rate per unit length. The dashed line indicates the experimental bound at which the onset of ballast scour occurs (Tsubaki et al., 2012b). The double line corresponds to the upper limit of the flow condition where no damage was observed.

The largest overtopping flow rate at which no damage was observed at the point s1 (Table A2, $\Delta h = 0.31 \text{ m}$ and $q = 0.43 \text{ m}^2 \text{ s}^{-1}$) and damage probability for this hazard level was 0.6–0.8 for all developed fragility curves (Figs. 13, 9, 10, 11, 12). The damage probabilities converge to unity for larger hazard level and convergent rate with increase of hazard level differs depending on the types of fragility curve. The fastest convergence of the damage probability to unity was observed in the ballast scour model and followed by the ballast and embankment scour model. The embankment scour model showed the slowest convergence to unity. The log-normal models also showed relatively slow convergence

to unity compared with the corresponding normal models. An overtopping flow rate of $0.5 \text{ m}^2 \text{ s}^{-1}$ (corresponding to an overtopping water depth of 0.4 m) is quite an intense flow from the viewpoint of earthen embankment overtopping (Apel et al., 2004) and it is very unlikely that no scour will occur during such an intense flow. The damage probability of the ballast scour model was almost unity but the damage probability of the embankment scour model and embankment and ballast scour model was about 0.9 and 0.95 for this range ($q = 0.5 \text{ m}^2 \text{ s}^{-1}$ and $\Delta h = 0.4 \text{ m}$). Thus, the log-normal models and the embankment scour models may underestimate the damage probability for large hazard level.

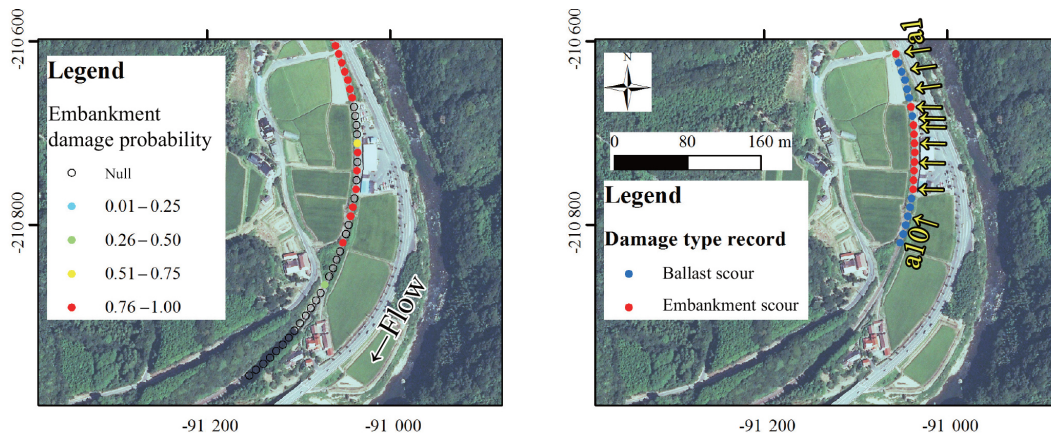
Figure 14. Estimated damage probability (left) and damage type record (right) at Asa River section M. The yellow symbols in the right map depict data points listed in Table A1.

A validation of the combined damage fragility curve, of which feasibility was discussed above, was conducted by comparing its calculated probabilities to the actual damage record. The normal distribution for combined ballast and embankment scour was determined to be the most feasible model based on the discussion in Sects. 5.1–5.3. Via the model, the damage probability along the rail track in the Asa River floodplain at 10 m intervals was calculated and plotted in Fig. 14 (left). Thirty-one of the data points, used in Sect. 4 and listed in Tables A1 and A2 to obtain the fragility curves, were selected where the damage type record was confident (e.g., not marginally at the border of two damage types), but a point array at 10 m intervals was used for the validation here. Damage probability in Fig. 14 (left) is calculated without regard to the types of failure (ballast or embankment scour), but it is calculated with the fragility curve for ballast and embankment scour; however, the actual damage record of the right figure distinguishes the type of damage. In Fig. 14, there is variability in the calculated result, but the area where the

ballast and embankment scours were observed is predicted as a high damage probability area. The points at which no damage was calculated are points at which the flood model calculated either a very shallow overtopping water depth, or no overtopping at all. The railway crest in this section is almost horizontal. Since the crest of the railway embankment consists of both rail and railway ties (sleepers), the 1 m^2 resolution lidar data cannot resolve this, and the 1.7 m^2 triangular mesh carries forward this variation, leading to an unavoidable difference between modeled and actual topography. Since actual railway crest elevation does not experience spurious variations at 10 m intervals, topography based on lidar data of limited resolution and accuracy might be improved by application of a spatial filter along the railway.

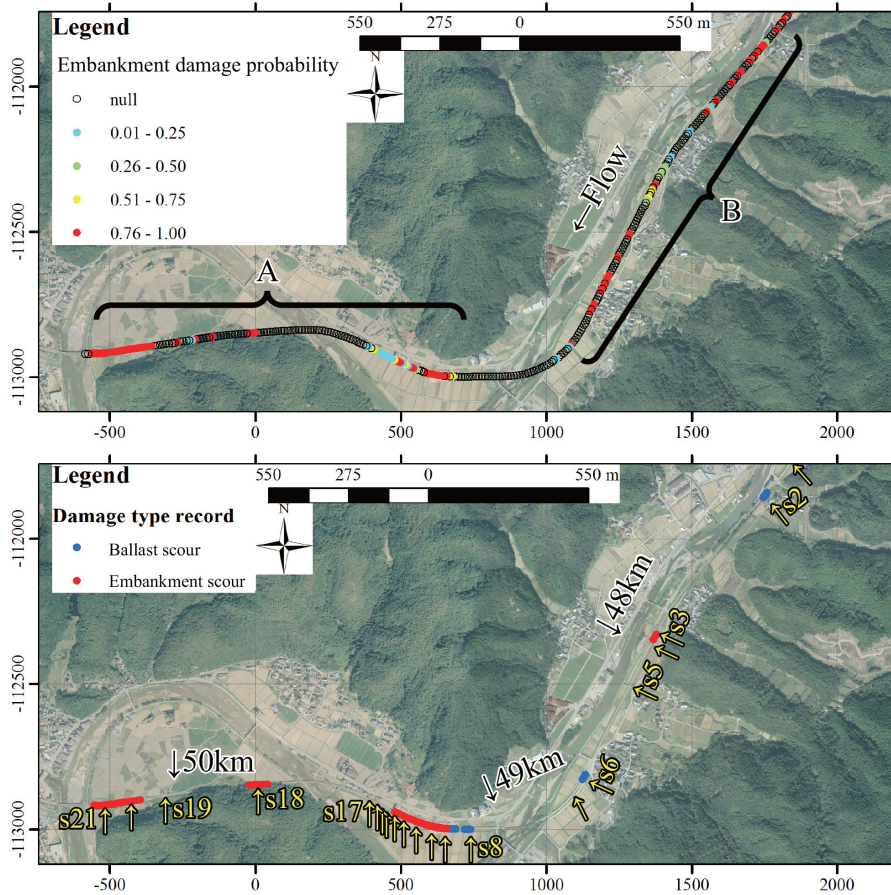
Figure 15. Estimated damage probability (top) and damage type record (bottom) at Sayo River section S. The yellow symbols in the bottom figure depict data points listed in Table A2. (Source: Kinki Regional Development Bureau, Ministry of Land, Infrastructure, Transport and Tourism Japan for the aerial photo taken in 2010.)

Figure 15 shows calculated and observed damage to the railway along the Sayo River. The domain is decomposed into two segments (A and B) in the discussion below. Continuous damage was recorded along a portion of Segment A, and this damage was reproduced well in the fragility curve calculation. In this segment, damage occurred in locations at which relatively steep slopes existed in the railway crest elevation profile (Fig. 16). Since the locations of railway embankment overtopping were governed by a longitudinal slope of the railway and large-scale topography in this segment A, the flood model was able to simulate actual overtopping location and flow rate with higher accuracy, and damage probability resulting from the fragility curve matched recorded damage well. In Segment B, estimated damage probability was high at points that experienced actual damage, but many other points estimated to have high damage probability experienced no actual damage. In regions such as this, where spatially sporadic damage is calculated, fragility curves are still useful for predicting whether damage will occur, but they cannot predict the specific locations at which the damage should be expected. In this segment, elevation of the railway embankment crest was very smooth, with no steep slopes in

crest elevation (Fig. 16). Therefore, the entire segment was overtopped with shallow surcharge. However, small errors in topography at the size of each model grid cell caused large difference in the overtopping water depth, resulting in erroneous damage probabilities at the 10 m intervals at which damage was assessed. The fragility curve concept can also account for uncertainty in hazard level (overtopping water depth in this paper) by adjusting the deviation parameters σ or ζ in Eq. (1) or (2) (Mander, 1999); in segments within which sporadic damage is predicted, the level of damage can be estimated by averaging the damage predicted for points within the segment. However, the reason damage in Segment B of Fig. 15 was not evaluated as such an average is that the error in grid-scale model topography was too large to just cause variations in overtopping water depth; rather, the error caused many points within the segment to not experience any overtopping at all. Therefore, the model predicted scattered damage for Segment B.

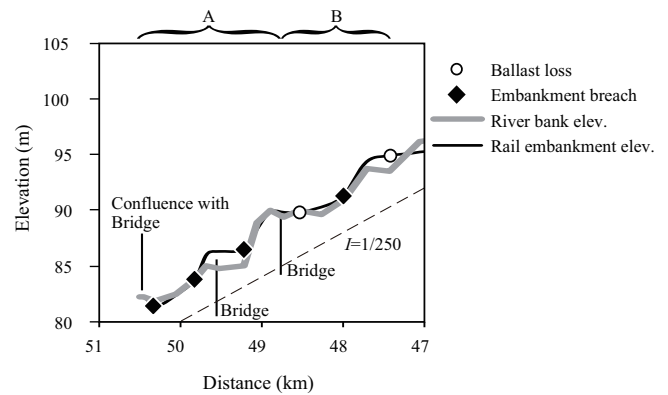
Figure 16. Longitudinal profiles of railway and riverbank elevation. The cross sections where the river and railway intersect are indicated as “bridge” (Tsubaki et al., 2012a).
