# Formation, breaching and flood consequences of a landslide dam near Bujumbura, Burundi

**Abstract.** This paper investigates the possible formation of a landslide dam on the Kanyosha River near Bujumbura, the capital of Burundi, as well as the interplay between the breaching of this landslide dam and the flooding along the river. We present an end-to-end analysis, ranging from the origin of the landslide up to the computation of flood waves induced by the dam breaching. The study includes three main steps. First, the mass movement site was investigated with various geophysical methods that allowed us to build a general 3-D model and detailed 2-D sections of the landslide. Second, this model was used for dynamic landslide process modelling with the Universal Distinct Element Code. The results showed that a 15 m high landslide dam may form on the river. Finally, a 2-D hydraulic model was set up to find out the consequences of the breaching of the landslide dam on flooding along the river, especially in an urban area located downstream. Based on 2-D maps of maximum water depth, flow velocity and wave propagation time, the results highlight that neglecting the influence of such land

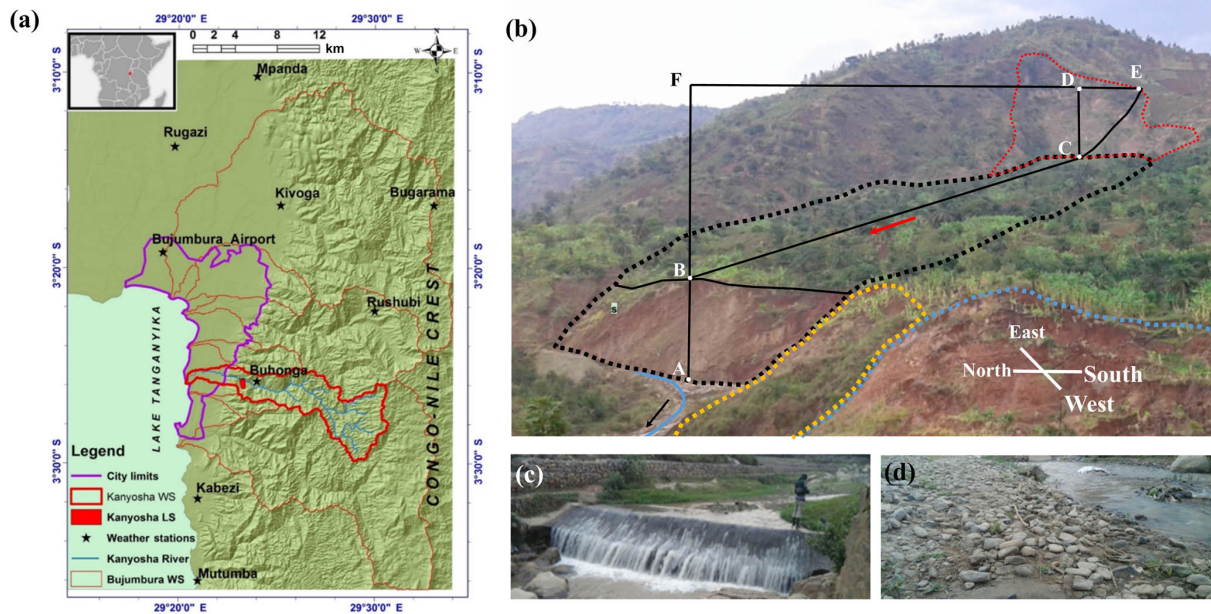
**Figure 1.** (a) Bujumbura region with indication of watersheds of the main rivers, the limits of the city and Lake Tanganyika. The watershed of the Kanyosha River is highlighted in the central part, with the river network inside. The weather stations in and around Bujumbura, the Kanyosha landslide (in the text called “Banana Tree Landslide”, also referred to as BTL, in red contours) and the Congo–Nile crest are also shown. “LS” and “WS” stand for “landslide” and “watershed”, respectively. (b) View of BTL (black dotted contour) and the main scarp (red dotted contour) as well as its lateral local instabilities (orange and light blue dotted contours). The landslide sliding direction and the river flow direction are indicated by the red and the black arrows, respectively. AB indicates the height (26 m) of the landslide frontal part near the river; BC outlines the BTL length in the sliding direction ( $\sim 750$  m); CD shows the height of the main scarp ( $\sim 75$  m) along profile points B–C–E. The blue line indicates the river channel axis. (c) Waterfall over a former flood control structure (located 270 m downstream of cross section 3 shown in Fig. 3). (d) View of the riverbed during the dry season with presence of cobbles and fine boulders that are deposited after floods during the wet season.

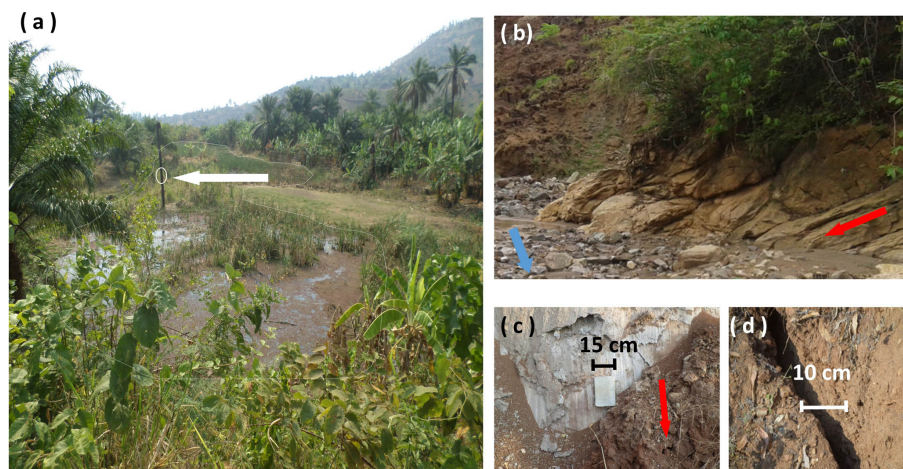
**Figure 2.** Field observations highlighting the critical stability state of BTL. **(a)** Pond on the landslide with an oil palm designated by the white arrow. This shows that these ponds are recent (oil palm trees do not grow in water; its particular foliage compared to others shows that its growth was stopped recently). **(b)** View of the rock structures at the foot of the landslide, generally dipping towards the north (left side), parallel to the sliding direction (red arrow). The blue arrow indicates the river flow direction. **(c)** View of a crack on the sliding interface in a clay layer. The red arrow shows the direction of sliding of the right part along the clay layer. **(d)** A crack found on the landslide surface.

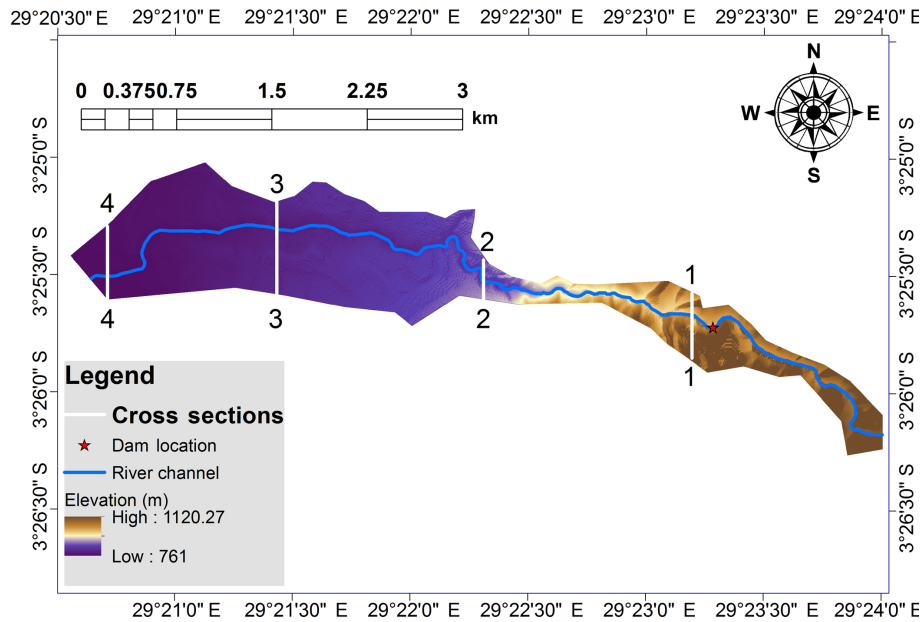
**Figure 3.** Digital elevation model (m) used for hydraulic modelling within the computational domain, with cross sections where hydrographs were extracted and dam location. The river main channel is also highlighted.

In this section, we examine to which extent the water depths are affected by the occurrence of a landslide dam breaching. The computed water depths are discussed here for four cross sections, labelled sections 1 to 4 (Fig. 3). Figure 13 displays the computed water depths for the pre-failure flow and for

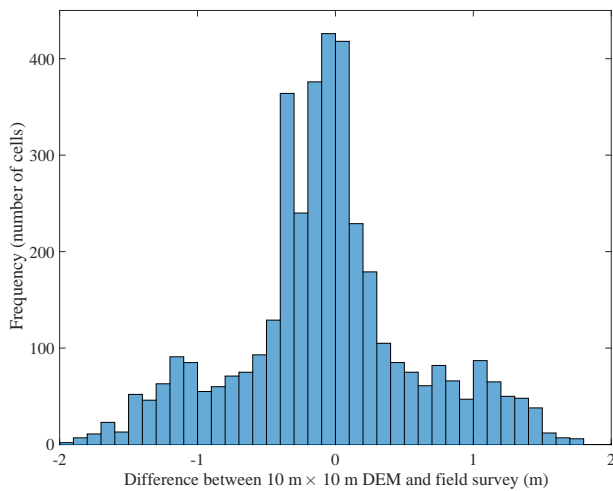
**Figure 4.** Elevation difference between the topography from field measurement and the resampled 2 m × 2 m DEM used for hydraulic modelling.

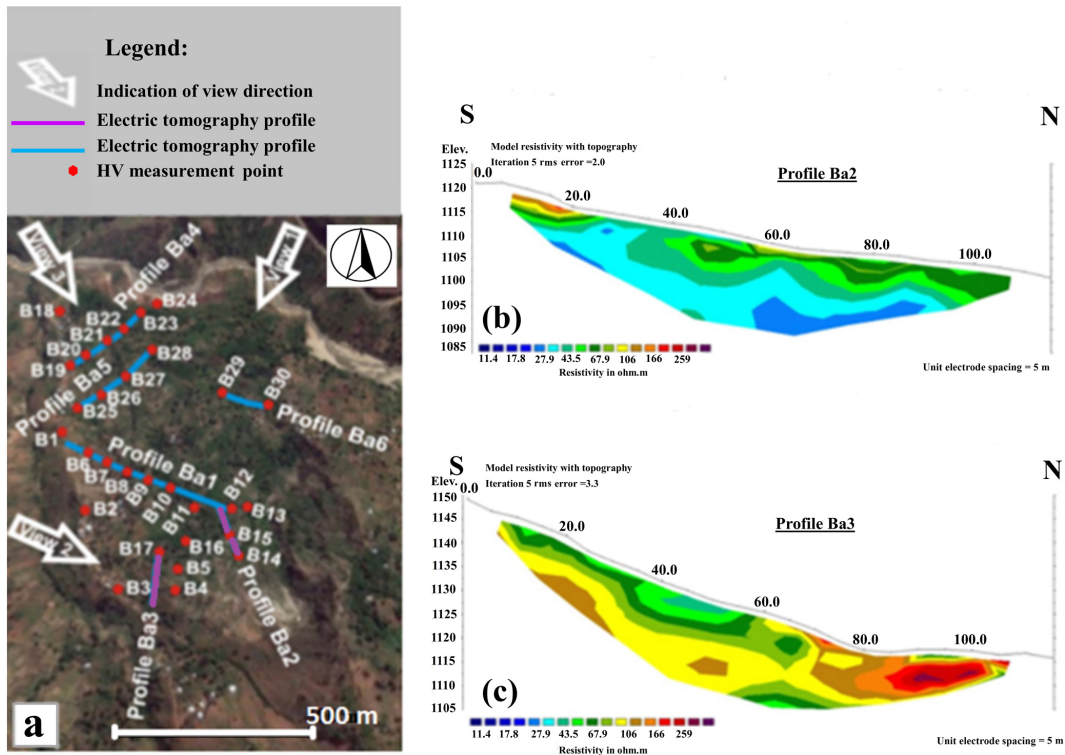
**Figure 5.** The Banana Tree Landslide field measurements: overview of ERT and HV measurement locations (a), ERT profiles Ba2 (b) and Ba3 (c). In panel (a), Ba2 and Ba3 profiles are highlighted in purple.

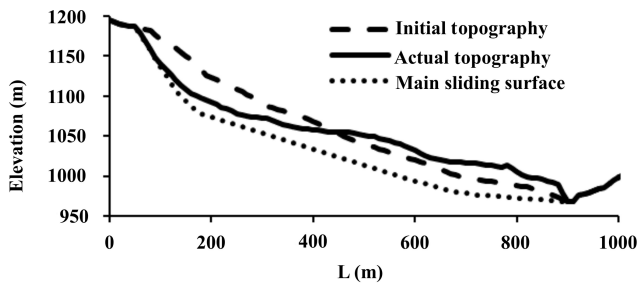
**Figure 6.** Initial and present BTL profiles. The larger thickness of the present profile in the downstream part of the model is a result of the relative lift-up after a trans-rotational sliding and material accumulation from the upper parts of the initial profile.

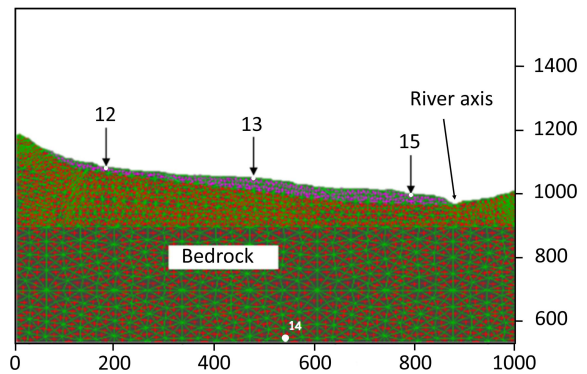
**Figure 7.** Materialization of blocks, joints and materials for the actual model. History (measurement) points 12, 13 and 15 (white dots) located, respectively, on the upper, middle and lower blocks correspond to the surface area where parameters were monitored (e.g. the  $x$  acceleration). Point 14 is located at the base of the model, within the bedrock. The axis of the Kanyosha River is located to the right of history point 15.

points 12, 13 and 15 in Fig. 7, which are located on the upper, middle and lower blocks, respectively). Cracks (joints) included between the blocks (that represent also main geomorphic and geophysical units observed in the field) allow for the simulation of a more flexible movement of the mass. The same material (material 1 in Table 1) was attributed to all landslide blocks. It corresponds to the average type of the material found within the landslide. The original material of BTL is a gneiss which, by weathering, is partially trans-

formed into a clay on the surface. The depth of the weathered layer is about 20 m. The study area experiences alternations between dry and rainy seasons. The long dry season (from June to September) is followed by the small rainy season (from October to December), then by the small dry season (during the months of January and February). The cycle ends with the strong rainy season from March to May, just before the return of the dry season. Since the photos in Fig. 2 were taken in October, the ground was relatively wet but not as wet as is usually the case in December and during the strong rainy season. Especially for the lower parts of the landslide, the humidity is never very low due to the recharge of the water table by the ponds of water located on the landslide. On the other hand, the groundwater recharge follows the dynamics of the seasons. In the context mentioned above, the action of the rainy season in the body of the landslide is quickly remarkable, due to the higher amounts of infiltrating water. Material 2 was attributed to the stable bedrock (Table 1 and Fig. 7).

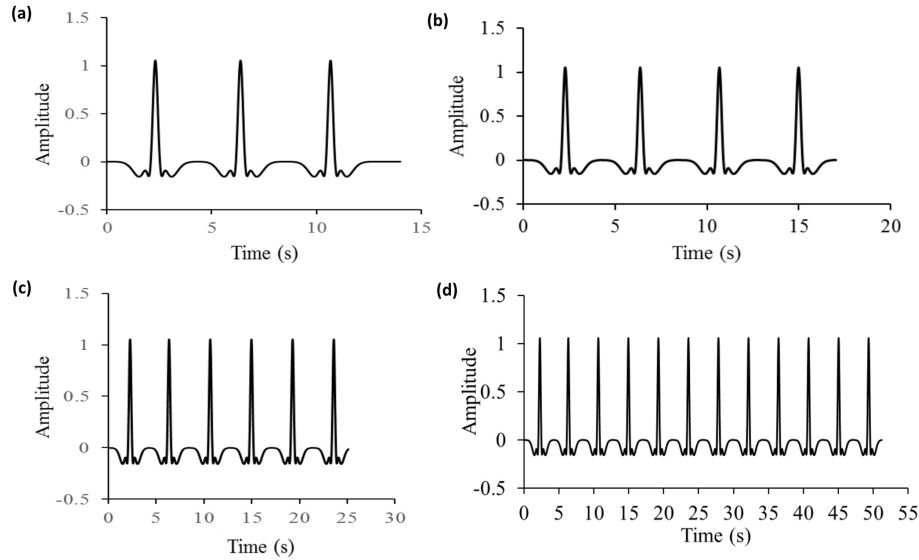
**Figure 8.** Four signals of changing duration and composed of Ricker wavelets (here with normalized amplitude), corresponding to 14 s (a), 17 s (b), 25 s (c) and 51 s (d), were used as seismic inputs.

Actually, a partial contribution of earthquake shaking to the destabilization of the slope is highly probable as the site is located in a seismically active area (see last seismic hazard maps of the western branch of the East African Rift by Delvaux et al., 2016). Data availability helps to refer to an existing database and case studies within the study area. Unfortunately, in the context of data scarcity in the region (for instance, there are no strong motion records available for the target area), it is not easy to fix suitable unique values for predictions. This was handled by the use of four shaking duration values to well illustrate the behaviour of the model corresponding to different scenarios. The seismic context was analysed on the basis of earthquake data from the Global Seismographic Network stations of the Incorporated Research Institutions for Seismology (IRIS) on the Lake Tanganyika region. Therefore, based on that situation, we applied a Ricker wavelet with maximum amplitude of 0.105 g (about 1.05 m s<sup>-2</sup>) and central frequencies of 0.5 and 1.4 Hz. The loading was varied in terms of changing shaking duration. Four different values were considered: 14, 17, 25 and 51 s. Figure 8 provides the corresponding signals.

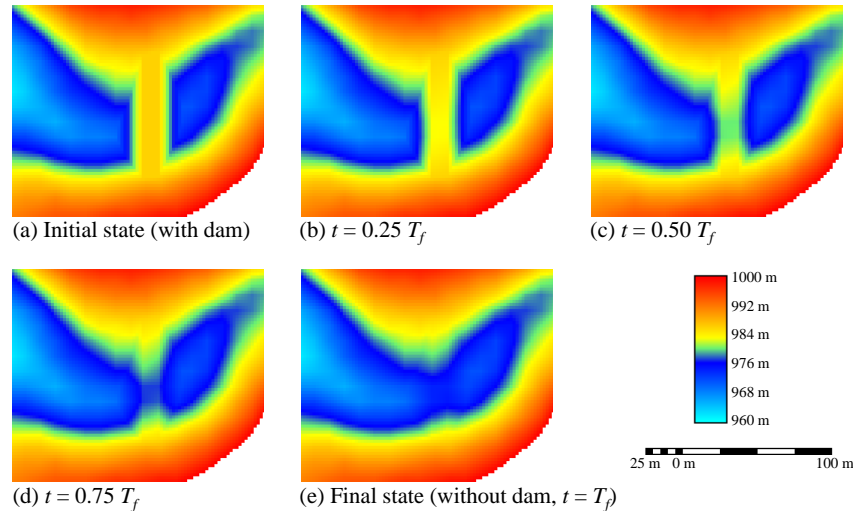
**Figure 9.** Plane view of the topography evolution in the near field of the landslide dam as a function of time ( $T_f$  stands for the breach formation time).

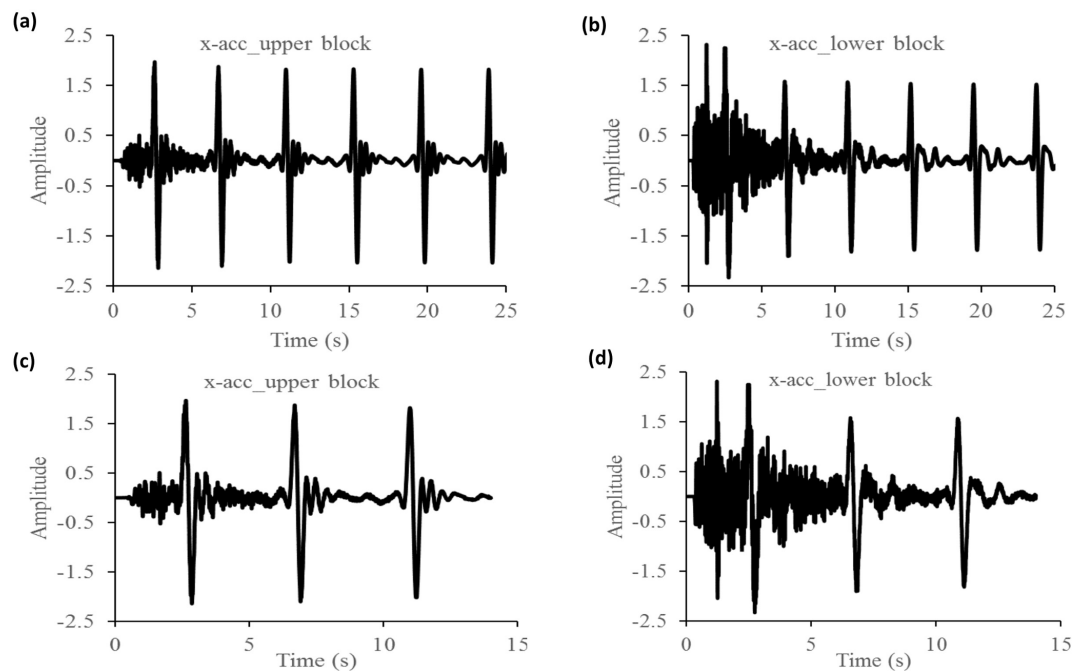
**Figure 10.**  $x$  acceleration for 25 s (a, b) and 14 s (c, d) computational time. Accelerations labelled as “ $x$ -acc\_lower block” and “ $x$ -acc\_upper block” correspond, respectively, to history points 15 and 12 mentioned in Fig. 7.

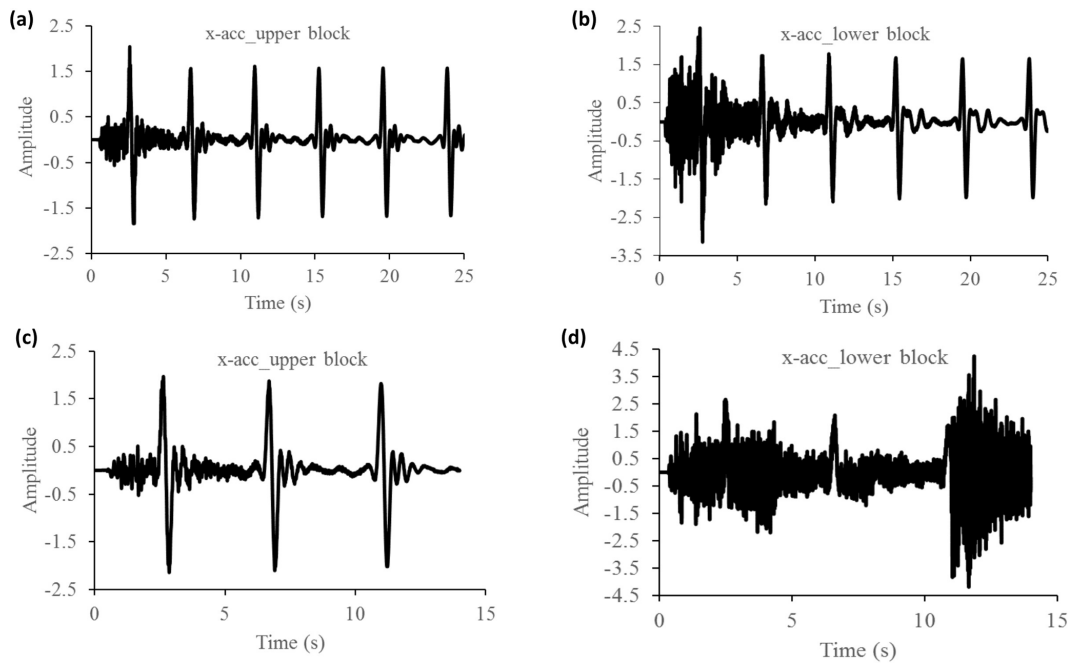
**Figure 11.** Actual *x* acceleration for 25 s (a, b) and 14 s (c, d) computational time.

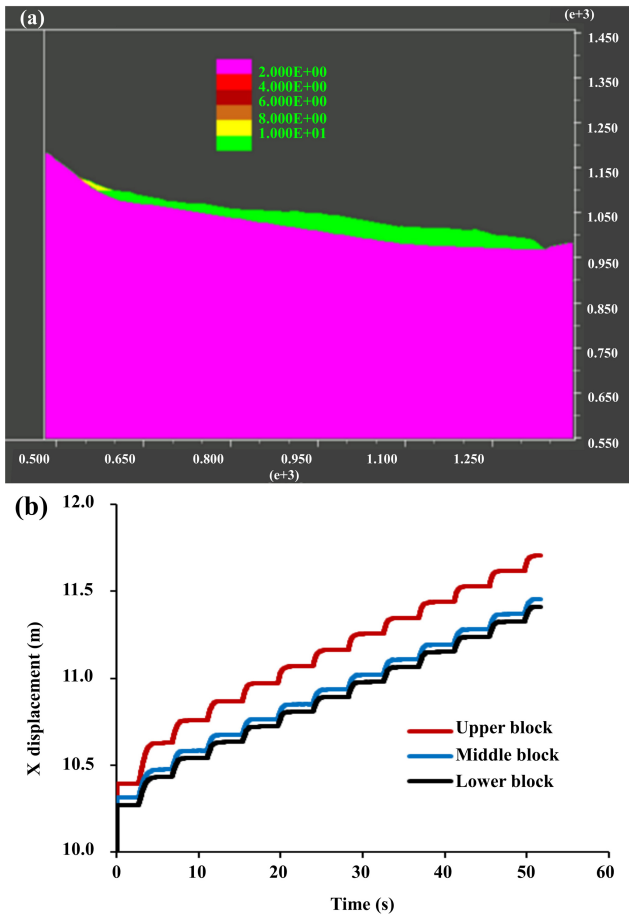
**Figure 12.** Plots of blocks (a) and displacements (b) as given in the UDEC output for run 13 (see Fig. S1b: using a cohesion of 0.01 MPa and a seismic shaking of 51 s).

The model sometimes provided disproportionate displacements between the three main blocks (Fig. 12b). This leads to compression and shear zones between the blocks and could even probably be the main cause of the spurts of groundwater to form the small lakes hanging up the Kanyosha River.

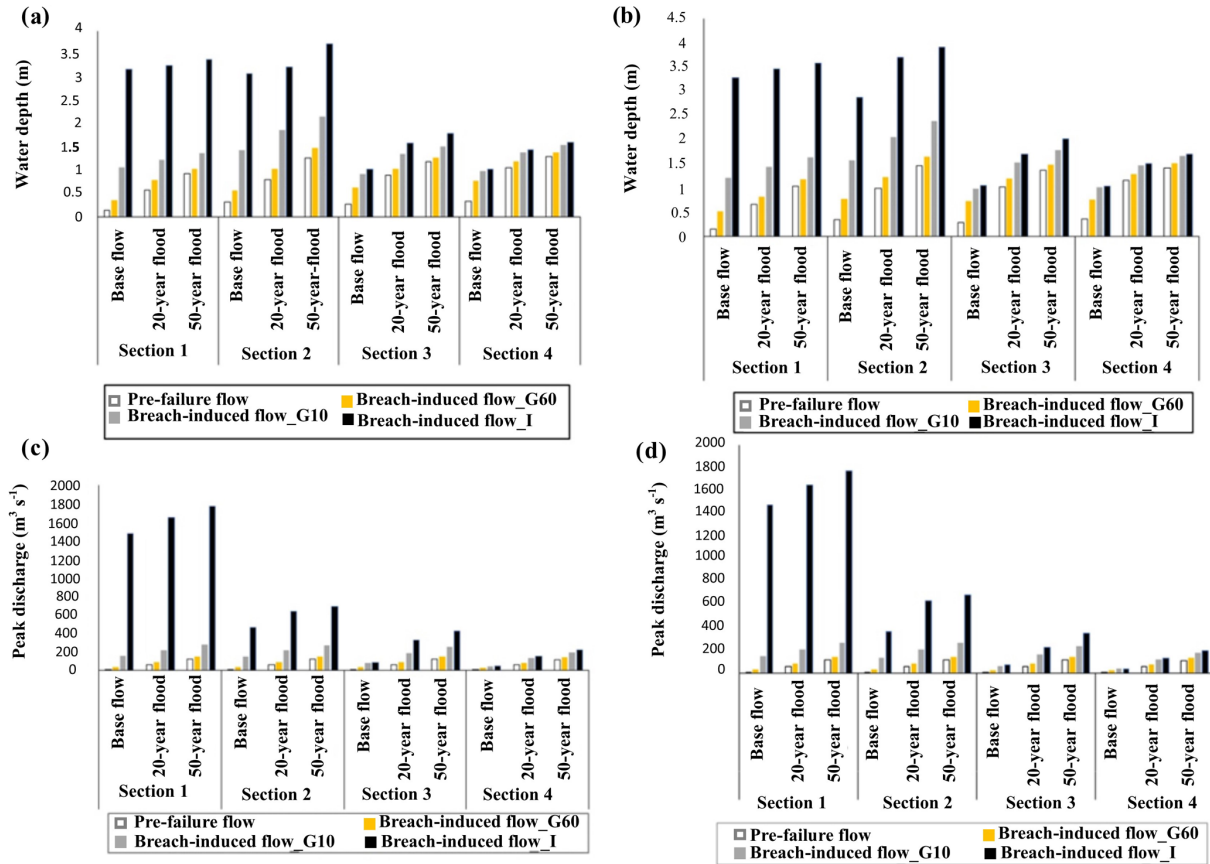
**Figure 13.** Computed maximum water depths (a, b) and peak discharges (c, d) in cross sections 1 to 4, for various pre-failure flow conditions (base flow, 20- and 50-year floods) and for roughness heights  $k_s = 0.1 \text{ m}$  (a, c) or  $0.3 \text{ m}$  (b, d). “Breach-induced flow\_G60”, “breach-induced flow\_G10” and “breach-induced flow\_I” stand for “flow induced by the failure of the landslide dam” with, respectively, a breaching time of 60 min, a breaching time of 10 min and an instantaneous failure.

the breach-induced flow, for sections 1 to 4, considering a roughness height of 0.1 m (Fig. 13a) and 0.3 m (Fig. 13b), as well as three pre-failure flow scenarios (base flow, 20-year flood and 50-year flood).

Nonetheless, in all cases, the increases in water depth as a result of dam breaching remain highly significant from the perspective of flood risk. These results show that dam breaching exacerbates considerably the flood conditions in the downstream river. This conclusion remains robust despite the high uncertainties on the roughness parameter. Indeed, as shown in Table 8, changing the roughness has little influence on the relative effect of dam breaching on the water depths. This is also confirmed by the high similarity between Fig. 13a and b.

but the peak flow after dam breaching remains at least 2–10 times larger than typical flood discharges (20- or 50-year floods) and can be 100 times larger than the base flow in the river. These results are only slightly affected by a change in the roughness height.

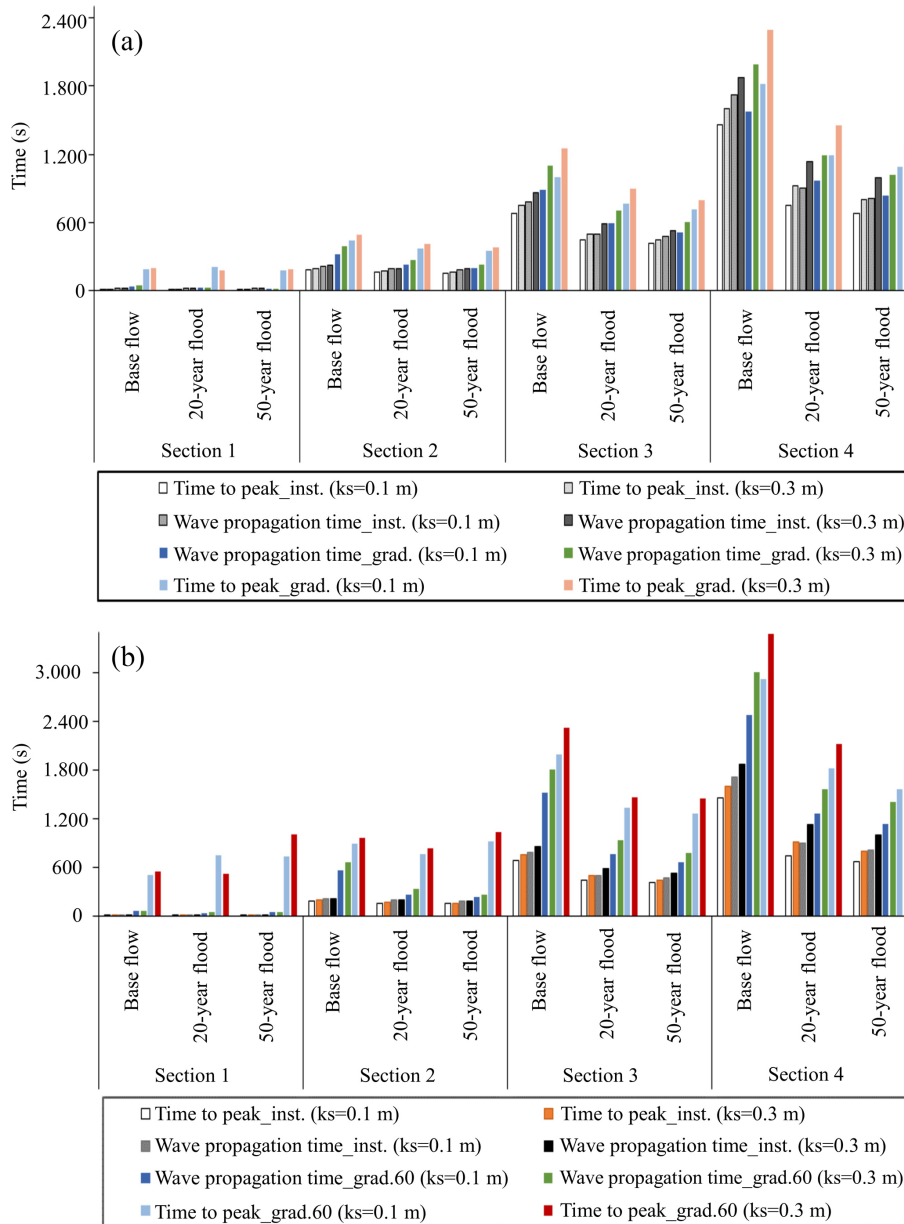
**Figure 14.** (a) Computed wave propagation time and time to peak in sections 1 to 4, for various pre-failure flow conditions (base flow, 20- and 50-year flood) and for two different roughness heights ( $k_s = 0.1$  m and  $k_s = 0.3$  m). The gradual failure time is 10 min. (b) Computed wave propagation time and time to peak in sections 1 to 4, for various pre-failure flow conditions (base flow, 20- and 50-year flood) and for two different roughness heights ( $k_s = 0.1$  m and  $k_s = 0.3$  m). The gradual failure time is 60 min.

Figure 14 displays the wave propagation time in sections 1 to 4, i.e. the time elapsed between the dam failure and the moment the flood wave reaches the corresponding section of the river. The time to peak, i.e. the time between the dam breaching and the arrival of the peak discharge in the corresponding river sections, is also displayed. Results are shown for two roughness heights,  $k_s = 0.1 \text{ m}$  and  $k_s = 0.3 \text{ m}$ .

Figure 14 shows also the diffusion of the flood wave as it propagates in the valley. While the difference between the wave arrival time and the time to peak is low in sections 1 and 2 (generally below 0.5 min), it reaches 1 to 2 min in section 3 and 2.5 to 4.5 min in section 4. This shows that the flood wave is considerably steeper in the upper part of the valley (sections 1 and 2). Also, the wave remains steeper when dam breaching occurs during a river flood than when it occurs during base flow.

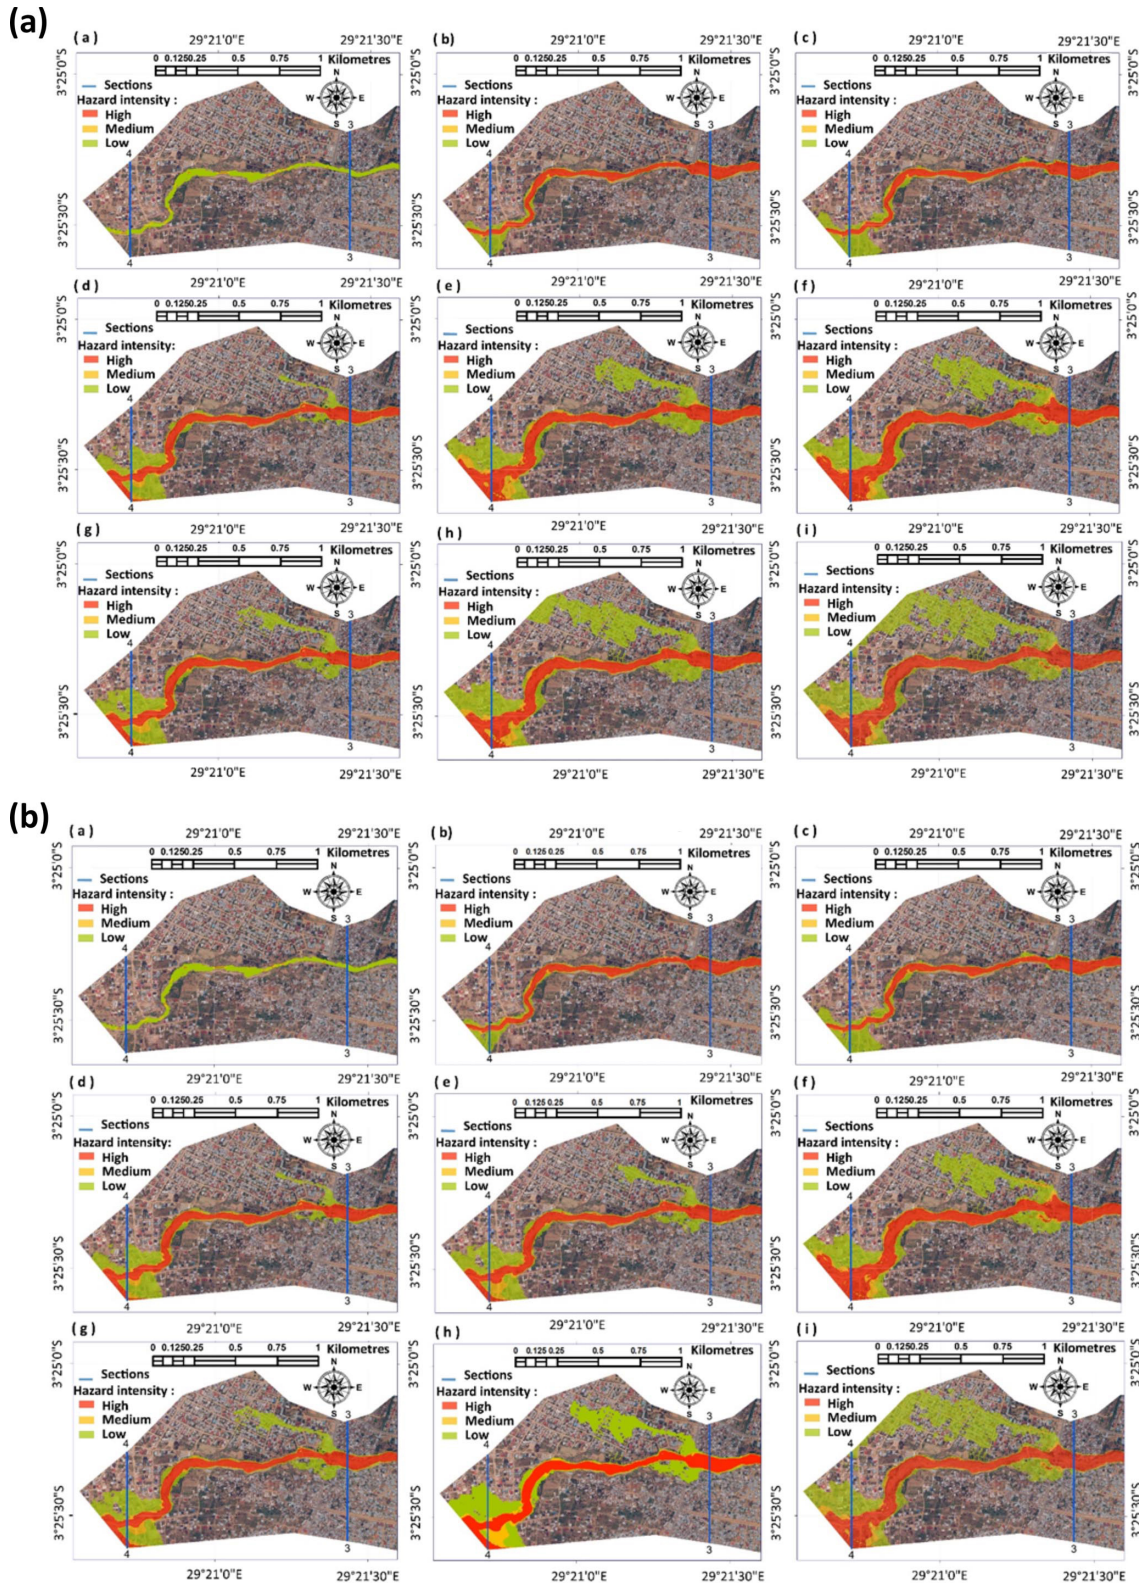
**Figure 15.** Flood intensity maps for various initial steady discharges and roughness: the first column (subfigures a, d, g) corresponds to the pre-failure scenarios, while the second (subfigures b, e, h) and third (subfigures c, f, i) columns relate to the gradual (a 10 min and b 60 min as breaching time) and instantaneous breaching. The first line (subfigures a, b, c) is based on the base flow and a roughness height of 0.1 m. The scenarios of the second line (subfigures d, e, f) are simulated using a 50-year flood and a roughness of 0.1 m. The third line (subfigures g, h, i) is similar to the second one but considers a roughness height of 0.3 m.

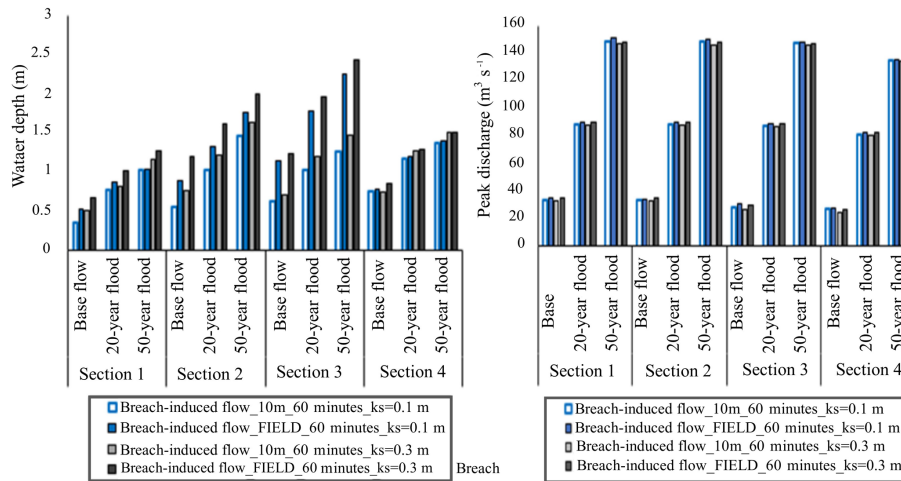
**Figure 16.** Water depth and peak discharge obtained from simulations based on the  $10\text{ m} \times 10\text{ m}$  DEM and from a topographic field survey. The breaching duration is 60 min.
