Landslides density map of S. Miguel Island, Azores archipelago

P. Valadão¹, J. L. Gaspar¹, G. Queiroz¹, and T. Ferreira¹

¹Centro de Vulcanologia e Avaliação de Riscos Geológicos, Departamento de Geociências, Universidade dos Açores, Rua Mãe de Deus, 9501-801 Ponta Delgada, Portugal

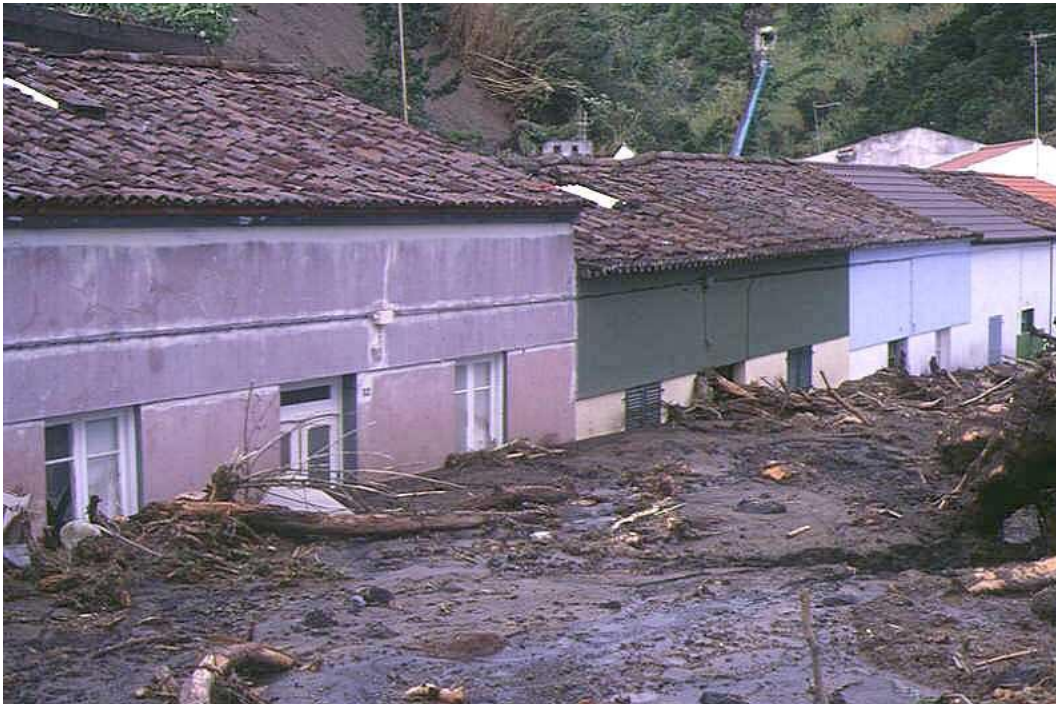
Fig. 6. Houses affected by debris flows during the 1997 Ribeira Quente event.

On 31 October 1997, nearly 1000 landslides occurred on S. Miguel Island, a few of them killing 29 people who were living in the Ribeira Quente village (Fig. 5). Povoação and Nordeste counties were particularly affected during this event (Gaspar et al., 1997; Gaspar and Guest, 1998). Several houses and bridges were partially or totally destroyed, communications, transportation and the energy supply system were disrupted and areas of fertile land became covered by mud (Fig. 6). Ribeira Quente village was isolated for more than 12 h (Fig. 7).

Most of the landslides were essentially very fluid debris flows, consisting of a mixture of water, pumice and ash. Trees with their root systems, tree trunks and branches were included in most deposits. Depending on the source, some debris flows included large blocks of lava.
