# Hydrogeomorphological analysis and modelling for a comprehensive understanding of flash-flood damage processes: the 9 October 2018 event in northeastern Mallorca

**Abstract.** A flash-flood event hit the northeastern part of Mallorca on 9 October 2018, causing 13 casualties. Mallorca is prone to catastrophic flash floods acting on a scenario of deep landscape transformation caused by Mediterranean tourist resorts. As global change may exacerbate devastating flash floods, analyses of catastrophic events are crucial to support effective prevention and mitigation measures. Field-based remote-sensing and modelling techniques were used in this study to evaluate rainfall–runoff processes at the catchment scale linked to hydrological modelling. Continuous streamflow monitoring data revealed a peak discharge of  $442 \text{ m}^3 \text{ s}^{-1}$  with an unprecedented runoff response. This exceptional behaviour triggered the natural disaster as a combination of heavy rainfall (249 mm in 10 h), karstic features and land cover disturbances in the Begura de Salma River catchment ( $23 \text{ km}^2$ ). Topography-based connectivity indices and geomorphic change detection were used as rapid p

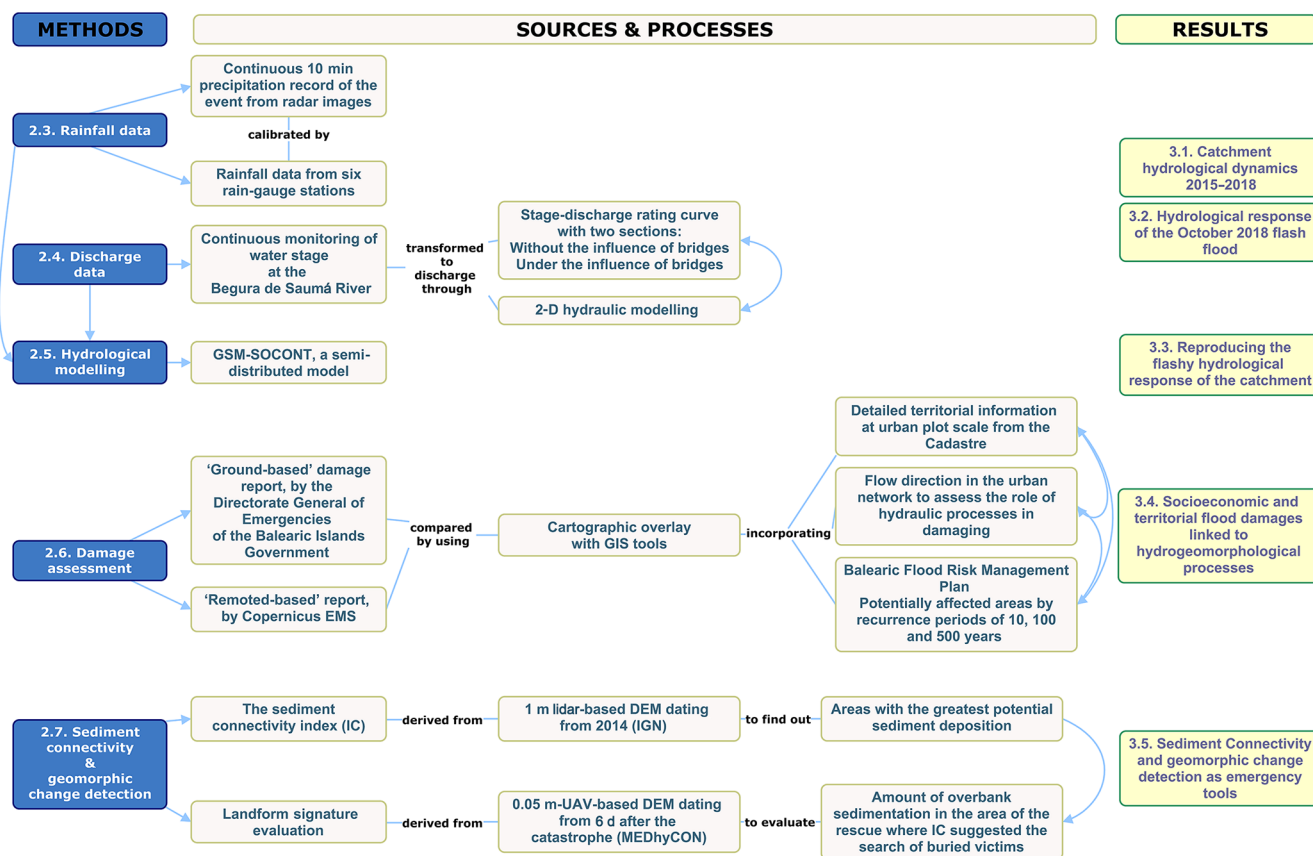
Figure 1. Workflow of the experimental design.

charge was developed through the analysis of the rainfall–runoff processes at a small spatial scale during this extreme event. Likewise, this analysis was linked to hydrological modelling to check the internal consistency of the information gathered by instruments and to flood damage and losses at the village of Sant Llorenç des Cardassar. Finally, HR-DTMs were generated by lidar 2014 data from the Spanish National Geographic Institute and by imagery captured through a low-cost UAV just 6 d after the catastrophe, to calculate a sediment connectivity index (IC) and measure geomorphic changes (Fig. 1).

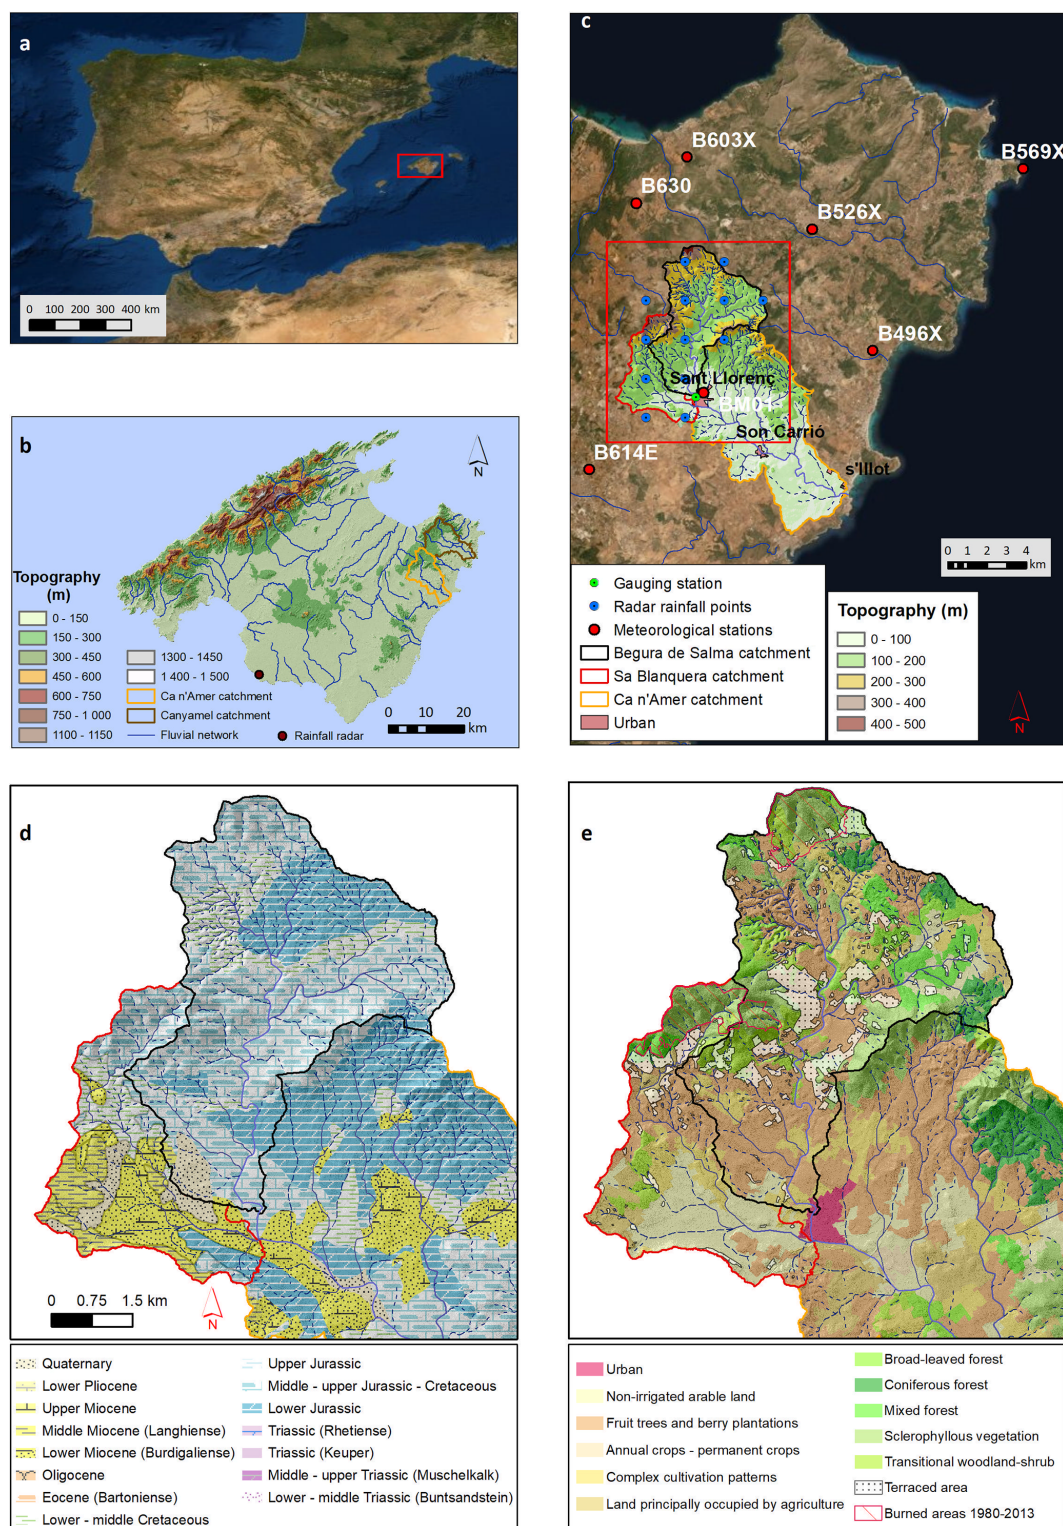
**Figure 2.** Main characteristics of affected basins during the 9 October 2018 flash flood. **(a)** Location of Mallorca in the western Mediterranean. **(b)** Topography and fluvial network of Mallorca with the location of the main basins affected: Canyamel and Ca n'Amer rivers. **(c)** Sa Blanca and Begura de Salma headwater river catchments within the Ca n'Amer River, with locations of rainfall and hydrometric stations; and radar rainfall points derived from a regular mesh of  $1 \times 1$  km. Source: <https://opendata.aemet.es> (last access: 15 May 2020). Background: aerial photography and DTM data (PNOA, 2015). **(d)** Lithology of both the Sa Blanca and Begura de Salma catchments. **(e)** Land use and terraced areas for the same headwater catchments. Source: Corine Land Cover (2018).

The 9 October storm affected the two northernmost catchments of Llevant county, i.e. the Ca n'Amer and Canyamel rivers (Fig. 2) with nine and four casualties, respectively, and significant damage. The synoptic situation was characteristic

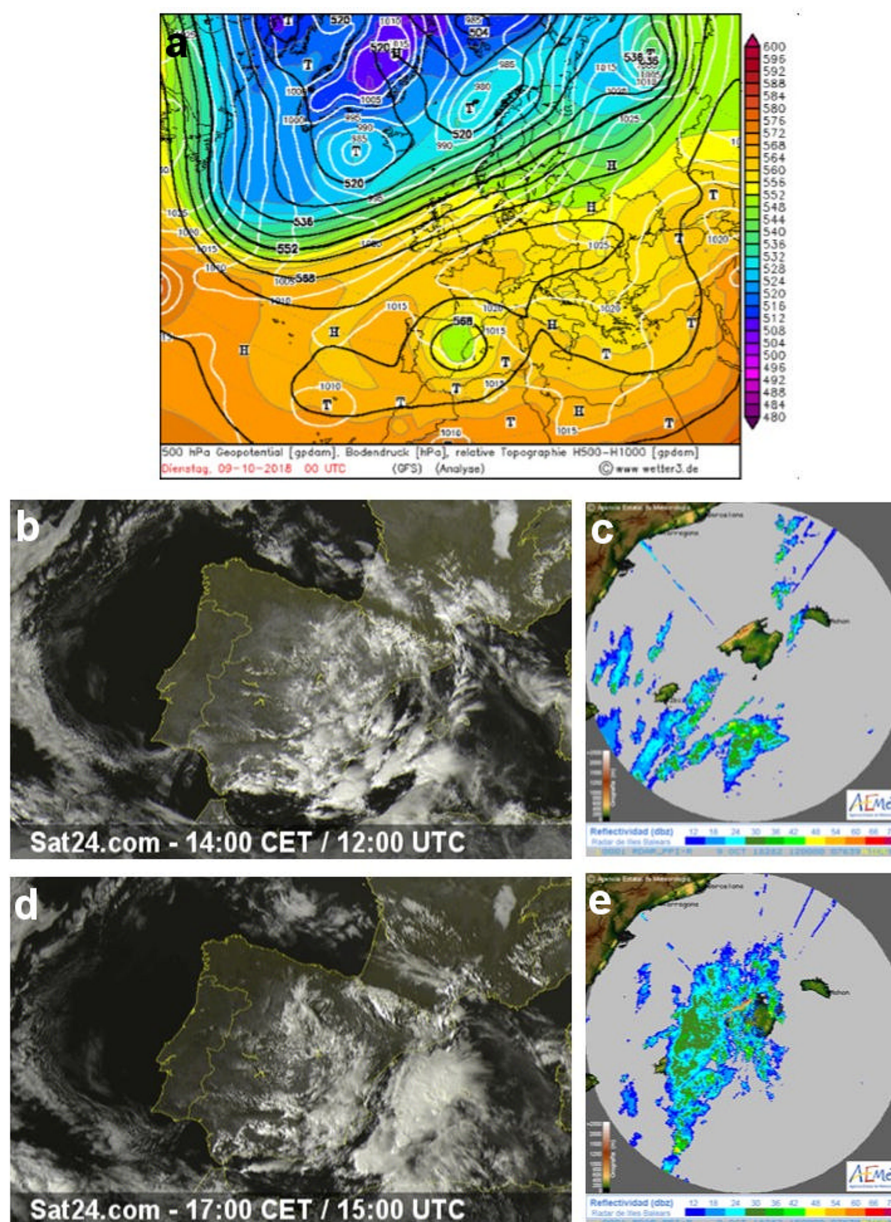
**Figure 3.** (a) Surface pressure and 500 hPa height analyses at 12:00 UTC on 9 October 2018 (source: <http://wetter3.de> (last access: 15 May 2020)), i.e. at the beginning of the precipitation event. Satellite image at (b) 12:00 UTC and (d) 15:00 UTC (source: <http://www.sat24.com>, last access: 15 May 2020). EUMETSAT and radar images are shown for the same hours (c, e) (source: <http://www.aemet.es>, last access: 15 May 2020).

of flash-flood events in the Western Mediterranean (Fig. 3a). A cut-off low at midlevel was located in the eastern part of the Iberian Peninsula and shallow low-level pressure affected the same region, driving warm and wet air from the Mediterranean Sea to the Balearic Islands and the eastern part of the Iberian Peninsula. This occurred in early October, when the sea surface temperature is close to its annual maximum in the Western Mediterranean, providing high quantities of moisture. Moreover, the cut-off low showed a typical divergence at midlevel on its eastern flank, affecting the Balearic Islands and favouring the development of deep convection. Convection started on the sea between the Balearics and the Iberian Peninsula (Fig. 3b and c) and, due to SW winds at mid-tropospheric levels, the convective cells started to move towards the Balearics, where heavy rainfall triggered the flash-flood event (Fig. 3d and e).

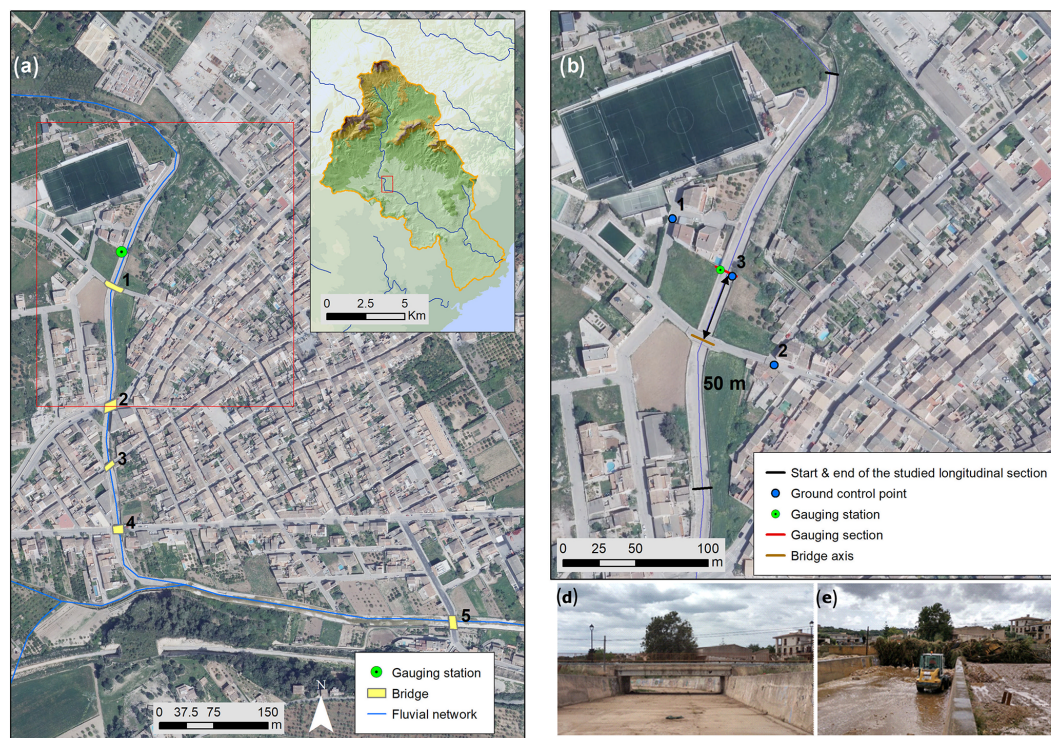
**Figure 4.** (a) Aerial view of the concrete channel of the Begura de Salma River that crosses the village of Sant Llorenç des Cardassar and the location of bridges. (b) Detailed aerial view of the very beginning of this concrete channel, where the hydrometric station is located. The photographs show a view of bridge 1 from the hydrometric station when (d) the digital equipment was installed on 10 June 2015 and (e) a few hours after the flash flood, on 10 October 2018. Background: aerial photography and DTM data (PNOA, 2015).

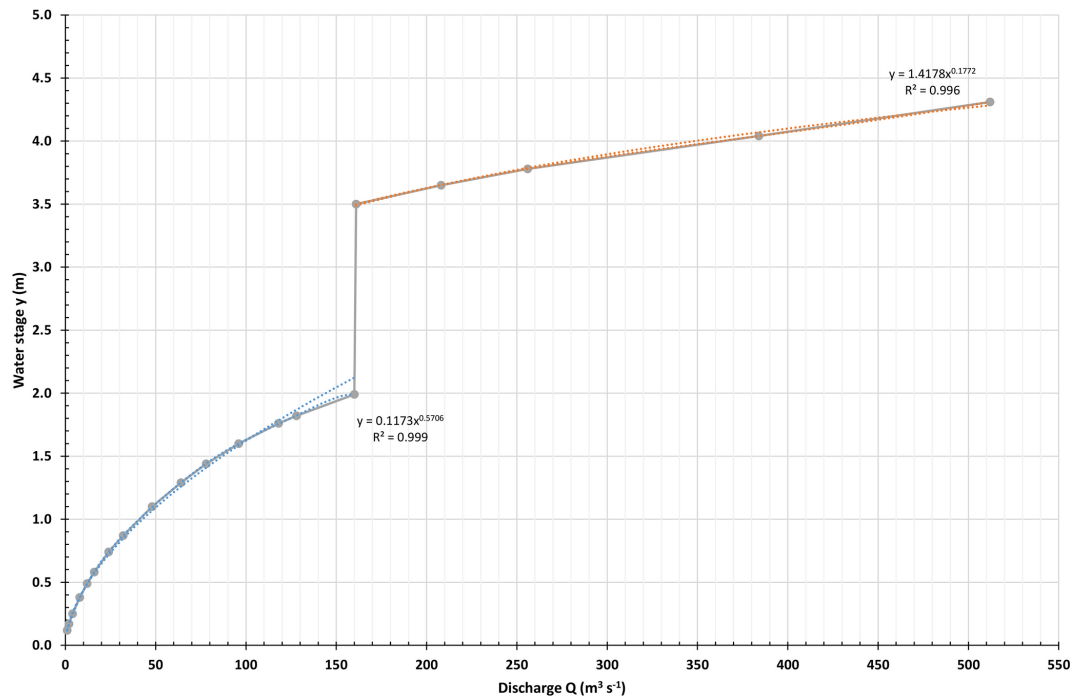
**Figure 5.** Stage–discharge rating curve performed by means of two-dimensional hydraulic modelling with two differentiated sections in accord with the influence of bridge 1 (see Fig. 3a) and its potential obstruction.

The SDRC was finally designed (see Fig. 5), showing clearly the two differentiated sections with a gap between them in WS of approximately 1.5 m because 1.4 m is the edge of road bridge 1 located just 50 m downstream from the hydrometric station. The SDRC is fitted to a power equation for both sections, obtaining high values of significance ( $R^2 > 0.990$ ). Thus, in the case of the first section of the SDRC, the adjustment was  $R^2$  of 0.999, operating in open-channel flows up to  $160 \text{ m}^3 \text{ s}^{-1}$  in bankfull conditions or even overbanking the channel but always without the bridges' influence. The second section, with a  $R^2$  of 0.996, defined for  $Q > 160 \text{ m}^3 \text{ s}^{-1}$ , was already influenced by the presence of the bridges, i.e. in open-channel flows but conditioned by the backwater generated in the flow under pressure inside the span of bridge 1 as well as over its concrete decks.

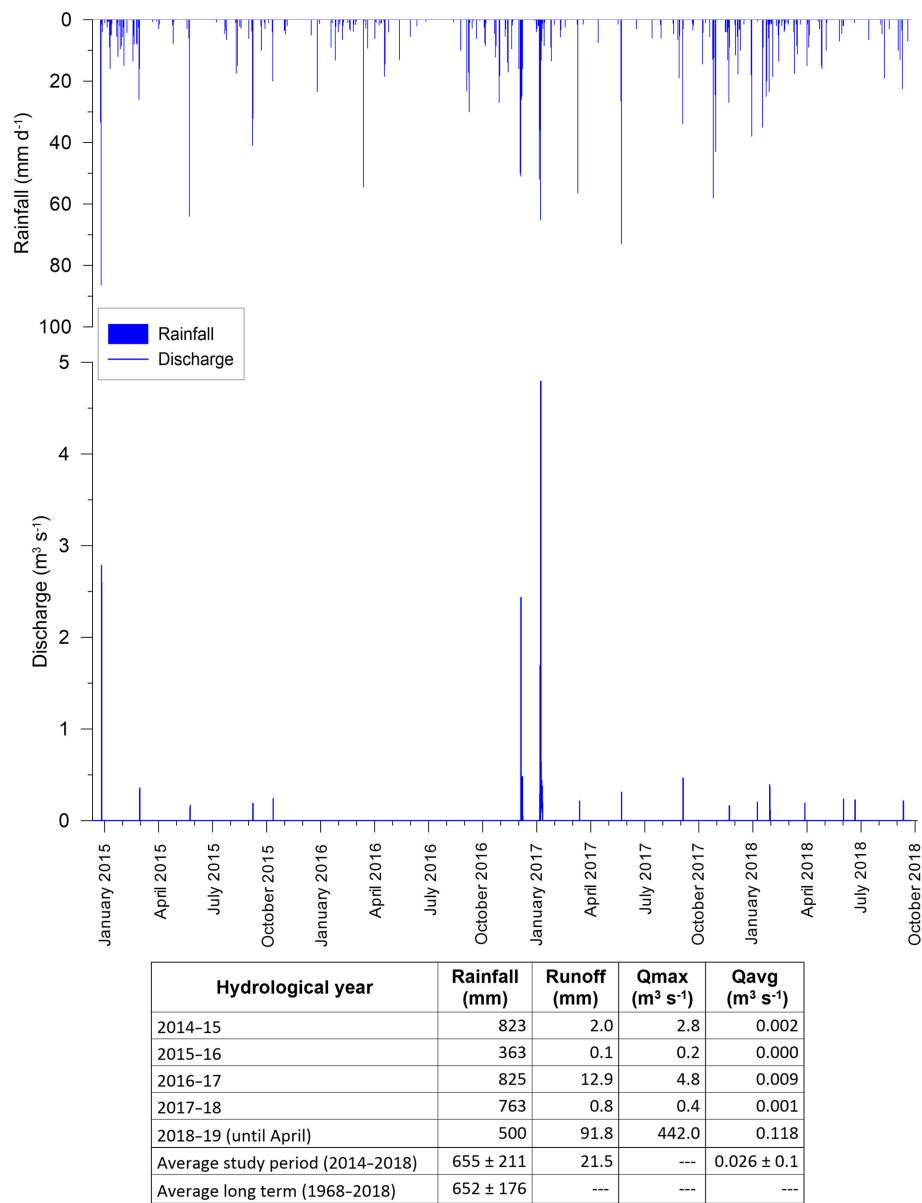
**Figure 6.** Discharge at 15 min intervals measured at the MEDhyCON hydrometric station located at the beginning of the concrete channel of the Begura de Salma River in Sant Llorenç des Cardassar. Likewise, the daily rainfall measured at the AEMET-B630 Ses Pastores during the monitored period (10 January 2015–30 September 2018), prior to the catastrophic flash flood of 9 October 2018, is shown. The bottom table displays the rainfall, runoff and peak discharge for hydrological years during study period. Rainfall data are from AEMET-B630 Ses Pastores, located 10.5 km from the Begura de Salma River catchment outlet and representative of the rainfall dynamics of the Llevant range’s headwaters.

The hydrological monitoring period assessed in this paper by using data from the hydrometric station was from 10 January 2015 to 30 September 2018 (Fig. 6). The month of October 2018 was reserved for a singular and deeper study that could describe the catastrophic flash-flood event better (see results, Sect. 3.2). This gives a series of almost 4 hydrological years under hydrometeorological conditions illustrating ephemeral behaviour of the Begura de Salma River that was average in terms of precipitation (see the inset table, Fig. 6). In terms of  $Q$ , this inset table also shows the behaviour during the study period of several hydrological parameters. However, these values cannot be compared in the long term due to errors of up to 2 orders of magnitude in  $Q$  values measured by the hydrometric network managed by the Balearic Islands Government (see Fortesa et al., 2019). Events of different magnitudes occurred during this study period, some of them representative of recurrence  $\approx 5$  years in terms of rainfall. However, only two events recorded peak  $Q$  (hereafter  $Q_{\text{peak}}$ ) values  $> 1 \text{ m}^3 \text{ s}^{-1}$ , both occurring in January, when the hydrological pathways were fully active due to saturation processes. In January 2015, 120 mm of rainfall in 48 h at the AEMET-B630 Ses Pastores rainfall station (see location in Fig. 2) created a flow response with a  $Q_{\text{peak}}$  of  $2.8 \text{ m}^3 \text{ s}^{-1}$ . Finally, in January 2017, 153 mm of rain fell in 72 h with a  $Q_{\text{peak}}$  of  $4.8 \text{ m}^3 \text{ s}^{-1}$ , the maximum recorded at the hydrometric station during the study period before the catastrophic flash flood.

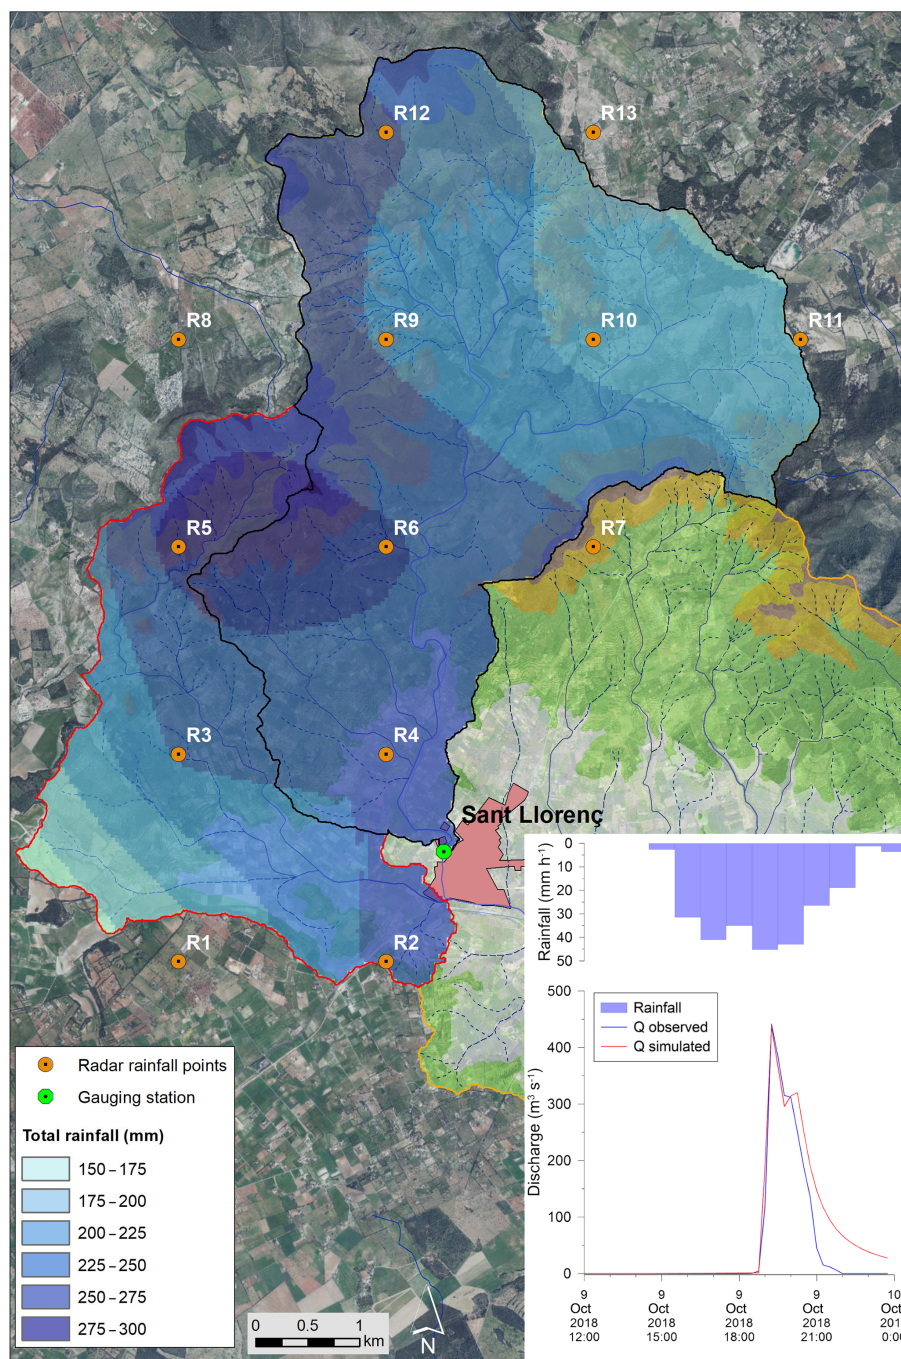
**Figure 7.** Map of isohyets of the rain storm of 9 October 2018 in the two headwater catchments of the Ca n' Amer River, i.e. the Sa Blanquera River and Begura de Salma River. Source: 10 min radar images obtained from the web <https://opendata.aemet.es/> (last access: 15 May 2020). The inset figure shows the discharge measured at the MEDhyCON hydrometric station, as well as the result of the rainfall-runoff simulation using a modified version of the GR3 model. Background: aerial photography and DTM data (PNOA, 2015).

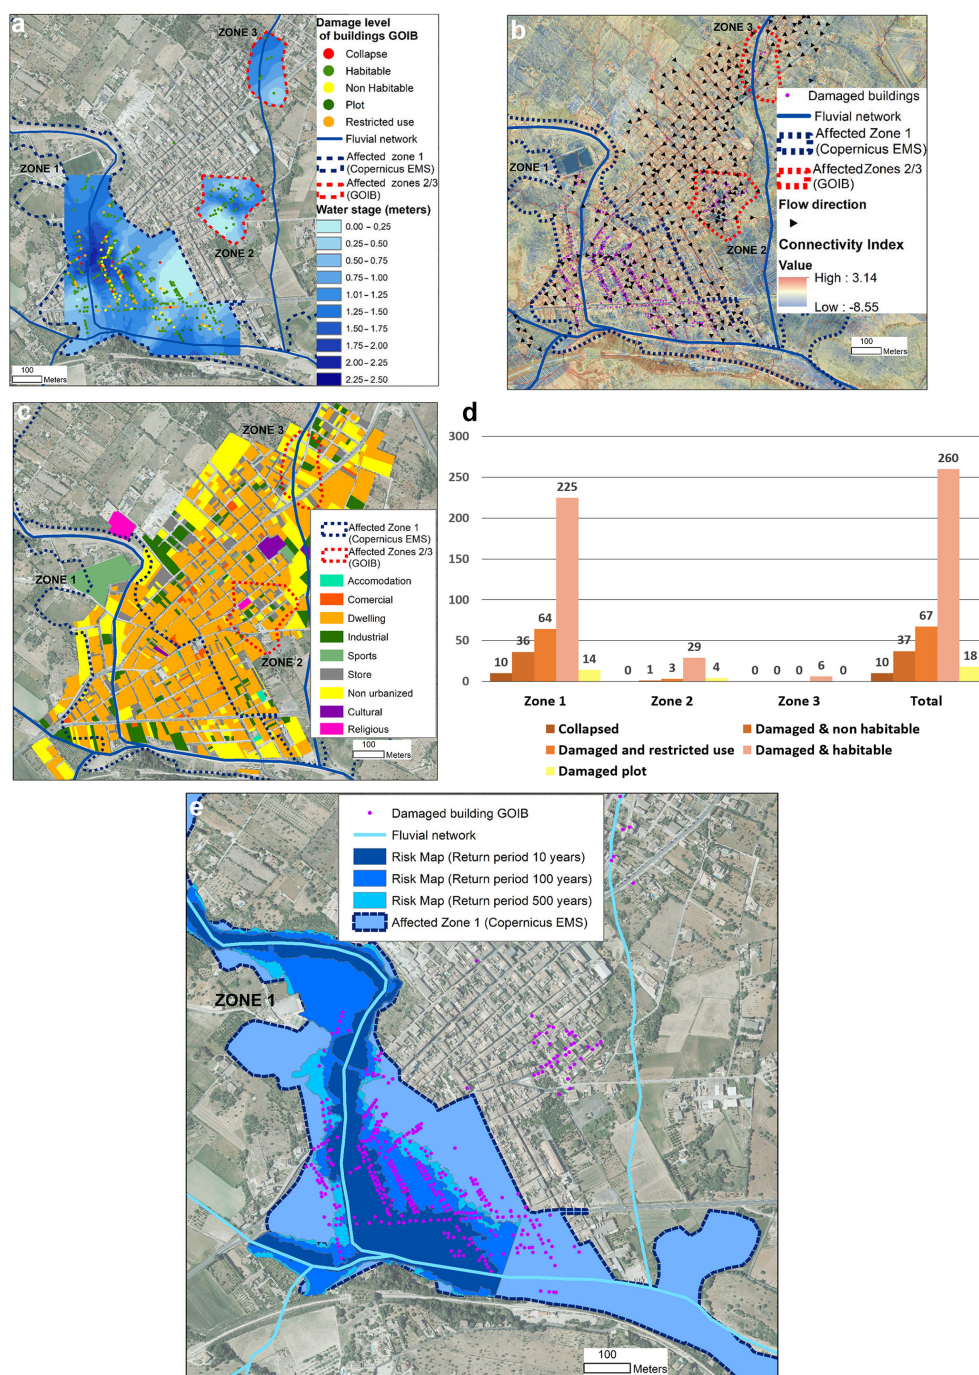
**Figure 8.** (a) Map of the damage level classification of buildings and water stage reached in the different affected zones at Sant Llorenç des Cardassar according to the Balearic Islands Autonomous Government, in comparison to the flood delimitation by Copernicus EMS. Flow direction and hydrological connectivity in the affected zones (b) (1, 2 and 3) in the Sant Llorenç des Cardassar urban network. (c) Economic activities by building in the urban area of Sant Llorenç des Cardassar and the delimitation of affected zones by the flash flood. (d) Damage level classification of buildings in the different affected zones in Sant Llorenç des Cardassar. (e) Official flood risk maps and flood delimitation by Copernicus EMS in the village of Sant Llorenç des Cardassar with the location of buildings affected by the flash flood of 9 October 2018. Background: aerial photography (PNOA, 2015). In Fig. 7d, the source of land use at the urban plot scale is the General Directorate for the Cadastre (<http://www.sedecatastro.gob.es/>, last access: 15 May 2020).

A territorial and hydrological analysis of the damage assessment is developed here. The location of the affected buildings and the WS reached in the streets and buildings provided by the emergencies department of the Balearic Islands Government and by the Copernicus EMS enabled three affected zones within the urban area of Sant Llorenç des Cardassar to be mapped (Fig. 8a). Zone 1 was due to the overbank flow of the Begura de Salma River and corresponded mostly to the affected areas defined by the Copernicus EMS. In this zone (1), the highest WS in the streets was reached, exceeding 3.3 m. Zones 2 and 3 were those urban areas affected by the overbank flow of the Sa Muntanyeta creek, located in the northernmost area of the village. The streets of Sant Llorenç des Cardassar rerouted the overbank flow from both the Begura de Salma River and the Sa Muntanyeta creek (Fig. 8b), causing significant damages to vehicles and movable public property. In addition, as most of the buildings in Sant Llorenç des Cardassar use the ground floor as a home or business, the event caused major flooding by water and mud that made their use impossible and required cleaning and restoration. According to the Balearic Islands Government, 392 damaged buildings and plots were inventoried in the urban area of Sant Llorenç des Cardassar, most of them in zone 1 (Fig. 8c and 8d). The flow direction illustrated how the north-to-south direction, parallel to the Begura de Salma River, caused most damage in zone 1, with 349 affected buildings and a WS average of approximately 1.03 m. Zones 2 and 3 had lower-intensity damage, with 37 and 6 affected buildings and a maximum WS of 1.80 m and 1.60 m, respectively. In these zones (2 and 3), the flow direction had no clear pattern because the Sa Muntanyeta creek has a small catchment (2.2 km<sup>2</sup>) and the urban street network and plots are not parallel to its natural flow direction.

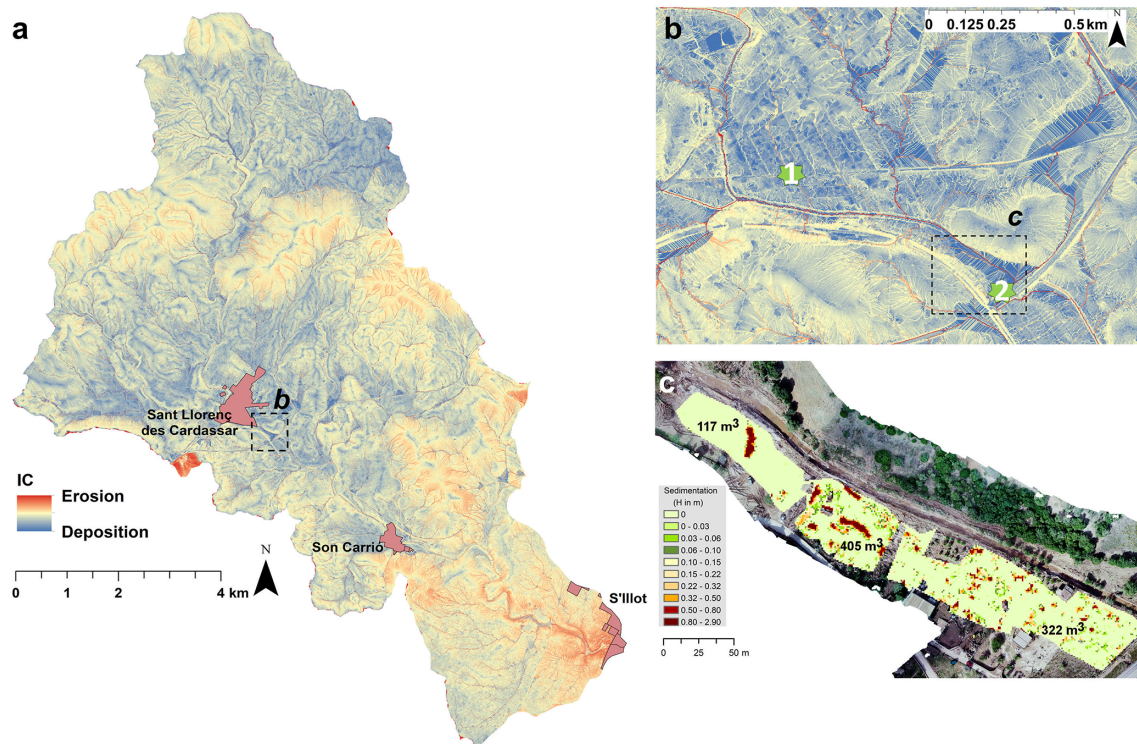
**Figure 9.** Spatial patterns of hydrological and sediment connectivity (deposition zones in blue colours) (a) in the Ca n'Amer River basin, (b) in the southeastern part of Sant Llorenç des Cardassar with numbers indicating (1) the point where the missing person was last seen and (2) where this person was found by using this connectivity index from a 2 m resolution digital terrain model (DTM) (Instituto Geográfico Nacional, 2014). (c) Overbank sedimentation estimated after the flash flood from a DTM performed with SfM from a UAV flight (15 October 2018) in relation to the ground points of the 2014 lidar data. Background aerial orthophotography of approximately 2 cm resolution also obtained from the drone images. Numbers indicate the total volume of deposited sediments in the three areas measured.
