Brief communication: Critical infrastructure impacts of the 2021 mid-July western European flood event

Abstract. Germany, Belgium and the Netherlands were hit by extreme precipitation and flooding in July 2021. This brief communication provides an overview of the impacts to large-scale critical infrastructure systems and how recovery has progressed. The results show that Germany and Belgium were particularly affected, with many infrastructure assets severely damaged or completely destroyed. Impacts range from completely destroyed bridges and sewage systems, to severely damaged schools and hospitals. We find that (large-scale) risk assessments, often focused on larger (river) flood events, do not find these local, but severe, impacts due to critical infrastructure failures. This may be the result of limited availability of validation material. As such, this brief communication not only will help to better understand how critical infrastructure can be affected by flooding, but also can be used as validation material for future flood risk assessments.

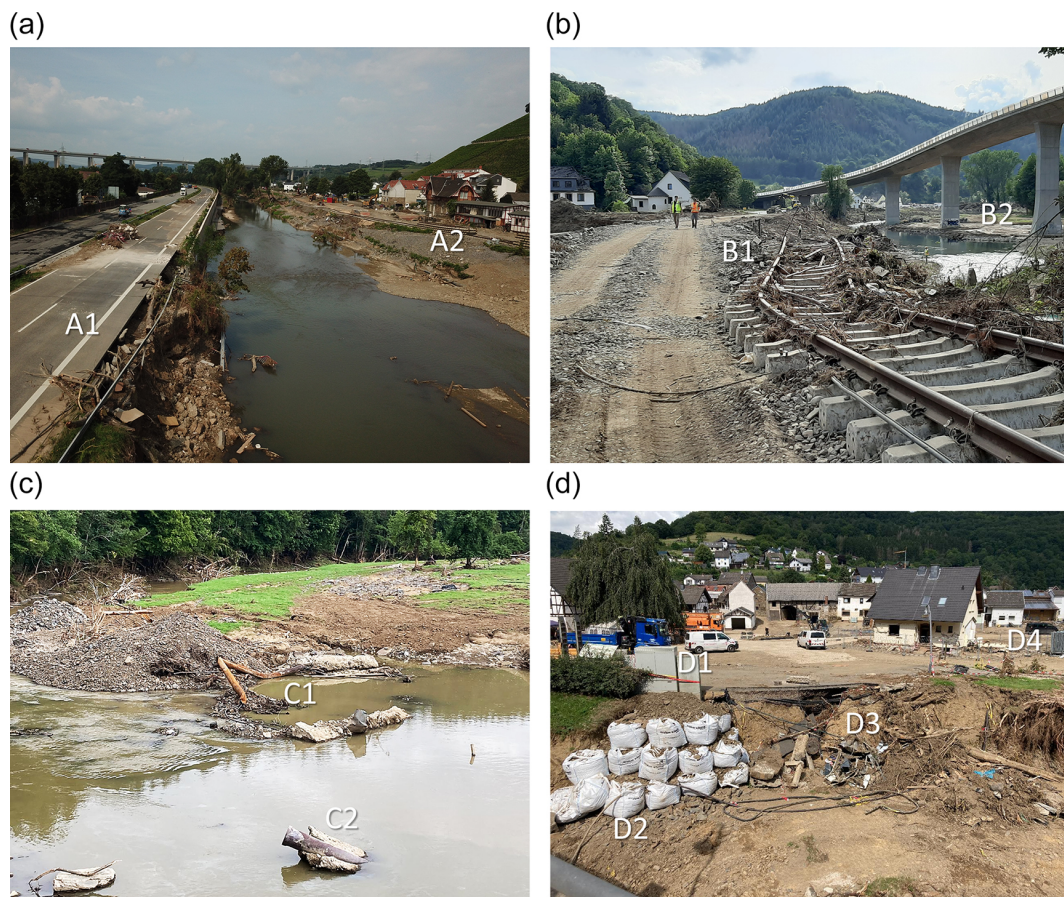
Figure 1. Damage in the Ahr valley, Germany (images taken on 11 August 2021). (a) Destruction of federal highway B266 (A1) and railway (A2) near Heimersheim. (b) Further upstream in the Ahr valley (Altenburg), large stretches of the Ahrtalbahn railway have been destroyed (B1) and the few remaining road and rail bridges show signs of temporary repairs (B2). (c) Riverbed erosion uncovered and destroyed many cables supposed to lie more than 80 cm below surface level (C1) as well as sewers (C2). (d) Inundated electricity distribution infrastructure (D1), road erosion and stabilization (D2), uncovered cables (D3), and collapsed buildings in Schuld. Pictures by Margreet van Marle/Deltares/GEERassociation, distributed under Creative Commons Attribution 4.0 license.

In Germany, road and railway infrastructure was severely damaged as documented exemplarily in Fig. 1. Cost estimates reach up to EURO 2 billion Euro (MDR, 2021). More than 130 km of motorways were closed directly after the event, of which 50 km were still closed two months later, with an estimated repair cost of EUR 100 million (Hauser, 2021). Of the 112 bridges in the flooded 40 km of the Ahr valley (Rhineland-Palatinate), 62 bridges were destroyed, 13 were severely damaged and only 35 were in operation a month after the flood event (MDR, 2021). Over 74 km of roads, paths and bridges in the Ahr valley have been (critically) damaged. In some cases, repairs are expected to take months to years (Zeit Online, 2021). For example, major freeway sections, including parts of the A1 motorway, were closed until early 2022 (24Rhein, 2022). In addition, about 50 000 cars were damaged, causing insurance claims of some EUR 450 million (ADAC, 2021). The German railway provider Deutsche Bahn expects asset damages of around EUR 1.3 billion. Among other things, 180 level crossings, almost 40 signal boxes, over 1000 catenary and signal masts, and 600 km of tracks were destroyed, as well as energy supply systems, elevators and lighting systems (MDR, 2021). As of 11 April 2022, 14 of the affected rail stretches are fully functional again. The less damaged stretches were functional again within 3 months, while some of the most damaged sections in the Ahr valley are expected to be finished by the end of 2025 (DB, 2022). In Belgium, approximately 10 km of railway tracks and 3000 sleeper tracks have to be replaced; 50 km of catenary needs to be repaired; and 70 000 t of railway track bed needs to be placed, with estimated costs between EUR 30 million–EUR 50 million (Rozendaal, 2021a). Most damages have been repaired within 2 weeks. The most severely damaged railway line (between the villages of Spa and Pepinster) was reopened again on 3 October 2021 (Rozendaal, 2021b). In the Netherlands, no large-scale damage has been reported to transport infrastructure. A few national highways were partly flooded (e.g. the A76 in both directions) or briefly closed (< 3 d) because of the potential of flooding. Most likely due to relative low-flow velocities, damage to Dutch national road infrastructure was limited. Several railway sections were closed (e.g. the rail-

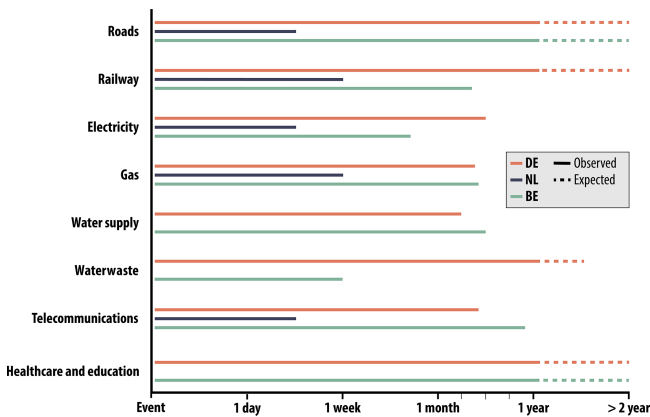
Figure 2. Overview of observed and expected reconstruction duration of each infrastructure sector considered in this study. It should be noted that this figure presents reconstruction efforts of the system. No line indicates that no impacts are observed. Solid waste is not included in the figure, as no impacts were recorded within each country.
