# Flood history in the karst environment of Castellana-Grotte (Apulia, southern Italy)

Mario Parise

National Research Council - IRPI, Bari, Italy

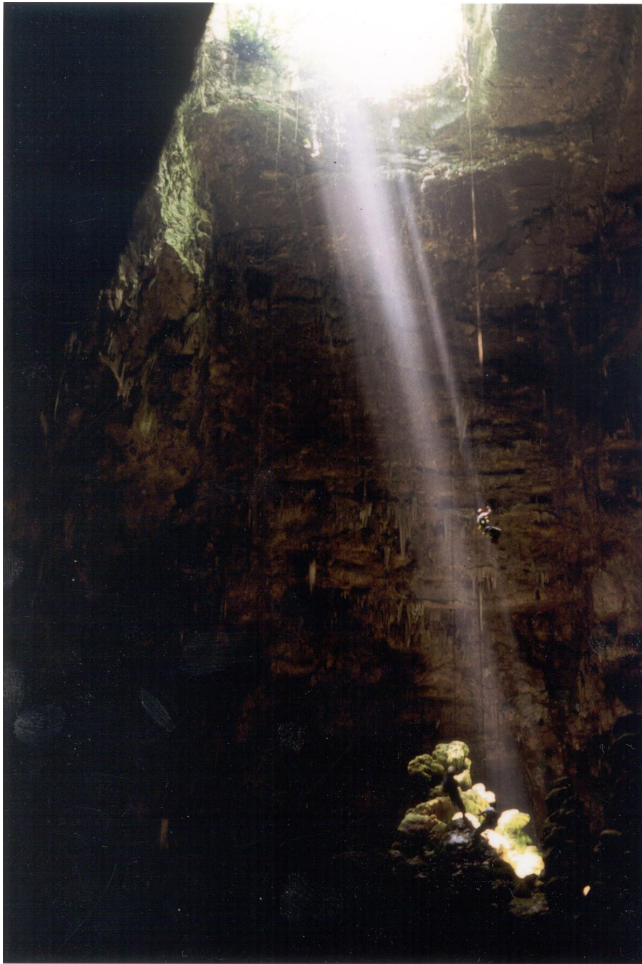
**Fig. 1.** The 75 m deep Grave, the entrance to the Castellana Caves (photo courtesy of Gianni Campanella).

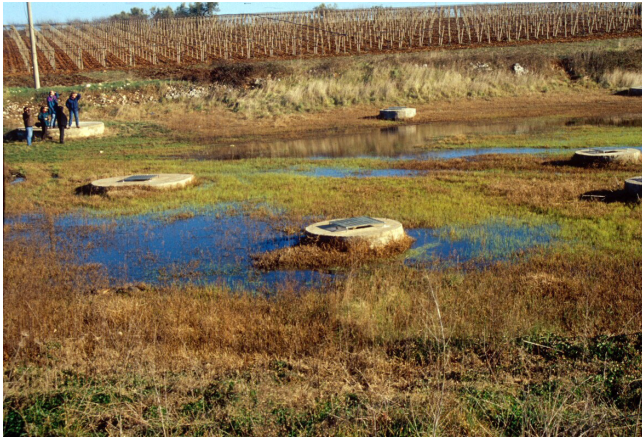
**Fig. 3.** Karst lake of Chienna, in the southeastern Murge, showing the several wells, built in local limestone rocks, inside the flooded area. In the proximity of this lake, some of the first human settlements of this area, dating back to Neolithic time, have been found (Coppola, 1981).

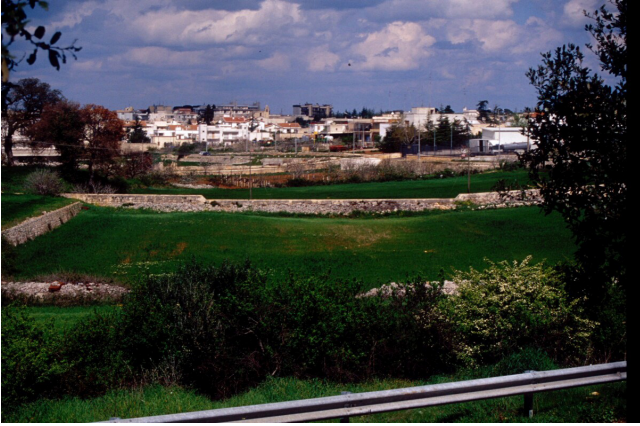
**Fig. 5.** View from the south of the karst valley of Castellana, showing the town at its lowest sector.

The oldest part of Castellana-Grotte lies at the bottom of a karst valley (Figs. 4 and 5), which main morphological features are represented by flat bottom valleys filled with alluvial deposits, detritus and *terre rosse*. Infilling materials have low permeability, so that on the occasion of intense rainfall most of the runoff occurs at the surface.

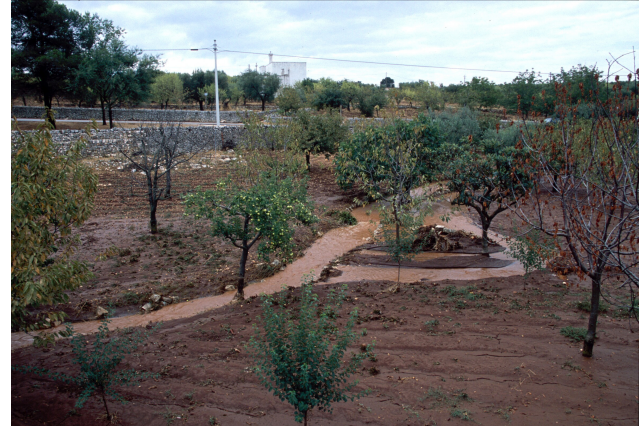
**Fig. 7.** Flooded area along the Province Road from Castellana-Grotte to Turi, after the intense rainstorms of 26–27 July 2002 (photo courtesy of Giuseppe Savino).

water to the population. On the other hand, flooding events have been recorded recently after prolonged rainfalls in the summer of 2002: the most significant occurred on 26 and 27 July 2002, and caused heavy damage to many towns and rural areas in Apulia (Fig. 7).

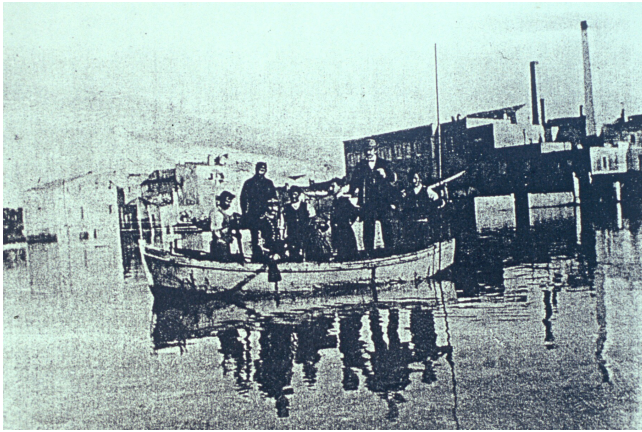
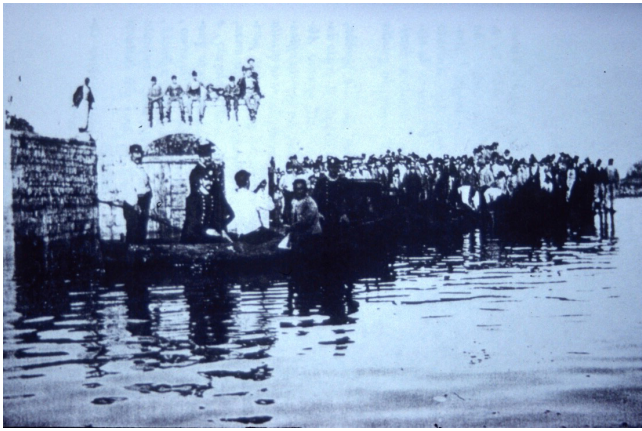
**Fig. 8.** Historical photos of the 1896 flood at Castellana (after AA.VV., 1996): (a) one of the boats used during rescue operation; (b) after the flood.

The 9 November 1896 flood is the best-documented event, being described in the work by the attorney Antonio Sgobba, which was published few weeks after the disaster. According to this testimony, the rainfall started in the morning, after a few days of intense antecedent rainfall. From 19:00 LT the main event began: there was a strong increase in the intensity of the rain and, after four hours of continuous rainfall, the lowest part of town was completely inundated by a huge lake that reached about one third of the entire town, with height of some 5.4 m at Largo Porta Grande. Boats had to be carried from Monopoli, the closest town at the seaside, to help people getting out of their houses (Fig. 8). Still today, many historical inscriptions on buildings in the historical centre of Castellana-Grotte recall the sad hours of that day (Fig. 9).

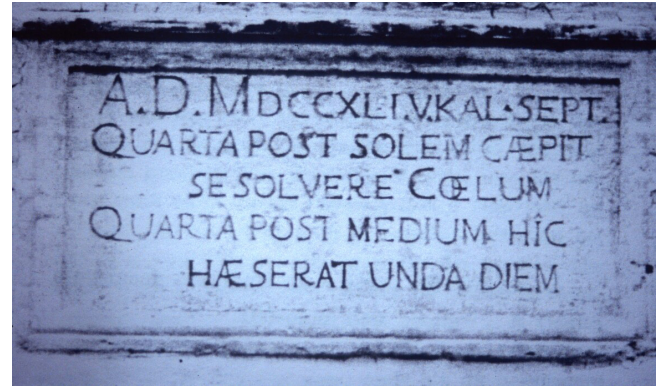
**Fig. 9.** Historical inscription recalling the 1741 flood (after AA.VV., 1996): on that occasion, the water reached a height of 6 m at Largo Porta Grande.

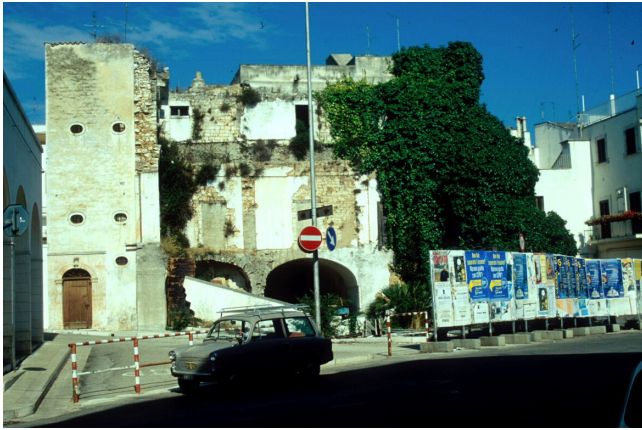
**Fig. 10.** Buildings involved in cases of subsidence at Largo Porta Grande (photo taken in 1999).

These subterraneans made still more complex the karst environment at Castellana-Grotte, and increased its high fragility, as was repeatedly demonstrated by other geological disasters that occurred at the very same site that was the theatre of the main floods (Largo Porta Grande; Fig. 10). Several cases of subsidence due to presence of underground cavities partly filled with colluvial deposits and terre rosse had to be registered since 1968 (Table 2); in more than one occasion, collapse of the above buildings, that had eventually to be evacuated, resulted.

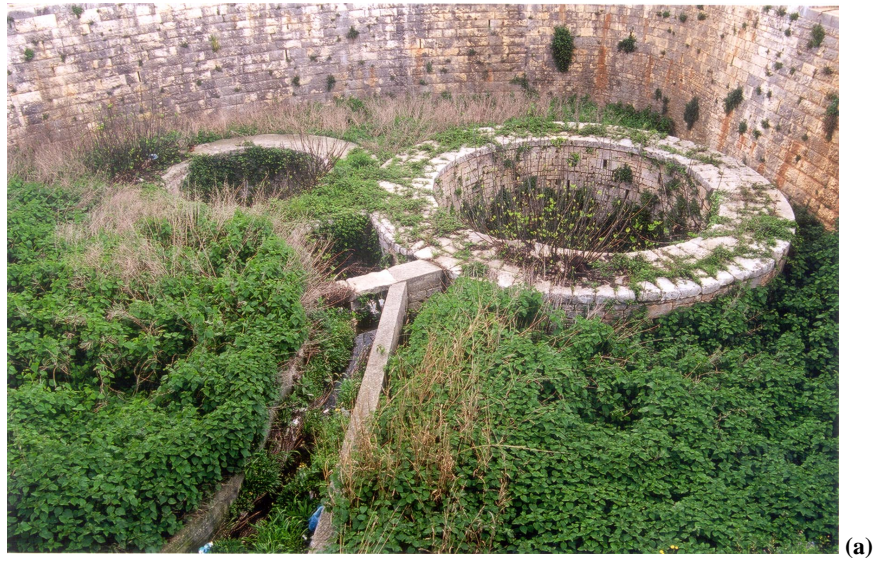
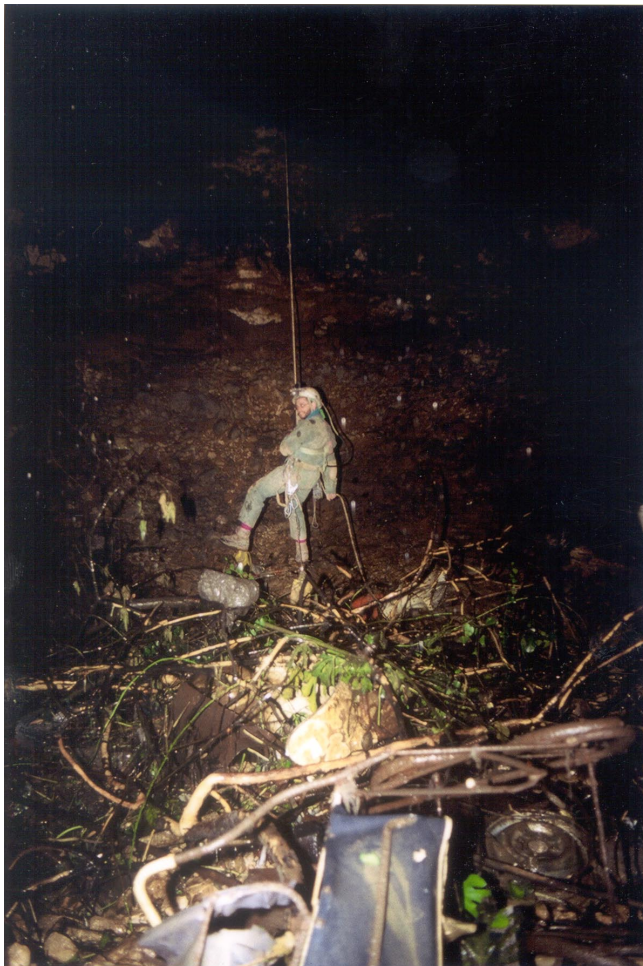
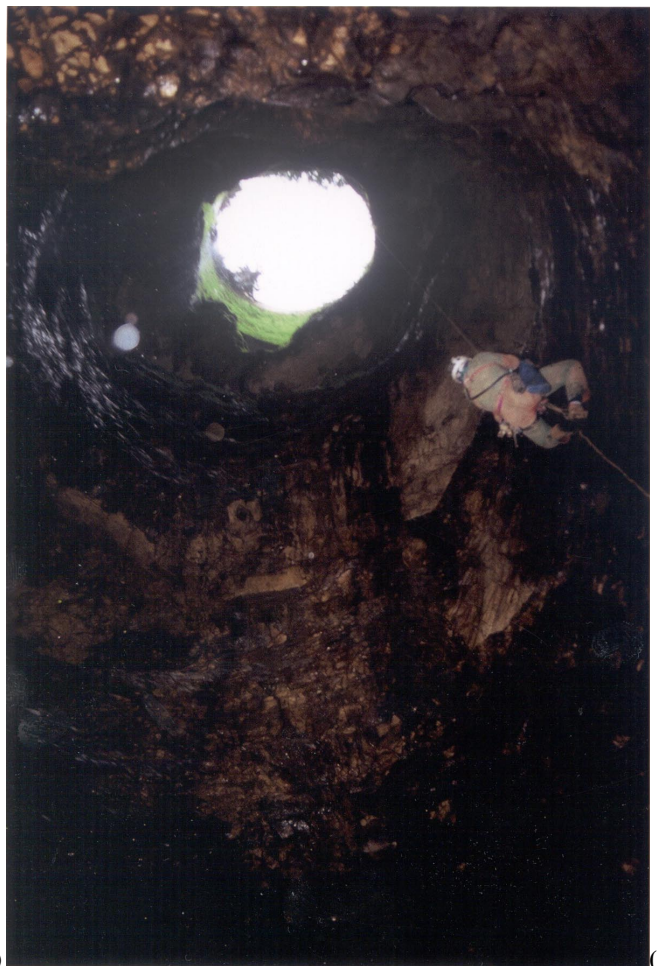
**Fig. 12.** The Gravinelle: (a) the cave double entrance; (b) the bottom of the cave, showing waste materials of different kind; (c) ascending the 40-m deep shaft (photos 12b and 12c courtesy of Domenico Sgobba).

After the 1896 event, many works were designed and realized in the lowest part of Castellana to facilitate infiltration of water underground. Actually, even before that, the need to realize hydraulic works was strongly felt in the town: the first project was designed to use some of the karst cavities in the area, where at least 4 deep shafts were known, by connecting them through horizontal tunnels to allow the amount of water to penetrate in depth and not to be collected at the surface on the occasion of intense precipitation. With this aim, in 1865 the shafts called "Gravinelle" were enlarged at the entrance, and a double opening to facilitate inflow of the waters was realized (Viterbo, 1913). Gravinelle is a karst shaft, some 40 m deep, created by karst processes which have enlarged a fracture in the rock mass (Figs. 11 and 12).

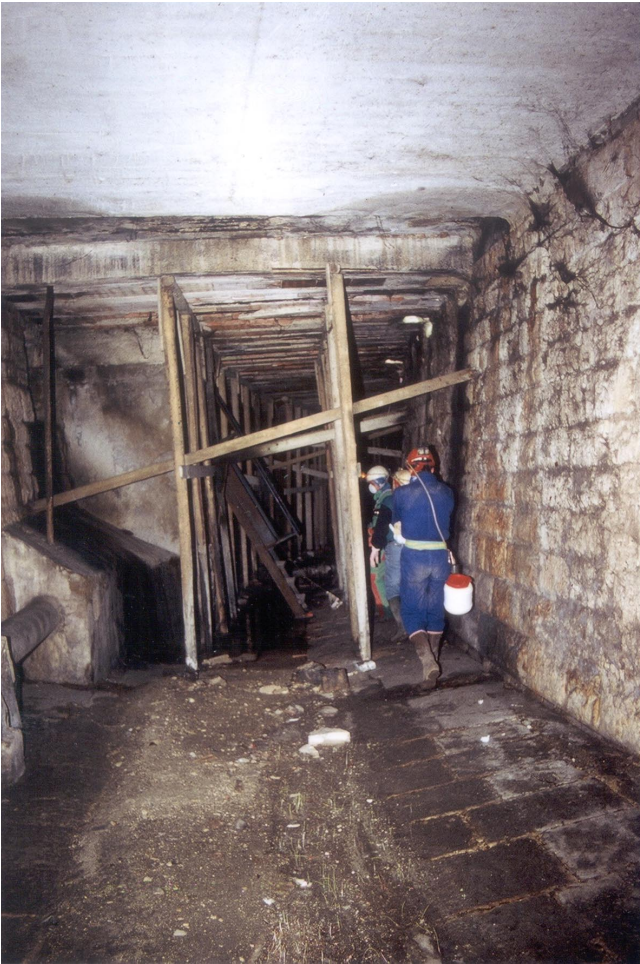
**Fig. 13.** Inside the Canalone (photo courtesy of Domenico Sgobba).

After further floods, including that catastrophic of 9 November 1896, a new project was designed, this time at the expense of the Italian State. Again, however, a new delay had to be registered, this time caused by the catastrophic 1909 Messina earthquake: the tragic aftermath of that event, and the very severe damage registered in Messina and Reggio Calabria, moved toward the southernmost tip of Italy most of the funds from the Italian government. Thus, only in 1911 the work eventually began at Castellana, to be completed two years later (Viterbo, 1913). At a depth of about 10 m, the Gravinelle were connected through an artificial tunnel (called *Canalone*, which means Big Channel; Figs. 13 and 14) to other shafts to the north, located at a distance of, respectively, about 1 km and 2.5 km (Manghisi, 1987). In addition, a second tunnel to be used as spillway was also built, for a length of 336 m. Another deep shaft (called “Gravaglione”), the only one left undisturbed after the works realized by the monks of S. Francesco di Paola, is still present along the *Canalone*; since 1913, it is used to drain the sewerage coming from the town.

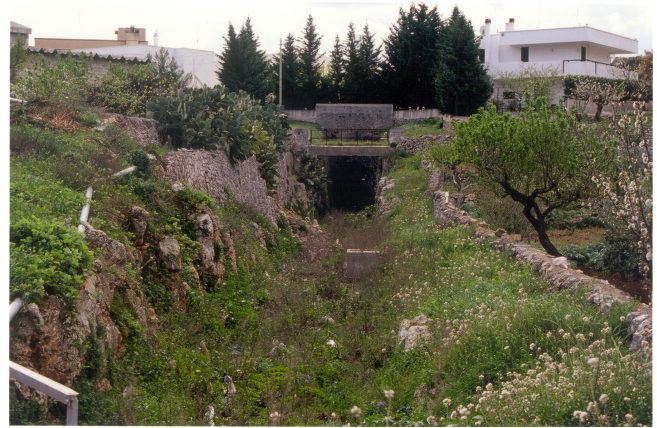
**Fig. 14.** Northern exit of the Canalone.
