A new approach to flood ~~loss~~ estimation and vulnerability assessment for historic buildings in England

V. Stephenson and D. D’Ayala

Civil, Environmental and Geomatic Engineering, University College London, London, UK

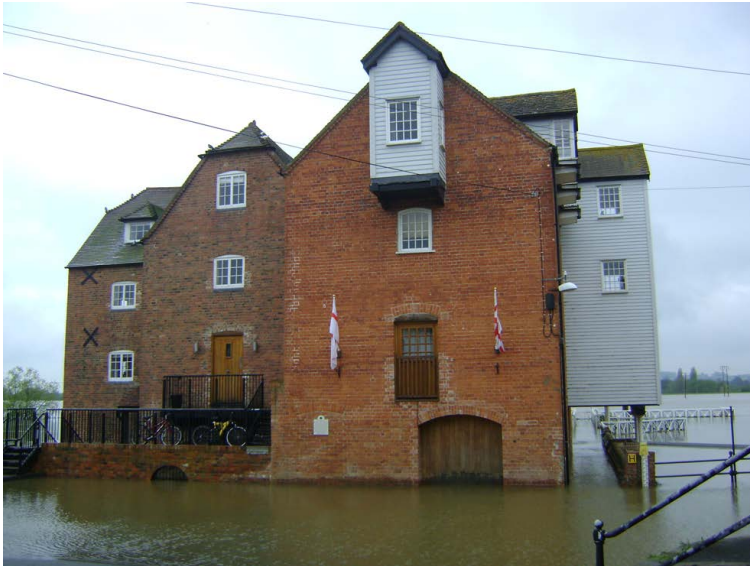
Fig. 1. Recent flooding at Tewkesbury (Stephenson and D’Ayala, 2012).

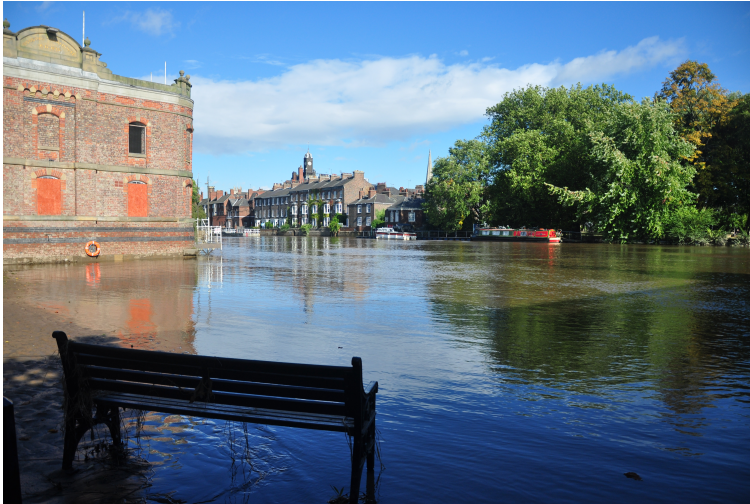
Fig. 2. Recent flood events at York (2012, photo courtesy of Y. Didem Aktas).

Of the three case study sites York (Fig. 2) is historically most prone to flooding, with the earliest detailed account of a flood event occurring in 1263 (MacDonald, 2011), and the most recent flooding taking place in 2012. The highest recorded flood inundation occurred in autumn 2000, although occurrences where the River Ouse, which runs through the centre of the city, floods its banks are common on an almost annual frequency. The historic building stock in York is widely variable and noticeable periods of growth can be observed through analysis of historic maps of the city. The earliest portions of the city date from Roman times, when the city was founded, whilst the medieval growth of the town is still evident through the large numbers of timber framed structures in the centre of the city, and there is also a strong Georgian architectural influence.

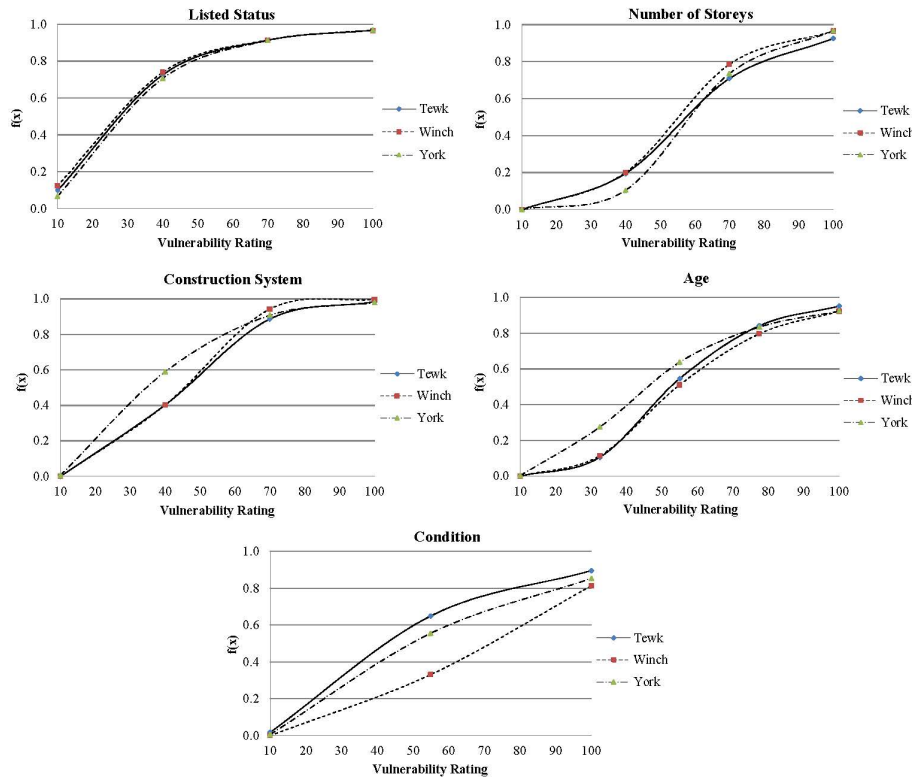
Cumulative log-normal distribution functions of the vulnerability ratings for each descriptor have been derived from the survey data. These are shown in Fig. 3. The curves are shown comparatively for each of the sites, and each fan of curves demonstrates the relative vulnerability of each site within the whole sample. The fans show a mixed degree of relative vulnerability between the sites, with each of the three locations providing the upper or lower boundary for one or more descriptor fan. In addition, each of the descriptors produces a fan of curves of slightly differing shape.

Fig. 3. Vulnerability descriptor log-normal cumulative distribution curves.

The exhibition of cumulative distribution functions that follow the expected shape of curves generated by fragility analysis of engineered structures (D'Ayala, 2005) is

a positive indication about the suitability of using these descriptors for vulnerability analysis, as these are applied when studying the vulnerability of buildings to damage through exposure to naturally occurring environmental hazards, such as earthquakes, volcanoes, and floods. The curves show for accurate comparison of different sites at different vulnerability thresholds on the same scale. This means that more accurate evaluation of the relative vulnerability of each stock group, and the individual buildings within the stock, can be determined relative to the general UK historic building field. This in turn will promote more informed allocation of resources to mitigate the risks.

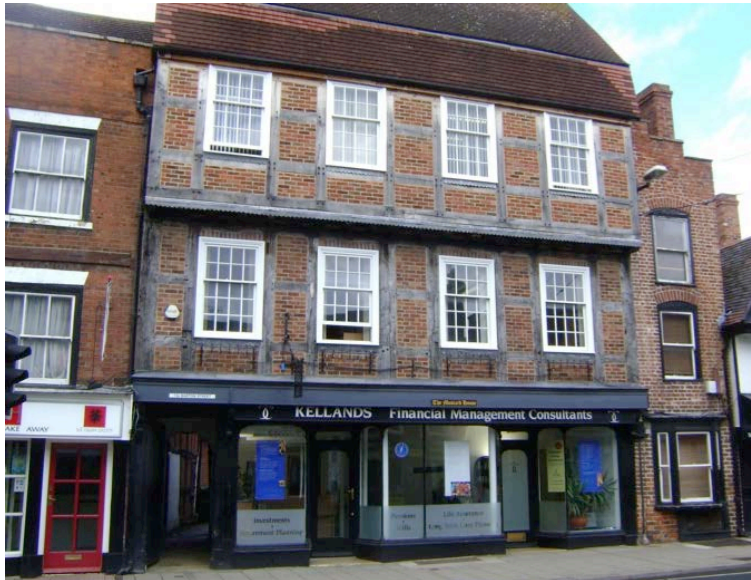
Barton Street, Tewkesbury	
Not Listed	10
3 Storeys	70
Timber Frame with BI	70
Georgian	55
Excellent Condition	10
Vulnerability Index	215/500
Mill Bank, Tewkesbury	
Grade II	40
3 Storeys	70
Timber Frame with BI	70
Medieval/Tudor	100
Excellent Condition	10
Vulnerability Index	290/500

Fig. 4a. Barton Street, Tewkesbury.

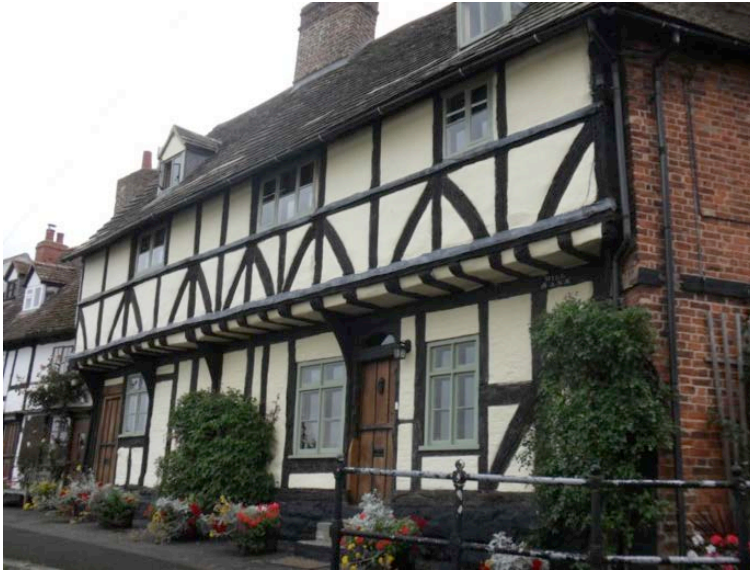
Fig. 4b. Mill Bank, Tewkesbury.

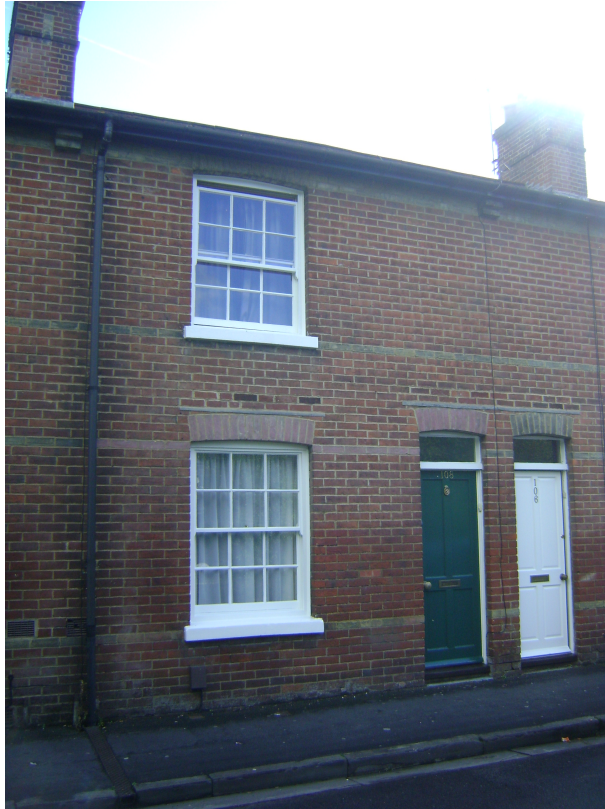
Water Lane, Winchester	
Not Listed	10
2 Storeys	40
Brick Masonry	40
Victorian	32.5
Good Condition	55
Vulnerability Index	177.5/500
Kingsgate Street, Winchester	
Grade II	40
3 Storeys	70
Brick Masonry	40
Jacobean	77.5
Poor Condition	100
Vulnerability Index	327.5/500

Fig. 5a. Water Lane, Winchester.

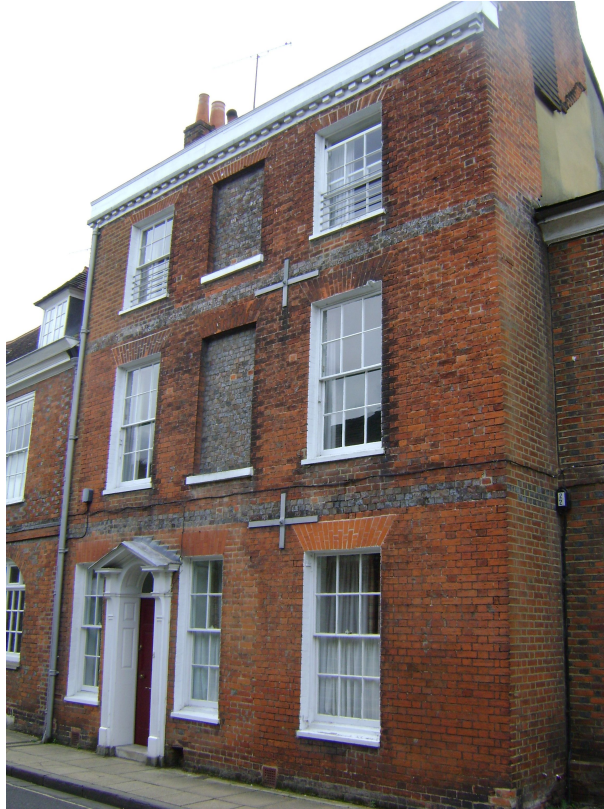
Fig. 5b. Kingsgate Street, Winchester.

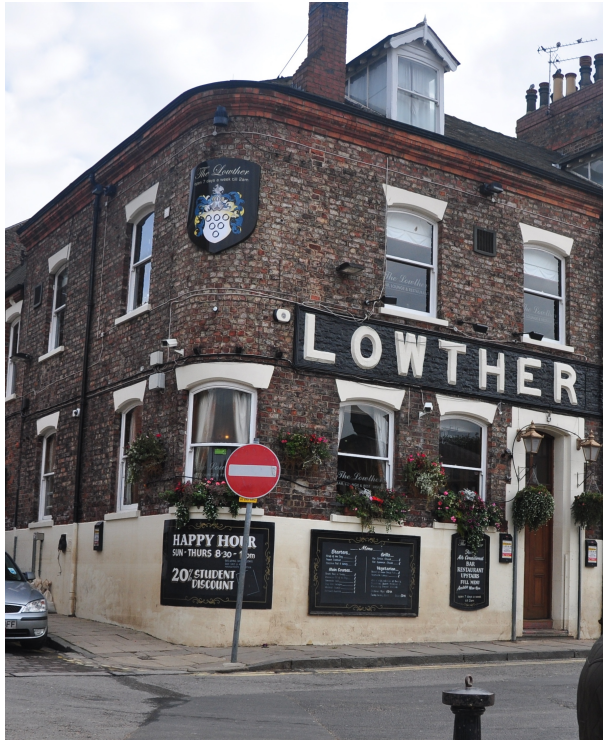
Riverfront, York	
Not Listed	10
3 Storeys	70
Brick Masonry	40
Georgian	55
Excellent Condition	10
Vulnerability Index	185/500
Fishergate, York	
Grade II	40
3 Storeys	70
Brick Masonry	40
Georgian	55
Poor Condition	100
Vulnerability Index	305/500

Fig. 6a. Riverfront, York.

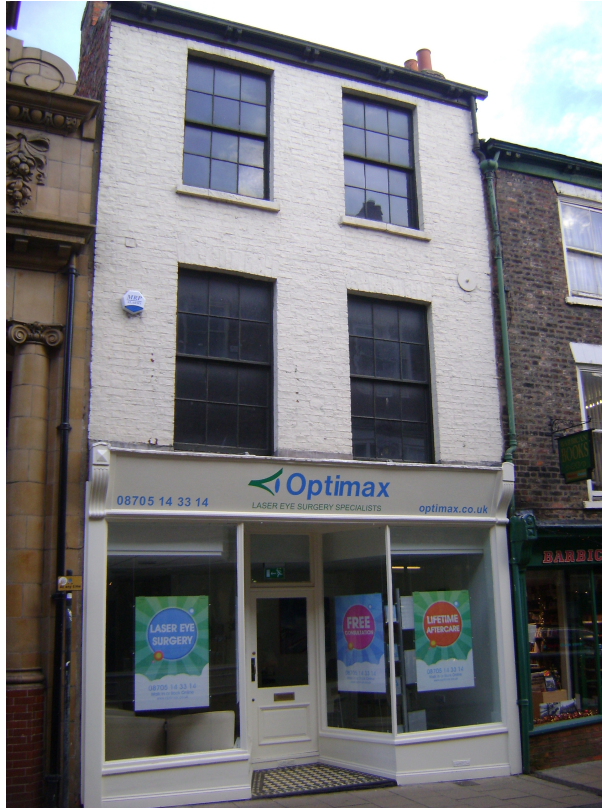
Fig. 6b. Fishergate, York.

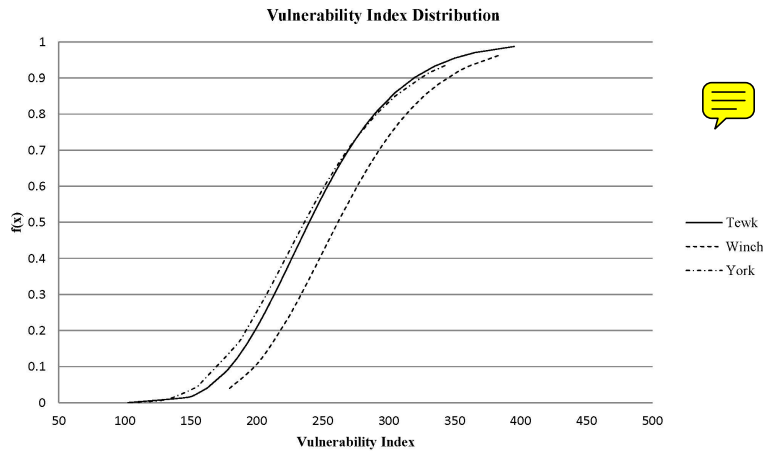
Fig. 7. Vulnerability index distribution.

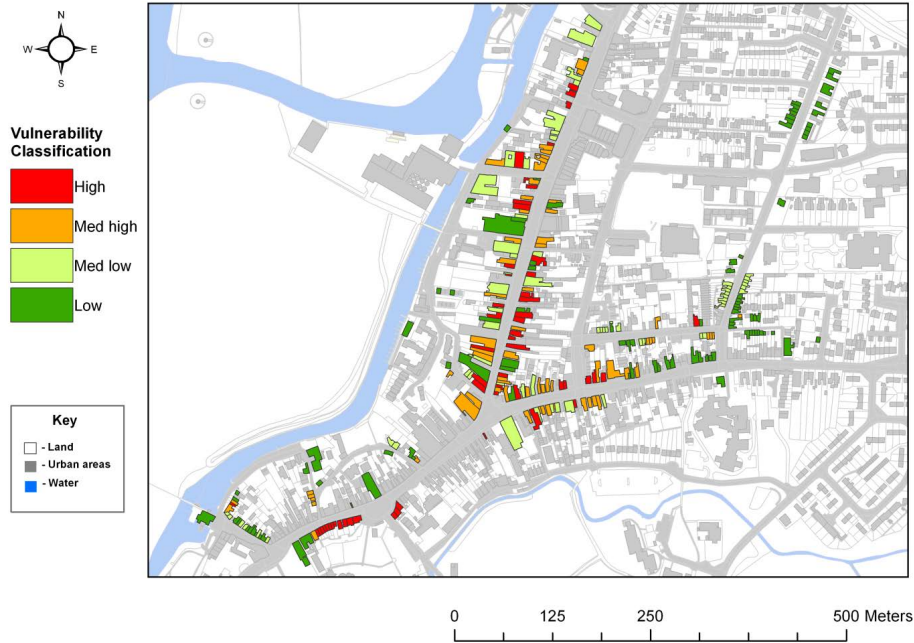
Further, more detailed assessment of the risk is achieved by analysing the vulnerability ratings in conjunction with the flood hazard through GIS mapping. This profiles the distribution of vulnerability geographically across the site, aligning it with the hazard posed from flood depth and extent. Figure 8 shows the VI value for each surveyed building on the site of Tewkesbury, classified into four categories of increasing vulnerability state. Buildings with less than 25% of the total vulnerability index are classified as low vulnerability, and each incremental 25% step equates to a higher classification.

Fig. 8. Vulnerability classification map of Tewkesbury.

As can be seen the use of this vulnerability indicator system, that is independent of the hazard, highlights building vulnerability prior to flood inundation, and therefore has a scattered distribution across the site. In order to develop the method into an assessment of risk, separate measure of the exposure of each building to the flood hazard is needed. This requires detailed measurement of the flood parameters at the scale of the individual building, which is little documented and requires original work to be done for each individual site. Work to this end is going and it will be set out in a future paper how this completed methodology for vulnerability assessment is used with the hazard measurement to determine risk at the building scale.
