Anonymous Referee #2

Revision comments to the paper: Mangrove Forest against Dyke-break induced Tsunami in Rapidly Subsiding Coasts. H. Takagi, T. Mikami, D. Fujii1, M. Esteban

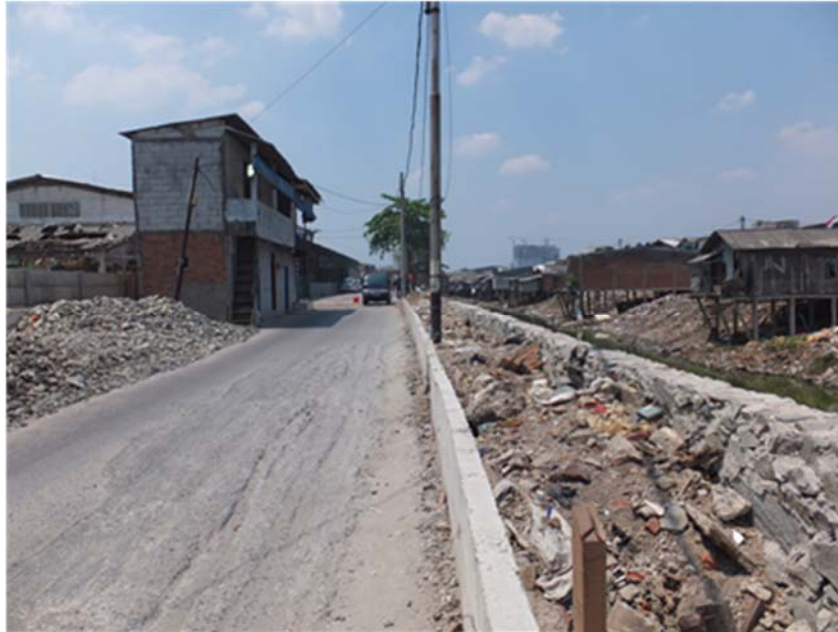
As the reviewer points out, the lower half of the plots indicated in Fig. 3 (c) shows a ring road which is relatively higher (-1.0 – -1.5 m) than the lowest part of the town (-2.5 – -3.0 m). However, the authors came to realize that the road was higher than surrounding areas. There were some corners where the ground measurement was not possible because of the difficulties in access to the area due to the presence of an off-limits area or informal settlement (please see the photo below). Instead of using the elevation along the road, the elevation of the lower half of the domain was conservatively assumed to be the same as the lowest part of the town in the numerical

model. The details on this treatment will be described in the revised manuscript.

Figure 7 showing the models bathymetry indicate a steady topography descent from the upper part of the domain (where the dyke breach is located) to the opposite side. Despite the poor selection of colours it can be seen that the roads around the breach are at around -1.5 m, while point 7 and beyond in the other side of the domain is about -3 m or more. This is not congruent with the much complex measured topography Printer-friendly version Discussion paper indicated in figure 3.

A better figure 7, showing clearly the model boundaries and the topography will be welcomed.

Since the simulation runs for only the beginning of 20 minutes after the breach, sea water passes through the community and accumulates in a lower part of the computational domain, making it possible to avoid imposing pseudo-open boundaries on the land. In the revised manuscript, the details will be carefully clarified.
