Exceptional floods in the Prut basin, Romania, in the context of heavy rains in the summer of 2010

Gheorghe Romanescu¹, Cristian Constantin Stoleriu
Alexandru Ioan Cuza, University of Iasi, Faculty of Geography and Geology, Department of
Geography, Bd. Carol I, 20 A, 700505 Iasi, Romania

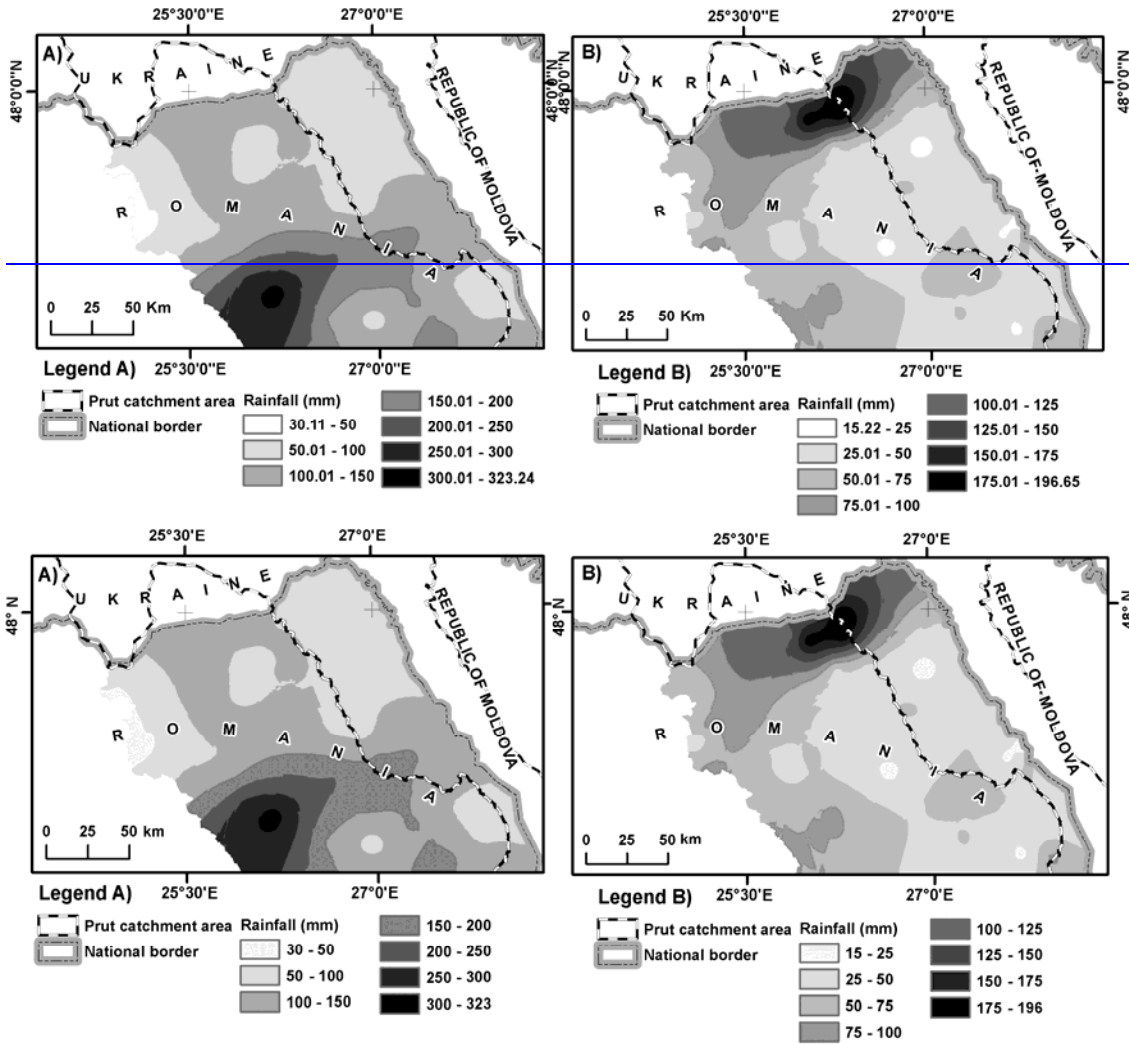
Figure 5. Cumulative precipitation amounts, in northeastern part of Romania, from 21-27 June 2010 (left) and 28 June-1 July 2010 (right) **Figure 4.** Cumulative precipitation amounts from 21-27 June 2010 (left) and 28 June-1 July 2010 (right)

302 ~~Tidal bores~~ Backwaters in the upper basins of the Prut and Siret (in northeast Romania)
303 recorded during the summer of 2010 were caused by atmospheric instability from 21 June-1
304 July 2010. At this time, the flood danger level (CP) was exceeded on the Prut and Jijia Rivers.
305 High amounts of rain fell during three periods: 21-24 June 2010, 26-27 June 2010, and 28
306 June-1 July 2010. Precipitation exceeding 100 mm was recorded from 21-24 June (105 mm,
307 at the Oroftiana station) and from 28 June-1 July 2010 (206 mm at Padureni and 110 mm at
308 Pomarla on the Buhai River). Very high rainfall rates occurred within a brief timeframe: 51.5
309 mm/50 min. was recorded at Oroftiana station on the Prut River and 42.0 mm/30 min. at
310 Padureni on the Buhai River (Romanescu and Stoleriu, 2013a,b; Tirnovan et al., 2014b) (Fig.
311 45).

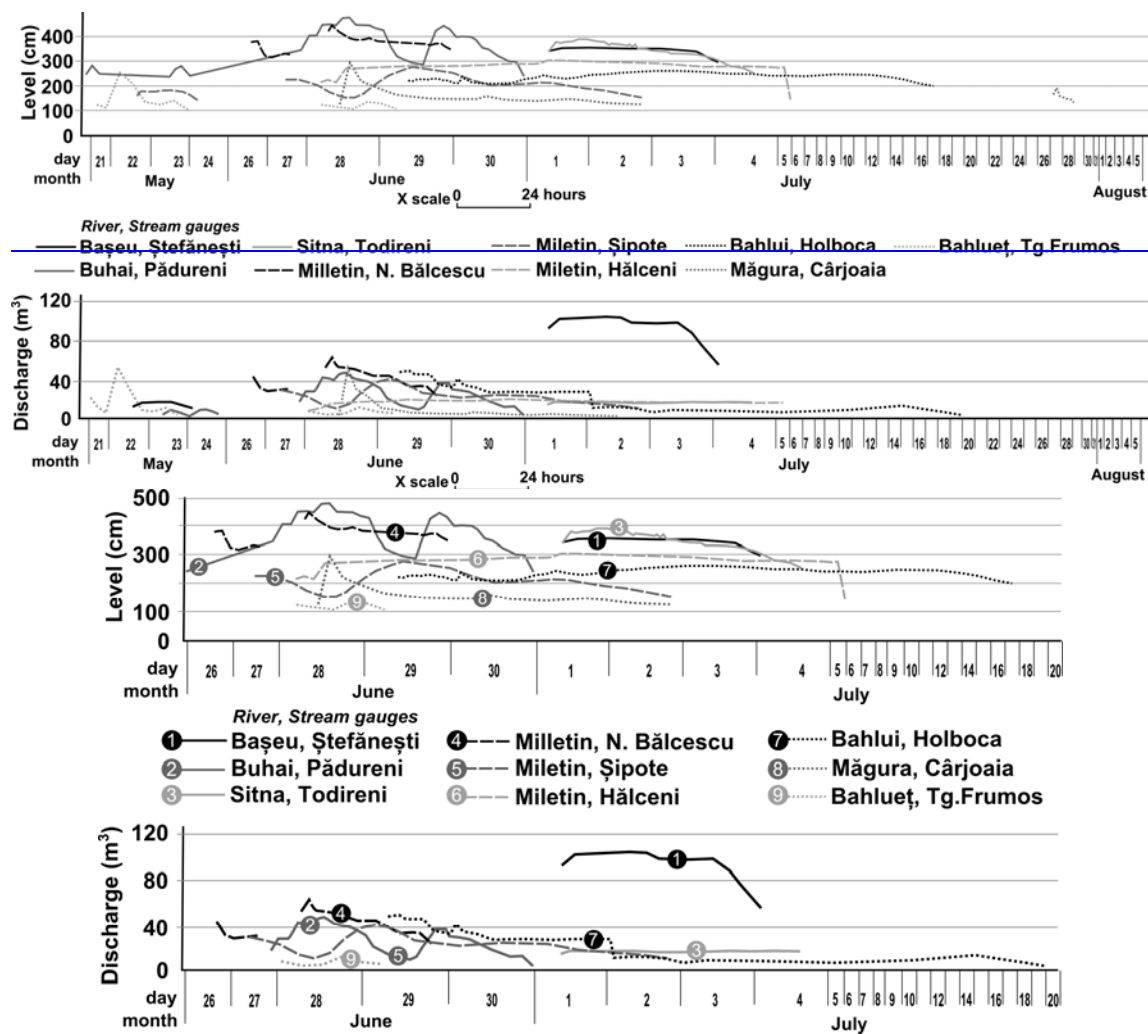
403
 404
 405 **Figure 67.** Water levels and discharge on the main Prut tributaries during the summer of
 406 2010: the Baseu, Buhai, Sitna, Miletin, Bahlui, Magura, and Bahluiet Rivers
 407

393 At the Todireni gauging station on the Sitna River (a tributary of the Jijia), floods
 394 occurred from 1-4 July 2010. The maximum discharge was 19 m³/s on 1, 2, and 4 July 2010.
 395 The flood level (CI) was exceeded on 1 and 2 July 2010. The maximum water level was 387
 396 cm on 1 July 2010. The flood warning level (CA) was exceeded on 4 July 2010 (Figs. 3, 67).

397 At the Nicolae Balcescu gauging station on the Miletin River (a tributary of the Jijia),
 398 floods were recorded from 26-29 June 2010. The maximum discharge was 60 m³/s on 6 June
 399 2010. The flood level (CI) was exceeded just once, on 28 June 2010. The maximum level was
 400 444 cm (+22 cm CI). The warning level (CA) was exceeded throughout the flooding period
 401 (Figs. 3, 67).
 402

408 At the Sipote gauging station on the Miletin, four [backwater tidal bores](#)
 409 from 22 June-2 July 2010. The maximum discharge was 45 m³/s on 29 June 2010. The flood
 410 level (CI) was exceeded from 29-30 June 2010. The maximum water level was 269 cm (+19
 411 cm CI). The warning level (CA) was exceeded throughout the flooding period (Figs. 3, 67).

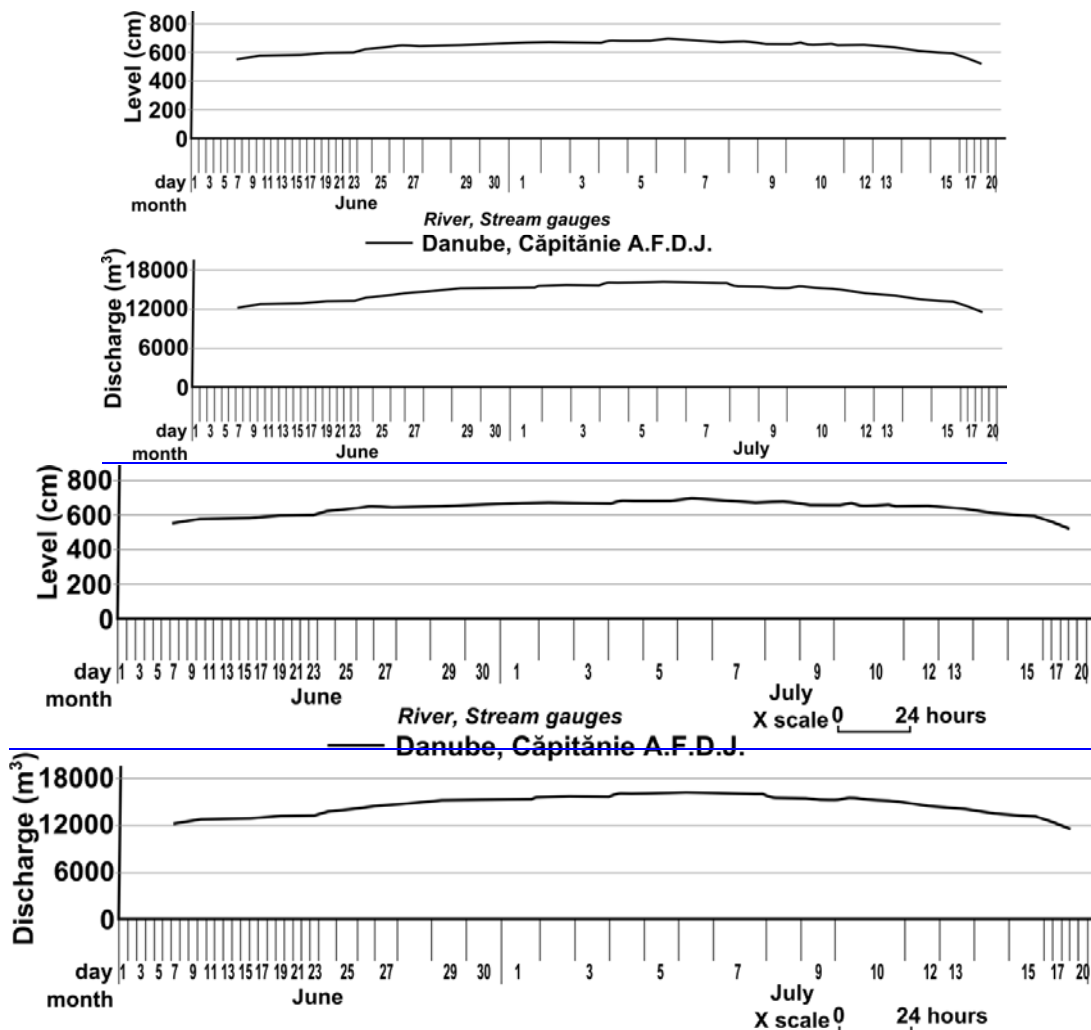
475 **Figure 89.** Water levels and discharge on the Danube at the Capitanie A.F.D.J. gauging
 476 station in the summer of 2010
 477

469 At the Capitanie A.F.D.J. gauging station on the Danube, record floods occurred. The
 470 maximum discharge was 16,300 m³/s on 5-6 July 2010, which is a historic discharge for the
 471 Galati station. The flood level (CI) was exceeded from 26 June-14 July 2010 (Fig. 89).
 472

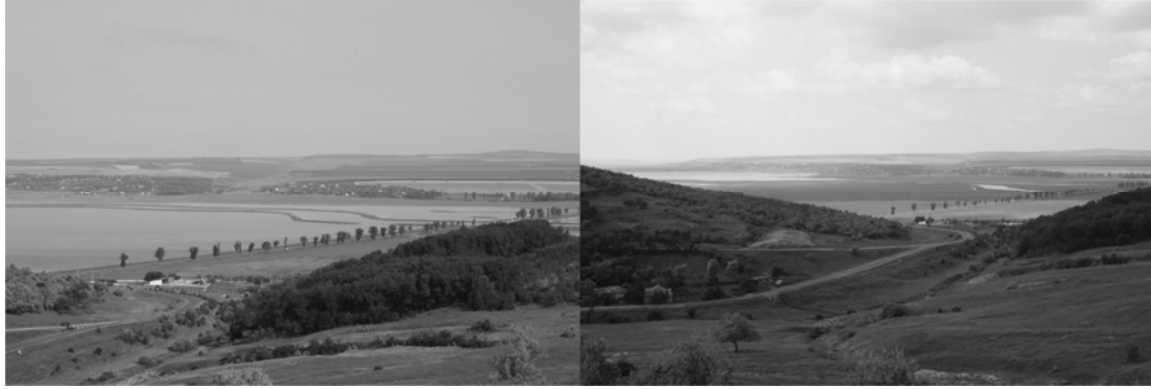
Figure 1011. Polders on the Jijia and the floods recorded in the summer of 2010: storage of excess water (left) and its elimination (right)

544 The system of polders in the lower reaches of the Jijia served as an effective trap for
545 surplus water. High discharges on the Danube, which reached a historic maximum of 16,300
546 m³/s at Galati (July 5th, 2010), would have flooded the city centre without the precincts
547 constructed on the Jijia that stopped a portion of the floodwaters. When the floods on the
548 Danube ceased, the water was gradually eliminated from the polders ~~was eliminated~~
549 ~~gradually~~, which explains why high water levels persisted in the lower Prut for a long time
550 (Fig. 1011).
551
