The Prut catchment basin spans three topographic levels: mountains, plateaus, and plains. The surface and underground water supply to the Prut varies by region and is extremely influenced by climatic conditions. This study underscores the role played by local heavy rains in the occurrence of floods, as well as the importance of ponds, mainly the Stanca-Costesti reservoir, in the mitigation of backwaters. We also analyse the local contribution of each catchment basin on the right side of the Prut to the occurrence of the exceptional floods in the summer of 2010. Finally, we consider the upstream discharge and its influence on the lower reaches of the Prut.

76 **2 Study area**

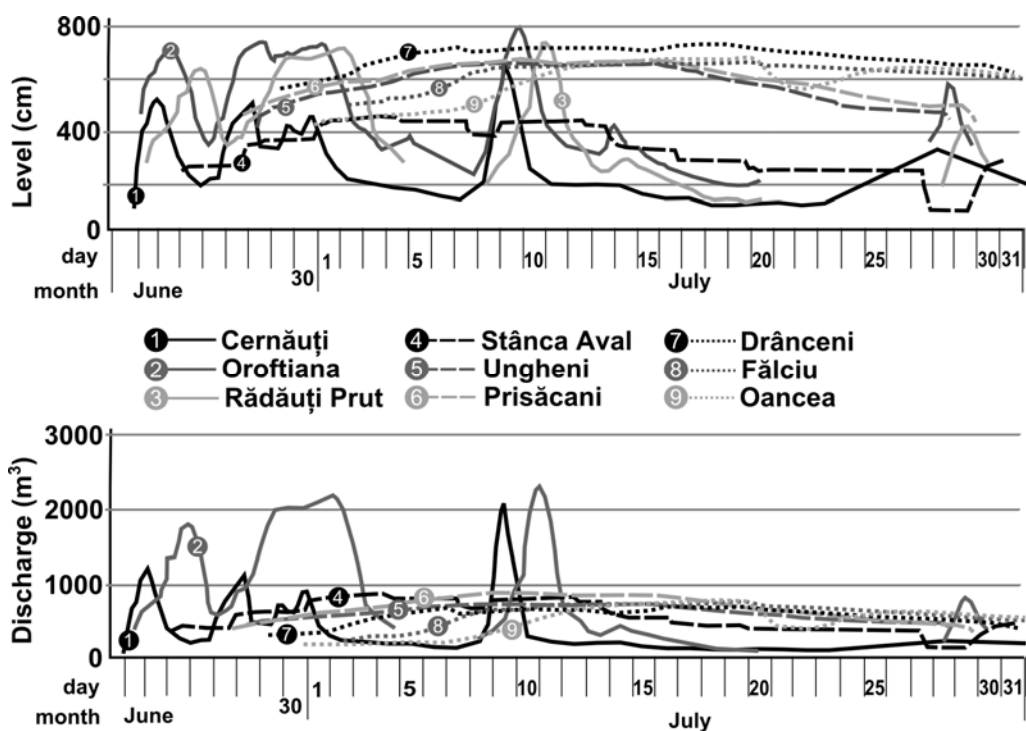
252
253 **Figure 6.** Water levels and discharge on the Prut River at the gauging stations of Cernauti,
254 Oroftiana, Radauti Prut, Stanca Aval (downstream), Ungheni, Prisacani, Dranceni, Falciu, and
255 Oancea during the summer of 2010
256

234 Precipitation in the Carpathian Mountains in Ukraine initiated a series of floods in the
 235 upper Prut basin. Among the five flood peaks recorded by the Cernauti gauging station, we
 236 noted one with a discharge of 2,070 m³/s recorded on 9 July 2010 at 12:00. In comparison,
 237 another flood recorded in May was not very high discharge value (308 m³/s). In the
 238 mountainous sector, the flood warning level (CA) was exceeded only twice, with water levels
 239 of 523 cm (+25 cm CA) and 645 cm (+145 cm CA) (Fig. 6).

240 At the Oroftiana gauging station, where only the water levels are measured, the
 241 flood danger level (CP) was exceeded four times, with levels of 716 cm (+66 cm CP), 743 cm
 242 (+93 cm CP), 736 cm (+86 cm CP), and 797 cm (+147 cm CP, on 9 July 2010 at 12:00). The
 243 flood warning level (CA) was exceeded throughout the entire flooding period (May-July
 244 2010). In the month of May, the flood levels (CI) were not exceeded (Fig. 6). At the Oroftiana
 245 gauging station, one registered solely the water levels data. And for all the other gauging
 246 stations the discharge data are being registered, in addition to water level.
 247

257 At the Radauti Prut gauging station, three important peaks were recorded on 26 June,
258 29 June-2 July 2010, and 10-11 July 2010. A maximum discharge of 2,310 m³/s was
259 registered on 10 July 2010 at 9 pm. The flood danger level (CP) was exceeded at four times,
260 with water levels of 643 cm (+43 cm CP, on 25 June 2010), 685 cm (+85 cm CP, on 29 June
261 2010), 721 cm (+121 cm CP, on 29 June-2 July 2010), and 744 cm (+144 cm CP, on 10-11
262 July 2010) (Fig. 6).

263 The Stanca Aval (downstream) gauging station is controlled by overflow from the
264 Stanca-Costesti reservoir. This control mitigates the flood hydrographs. The maximum
265 discharge value at this station was 885 m³/s on 3 July 2010. The flood level (CI) was
266 exceeded from the beginning to the end of the flooding period. The flood danger level (CP)
267 was exceeded from 1-13 July 2010, reaching a maximum water level of 460 cm (+85 cm CP,
268 on 3 July 2010) (Fig. 6).

269 At the Ungheni gauging station, floods were recorded throughout the entire month of
270 July. The maximum discharge was 673 m³/s on 8 July 2010. Flooding continued until 5
271 August 2010. The flood danger level (CP) was exceeded during the 12-day period from 6-17
272 July 2010. The maximum water level was 661 cm (+1 cm CP) (Fig. 6).

273 Floods were also recorded throughout July at the Prisacani gauging station. The
274 maximum discharge was 886 m³/s on 9 July 2010. Flooding continued until 5 August 2010.
275 The flood danger level (CP) was exceeded during the 16-day period from 4-19 July 2010. The
276 maximum water level was 673 cm (+73 cm CP) (Fig. 6).

277 At the Dranceni gauging station, floods were recorded over a long period from the end
278 of June until the beginning of August. The maximum discharge was 718 m³/s on 17 July
279 2010. The flood danger level (CP) was reached or exceeded during the 18-day period from 4-
280 22 July 2010. The maximum water level was 729 cm (+29 cm CP) (Fig. 6).

281 At the Falciu gauging station, floods occurred throughout July and during the first half
 282 of August. The maximum discharge was 722 m³/s on 19 July 2010. The flood danger level
 283 (CP) was reached or exceeded during the 35-day period from 6 July-2 August 2010. The
 284 maximum water level was 655 cm (+55 cm CP) (Fig. 6).

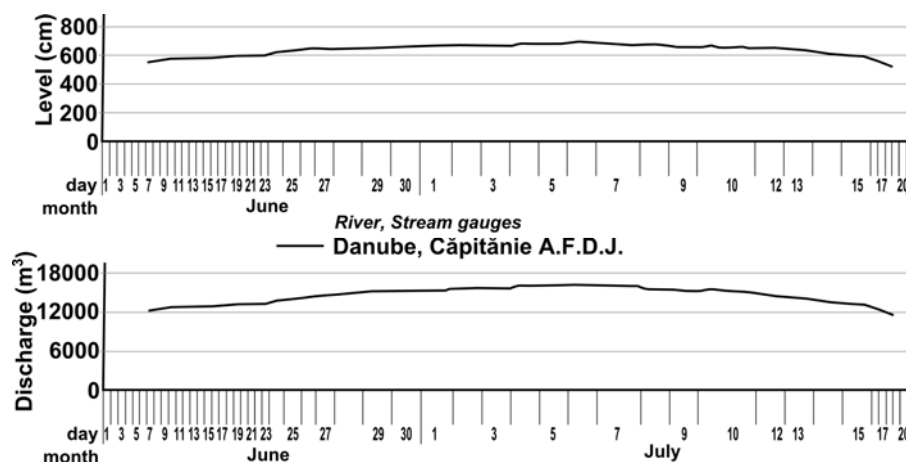
382
383 **Figure 9.** Water levels and discharge on the Danube at the Capitanie A.F.D.J. gauging station
384 in the summer of 2010
385

At the Capitanie A.F.D.J. gauging station on the Danube, record floods occurred. The maximum discharge was 16,300 m³/s on 5-6 July 2010, which is a historic discharge for the Galati station. The flood level (CI) was exceeded from 26 June-14 July 2010 (Fig. 9).

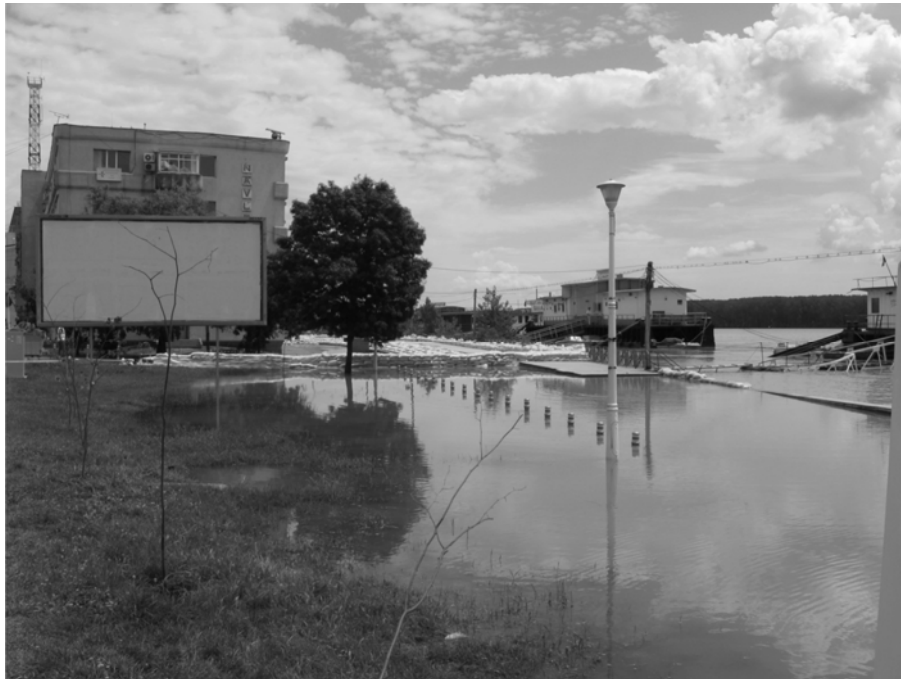
Figure 12. Flooding of the sea-cliff and the NAVROM headquarters in Galati
