Exceptional floods in the Prut basin, Romania, in the context of heavy rains in the summer of 2010

Gheorghe Romanescu¹, Cristian Constantin Stoleriu
Alexandru Ioan Cuza, University of Iasi, Faculty of Geography and Geology, Department of
Geography, Bd. Carol I, 20 A, 700505 Iasi, Romania

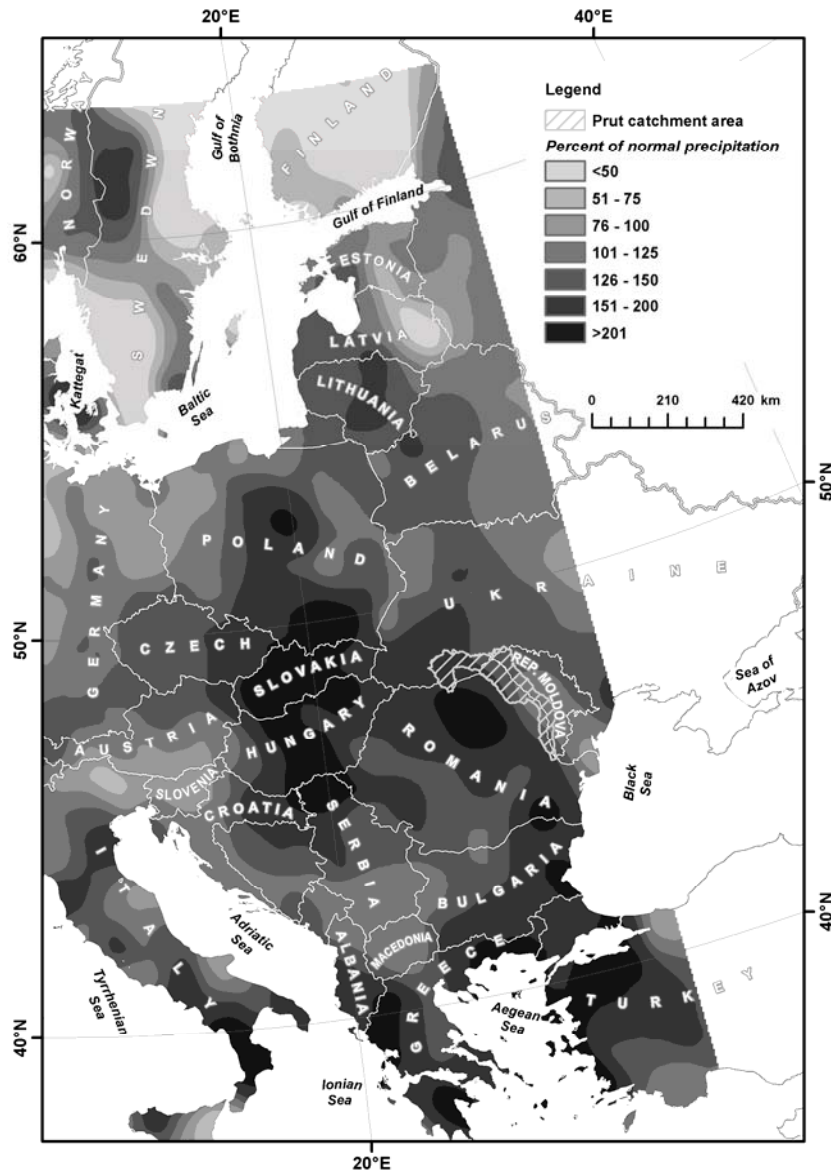
Figure 4. Cumulative precipitation for May-July (2010) interval, divided by normal precipitation- Climate Prediction Center (source data: NOAA)

208 context was disturbed by local physical-geographical factors, especially by the orography of
 209 Eastern Carpathians, which led to extremely powerful heavy rains: e.g. 100-200 mm in 24
 210 hours at the sources of Jijia (representing the amount that normally falls during June and July)
 211 or 40-60 mm in 24 hours at the Romanian frontier with Ukraine and the Republic of Moldova.
 212 The quantity of rainfall in 24 hours were 2-3 higher than the normal values for this period
 213 (Hustiu, 2011) (Fig. 4).

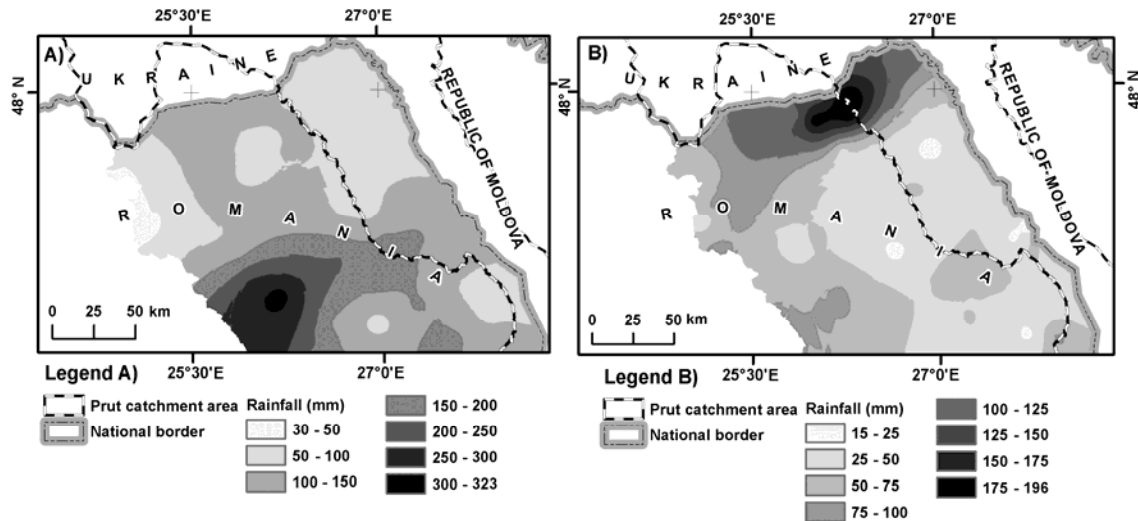
249 **Figure 5.** Cumulative precipitation amounts, in northeastern part of Romania, from 21-27
 250 June 2010 (left) and 28 June-1 July 2010 (right)
 251
 252

230 July 2010. Precipitation exceeding 100 mm was recorded from 21-24 June (105 mm, at the
 231 Oroftiana station) and from 28 June-1 July 2010 (206 mm at Padureni and 110 mm at Pomarla
 232 on the Buhai River). Very high rainfall rates occurred within a brief timeframe: 51.5 mm/50
 233 min. was recorded at Oroftiana station on the Prut River and 42.0 mm/30 min. at Padureni on
 234 the Buhai River (Romanescu and Stoleriu, 2013a,b; Tirnovan et al., 2014b) (Fig. 5).

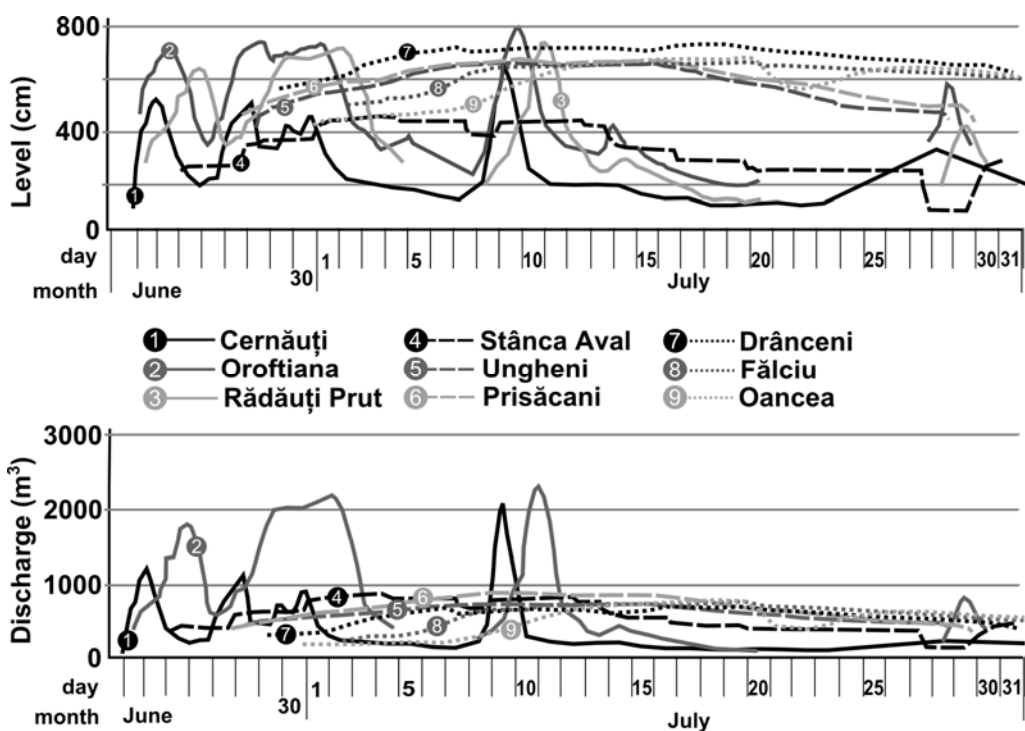
253
254 **Figure 6.** Water levels and discharge on the Prut River at the gauging stations of Cernauti,
255 Oroftiana, Radauti Prut, Stanca Aval (downstream), Ungheni, Prisacani, Dranceni, Falciu, and
256 Oancea during the summer of 2010
257

235 Precipitation in the Carpathian Mountains in Ukraine initiated a series of floods in the
 236 upper Prut basin. Among the five flood peaks recorded by the Cernauti gauging station, we
 237 noted one with a discharge of 2,070 m³/s recorded on 9 July 2010 at 12:00. In comparison,
 238 another flood recorded in May was not very high discharge value (308 m³/s). In the
 239 mountainous sector, the flood warning level (CA) was exceeded only twice, with water levels
 240 of 523 cm (+25 cm CA) and 645 cm (+145 cm CA) (Fig. 6).

241 At the Oroftiana gauging station, where only the water levels are measured, the
 242 flood danger level (CP) was exceeded four times, with levels of 716 cm (+66 cm CP), 743 cm
 243 (+93 cm CP), 736 cm (+86 cm CP), and 797 cm (+147 cm CP, on 9 July 2010 at 12:00). The
 244 flood warning level (CA) was exceeded throughout the entire flooding period (May-July
 245 2010). In the month of May, the flood levels (CI) were not exceeded (Fig. 6). At the Oroftiana
 246 gauging station, one registered solely the water levels data. And for all the other gauging
 247 stations the discharge data are being registered, in addition to water level.
 248

258 At the Radauti Prut gauging station, three important peaks were recorded on 26 June,
259 29 June-2 July 2010, and 10-11 July 2010. A maximum discharge of 2,310 m³/s was
260 registered on 10 July 2010 at 9 pm. The flood danger level (CP) was exceeded at four times,
261 with water levels of 643 cm (+43 cm CP, on 25 June 2010), 685 cm (+85 cm CP, on 29 June
262 2010), 721 cm (+121 cm CP, on 29 June-2 July 2010), and 744 cm (+144 cm CP, on 10-11
263 July 2010) (Fig. 6).

264 The Stanca Aval (downstream) gauging station is controlled by overflow from the
265 Stanca-Costesti reservoir. This control mitigates the flood hydrographs. The maximum
266 discharge value at this station was 885 m³/s on 3 July 2010. The flood level (CI) was
267 exceeded from the beginning to the end of the flooding period. The flood danger level (CP)
268 was exceeded from 1-13 July 2010, reaching a maximum water level of 460 cm (+85 cm CP,
269 on 3 July 2010) (Fig. 6).

270 At the Ungheni gauging station, floods were recorded throughout the entire month of
271 July. The maximum discharge was 673 m³/s on 8 July 2010. Flooding continued until 5
272 August 2010. The flood danger level (CP) was exceeded during the 12-day period from 6-17
273 July 2010. The maximum water level was 661 cm (+1 cm CP) (Fig. 6).

274 Floods were also recorded throughout July at the Prisacani gauging station. The
275 maximum discharge was 886 m³/s on 9 July 2010. Flooding continued until 5 August 2010.
276 The flood danger level (CP) was exceeded during the 16-day period from 4-19 July 2010. The
277 maximum water level was 673 cm (+73 cm CP) (Fig. 6).

278 At the Dranceni gauging station, floods were recorded over a long period from the end
279 of June until the beginning of August. The maximum discharge was 718 m³/s on 17 July
280 2010. The flood danger level (CP) was reached or exceeded during the 18-day period from 4-
281 22 July 2010. The maximum water level was 729 cm (+29 cm CP) (Fig. 6).

282 At the Falciu gauging station, floods occurred throughout July and during the first half
 283 of August. The maximum discharge was 722 m³/s on 19 July 2010. The flood danger level
 284 (CP) was reached or exceeded during the 35-day period from 6 July-2 August 2010. The
 285 maximum water level was 655 cm (+55 cm CP) (Fig. 6).

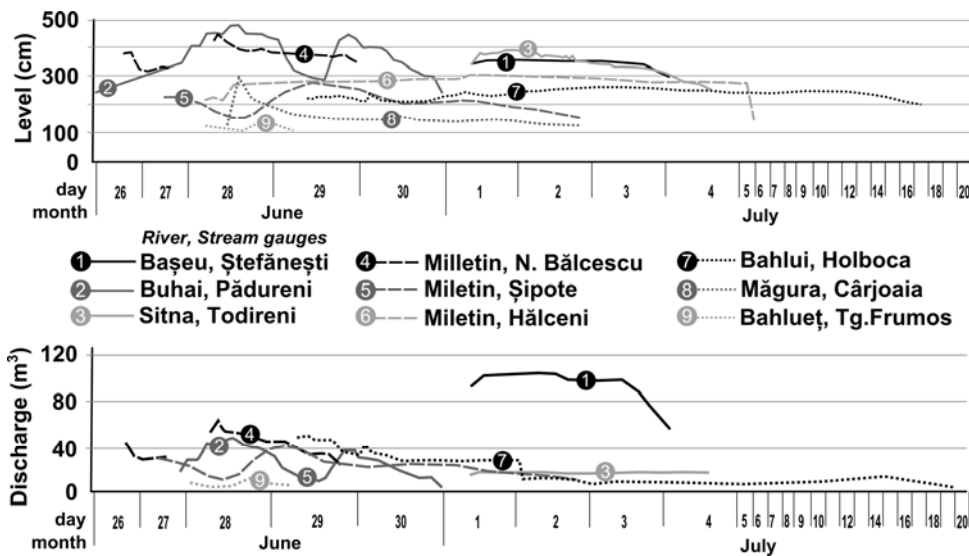
316 **Figure 7.** Water levels and discharge on the main Prut tributaries during the summer of 2010:
317 the Baseu, Buhai, Sitna, Miletin, Bahlui, Magura, and Bahluiet Rivers

301 At the Padureni gauging station on the Buhai River, two backwaters were recorded in
 302 June and a secondary backwater in May. The maximum discharge was 470 m³/s on 28 June
 303 2010. The flood danger level was exceeded during both backwaters, with water levels of 470
 304 cm (+120 cm CP, on 28 June 2010) and 440 cm (+90 cm CP, on 29 June 2010) (Figs. 3, 7).

305 At the Todireni gauging station on the Sitna River (a tributary of the Jijia), floods
 306 occurred from 1-4 July 2010. The maximum discharge was 19 m³/s on 1, 2, and 4 July 2010.
 307 The flood level (CI) was exceeded on 1 and 2 July 2010. The maximum water level was 387
 308 cm on 1 July 2010. The flood warning level (CA) was exceeded on 4 July 2010 (Figs. 3, 7).

309 At the Nicolae Balcescu gauging station on the Miletin River (a tributary of the Jijia),
 310 floods were recorded from 26-29 June 2010. The maximum discharge was 60 m³/s on 6 June
 311 2010. The flood level (CI) was exceeded just once, on 28 June 2010. The maximum level was
 312 444 cm (+22 cm CI). The warning level (CA) was exceeded throughout the flooding period
 313 (Figs. 3, 7).

319 At the Sipote gauging station on the Miletin, four backwaters were recorded from 22
320 June-2 July 2010. The maximum discharge was $45 \text{ m}^3/\text{s}$ on 29 June 2010. The flood level (CI)
321 was exceeded from 29-30 June 2010. The maximum water level was 269 cm (+19 cm CI).
322 The warning level (CA) was exceeded throughout the flooding period (Figs. 3, 7).

323 At the Halceni gauging station on the Miletin, floods were recorded from 28 June-5
324 July 2010. The maximum discharge was $32 \text{ m}^3/\text{s}$ on 1-2 July 2010. The flood danger level
325 (CP) was exceeded during the peak discharge period, with a water level of 302 cm (+2 cm
326 CP). The flood level (CI) was exceeded throughout the flooding period (Figs. 3, 7).

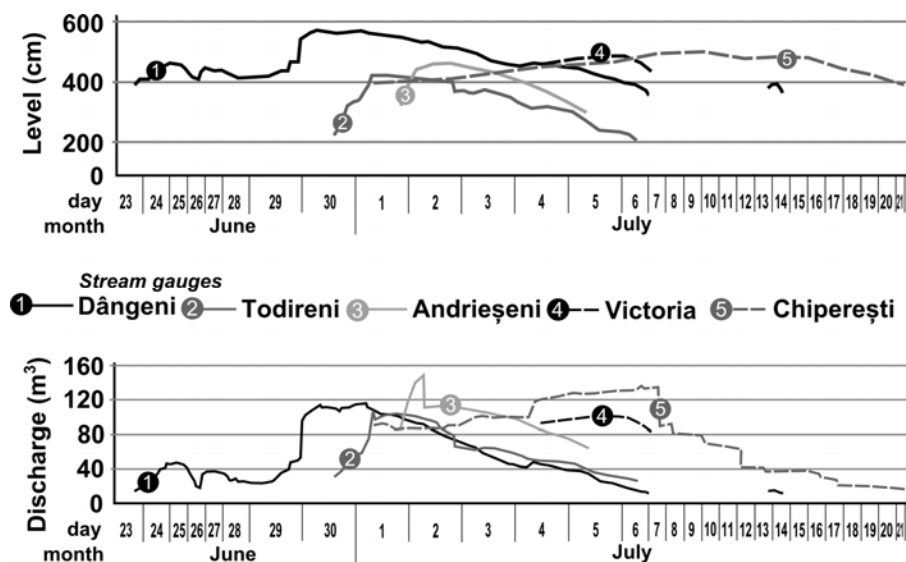
Figure 8. Water levels and discharge on the Jijia River at the gauging stations of Dângeni, Todireni, Andrieseni, Victoria, and Chiperesti during the summer of 2010

348 At the Dorohoi gauging station on the Jijia, several backwaters were recorded from 21
349 May-7 July 2010. The maximum discharge was $119 \text{ m}^3/\text{s}$ on 29 June 2010. The flood danger
350 level (CP) was exceeded from 29-30 June 2010. The maximum water level was 760 cm (+160
351 cm CP). The flood warning level (CA) was exceeded throughout the flooding period (Figs. 3,
352 8).

At the Victoria gauging station on the Jijia, flooding occurred from 4-7 July 2010. The peak discharge was 100 m³/s on 5 July 2010. The flood warning level (CA) was exceeded throughout the flooding period. The maximum water level was 485 cm (+35 cm CA) (Figs. 3, 8).

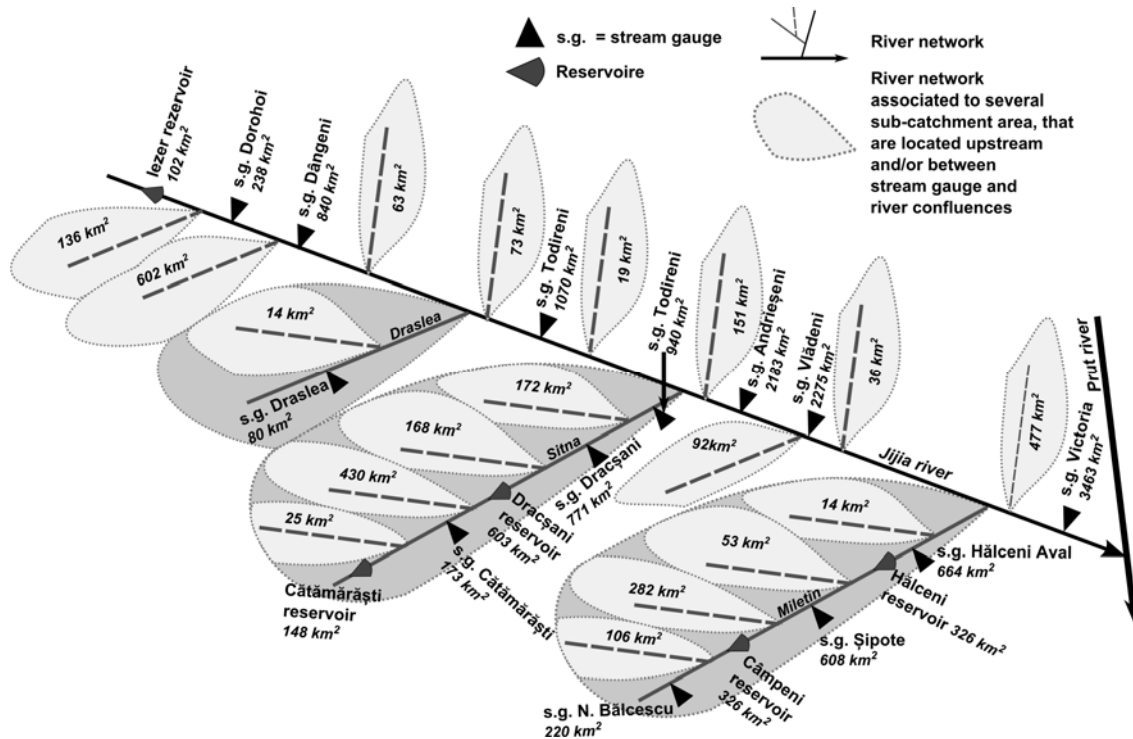
425 **Figure 10.** Distribution of sub-basins within the Jijia catchment and placement of the main
 426 ponds
 427
 428

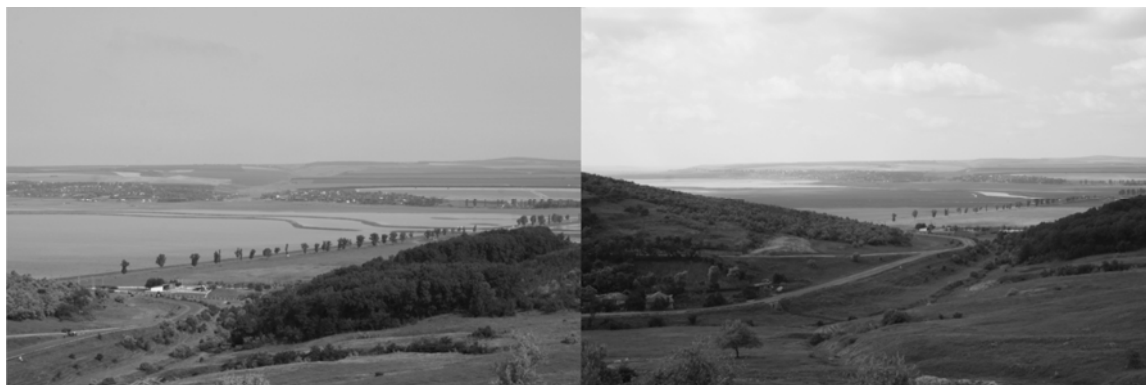
452 **Figure 11.** Polders on the Jijia and the floods recorded in the summer of 2010: storage of
 453 excess water (left) and its elimination (right)
 454
 455

445 The system of polders in the lower reaches of the Jijia served as an effective trap for
 446 surplus water. High discharges on the Danube, which reached a historic maximum of 16,300
 447 m³/s at Galati (July 5th, 2010), would have flooded the city centre without the precincts
 448 constructed on the Jijia that stopped a portion of the floodwaters. When the floods on the

449 Danube ceased, the water was gradually eliminated from the polders, which explains why
 450 high water levels persisted in the lower Prut for a long time (Fig. 11).
 451

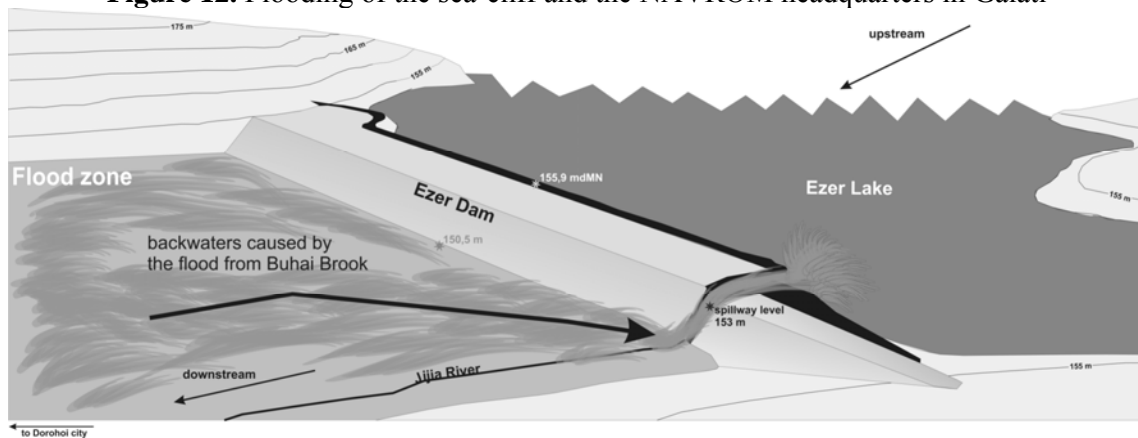
Figure 13. The “spider flow” phenomenon in which the Buhai waters climbed the Ezer dam on the Jijia, in the area of confluence of the two rivers

The floods recorded in the summer of 2010 in the Buhai catchment (a tributary of the Jijia, which is a tributary of the Prut) caused backwaters to emerge at the mouth of the river. The manifestation of this backwater phenomenon is unique because the floodwaters of the Buhai River climbed the Ezer dam (on the Jijia River) and flooded its lacustrine cuvette. The phenomenon was named “spider flow” (Romanescu and Stoleriu, 2013a,b) (Fig. 13).

535 The 2010 floods caused a unique backwater phenomenon at the mouth of the Buhai
536 River. Floodwaters from the Buhai climbed the Ezer dam (situated on the Jijia River) and
537 flooded its lacustrine cuvette. The phenomenon was called “spider flow”. In order to avoid
538 such phenomena it is necessary to increase the height of the overflow structure.
