Historical Analysis of Rainfall-Triggered Rockfalls: the Case Study of the Disaster of the Ancient Hydrothermal Sclafani Spa (Madonie Mts., Northern-Central Sicily, Italy) in 1851

Abstract. In 1851, the region of Sicily experienced many rainstorm-induced landslides. On 13 March 1851, a rainstorm brought about a severe rockfall disaster near the small town of Sclafani (Madonie Mountains, northern-central Sicily, Italy). Rocks detached from the carbonate crest of Mt. Sclafani (813 m above sea level) fell downslope, causing the collapse of the ancient hydrothermal spa (about 430 m above sea level) and burying it under their fragments. Fortunately, the event did not cause injuries or victims. Given its geological, geomorphological and tectonic features, the calcareous-dolomitic and carbonate-siliciclastic relief of Mt. Sclafani is extremely prone to landsliding. This study combines the findings from detailed geological and geomorphological field surveys and from a critical review of documentary data. A thorough analysis of documentary sources and historical maps made it possible to identify the location (previously unknown) of the ancient spa. The rockfall dynamics was traced back by

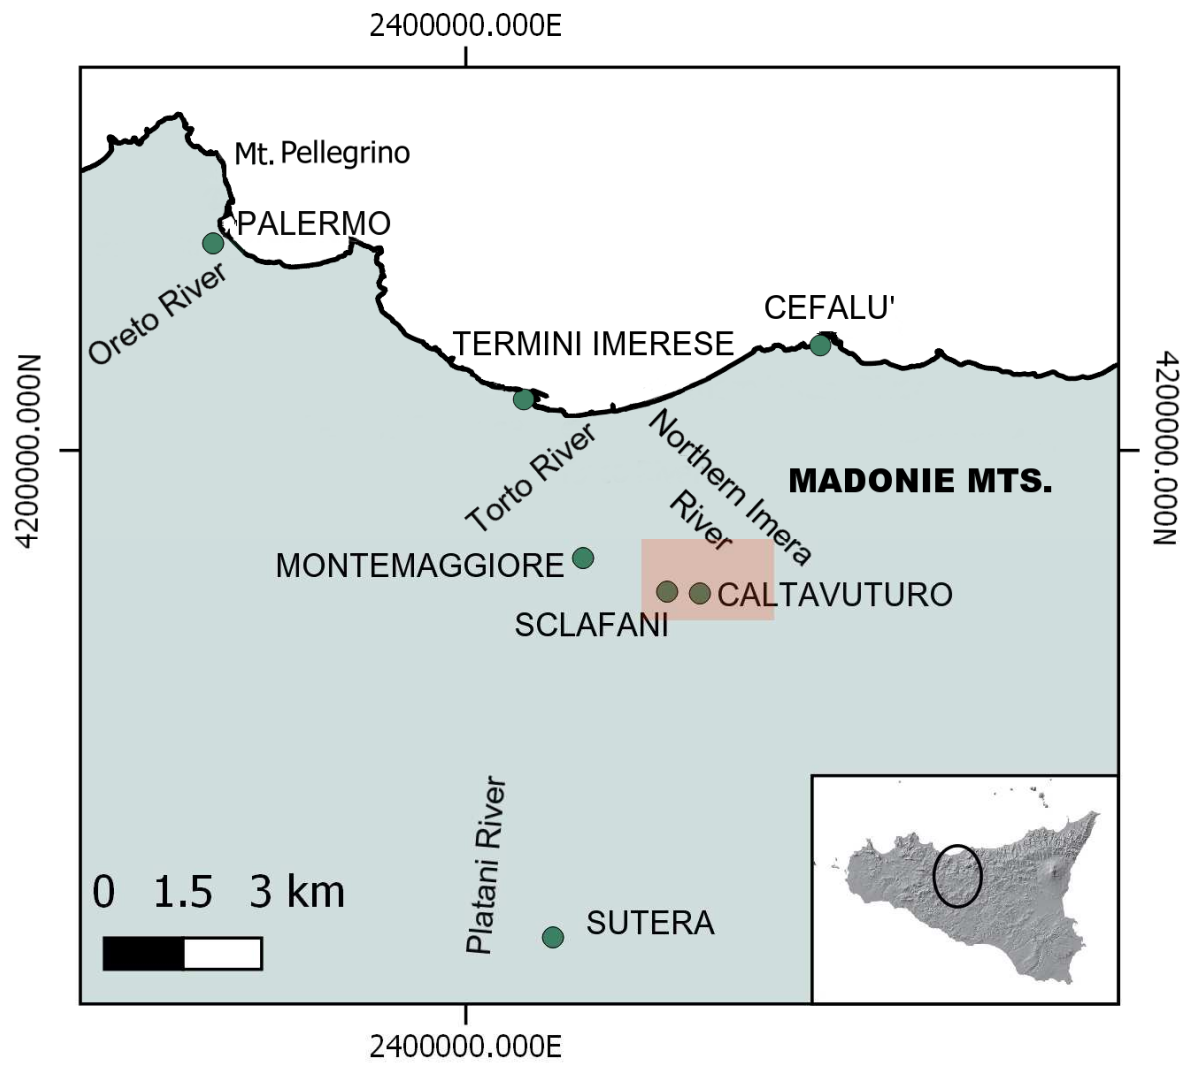
Fig. 01

The extreme weather event affected the northern region and its central and western sectors almost entirely (Fig. 1) and was accompanied by heavy rain (Anonymous, 1847-59; Anonymous, 1851, Anonymous, 1851-52; Benso et al.,
70 1851; Di Marzo, 1859; Possenti, 1865; Aureli et al., 2008 and references therein). This torrential rain triggered a large number of shallow landslides in mountainous or hilly areas and floods in coastal plains, producing substantial

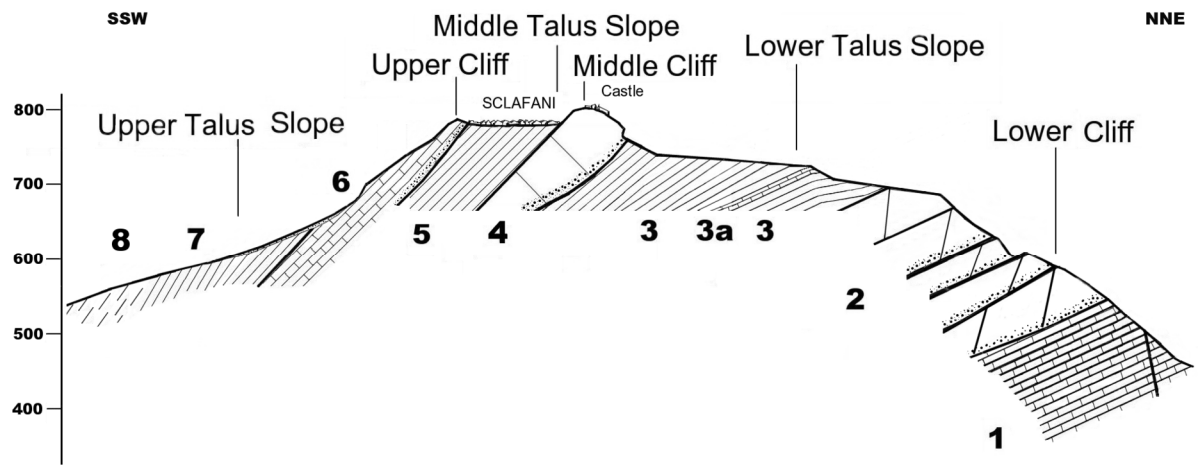
Fig. 03

195 Mt. Sclafani is a morphostructural high of the large CRSSA, markedly dissected by the recent faults with the highest angle. This typical isolated relief with a pyramidal shape and a triangular base is bordered on its E and W sides by an N-S-trending normal fault/fault line scarp. Its NW slope is bounded by a fault line scarp that was interpreted in different ways (see Discussion). Mt. Sclafani consists of three S-dipping slopes, separated by less steep slopes. Owing to selective erosion, this morphology corresponds to carbonate and siliciclastic levels, respectively. These levels give 200 rise to fall-prone hard-on-soft landforms (see Fig. 3):

- Lower Cliff: about 230-10m high, calcareous-dolomitic (Scillato and Fanusi fms.); it shows selective erosion steps, with small caves and protruding ledges and is locally shaped by arcuate rockfall niches;
- Lower Talus Slope: roughly 240-40m high, siliceous and subordinately calcareous-marly (radiolarian member, Crisanti fm.), with morphoselection ledges;
- 205 - Middle Cliff: approximately 30-20m high, calcareous (Ellipsactinia breccias member, Crisanti fm.) and crowned by the ruins of the medieval castle; its steep undercut cliffs are rockfall-prone; this is the source area of the 1851 event (height approximately 730-750m a.s.l.);

- Middle Talus Slope: marly-calcareous (marly-spiculitic member, Crisanti fm.);
- Upper Cliff: calcareous (Rudistid breccias member, Crisanti fm.); also these steep undercut scarps are rockfall-prone;
- Upper Talus Slope: calcareous-marly (Caltavuturo fm.) and terrigenous (Numidian flysch).

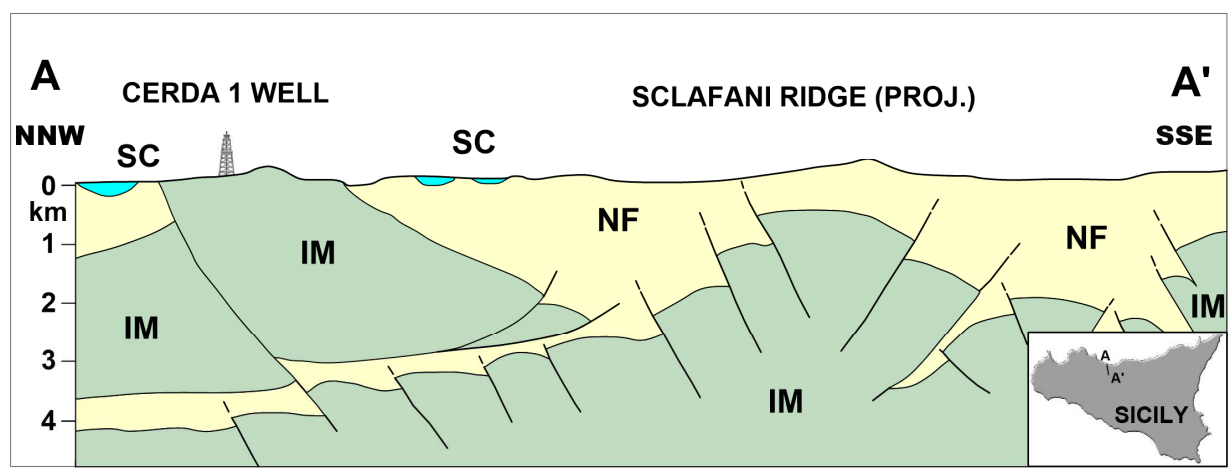
Fig. 04

165
170 The upper portion of the SI.RI.PRO (Fig. 4) exhibits a stack of N-dipping, imbricated thrust sheets, affecting the thin basinal successions of Meso-Cenozoic age (Imerese unit, Numidian flysch and Sicilidi); the latter were emplaced during compressional event I. The Imerese thrust sheets appear to have been cut by deep-seated high-angle faults (generated at a deeper structural level) and then folded and lifted, giving rise to N-dipping features (i.e. backthrusts).
During the Pleistocene, NW-SE- and NE-SW-trending normal faults, correlated with an extensional tectonic event of a high angle, involved the study area. Finally, the occurrence of N-S- and E-W-oriented transtensional faults is consistent with a quasi-vertical maximum compression.

Figure 04 – Interpreted northern transect of the S.I.R.I.PRO. crustal seismic reflection profile, showing the
hydrostructural setting of the tectonic units near the Sclafani area (drawing modified after Catalano et al., 2011a). NF
(Numidian Flysch, cap rock); SC (Sicilidi Units); IM (Imerese Units, multilayered reservoir).

290 Therefore, in this study (see structural sketch map in Fig. 2), the TSF was interpreted as the SW prolongation of the TCF. In agreement with these data, the SI.RI.PRO crustal seismic profile displays the buried Imerese tectonic high with N-dipping thrusts, which occurred in response to the basement thrust and associated uplift. The deep crustal uplift was ascribed to the Pliocene-lower Pleistocene (Catalano et al., 2013). The general uplift of this sector of the Madonie Mts. has accelerated the effects of exogenous processes and, consequently, gravitational movements.

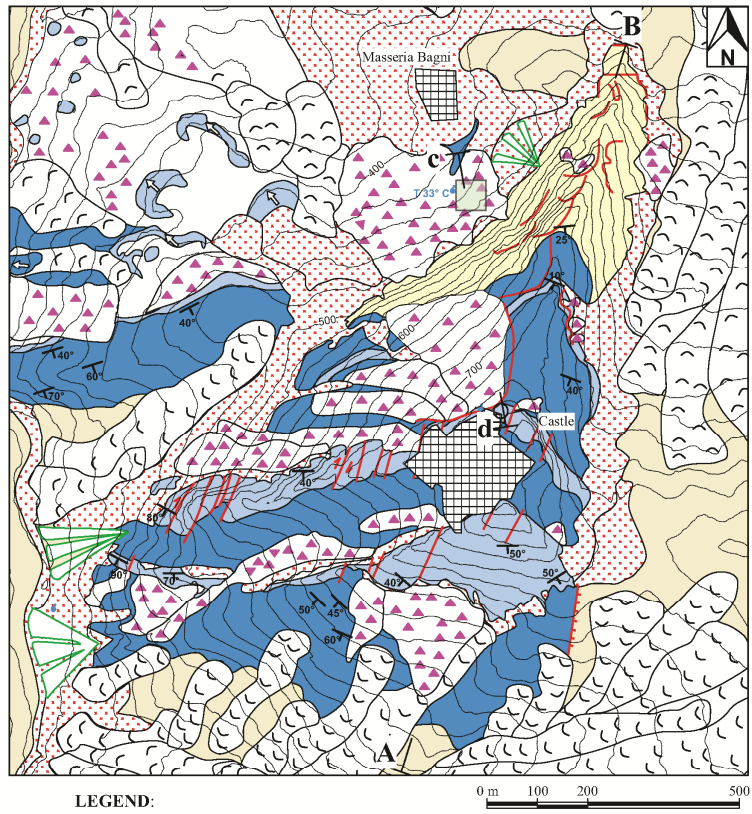
Fig. 05

190 Fieldwork on Mt. Sclafani began with detailed geomorphological reconnaissance studies and mapping (original scale 1:10,000; area: 2.2 km², Fig. 5), based on the guidelines proposed by the Servizio Geologico Italiano (Gruppo di Lavoro per la Cartografia Geomorfologica, 1994). For general assessments of geomorphological mapping in geohazards, Lee (2001) recommends 1:10,000 as a suitable scale. The map of Fig. 5 is the synthesis of a meticulous field survey, which was fine-tuned by carefully interpreting topographical and cadastral maps, aerial photographs and satellite images.

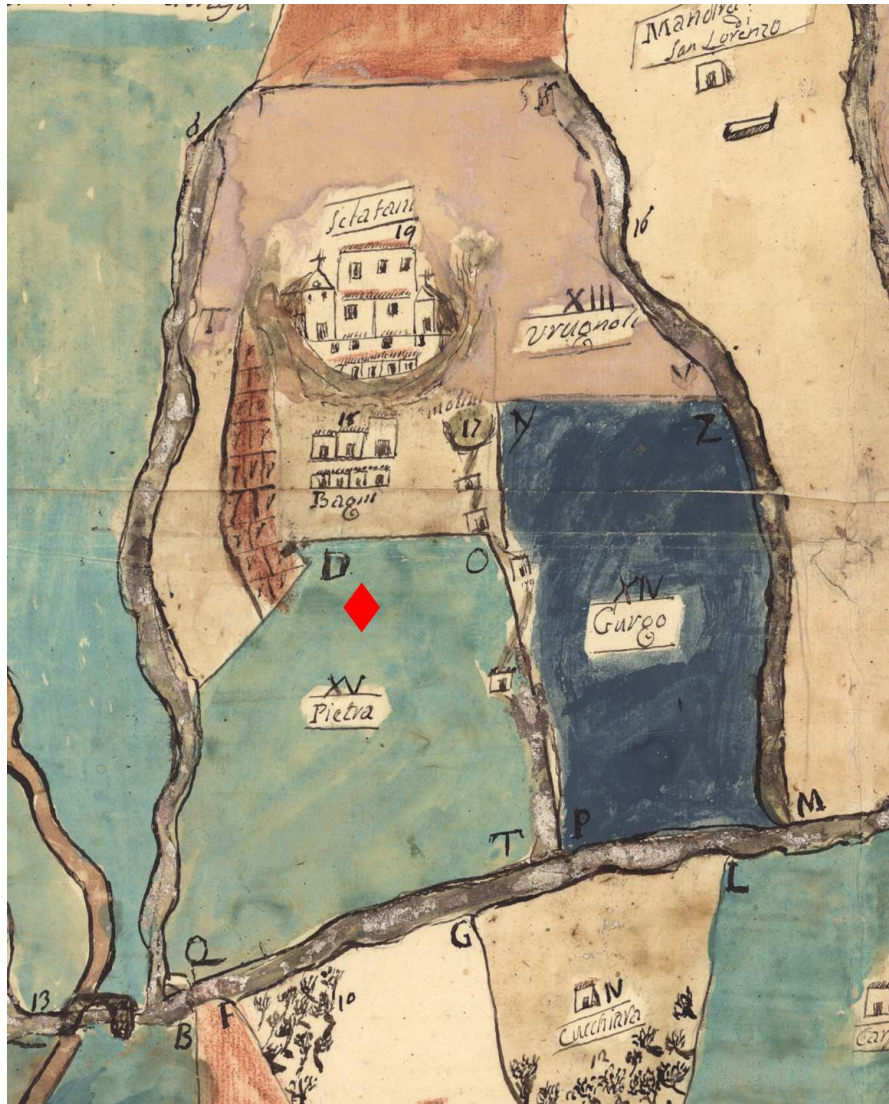
Figure 05 – Simplified geological and geomorphological map of Mt. Sclafani (equidistance of elevation contours:
20m), shown the sector crossed by the section (A-B) of Fig. 3 and the profile (c-d), of Fig. S6 (see Supplementary
Information).

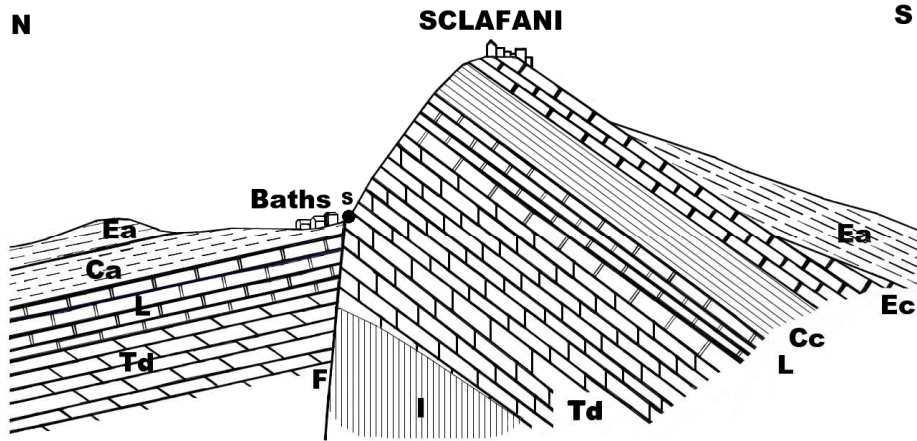
Fig. 08

The site of the ancient spa at the footslope of Mt. Sclafani is clearly visible in the pioneering geological and hydrogeological sketch (based on the Bourbon maps) drawn by Felice Giordano (Fig. 8), a mining engineer who worked in Sicily in 1860 (Daubrée, 1887). Furthermore, the very detailed 1847 engraving (Cappa, 1847), portraying
325 the “ancient Sclafani spa” prior to the disaster, shows a site with a gentle topographic slope; this is due, in part, to the expansion work carried out at the time at the foot of the slope (Fig. 9).

725 Figure 08 – N-S geological and hydrogeological sketch (not in scale) of Mt. Sclafani drawn by Felice Giordano, approximately in 1860, using the Bourbon maps of 1849-52 (drawing modified after Doubrée, 1887). Legend: I. marls (Trias, Impermeable, not outcropping); Td. Dolomites (Trias); L. Limestones (Lias); Ca. clays (Cenomanian); Cc. Marls and limestones (upper Cretaceous); Ec. Limestones (lower Eocene); Ea. Speckled clays (middle Eocene); F. Fault; S. Thermal springs and location of the ancient Sclafani spa.

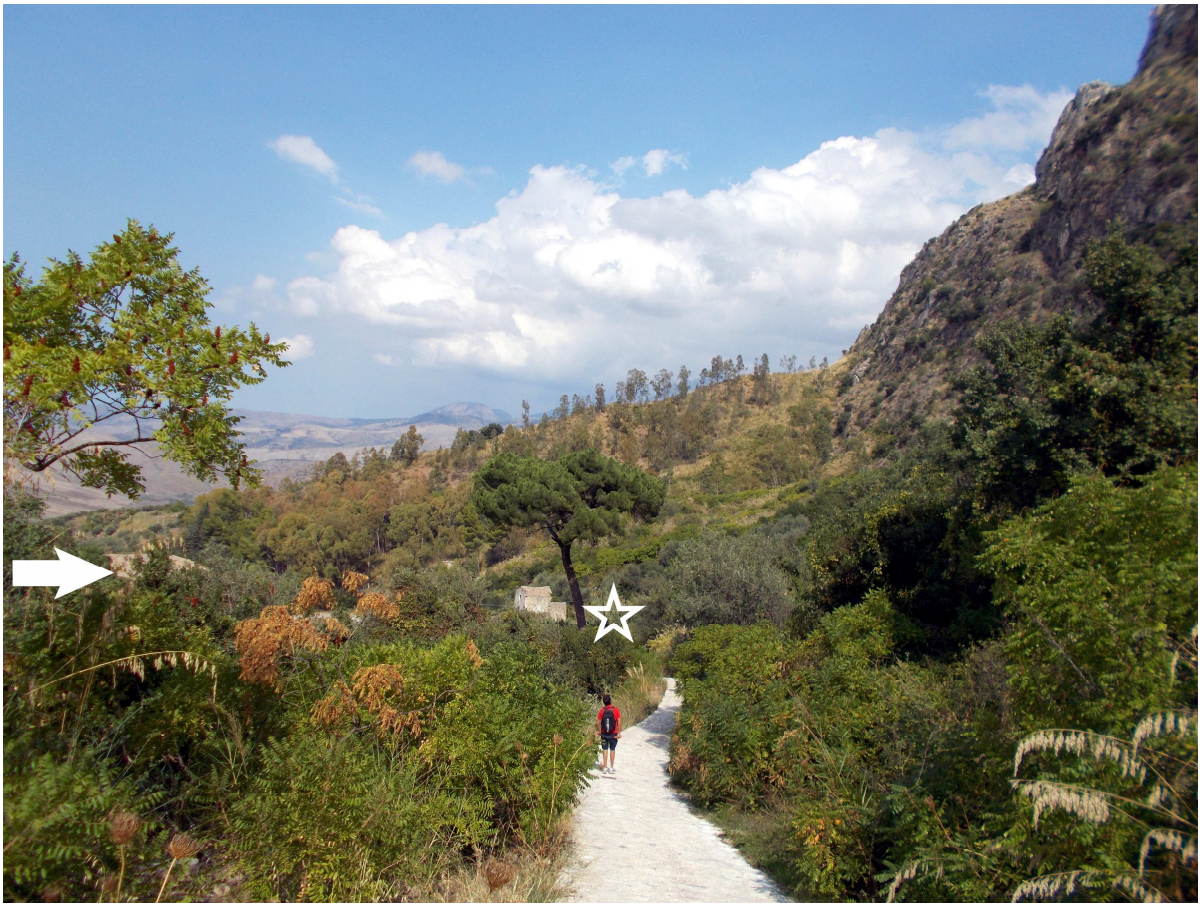
Fig. 10

735 Figure 10 – The present landscape surrounding the site of the ancient Sclafani spa. The arrow indicates the location of the new thermal new one-floor thermal establishment (1856-57, the so-called “Masseria Bagni” i.e. “thermal bath farm”). The star indicates the today’s location of Sclafani thermal springs. For vantage point, see Fig. S4 in **Supplementary Information**.
