Referee #1 comments: E. Pelinovsky

3. I am not sure that the title properly reflects the context. Perhaps, the title 'Catalogue of extreme wave events in Ireland: revised and updated for 14680 BP – 2016" will be better.
We have changed the title based on this recommendation.

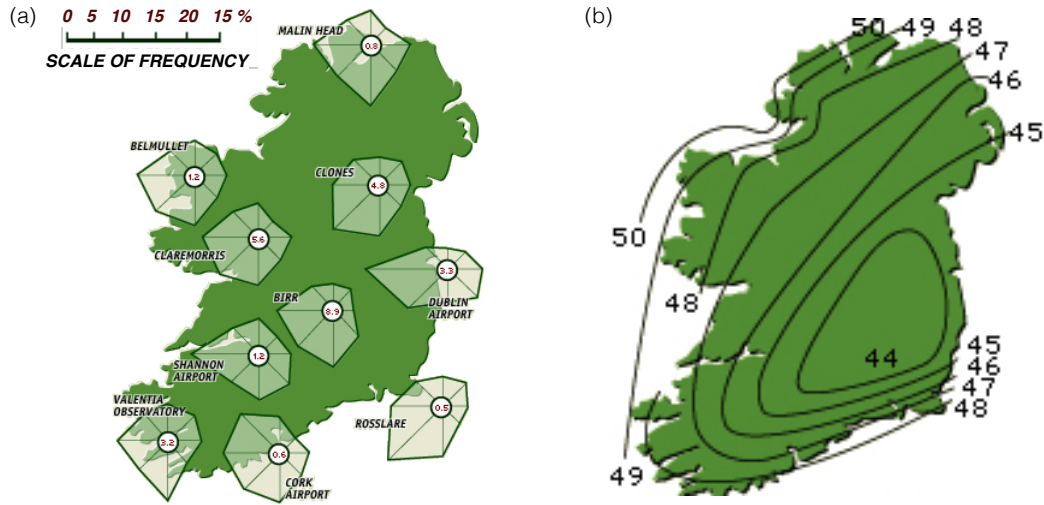
Figure 1. (a) Percentage Frequency of wind direction with circled number representing the percentage of calm days. (b) Maximum gust speed likely to be exceeded once in 50 years (m/s). (Met Éireann, 2016c)

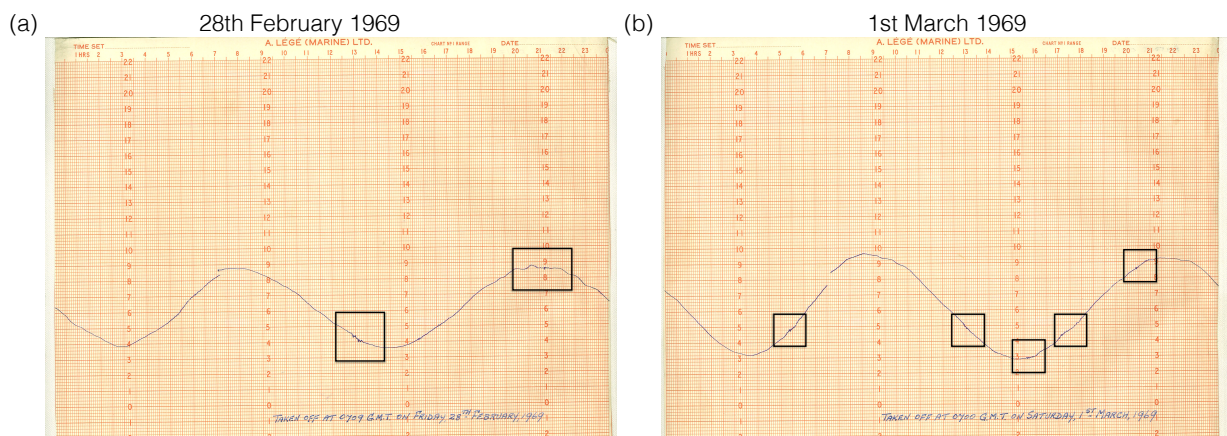
Figure 2. Tide gauge recordings at Belfast harbour on (a) 28th February 1969 and (b) 1st March 1969. Minor oscillations can be seen upon close inspection ([black boxes](#)), with the first wave arriving at approximately 1pm. Retrieved through personal contact with the the Permanent Service for Mean Sea Level (2016), (Holgate et al., 2013).

4. Figure 2 and 3. It will be interesting to indicate by an arrow the tsunami entry time or, if it is difficult the earthquake time.
We have added boxes around the visible oscillations in the tide gauge figures.

In addition to the 1755, 1761, 1941 and 1975 Lisbon, tsunamis documented in O’Brien et al. (2013), there was another significant earthquake and tsunami near Lisbon on the 28 February 1969. The tide gauge recordings at Belfast harbour show small oscillations which may be the arrival of this tsunami, see Figures 2. In addition, another tide gauge recording has been located for the 1975 tsunami. The recording is taken at Belfast harbour and is shown in Figure 3.

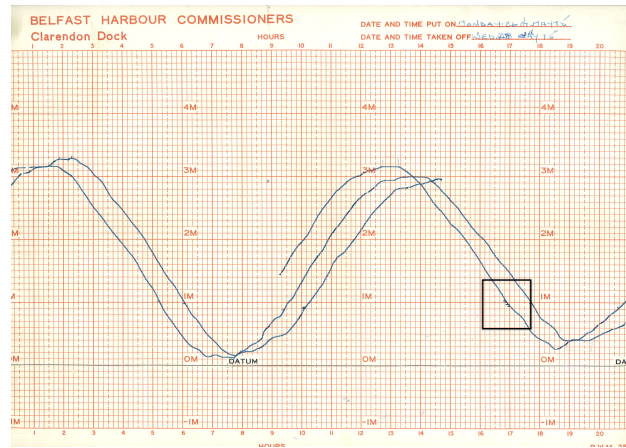
Figure 3. Tide gauge recordings at Belfast harbour on (a) 23rd – 26th May 1975 and (b) 26th – 28th May 1975. Minor oscillations can be seen upon close inspection [at approximately 5pm](#). Retrieved through personal contact with the Permanent Service for Mean Sea Level (2016), (Holgate et al., 2013).

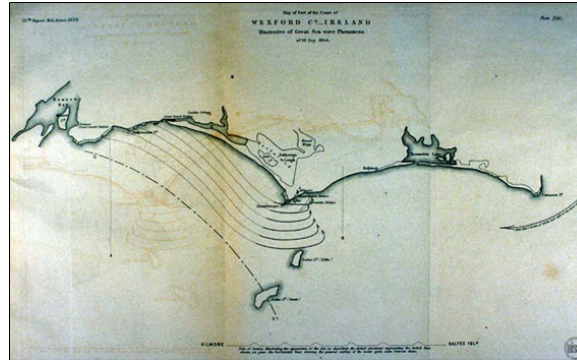
Figure 4. A tsunami at Kilmore Quay on 16 September 1854 (Mallet and Mallet, 1854).

A map depicting the tsunami at Kilmore Quay on the 16 September 1854 has come to light since the publication of O'Brien et al. (2013), see Figure 4.

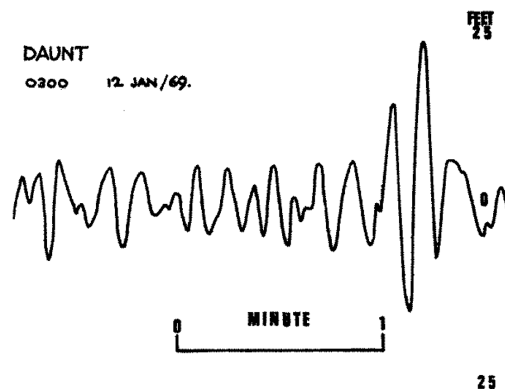
Figure 6. Wave recorder trace taken on 12th January 1969 (Figure 1 in Draper (1971))

Draper (1971) shows a record from the 12th January 1969 taken by the Commissioners of Irish Lights with a shipborne wave recorder on *Daunt* light-vessel off Cork showing a wave that is 4.1 times the average wave height. Given that the average wave height would usually be around 0.63 times the significant wave height, this wave would be approximately 2.6 times the significant wave height. See Figure 6.

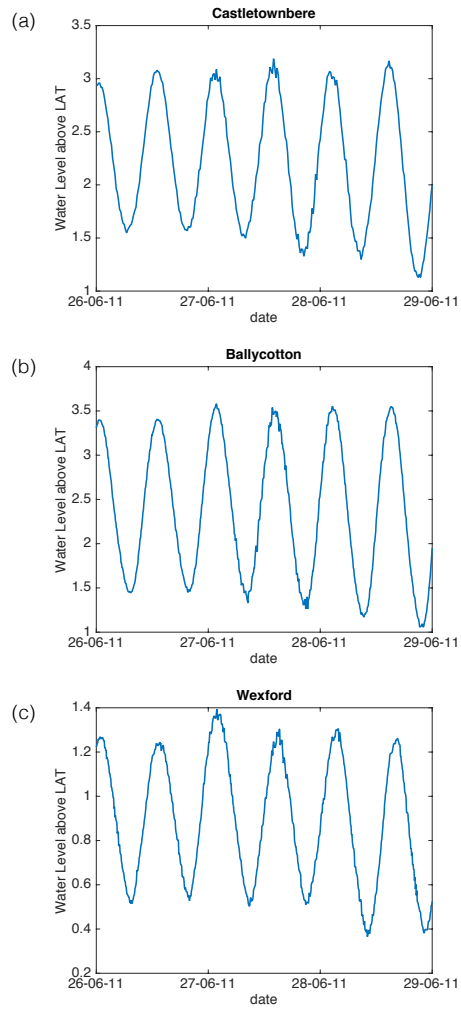
Figure 7. Tide gauge data from 26th-29th June 2011 at (a) Castletownbere (SW coast), (b) Ballycotton (S coast) and (c) Wexford (SE coast), small oscillations are clearly visible. [Data retrieved from The Marine Institute \(2017a\)](#).

The National Oceanic and Atmospheric Administration (2016) Tsunami database records a questionable tsunami on 27 June 2011 in Plymouth, England with run up values recorded at Newlyn, Plymouth, Portsmouth and St Michael's Mount. The tide gauge record at Castletownbere, Wexford and Ballycotton shows evidence of this wave in Figure 7. The tsunami cause is given as meteorological on the NOAA database, however, a BBC News report on 29/06/2011 suggests it was due to a sub-marine landslide.

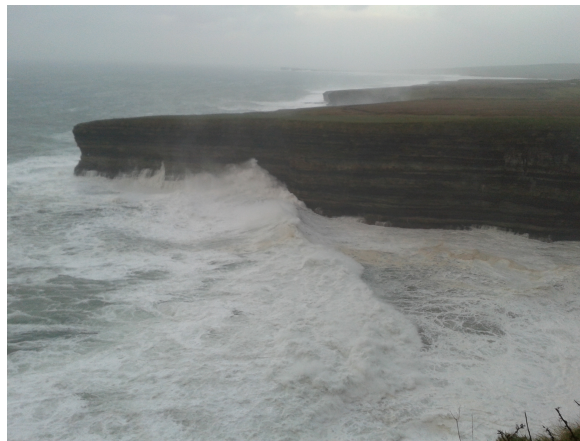
Figure 8. The sea condition as viewed from the platform at the Céide fields, Co. Mayo on the December 10th 2014.

Nearby at Portacloy, the sea state caused a World War 2 look out post to collapse on the same day. A photo of the sea condition in the area on this day are shown in Figure 8.

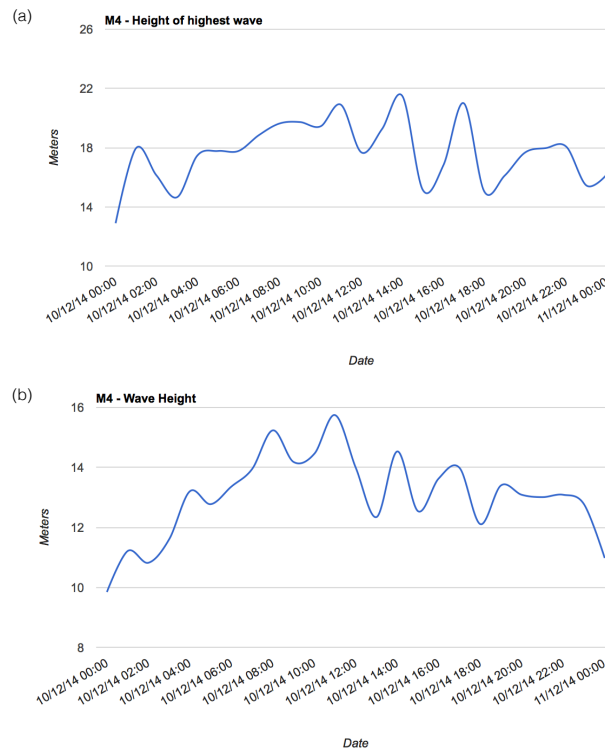
Figure 9. M4 records of (a) maximum wave height (m) and (b) significant wave height (m) on the 10th December 2014. [Data retrieved from The Marine Institute \(2017a\)](#) .

The M4 buoy located off the coast, Northeast of Belderrig, recorded a maximum wave height of 21.5 m on the same day, with a corresponding significant wave height of 14.5 m (see Figure 9). This is not classified as a rogue wave, however the
10 waves hitting the coast of Co. Mayo on this day did significant damage. A local man pointed out that if the large waves had hit the coast at high tide, the damage could have been far worse. (*Personal contact with Seamus Caulfield and Gretta Byrne*)

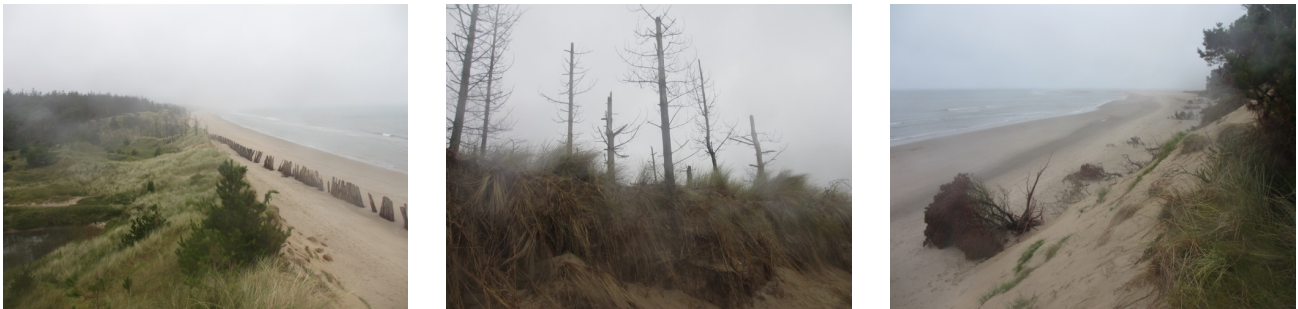
Figure 10. Pictures of the sand dunes at Culleton's Gap, Co. Wexford taken on 18 September 2016 approximately one month after the gales.
(Source: *James Herterich*)

The sand dunes at Culleton’s Gap (The Raven), near Curracloe, Co. Wexford were altered after gales on the 20th August 2016¹. Trees that line the beach were damaged, sand was shifted and tree roots were exposed (see Figure 10). Locals say that this is a common phenomenon in the region, particularly with strong easterly winds. Presumably it is a combination of wind and waves that alters the dunes here.

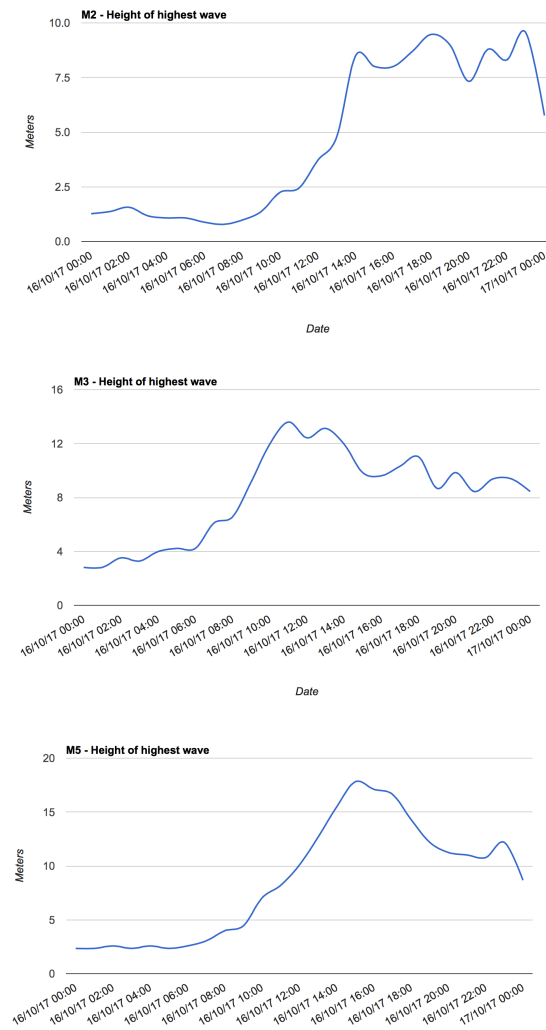
Figure 11. [Maximum wave height recordings on the M2, M3 and M5 buoys during Storm Ophelia on the 16th October 2017. The largest waves recorded were 9.6 m \(M2\), 13.6 M \(M3\) and 17.8 m \(M5\). Data retrieved from The Marine Institute \(2017a\) .](#)

<u>Location</u>	<u>Maximum Wave Height, H</u>	<u>Significant Wave Height, H_s</u>
<u>M2 Buoy</u>	<u>9.6 m</u>	<u>5.1 m</u>
<u>M3 Buoy</u>	<u>13.6 m</u>	<u>9.8 m</u>
<u>M5 Buoy</u>	<u>17.8 m</u>	<u>13 m</u>
<u>Belmullet Berth A Buoy (see Section 5.2.9)</u>	<u>18.5 m</u>	<u>4.41 m</u>
<u>Kinsale Energy Gas Platform</u>	<u>26.1 m</u>	<u>14.2 m</u>

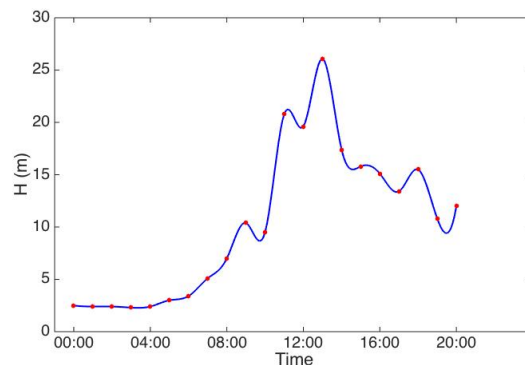
Figure 12. [Maximum wave height recordings at the Kinsale Energy Gas Platform during Storm Ophelia on the 16th October 2017. A 26.1 m wave was recorded. Data courtesy of Emily Gleeson at Met Éireann.](#)

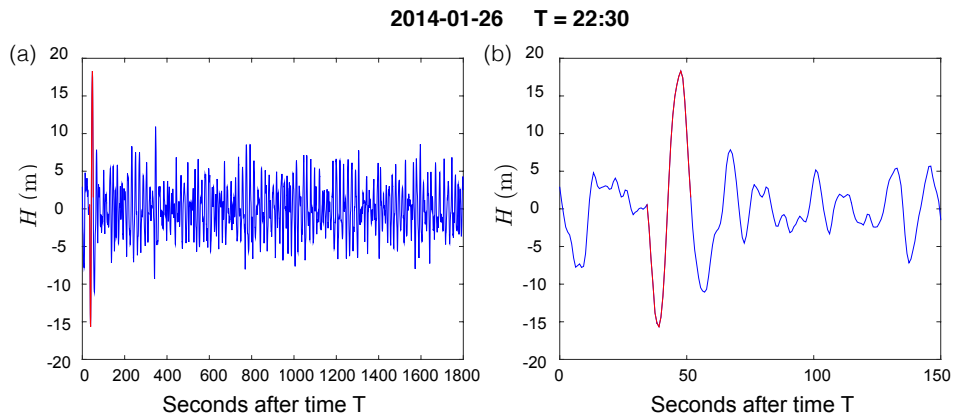
Figure 13. 33.96 m wave recorded at Killard ESB Platform on 26th January 2014 (a) between 22:30 and 23:00 and (b) zoomed in. The wave as identified by its crest-to-trough is highlighted in red.

A rogue wave was observed by a Waverider buoy near Killard deployed by the ESB, on the 28th January 2014 with a maximum trough-to-crest (upcrossing) value of 26.45m [with a significant wave height of 11.4 m](#) (Fedele et al., 2016). Analysis of the raw data shows that a rogue wave with a crest-to-trough/downcrossing value of 33.96 m was possibly recorded on 26th January 2014 at 22:30. [See Figure 11.30, with a significant wave height of 12.28 m. See Figure 13.](#) Note that there were 7 rogue waves greater than 20 m identified on this day, using both the upcrossing and downcrossing method, though 2 were part of the same wave packet. In addition there were 3 rogue waves greater than 20 m identified the following day, 27th January 2014 but none on the 28th.

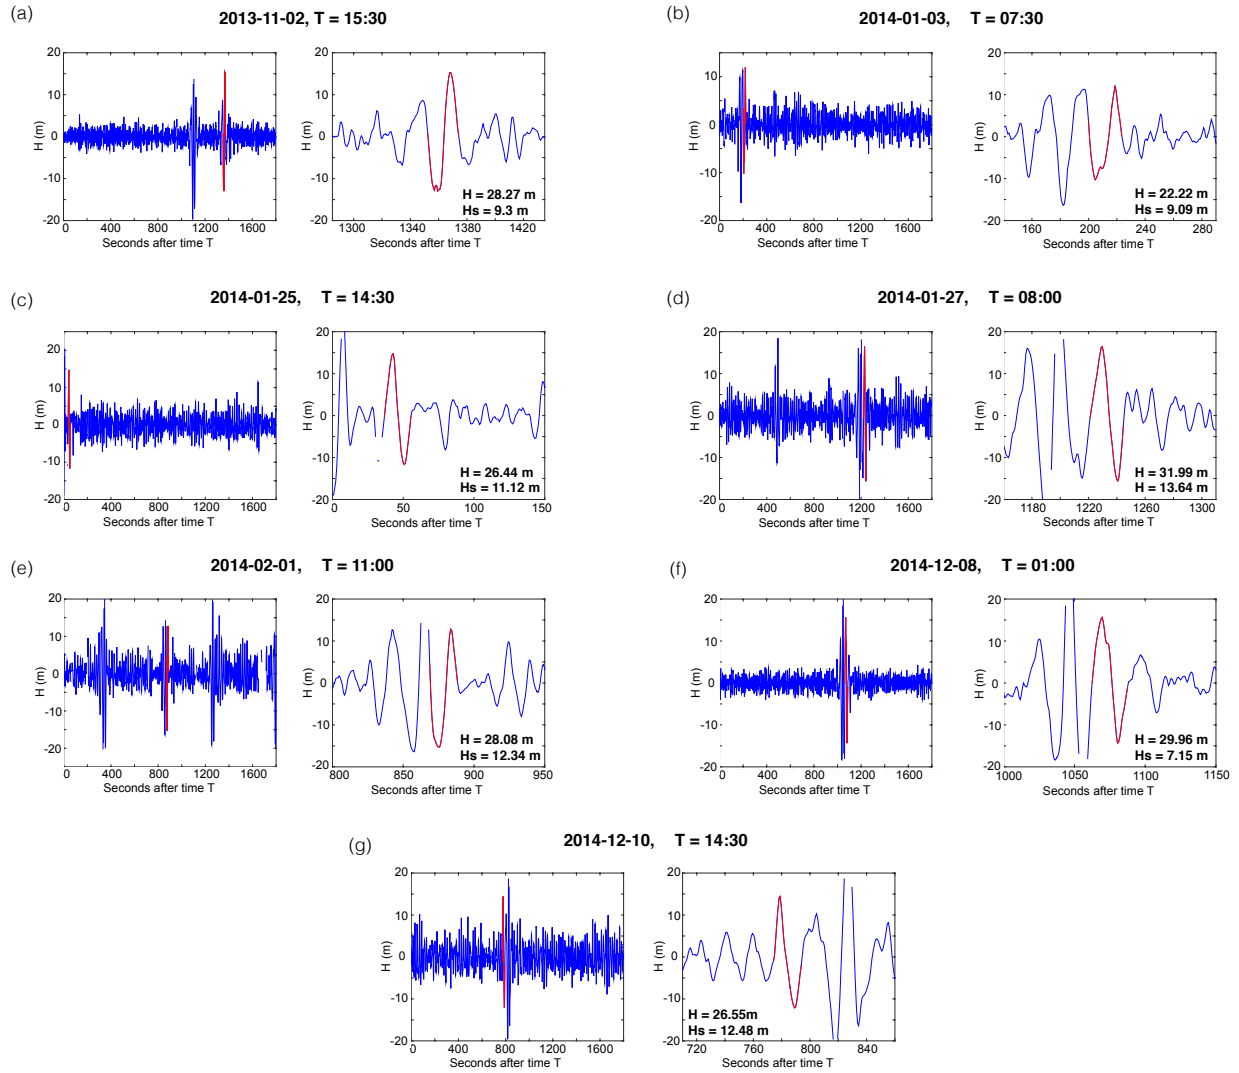
Figure 14. Large rogue waves recorded at Killard ESB Platform. Wave height recordings for the 30 minute duration when wave occurred (left column) and zoomed in around the time of event (right column). The waves are highlighted in red -with wave height (aH) -and significant wave height (bH_s) inset into zoomed figure. (a) 02/11/2013, 15:30. (b) -, (d) -03/01/2014, 07:30, (ec) -, (f) -25/01/2014, 14:30. (gd) -, (h) -27/01/2014, 08:00. (ie) -, (j) -01/02/2014, 11:00. (kf) -, (t) -08/12/2014, 01:00. (mg) -, (n) -10/12/2014, 14:30.

Furthermore, multiple rogue waves greater than 20 m have been recorded by this buoy between November 2011 and January 2015. It should be noted that the buoy was out of action Feb - Jul 2012 and Jan - Sep 2013 for various reasons. A total of 20 waves (on 7 days) were identified using upcrossing and downcrossing methods. For each of these days, the rogue wave with maximum wave height is plotted in Figure [12.14](#). Note that some values are missing due to the devices recording being irreparable. (The sensors on the Waverider buoy can only record a displacement of ± 20.48 m. Waves may actually have been higher, just not recordable.)

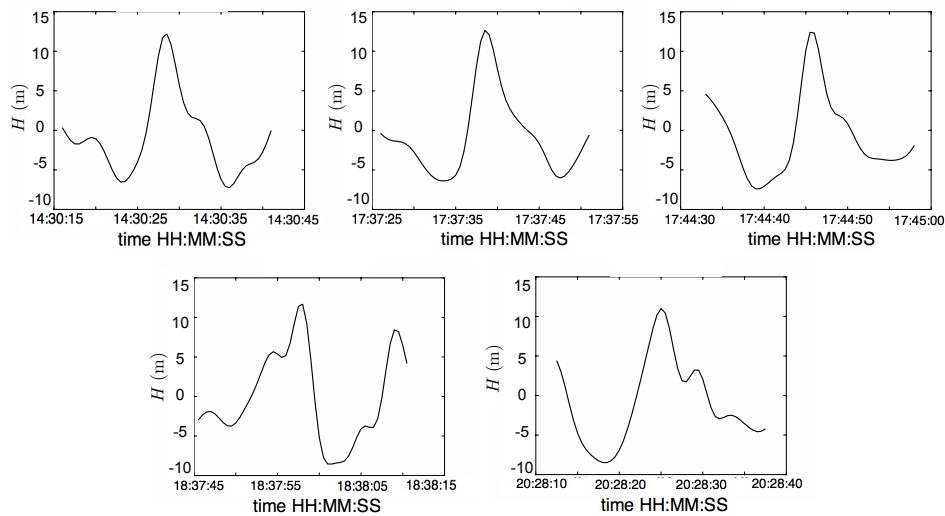
Figure 15. Large waves recorded by an ADCP near Killard, Co. Clare on the 22nd February 2015.

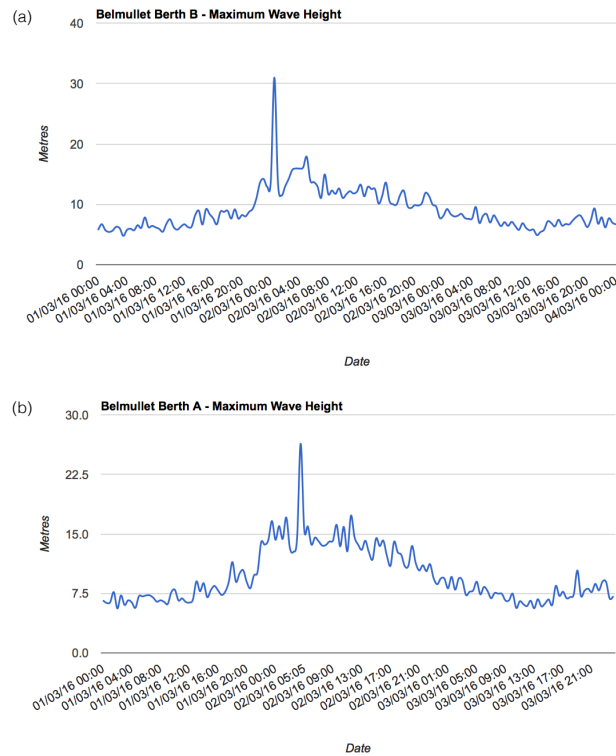
Figure 16. Maximum wave height at (a) Belmullet Berth B and (b) Belmullet Berth A wave buoys on 1st - 3rd March 2016. [Data retrieved from The Marine Institute \(2017a\)](#).

Storm Jake in late February/early March 2016 brought severe weather to Ireland. On the 2nd March at the Belmullet Berth B wave buoy, a 30.96m wave was recorded with a significant wave height of 8.810.69 m, classifying it as a rogue wave. See Figure 1416. However, the buoys can only be considered reliable within a certain range of displacement from mean sea level, so very large wave recordings like this should be treated with caution. Furthermore, without the raw data we could not check the validity of these measurements. Although, the nearby Belmullet Berth A wave buoy also recorded a very-large-wave-wave

measuring 26.35 m (with a significant wave height of 11.94 m) at around the same time (Figure 14.16) giving more confidence in the recording.

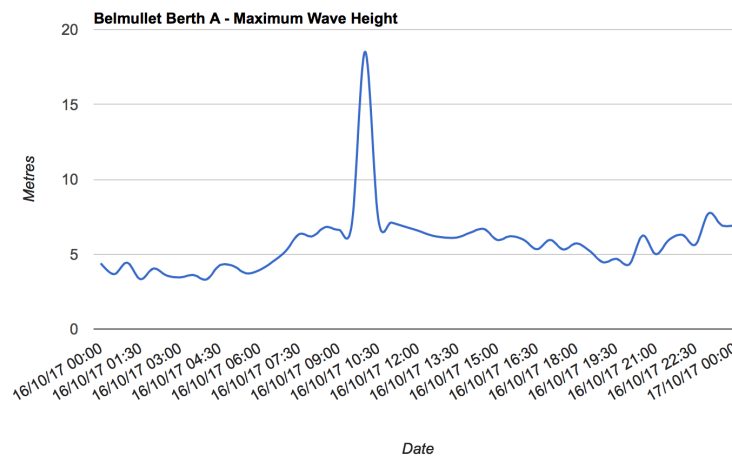
Figure 17. [Maximum wave height recordings on the Belmullet Berth A buoy during Storm Ophelia on the 16th October 2017. An 18.5 m rogue wave was recorded with a significant wave height of 4.41 m. Data retrieved from The Marine Institute \(2017a\) .](#)

A number of large waves were recorded during Storm Ophelia on the 16th October 2017, see Section 5.1.7. However, only one of these waves can be classified as a rogue wave. An 18.5 m wave was recorded by the Belmullet Berth A wave buoy, with a significant wave height of 4.41 m. See Figure 17 and Table 5.

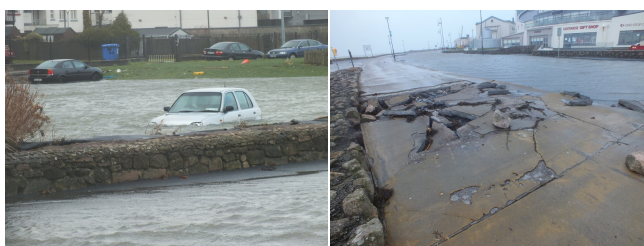
Figure 18. Photos of Galway on 1st February 2014 (credit: Emiliano Renzi)

Another storm on the 1st February 2014 caused more coastal flooding and damage across the country. Coastal flooding was worst in Co. Cork, particularly in Cork city, Clonakilty and Kinsale. In Co. Kerry there was over 0.75 m flooding in homes around Ballybunion. Floods also hit the Maharees area causing damage to Scraggane Pier road, Castlegregory beach and the sand dunes at Stradbally beach. Areas of Limerick, Waterford and Galway (see Figure 1518) were also effected by flooding. (*Irish Independent* 5 February 2014, *The Kerryman* 5 February 2014, *The Southern Star* 8 February 2014).

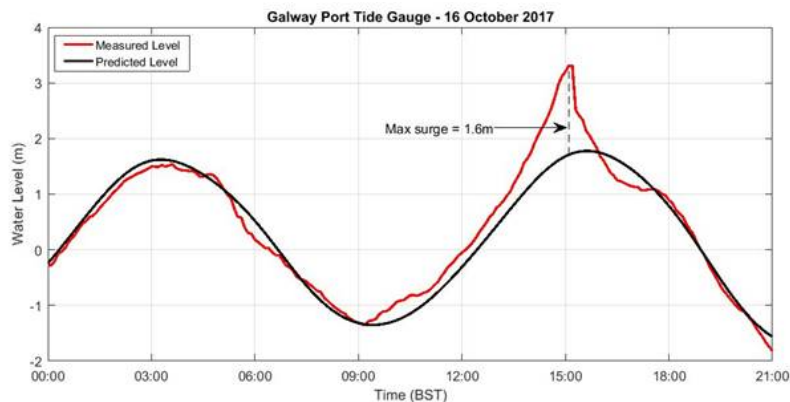
Figure 19. [Tide gauge recordings from Galway Port during Storm Ophelia on the 16th October 2017 \(figure retrieved from The Marine Institute \(2017b\) \).](#)

20 In addition to a number of large waves that occurred during Storm Ophelia (see Section 5.1.7 and Section 5.2.9), a significant storm surge was recorded in Galway Port. The surge was 1.6 m above predicted sea level and occurred 30 minutes before high tide. This resulted in flooding at the Docks, Spanish Arch and Salthill Promenade in Galway. Fortunately, the surge quickly dissipated, likely due to a rapid change in the speed and direction of the wind (The Marine Institute, 2017b) . See Figure 19.

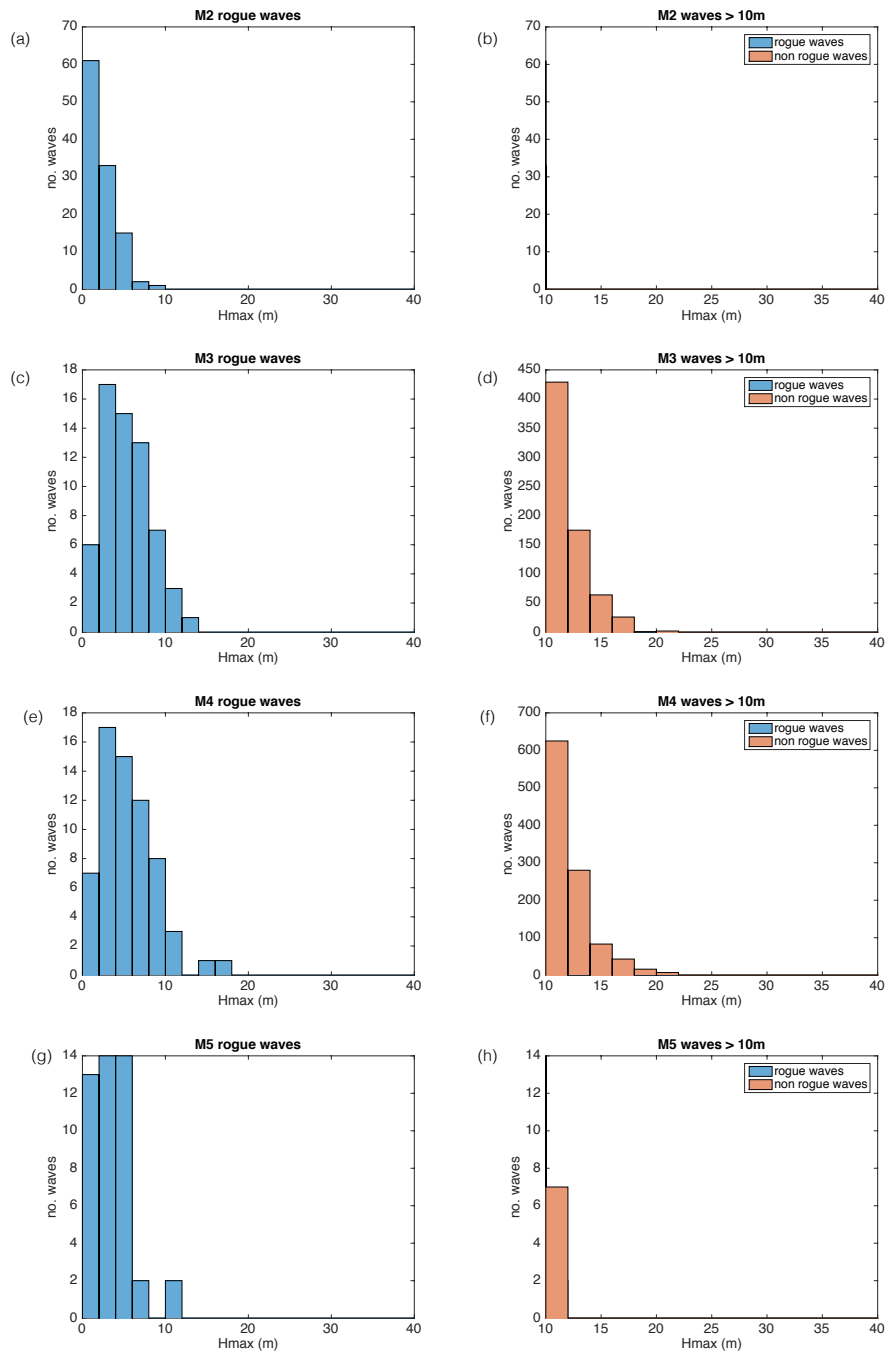
Figure 22. Number of rogue waves (left column) and number of large waves greater than 10 m (right column) recorded for each buoy (a), (b) M2; (c), (d) M3; (e), (f) M4; (g), (h) M5; for data available between March 2011 and June 2016 (M2: 31/03/11 - 01/07/16, M3: 01/06/12 - 01/07/16, M4: 07/06/11 - 01/02/16, M5: 23/01/12 - 01/07/16). [Data retrieved from The Marine Institute \(2017a\)](#).
