Catalogue of extreme wave events in Ireland: revised and updated for 14680 BP - 2017

Abstract. This paper aims to extend and update the survey of extreme wave events in Ireland that was previously carried out by O'Brien et al. (2013). The original catalogue highlighted the frequency of such events dating back as far as the turn of the last ice age through to 2012. Ireland's marine territory extends far beyond its coastline and is one of the largest seabed territories in Europe. It is therefore not surprising that extreme waves have continued to occur regularly since 2012, particularly considering the severity of weather during the winters of 2013-14 and 2015-16. In addition, a large number of storm surges have been identified since the publication of the original catalogue. This paper updates the O'Brien et al. (2013) catalogue to include events up to the end of ~~2016-~~2017. Storm surges are included as a new category and events are categorised into long waves (tsunamis and storm surges) and short waves (storm and rogue waves). New results prior to 2012 are also included and some of the events previously documented are reclassified. Important questions regarding public safety, s

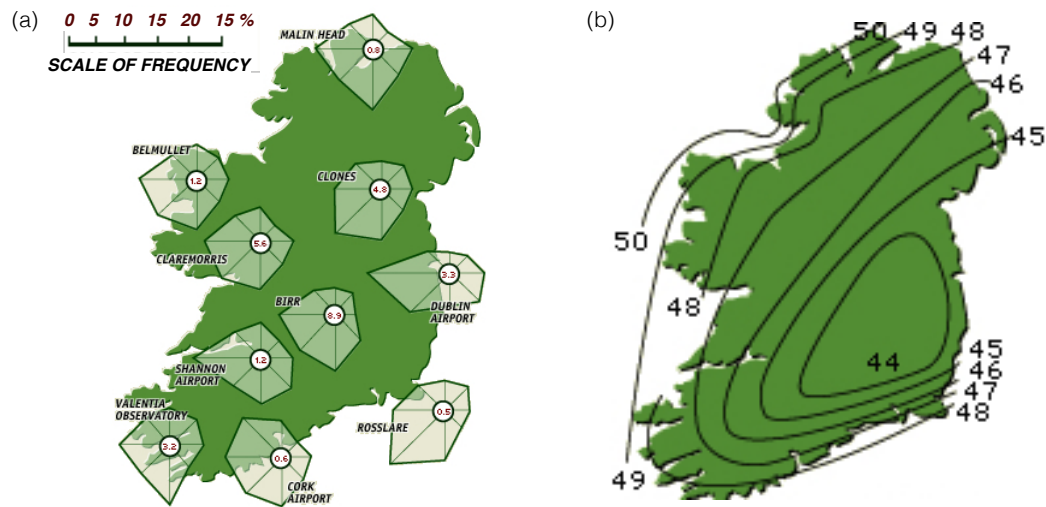
Figure 1. (a) Percentage [Frequency-frequency](#) of wind direction with circled number representing the percentage of calm days. (b) Maximum gust speed likely to be exceeded once in 50 years (m/s). (Met Éireann, 2016c)

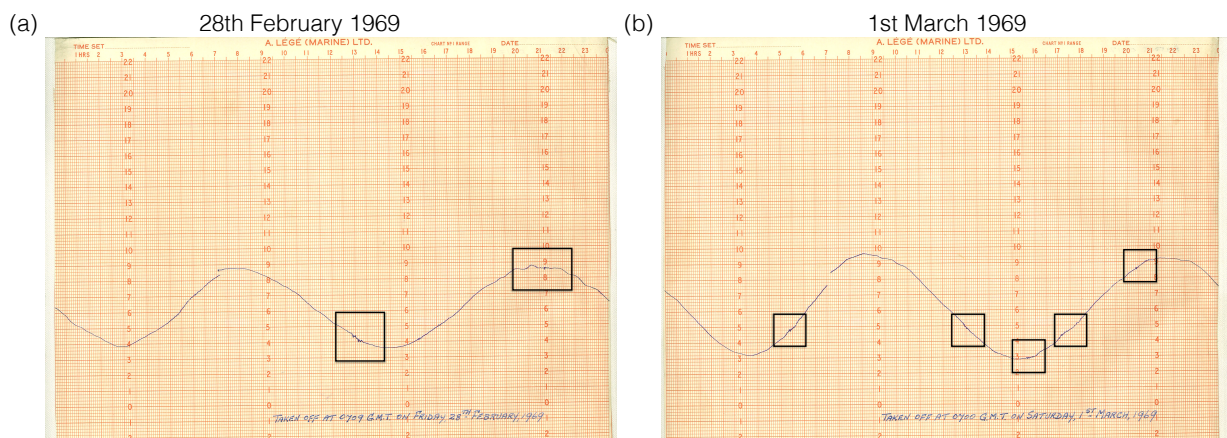
Figure 2. Tide gauge recordings at Belfast harbour on (a) 28th February 1969 and (b) 1st March 1969. Minor oscillations can be seen upon close inspection (black boxes), with the first wave arriving at approximately 1pm. Retrieved through personal contact with the the Permanent Service for Mean Sea Level (2016), (Holgate et al., 2013).

In addition to the 1755, 1761, 1941 and 1975 Lisbon, tsunamis documented in O’Brien et al. (2013), there was another significant earthquake and tsunami near Lisbon on the 28 February 1969. The tide gauge recordings at Belfast harbour show small oscillations which may be the arrival of this tsunami, see [Figures-Figure 2](#). In addition, another tide gauge recording has been located for the 1975 tsunami. The recording is taken at Belfast harbour and is shown in Figure 3.

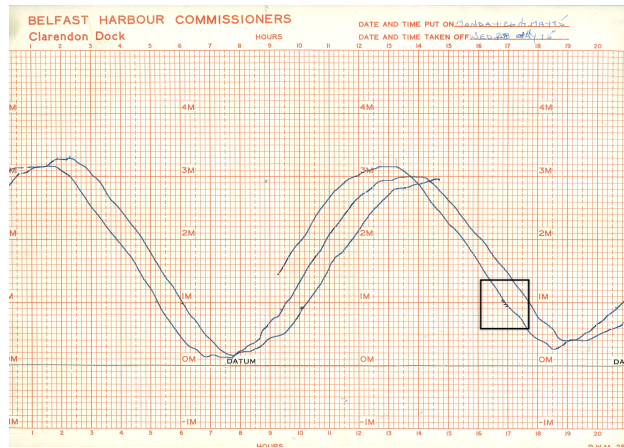
Figure 3. Tide gauge recordings at Belfast harbour 26th - 28th May 1975. Minor oscillations can be seen upon close inspection at approximately 5pm. Retrieved through personal contact with the Permanent Service for Mean Sea Level (2016), (Holgate et al., 2013).

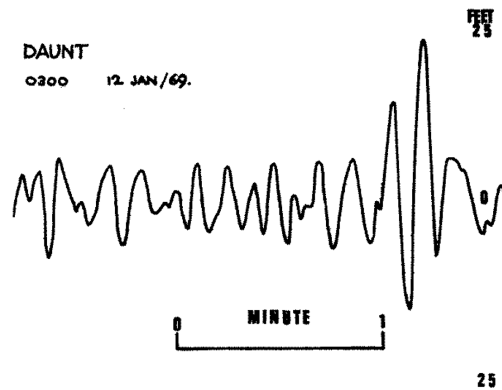
Figure 6. Wave recorder trace taken on 12th January 1969 (Figure 1 in Draper (1971))

Draper (1971) shows a record from the 12th January 1969 taken by the Commissioners of Irish Lights with a shipborne wave recorder on *Daunt* light-vessel off Cork showing a wave that is 4.1 times the average wave height. Given that the average wave height would usually be around 0.63 times the significant wave height, this wave would be approximately 2.6 times the significant wave height. See Figure 6.

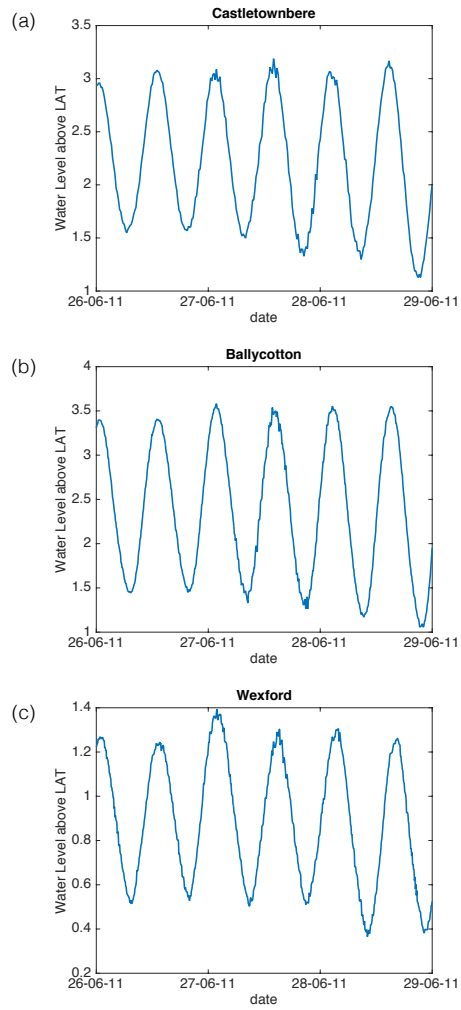
Figure 7. Tide gauge data from 26th-29th June 2011 at (a) Castletownbere (SW coast), (b) Ballycotton (S coast) and (c) Wexford (SE coast), small oscillations are clearly visible. Data retrieved from The Marine Institute (2017a).

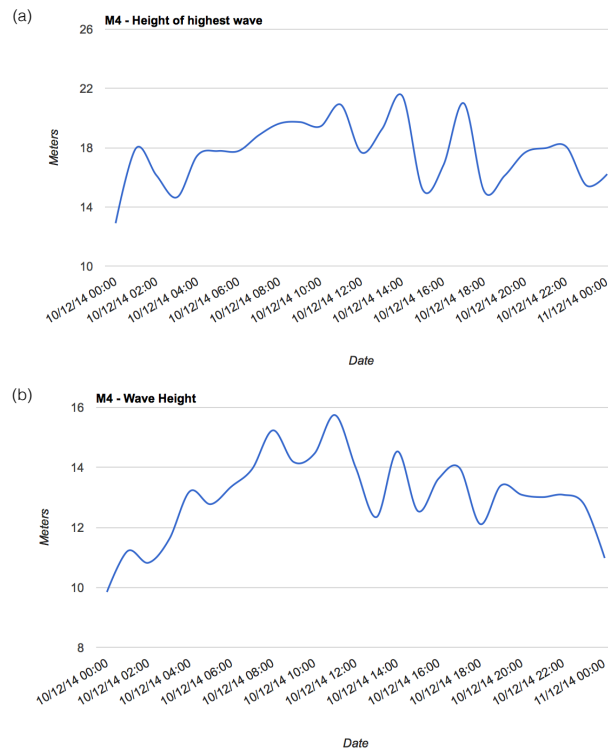
Figure 9. M4 records of (a) maximum wave height (m) and (b) significant wave height (m) on the 10th December 2014. Data retrieved from The Marine Institute (2017a).

The M4 buoy located off the coast, Northeast of Belderrig, recorded a maximum wave height of 21.5 m on the same day,
10 with a corresponding significant wave height of 14.5 m (see Figure 9). This is not classified as a rogue wave, however the waves hitting the coast of Co. Mayo on this day did significant damage. A local man pointed out that if the large waves had hit the coast at high tide, the damage could have been far worse. (*Personal contact with Seamus Caulfield and Gretta Byrne*)

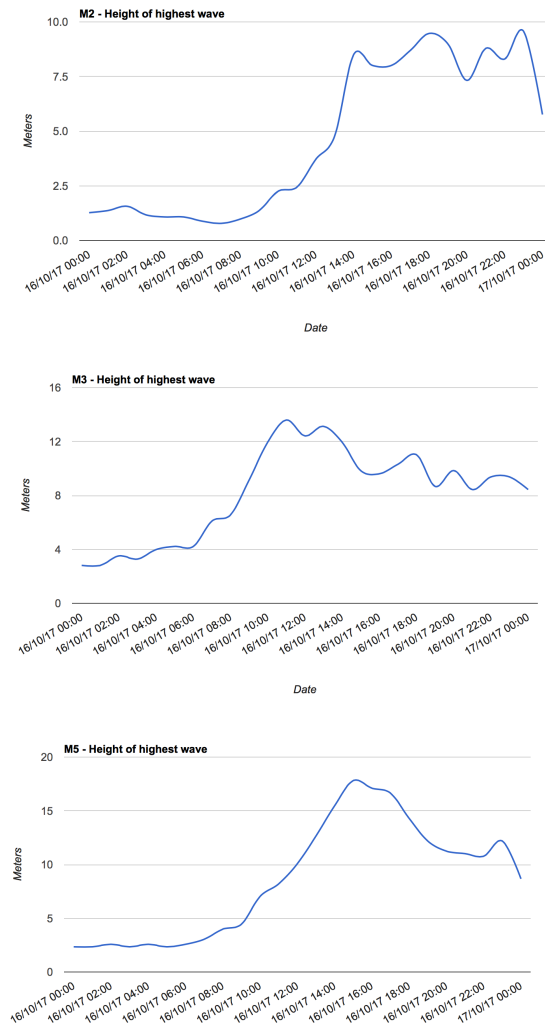
Figure 11. Maximum wave height recordings on the M2, M3 and M5 buoys during Storm Ophelia on the 16th October 2017. The largest waves recorded were 9.6 m (M2), 13.6 M (M3) and 17.8 m (M5). Data retrieved from The Marine Institute (2017a).

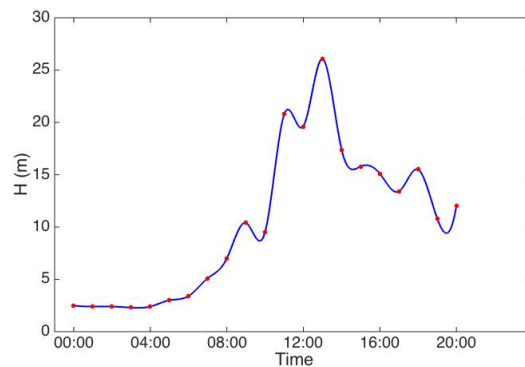
Figure 12. Maximum wave height recordings at the Kinsale Energy Gas Platform during Storm Ophelia on the 16th October 2017. A 26.1 m wave was recorded. Data courtesy of Emily Gleeson at Met Éireann.

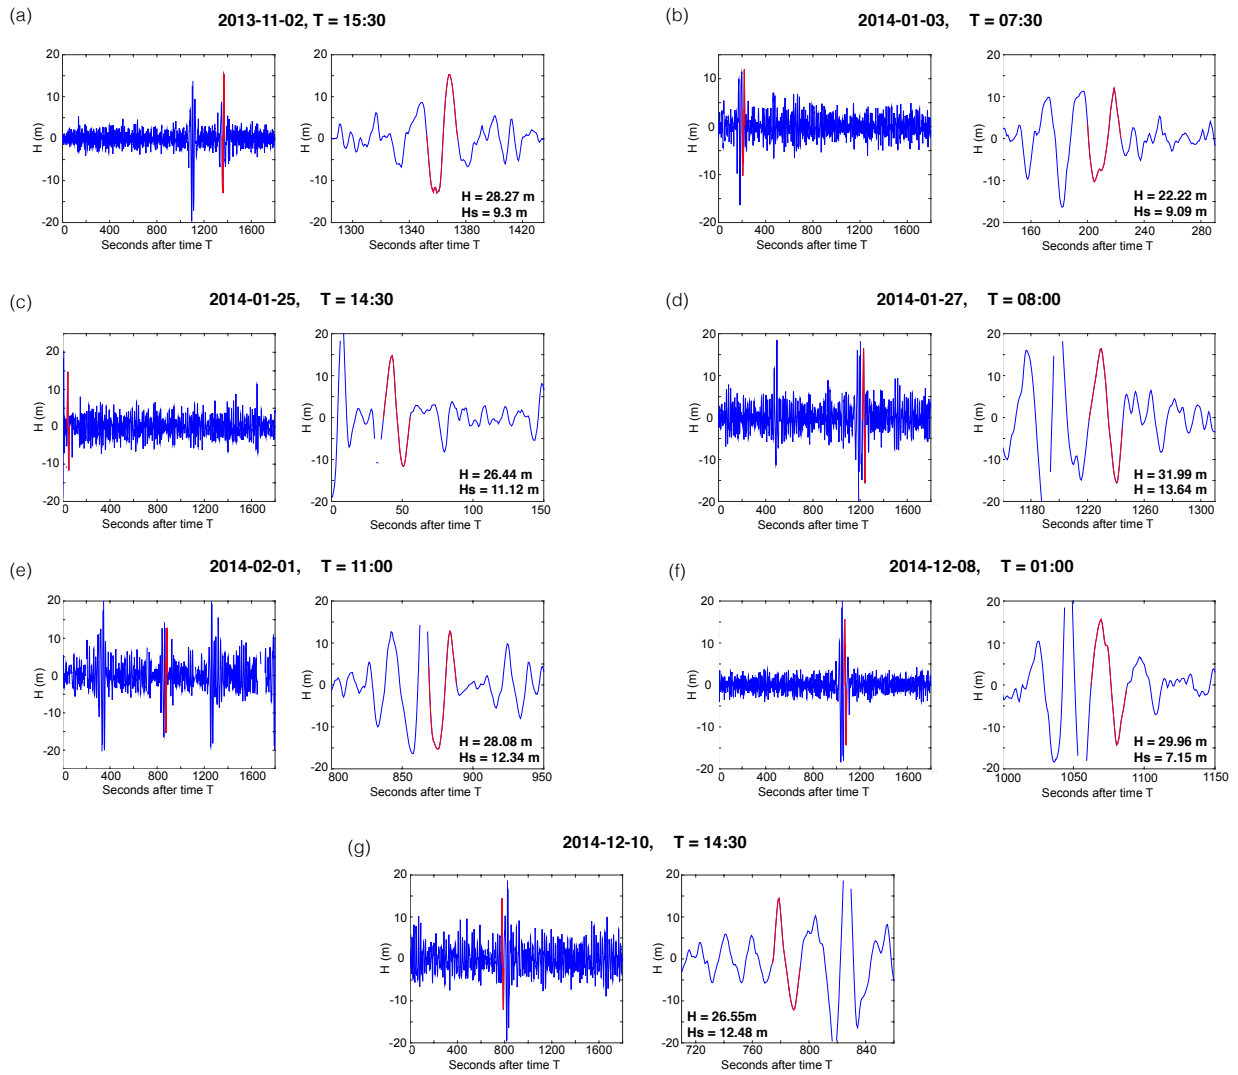
Figure 14. Large rogue waves recorded at Killard ESB Platform. Wave height recordings for the 30 minute duration when wave occurred (left column) and zoomed in around the time of event (right column). The waves are highlighted in red with wave height (H) and significant wave height (H_s) inset into zoomed figure. (a) 02/11/2013, 15:30. (b) 03/01/2014, 07:30, (c) 25/01/2014, 14:30. (d) 27/01/2014, 08:00. (e) 01/02/2014, 11:00. (f) 08/12/2014, 01:00. (g) 10/12/2014, 14:30.

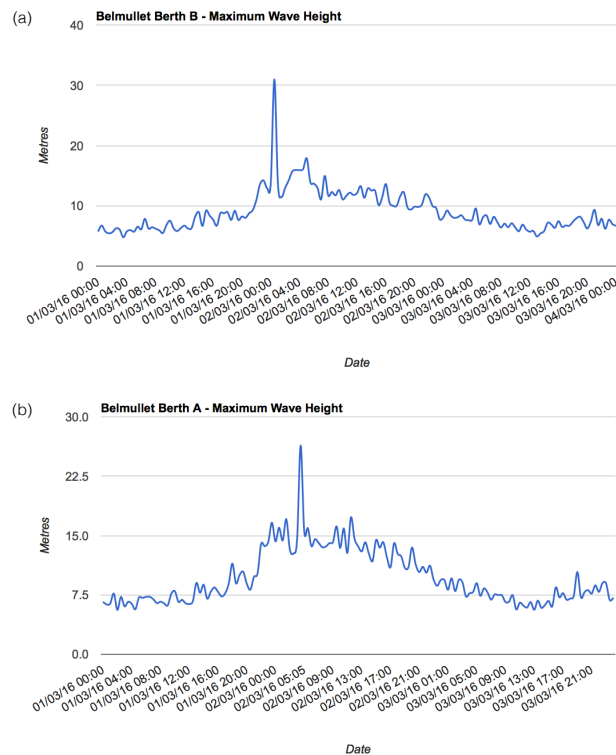
Figure 16. Maximum wave height at (a) Belmullet Berth B and (b) Belmullet Berth A wave buoys on 1st - 3rd March 2016. Data retrieved from The Marine Institute (2017a).

Moreover, in 2016, Storm Jake hit Ireland with severe winds of up to 133 km/hr on 2 March, and a 30.96 m wave was recorded at 00:30 on the wave buoy Belmullet Berth B (Figure 16). This could be interpreted as a suspicious reading given how big it is, however the nearby wave buoy Belmullet Berth A also recorded a 26.35 m wave at 03:30 (Figure 16) indicating that there were very ~~rage~~-large waves in the region. Since the buoy network was only set up in November 2000, it is not surprising that the record has been broken since 2011.

Storm Jake in late February/early March 2016 brought severe weather to Ireland. On the 2nd March at the Belmullet Berth B wave buoy, a 30.96m wave was recorded with a significant wave height of 10.69 m, classifying it as a rogue wave. See Figure 16. However, the buoys can only be considered reliable within a certain range of displacement from mean sea level, so very large wave recordings like this should be treated with caution. Furthermore, without the raw data we could not check the validity of these measurements. Although, the nearby Belmullet Berth A wave buoy also recorded a wave measuring 26.35 m (with a significant wave height of 11.94 m) at around the same time (Figure 16) giving more confidence in the recording.

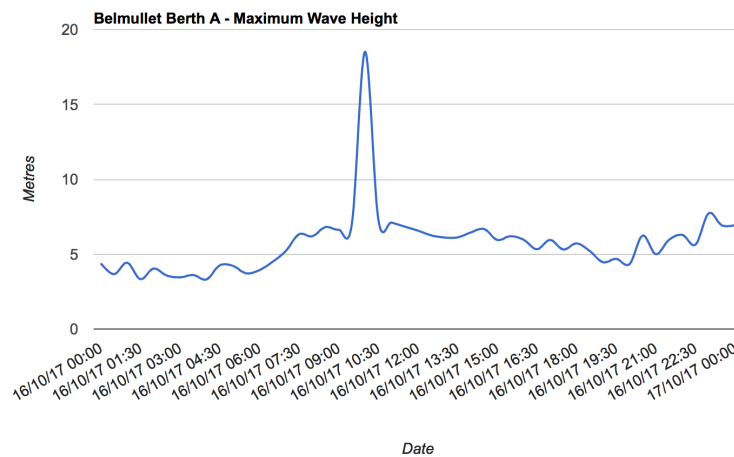
Figure 17. Maximum wave height recordings on the Belmullet Berth A buoy during Storm Ophelia on the 16th October 2017. An 18.5 m rogue wave was recorded with a significant wave height of 4.41 m. Data retrieved from The Marine Institute (2017a).

- 5 A number of large waves were recorded during Storm Ophelia on the 16th October 2017, see Section 5.1.7. However, only one of these waves can be classified as a rogue wave. An 18.5 m wave was recorded by the Belmullet Berth A wave buoy, with a significant wave height of 4.41 m. See Figure 17 and Table 5.

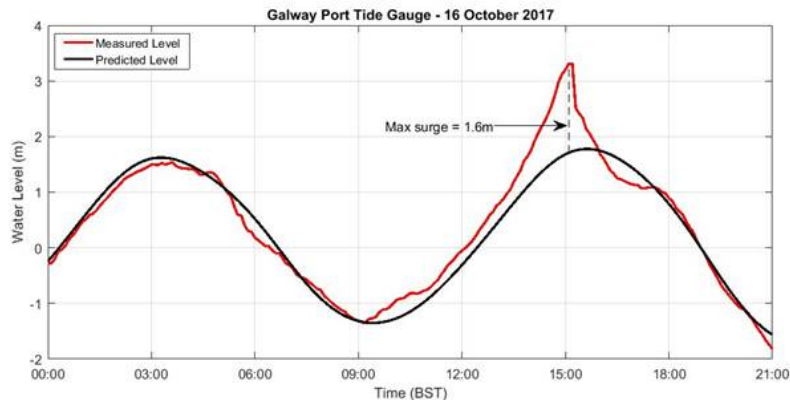
Figure 19. Tide gauge recordings from Galway Port during Storm Ophelia on the 16th October 2017 (figure retrieved from The Marine Institute (2017b)).

In addition to a number of large waves that occurred during Storm Ophelia (see Section 5.1.7 and Section 5.2.9), a significant storm surge was recorded in Galway Port. The surge was 1.6 m above predicted sea level and occurred 30 minutes before high tide. This resulted in flooding at the Docks, Spanish Arch and Salthill Promenade in Galway. Fortunately, the surge quickly dissipated, likely due to a rapid change in the speed and direction of the wind (The Marine Institute, 2017b). See Figure 19.

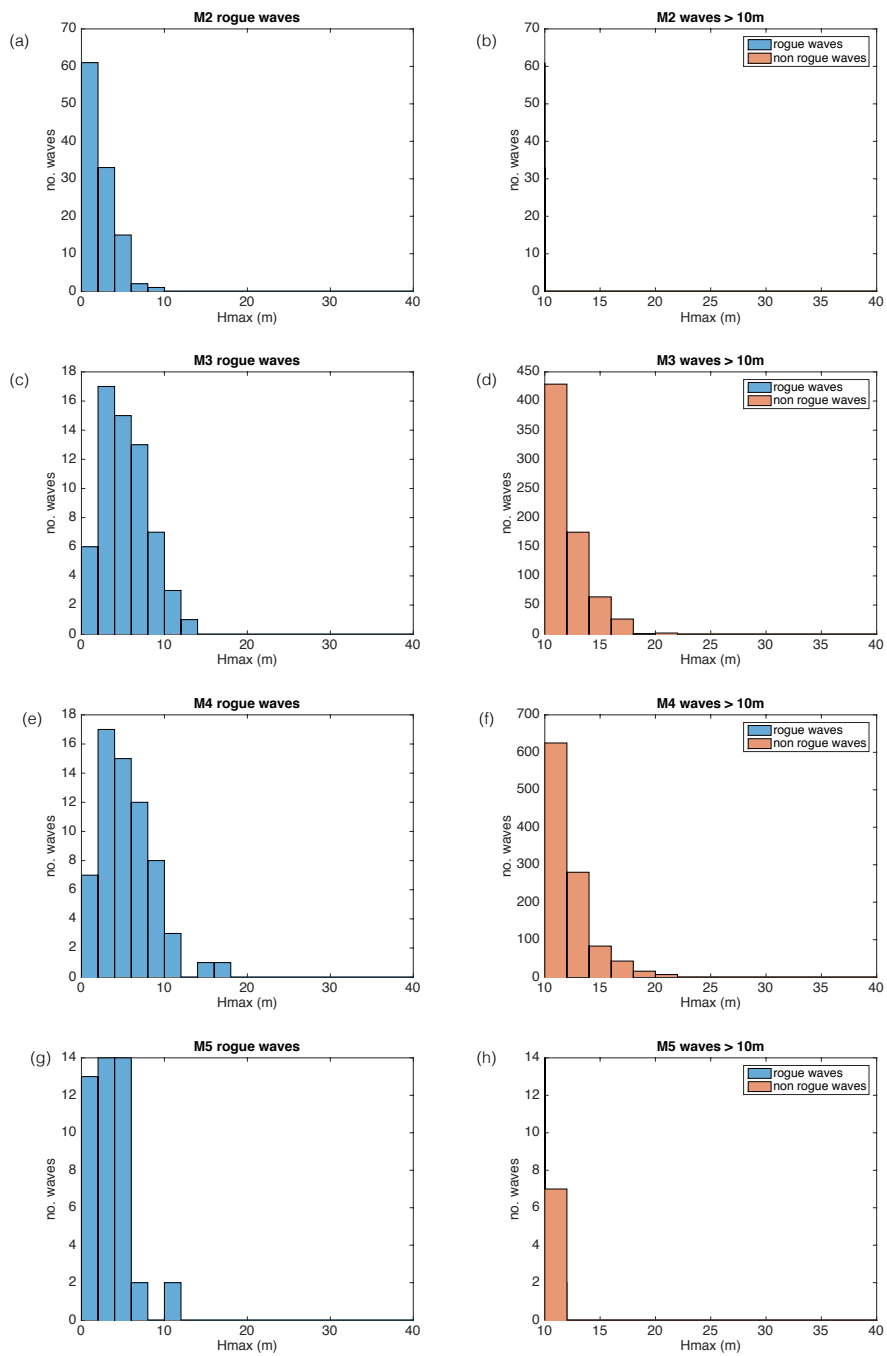
Figure 22. Number of rogue waves (left column) and number of large waves greater than 10 m (right column) recorded for each buoy (a), (b) M2; (c), (d) M3; (e), (f) M4; (g), (h) M5; for data available between March 2011 and June 2016 (M2: 31/03/11 - 01/07/16, M3: 01/06/12 - 01/07/16, M4: 07/06/11 - 01/02/16, M5: 23/01/12 - 01/07/16). Data retrieved from The Marine Institute (2017a).
