Extreme wave events in Ireland: 2012 - 2016

Abstract. This paper aims to extend and update the survey of extreme wave events in Ireland that was previously carried out by O'Brien et al. (2013). The original catalogue highlighted the frequency of such events dating back as far as the turn of the last ice age through to 2012. Ireland's marine territory extends far beyond its coastline and is one of the largest seabed territories in Europe. It is therefore not surprising that extreme waves have continued to occur regularly since 2012, particularly considering the severity of weather during the winters of 2013-14 and 2015-16. In addition, a large number of storm surges have been identified since the publication of the original catalogue. This paper updates the O'Brien et al. (2013) catalogue to include events up to the end of 2016. Storm surges are included as a new category and events are categorised into long waves (tsunamis and storm surges) and short waves (storm and rogue waves). New results prior to 2012 are also included and some of the events previously documented are reclassified. Important questions regarding public safety, services and the influence of climate change are al

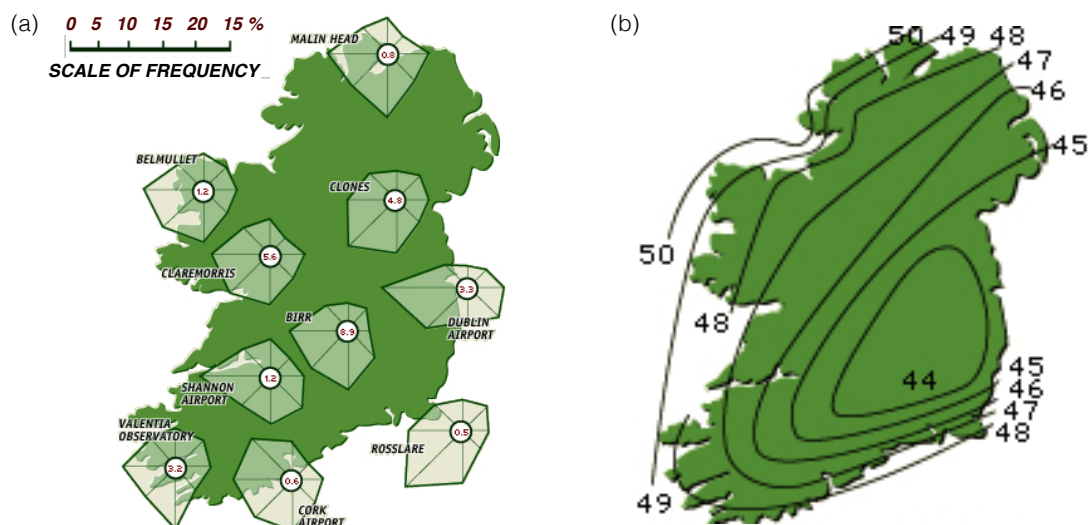
Figure 1. (a) Percentage Frequency of wind direction with circled number representing the percentage of calm days. (b) Maximum gust speed likely to be exceeded once in 50 years (m/s). (Met Éireann, 2016c)

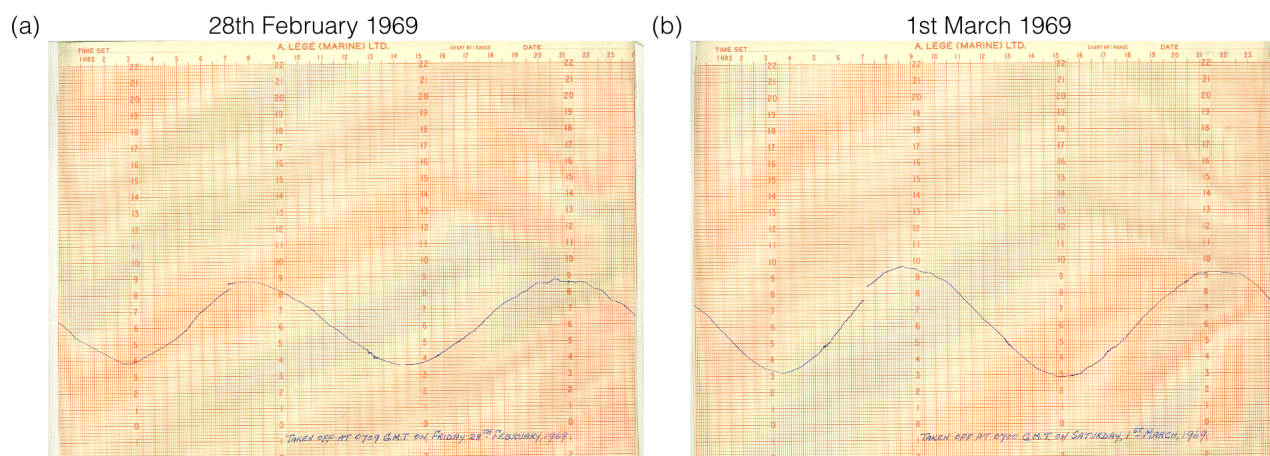
Figure 2. Tide gauge recordings at Belfast harbour on (a) 28th February 1969 and (b) 1st March 1969. Minor oscillations can be seen upon close inspection. Retrieved through personal contact with the the Permanent Service for Mean Sea Level (2016), (Holgate et al., 2013).

In addition to the 1755, 1761, 1941 and 1975 Lisbon, tsunamis documented in O’Brien et al. (2013), there was another significant earthquake and tsunami near Lisbon on the 28 February 1969. The tide gauge recordings at Belfast harbour show small oscillations which may be the arrival of this tsunami, see Figures 2. In addition, another tide gauge recording has been located for the 1975 tsunami. The recording is taken at Belfast harbour and is shown in Figure 3.

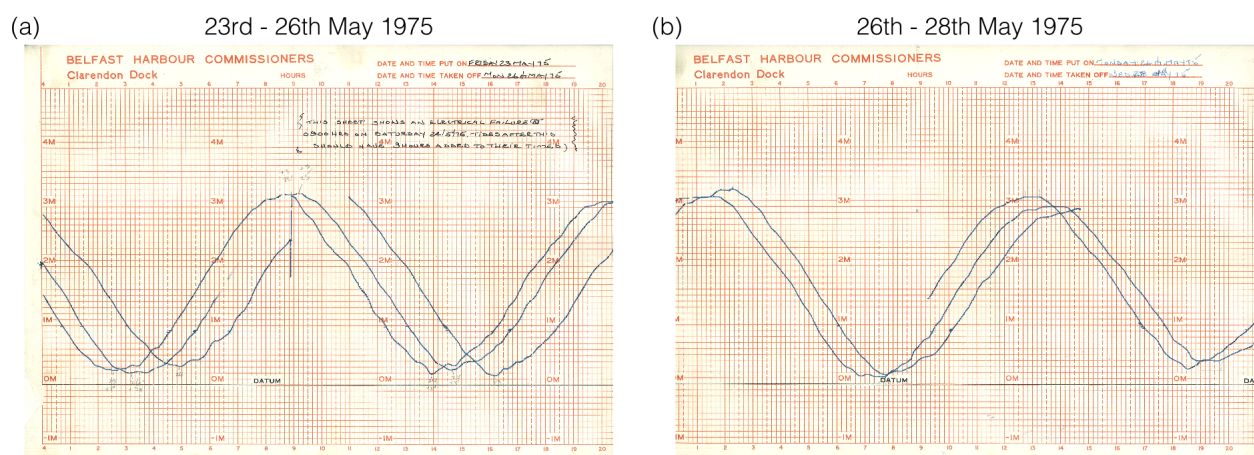
Figure 3. Tide gauge recordings at Belfast harbour on (a) 23rd - 26th May 1975 and (b) 26th - 28th May 1975. Minor oscillations can be seen upon close inspection. Retrieved through personal contact with the Permanent Service for Mean Sea Level (2016), (Holgate et al., 2013).

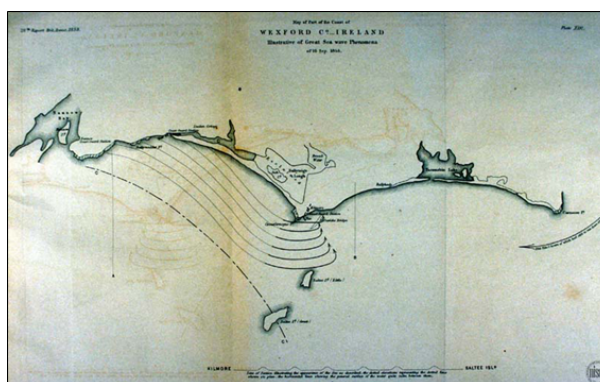
Figure 4. A tsunami at Kilmore Quay on 16 September 1854 (Mallet and Mallet, 1854).

A map depicting the tsunami at Kilmore Quay on the 16 September 1854 has come to light since the publication of O'Brien et al. (2013), see Figure 4.

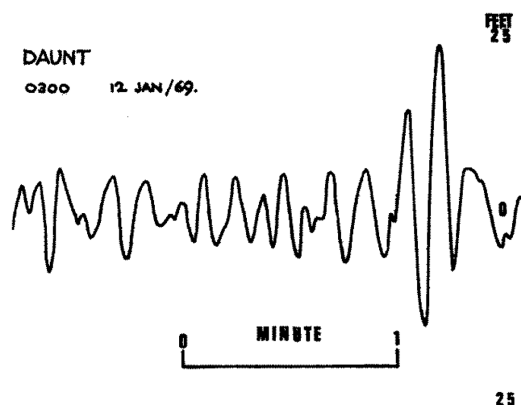
Figure 6. Wave recorder trace taken on 12th January 1969 (Figure 1 in Draper (1971))

Draper (1971) shows a record from the 12th January 1969 taken by the Commissioners of Irish Lights with a shipborne wave recorder on *Daunt* light-vessel off Cork showing a wave that is 4.1 times the average wave height. Given that the average wave height would usually be around 0.63 times the significant wave height, this wave would be approximately 2.6 times the significant wave height. See Figure 6.

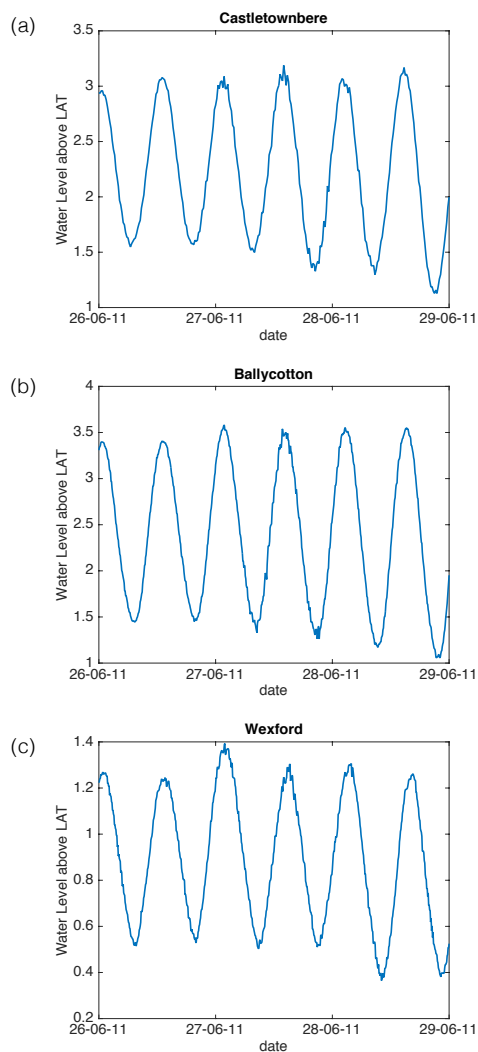
Figure 7. Tide gauge data from 26th-29th June 2011 at (a) Castletownbere (SW coast), (b) Ballycotton (S coast) and (c) Wexford (SE coast), small oscillations are clearly visible.

- 20 The National Oceanic and Atmospheric Administration (2016) Tsunami database records a questionable tsunami on 27 June 2011 in Plymouth, England with run up values recorded at Newlyn, Plymouth, Portsmouth and St Michael’s Mount. The tide gauge record at Castletownbere, Wexford and Ballycotton shows evidence of this wave in Figure 7. The tsunami cause is given as meteorological on the NOAA database, however, a BBC News report on 29/06/2011 suggests it was due to a sub-marine landslide.

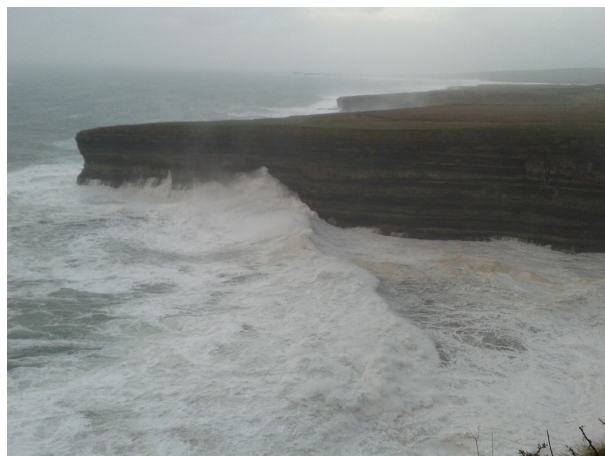
Figure 8. The sea condition as viewed from the platform at the Céide fields, Co. Mayo on the December 10th 2014.

Nearby at Portacloy, the sea state caused a World War 2 look out post to collapse on the same day. A photo of the sea condition in the area on this day are shown in Figure 8.

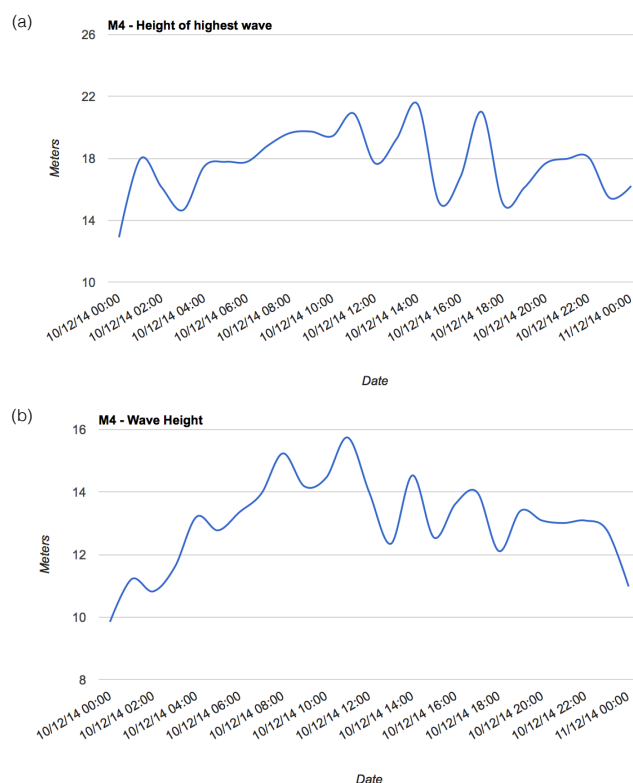
Figure 9. M4 records of (a) maximum wave height (m) and (b) significant wave height (m) on the 10th December 2014.

The M4 buoy located off the coast, Northeast of Belderrig, recorded a maximum wave height of 21.5 m on the same day, with a corresponding significant wave height of 14.5 m (see Figure 9). This is not classified as a rogue wave, however the waves hitting the coast of Co. Mayo on this day did significant damage. A local man pointed out that if the large waves had hit the coast at high tide, the damage could have been far worse. (*Personal contact with Seamus Caulfield and Gretta Byrne*)

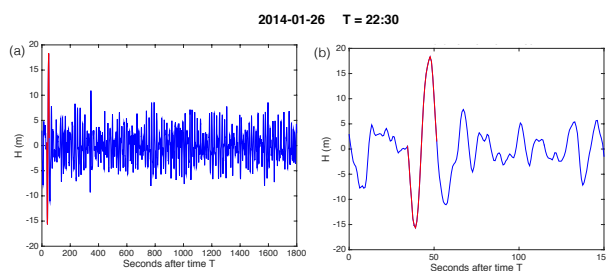
Figure 11. 33.96 m wave recorded at Killard ESB Platform on 26th January 2014 (a) between 22:30 and 23:00 and (b) zoomed in. The wave as identified by its crest-to-trough is highlighted in red.

A rogue wave was observed by a Waverider buoy near Killard deployed by the ESB, on the 28th January 2014 with a maximum trough-to-crest (upcrossing) value of 26.45m (Fedele et al., 2016). Analysis of the raw data shows that a rogue wave with a crest-to-trough/downcrossing value of 33.96 m was possibly recorded on 26th January 2014 at 22:30. See Figure 11. Note that there were 7 rogue waves greater than 20 m identified on this day, using both the upcrossing and downcrossing method, though
 15 2 were part of the same wave packet. In addition there were 3 rogue waves greater than 20 m identified the following day, 27th January 2014 but none on the 28th.

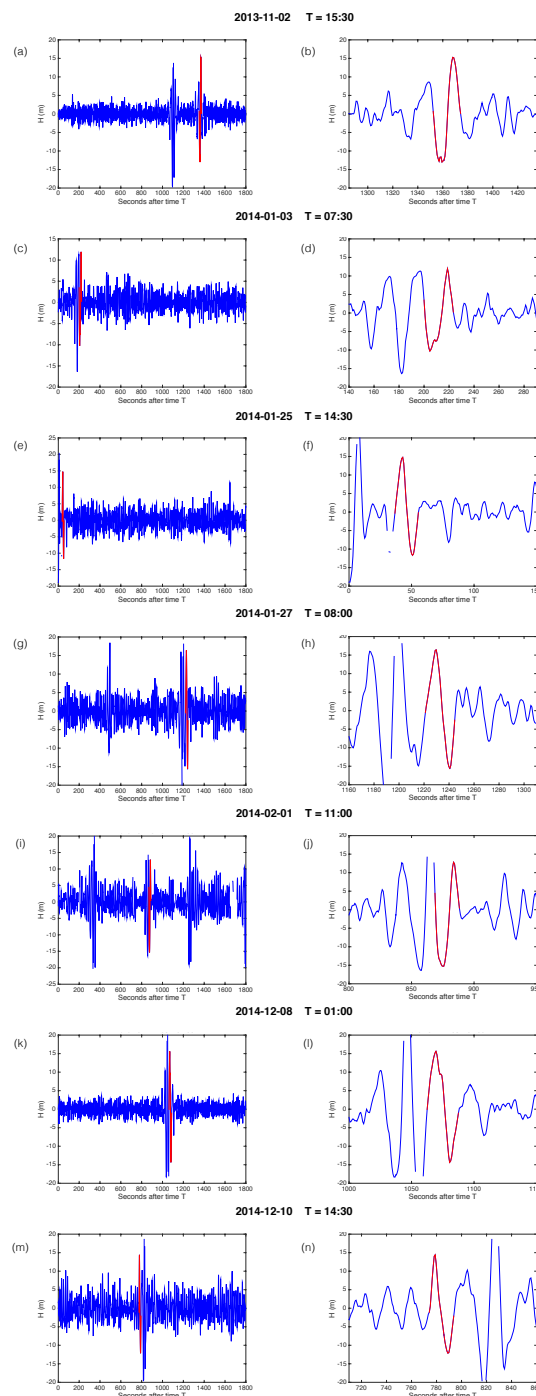
Figure 12. Large rogue waves recorded at Killard ESB Platform. Wave height recordings for the 30 minute duration when wave occurred (left column) and zoomed around the time of event (right column). The waves are highlighted in red. (a), (b) 02/11/2013, 15:30. (c), (d) 03/01/2014, 07:30, (e), (f) 25/01/2014, 14:30. (g), (h) 27/01/2014, 08:00. (i), (j) 01/02/2014, 11:00. (k), (l) 08/12/2014, 01:00. (m), (n) 10/12/2014, 14:30.

Furthermore, multiple rogue waves greater than 20 m have been recorded by this buoy between November 2011 and January 2015. It should be noted that the buoy was out of action Feb - Jul 2012 and Jan - Sep 2013 for various reasons. A total of 20 waves (on 7 days) were identified using upcrossing and downcrossing methods. For each of these days, the rogue wave with maximum wave height is plotted in Figure 12. Note that some values are missing due to the devices recording being irreparable. (The sensors on the Waverider buoy can only record a displacement of ± 20.48 m. Waves may actually have been higher, just not recordable.)

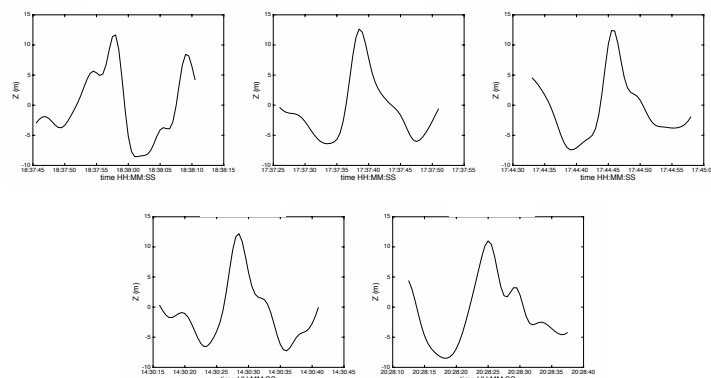
Figure 13. Large waves recorded by an ADCP near Killard, Co. Clare on the 22nd February 2015.

- 5 Flanagan et al. (2016) deployed a state-of-the-art Sentinel V Acoustic Doppler Current Profiler (ADCP) off the west coast of Ireland near Killard, Co. Clare from the 9th February to 1st May 2015. Their aim was to gather accurate wave measurements in extreme conditions. Of the 750,000 waves recorded and analysed, 13 were rogue waves (approximately 1 in every 60,000) and only 3 of these waves were greater than 4m and none exceeded 10m. A similar study of field measurements (Christou and Ewans, 2014) measured 3649 rogue waves in 122 million individual waves (approximately 1 in every 30,000).
- 10 A number of large waves with amplitudes close to 20m were recorded on the 22nd February, see Figure 13. This shows that large waves of interest are not always classified as rogue waves.

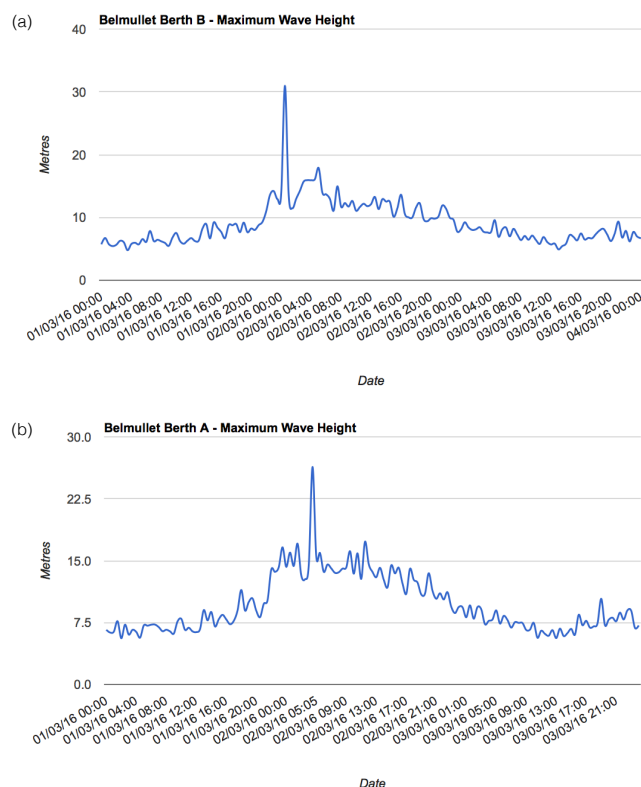
Figure 14. Maximum wave height at (a) Belmullet Berth B and (b) Belmullet Berth A wave buoys on 1st - 3rd March 2016.

Then in 2016, Storm Jake hit Ireland with severe winds of up to 133 km/hr on 2 March, and a 30.96 m wave was recorded at 00:30 on the wave buoy Belmullet Berth B (Figure 14). This could be interpreted as a suspicious reading given how big it is, however the nearby wave buoy Belmullet Berth A also recorded a 26.35 m wave at 03:30 (Figure 14) indicating that there were very large waves in the region. Since the buoy network was only set up in November 2000, it is not surprising that the record has been broken since 2011.

On the 7th August 2016, the Belmullet Berth A wave buoy recorded a rogue wave, in excess of 13 m (significant wave height of approximately 6 m). This was during a period of unusually windy conditions for the summer season.

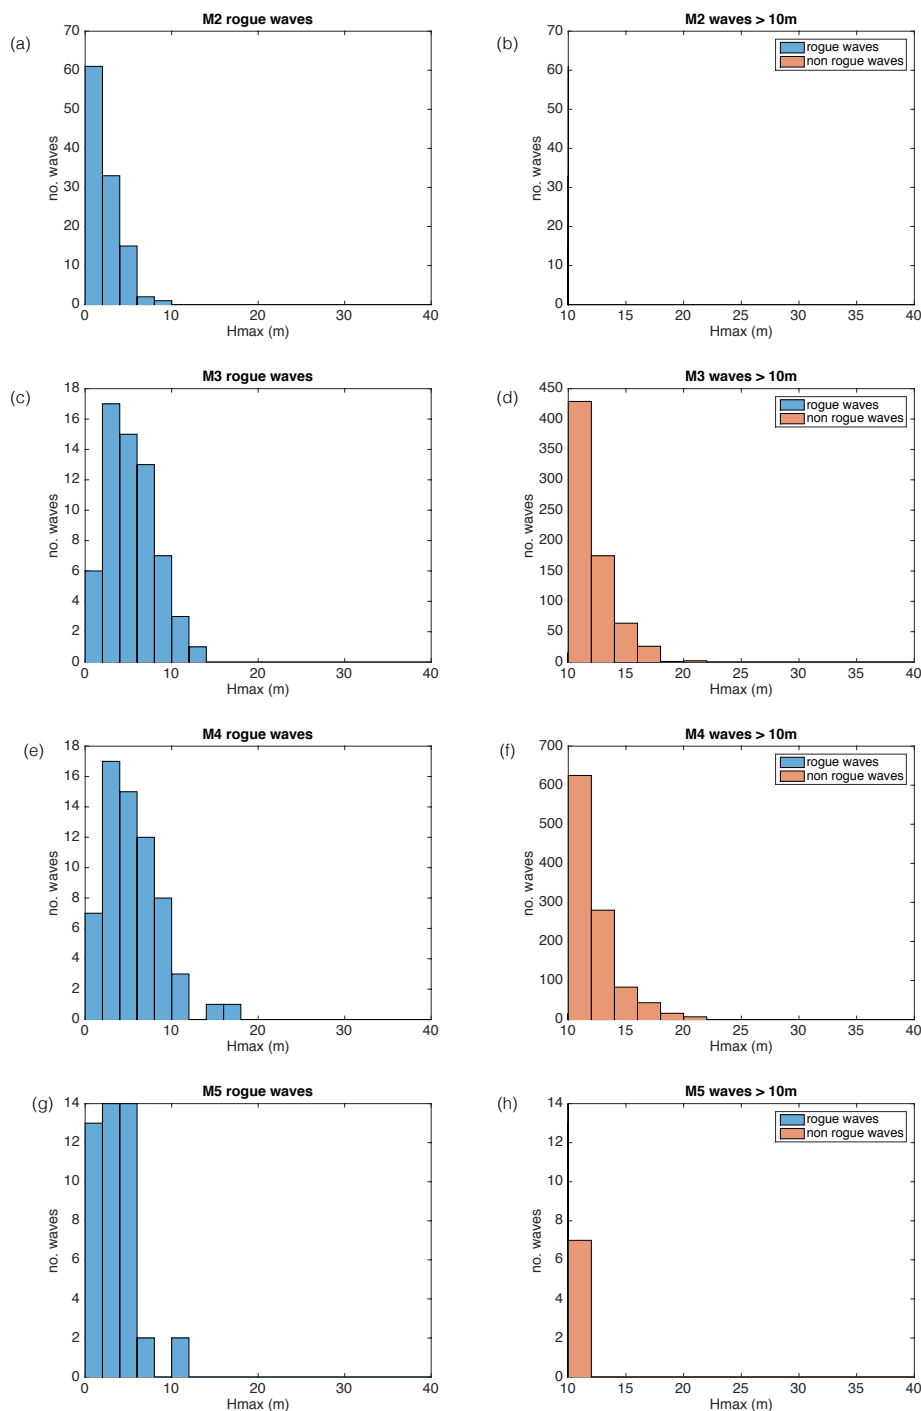
Figure 18. Number of rogue waves (left column) and number of large waves greater than 10 m (right column) recorded for each buoy (a), (b) M2; (c), (d) M3; (e), (f) M4; (g), (h) M5; for data available between March 2011 and June 2016 (M2: 31/03/11 - 01/07/16, M3: 01/06/12 - 01/07/16, M4: 07/06/11 - 01/02/16, M5: 23/01/12 - 01/07/16).

Table 5. The number of rogue waves and large waves recorded for buoys M2 - M5 between March 2011 and June 2016 (M2: 31/03/11 - 01/07/16, M3: 01/06/12 - 01/07/16, M4: 07/06/11 - 01/02/16, M5: 23/01/12 - 01/07/16).
