Response to reviewer

R: the title will be modified according to suggestions of both reviewers, for example: “Development and application of tsunami fragility curve of the 2015 tsunami in Coquimbo, Chile”.

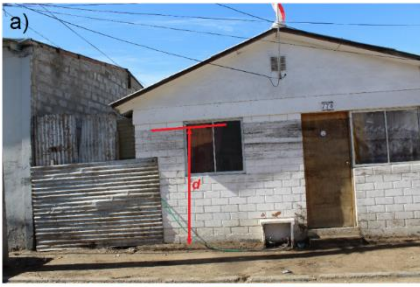
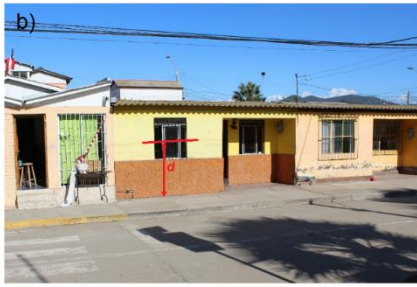
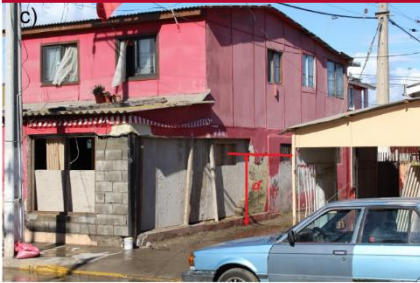
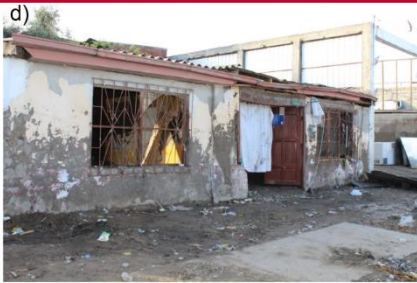
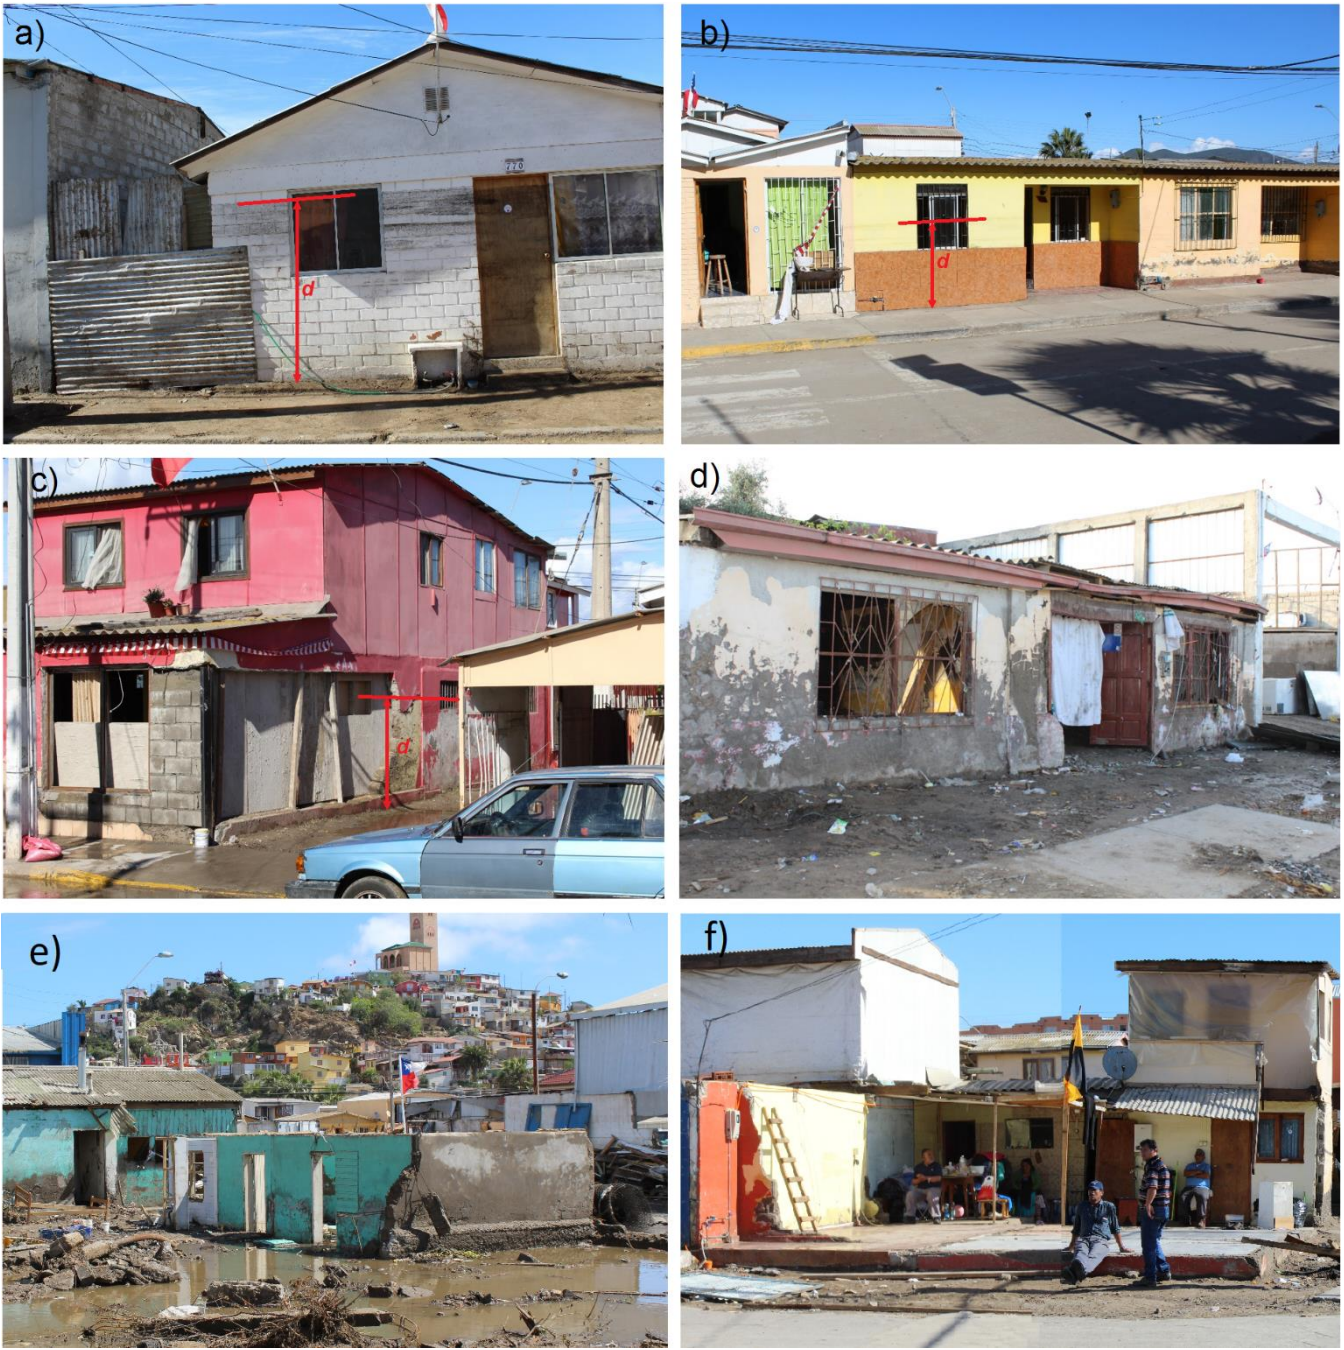
Figure 2: Photographs of surveyed masonry houses after by the September 16th 2015 tsunami in the Coquimbo area. The red letter d indicates the observed tsunami inundation flow depth. All photos were taken on September 22nd of 2015. a) and b) Houses with no damage. c) 2-story house with moderate damage. d) 1-story house with major damage. e) 1-story house with complete damage. f) Washed away structure.

R: we added a description of the structures in Figure 2. Both structures in 2c and d were originally made of confined masonry. The structure in figure 2c was being repaired at the moment of the field survey with masonry made of concrete blocks.

structures and marks of ~~inundation~~ depth surveyed in Coquimbo immediately after the 2015 tsunami. Figures 2a and b show masonry houses that were not damaged by the tsunami despite ~~inundation~~ depths that ranged from 1.5 to 2 m. Meanwhile, Figures 2c and d show houses with moderate to major damage, possibly to be used after major repairs. As a matter of fact, the house in Figure 2c was being repaired at the time of the field survey and the ~~gray~~ wall in the corner was built a few days earlier. Meanwhile, the house in Figure 2d was abandoned, since all interior walls, windows, doors and the roof were completely damaged and major repairs and retrofitting will be needed. Figure 2e shows a completely damaged structure with its interior walls and roof completely removed, while Figure 2f shows the remaining foundation of a washed-away structure. Even though the damage to ~~the~~ structure could be due to ~~the~~ earthquake and tsunami, it was observed that the damage due to the earthquake was limited (Candia et al., 2017) and the ~~structures~~ most affected by the earthquake were made of adobe (Fernández et al., 2017). In addition, the authors had the opportunity to compare damage to inundated and non-inundated houses in Coquimbo; in order to be sure that the structural damage to inundated houses was due to the tsunami. In order to avoid including light damage (due to the earthquake) as tsunami damage, we used a two-level damage scale. Therefore, the present work assumed that the damage to flooded structures was due only to the tsunami.

In addition, the two-level damage scale is used due to the small amount of inundated structures (568) and the comparison with the existing fragility curve of Dichato (Mas et al., 2012), which has only two damage levels, two damage levels were defined; thus, it was possible to obtain one fragility curve. The first level, called “~~surviving not destroyed~~,” included structures with no damage or minor to major damage, which correspond to levels 1, 2 and 3 given by Suppasri et al. (2013). These damage levels imply that there is slight to severe damage to non-structural components; therefore, it is possible to use the structures after moderate to major repairs (Figures 2a, b and c). The other damage level, called “destroyed,” included damage levels 4 to 6 according to Suppasri et al. (2013), i.e., structures that experienced severe damage to walls or columns or that had completely collapsed (Figures 2 d, e and f).

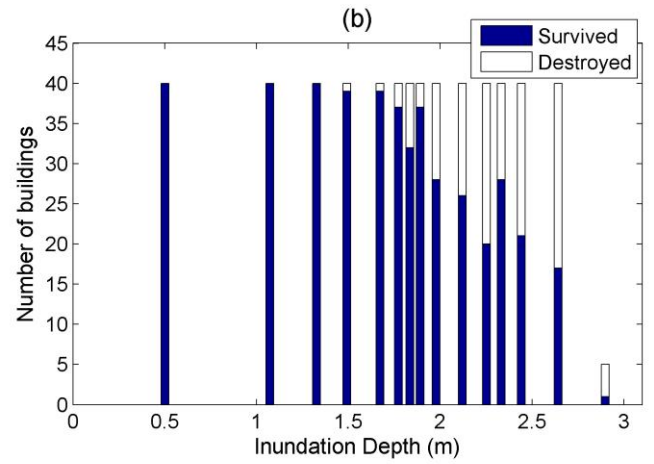
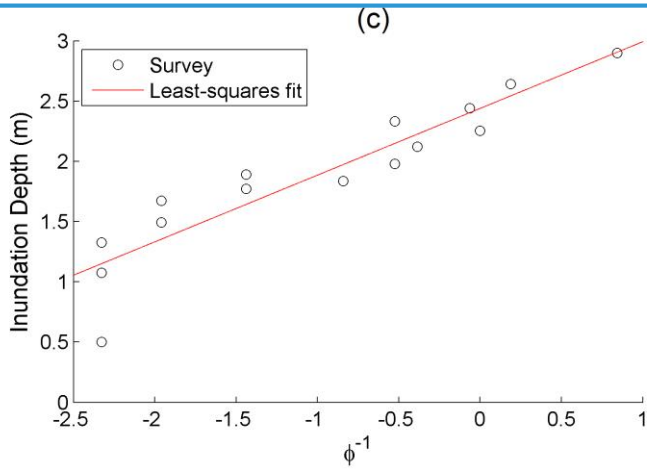
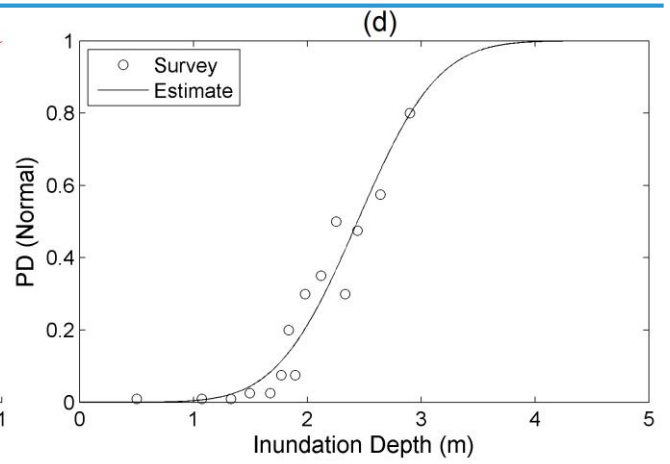
Figure 87. Developing the tsunami fragility curve. a) **Inundation depths from Numerical simulation.** b) Histogram of the number of destroyed and **surviving-not-destroyed** structures in terms of the **tsunami intensity measures** **inundation depth** within the inundation area. **be** Plot of data on normal probability paper and least-squares fit. **ce**) Fragility function for building damage in terms of **the tsunami intensity measures** **inundation depth**; the solid line is the best-fit curve of the plot (o: the distribution of damage probability).

-Figure 8. "probability of occurrence" is not a good label for the y-axis, as it appears to show CDF's of inundation depth, which is not the case. The axis label should be "probability of damage" or similar.

Figure 87 shows the tsunami inundation depth and the results of the tsunami fragility curves of Coquimbo for flow inundation depth, flow velocity and hydrodynamic force. The sample size was defined to be 40 structures; thus, 15 inundation depth ranges were used. Figure 87ab shows the histogram, while Figure 87cd shows the relationship between damage probability and inundation depth (upper panel), flow velocity (central panel) and hydrodynamic force (lower panel) with the solid line being the best-fit curve of the plot. The fragility curves were was estimated by means of regression analysis, as shown in Figure 87be. The statistical parameters of the developed fragility functions are shown in Table 1. In Figure 87, iThe values of μ and σ were found to be 2.4395 and 0.5537, respectively, with a correlation factor $R^2 = 0.852$.

It is possible to observe that inundation flow depths lower than 1.5 m did not generate damage to the surveyed structures and the damage probability of the curve is lower less than 10%. Moreover, the fragility curve shows that flow-inundation depths higher than 4 m could result in a 100% probability of severe damage to mixed structures in Coquimbo. With regards to the flow velocity, it is observed that most of data have velocities smaller than 2.5 m/s, with a damage probability less than 40%. In a similar manner, a hydrodynamic force lower than 2.5 kN/m proves to have a damage probability of less than 20%.

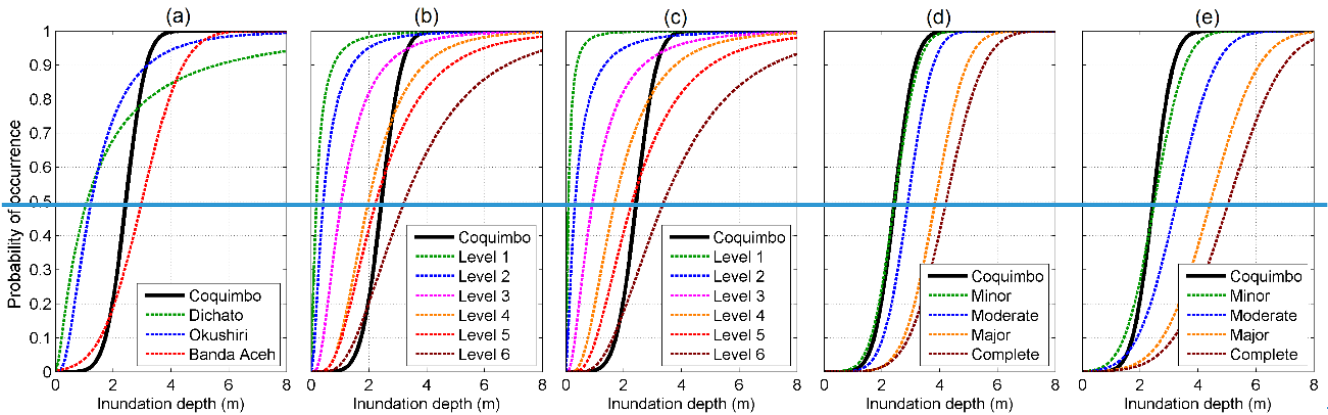
Figure 89. Tsunami fragility curves for damage probability developed for other locations and different damage levels. a) Two levels of damage obtained for three-five different places cities in Chile, Japan, and Indonesia, Thailand and American Samoa. b) Six damage levels for wooden structures given by Suppasri et al., (2013). c) Six damage levels for mixed-material structures by Suppasri et al., (2013). d) Four damage levels for wooden houses given by Suppasri et al., (2012). e) Four damage levels for mixed-material structures given by Suppasri et al., (2012).

In addition, the fragility curve as a function of the flow velocity shows significant damage (~50%) for velocities of 2 m/s, and only 80% probability of damage for velocities as high as 8 m/s (Gokon et al., 2014). Since all types of structures are analysed in a single curve, it is believed that low velocities would easily generate damage to wooden structures, while reinforced concrete structures would require higher inundation depths and flow velocities to be damaged. The relatively high damage probability at low inundation depths could be also due to the ria-type coast of American Samoa (Gokon et al., 2014).

Figures 9b and c show the comparison of the Coquimbo fragility curve with the curves given by Suppasri et al. (2013) for wooden and mixed materials in Japan, respectively. The study considered more than 250,000 damaged buildings surveyed after the 2011 Great East Japan Tsunami and made it possible to analyse different damage levels and building materials. In general, it is seen that wooden and mixed structures in Japan have similar behaviour. If damage level 4 (complete damage) is analysed, the damage probability is higher than in Coquimbo at an inundation depth lower than 2 m. Similar to the cases of Dichato and Okushiri, it is observed that wooden and mixed structures in Japan have a relatively high probability of complete damage (level 4), ranging from 50 to 60%, while in Coquimbo it is only 20%.

Another group of fragility curves for wooden and mixed structures is shown in Figures 9d and e, respectively, which were obtained from survey data of the 2011 Japan tsunami in the Sendai and Ishinomaki plains (Suppasri et al., 2012). These curves show that structures located in flat areas are less impacted by tsunami despite large inundation depths, in contrast to what happened in areas with ria topography such as the Sanriku coast (Suppasri et al., 2013; Suppasri et al., 2012) and semi-closed bays such as Dichato (Mas et al., 2012). This behaviour is in good agreement with damage observed in the Coquimbo area, where the flat area and distance from shore could decrease tsunami impact. Thus, based on influence of inundation depth and flow velocity influence on tsunami damage, De Risi et al., (2017) proposed the development of vulnerability models related to specific topographic contexts, such as plain-type or ria-type coasts. They found that ria-type coasts experience greater damage probability than plain-type coast at the same inundation depth.

However, it is interesting to notice that, from Figure 8d, it is possible to observe that the Coquimbo fragility curve (destroyed or completely damaged) overlaps with the minor-damage-level curve for wood and mixed-material houses in flat areas in Japan (Figure 9d and e). A possible explanation is that houses in Japan are relatively new and built according to strict construction standards (Suppasri et al., 2012), in contrast to what was observed in Coquimbo, where old houses are found (See Figure 2), although, it could also be due to the local topographic features of Coquimbo. This finding suggests that topography as well as structure quality should be considered in tsunami damage estimation.

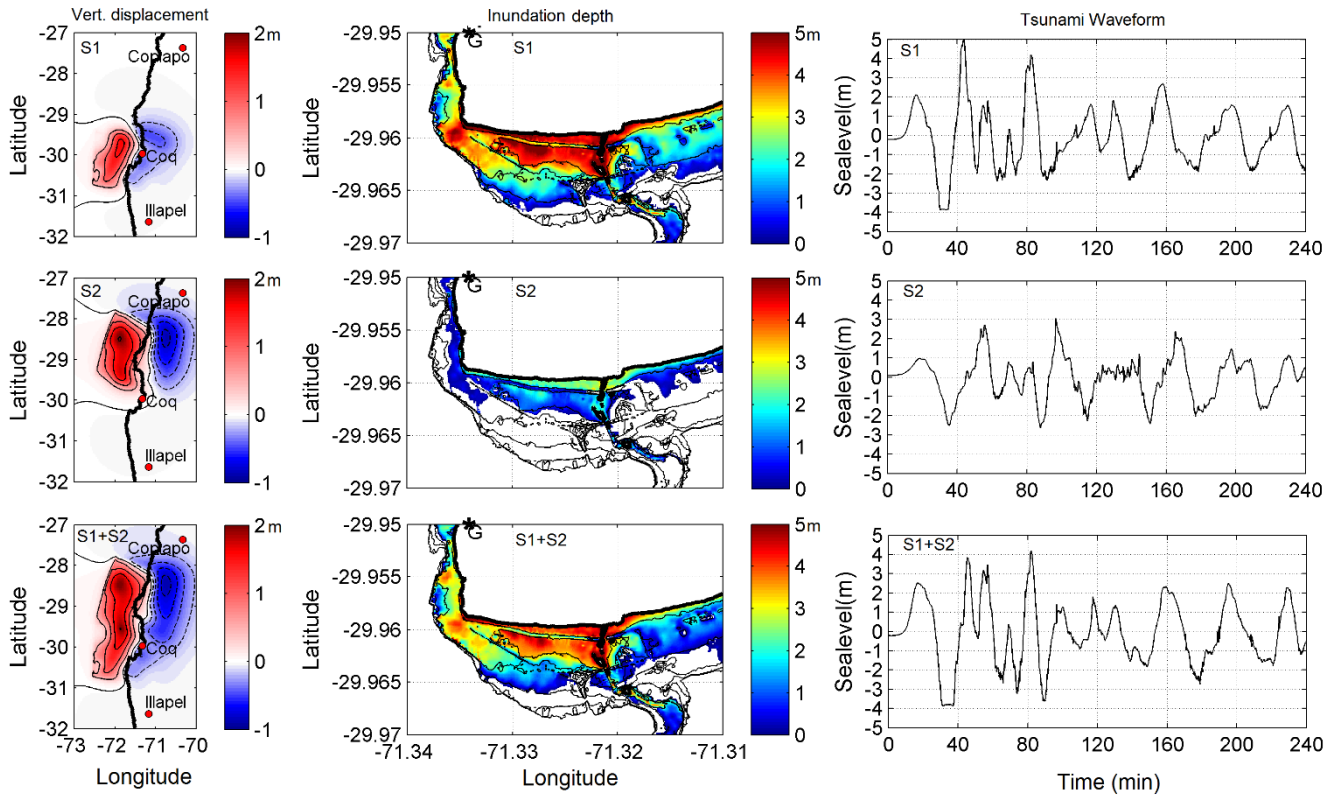
Figure 4011. Results of tsunami numerical simulations for case 1 and the three scenarios, S1, S2 and S1+S2. Left **row/column**: vertical seafloor displacement. Central **column/row**: maximum inundation depth; the asterisk indicates the location of the tide gauge; **thin black lines represent the contour lines every 2 m**. Right **column/row**: tsunami wave form during an elapsed time of 4 h at the Coquimbo tide gauge G.

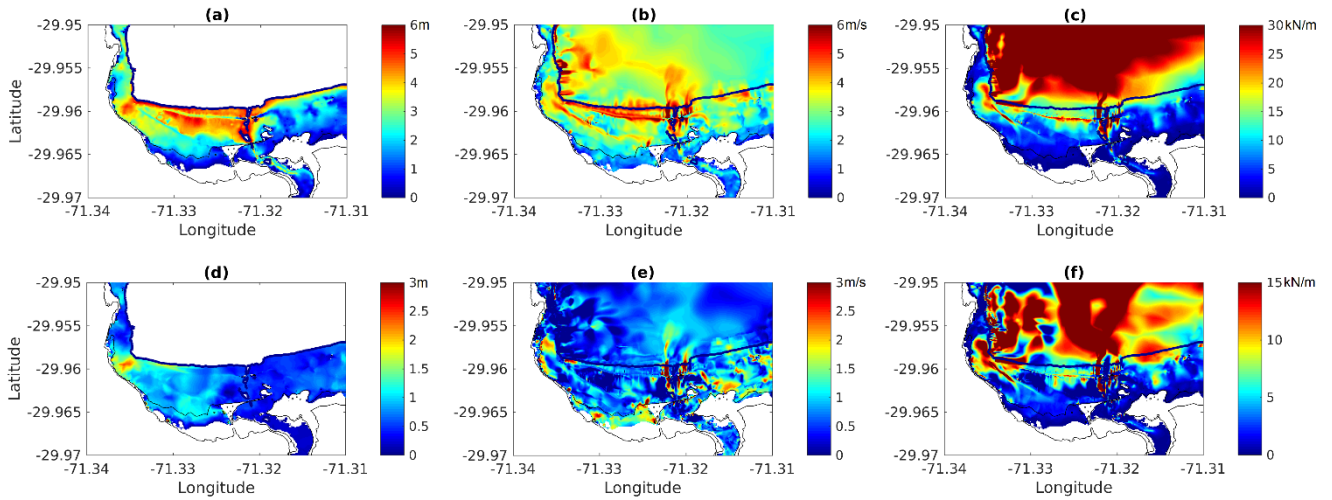
Figure 12. Results of tsunami numerical simulation of S1 event (Mw 8.2). a) Inundation depth b) Flow velocity, c) Hydrodynamic force, d) Difference of
