# Formation, breaching and flood consequences of a landslide dam near Bujumbura, Burundi

Abstract. This paper investigates the possible formation of a landslide dam on the Kanyosha River near Bujumbura, the capital of Burundi, as well as the interplay between the breaching of this landslide dam and the flooding along the river. We present an end-to-end analysis, ranging from the origin of the landslide up to the computation of flood waves induced by the dam breaching. The study includes three main steps. First, the mass movement site was investigated with various geophysical methods that allowed us to build a general 3D model and detailed 2D sections of the landslide. Second, this model was used for dynamic landslide process modelling with the Universal Distinct Element Code. The results showed that a fifteen-meter-high landslide dam may form on the river. Finally, a 2D hydraulic model was setup to find out the consequences of the breaching of the landslide dam on flooding along the river, especially in an urban area located downstream. Based on 2D maps of maximum water depth, flow velocity and wave propagation time, the results highlight that neglecting the influence of such land

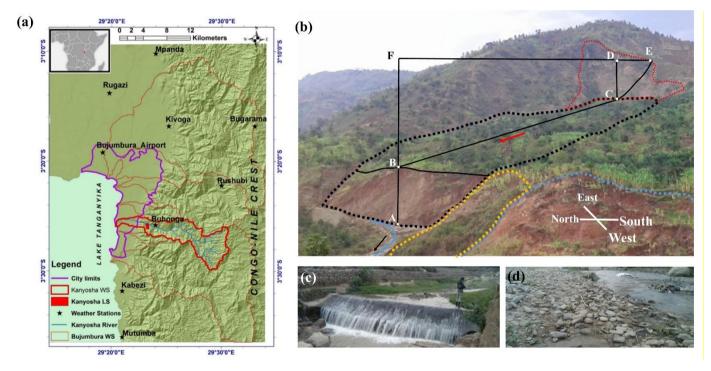
Figure 1. (a) Map of Bujumbura region (specific polocation in equatorial Africa marked by a red point in the general map in the left upper corner) with indication of watersheds for the main rivers, the limits of the city and the Lake Tanganyika. The watershed of the Kanyosha River is highlighted in the central part, with the river network inside. The weather stations in and around Bujumbura, the Kanyosha Landslide (in the text called 'Banana Tree Landslide', also referred to as BTL, in red contours) and the Congo- Nile crest are also shown. 'LS' and 'WS' stand for 'Landslide' and 'Watershed', respectively. (b) View of BTL (black dotted contour) and the main scarp (red dotted contour) as well as a possibilities (orange and light blue dotted contours). The landslide sliding direction and the river flow direction are indicated by the red and the black arrows, respectively. AB indicates the height (=26 m) of the landslide frontal part near the river; BC outlines the BTL length in the sliding direction (~750 m); CD shows the height of the main scarp (~75m) along profile BCE. The blue line indicates the river channel axis. (c) Waterfall over a former flood control structure. (located 270 m downstream of cross-section 3 shown in Fig. 3) (d) View of the river bed during the dry season with presence of cobbles and fine boulders that are deposited after floods during the wet season.

Our recent observations show that the western part of the landslide (in the foreground of Fig. 1b), with relatively soft slopes, is marked by very local slope instabilities (yellow and light blue dotted contours) that do not contribute to the general movement. However, the eastern part (black dot outlines in Fig. 1b) presents steep slopes near the river; this active zone is 250 m wide and could soon move to form a landslide dam. The presence of water ponds in this eastern part (Fig. 2a) is likely to contribute to future instability that could develop along the main sliding axis BC (shown in Fig. 1b).

- Details on the Udden-Wentworth grain-size scale nomenclature are provided in Supplement 1 (Table S1). Globally, the first group is hydraulically predominant. Here, the variability of the grain size was accounted for by means of sensitivity analysis (Section 3.3). In 2006, hydraulic structures were constructed to regulate the river; but they were quickly damaged by floods during the following rainy seasons. Nonetheless, isolated coarse materials resulting from the destruction of these structures are observed. They join the second group described above. The accumulation of material upstream of the remains of the structures often form horizontal platforms, generating small waterfalls (Fig. 1c).

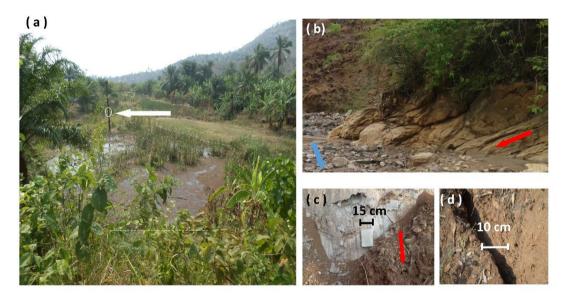
Figure 2. Field observations highlighting the critical stability state of BTL: (a) Pond on the landslide with an oil palm designated by the white arrow. This shows that these ponds are recent (oil palm trees do not grow in water; its particular foliage compared to others shows that its growth was stopped recently). (b) View of the rock structures at the foot of the landslide, generally dipping towards the north (left side), parallel to the sliding direction (red arrow). The blue arrow indicates the river flow direction. (c) View of a crack on the sliding interface in a clay layer. The red arrow shows the direction of sliding of the right part along the clay layer. (d) A crack found on the landslide surface.

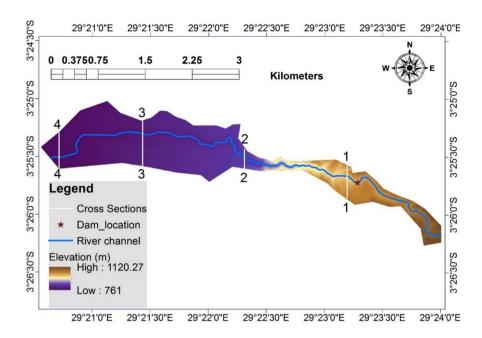
Figure 3. all elevation model (m) used for hydraulic modelling within the computational domain, with cross-sections where hydrographs were extracted and dam location. The river main channel is also highlighted.

In this section, we examine to which extent the water depths are affected by the occurrence of a landslide dam breaching. The computed water depths are discussed here for four cross-sections, labelled sections 1 to 4 (Fig. 3). Figure 13 displays the computed water depths for the pre-failure flow and for the breach-induced flow, for section 1 to 4, considering a roughness height of 0.1 m (Fig. 13a) and 0.3 m (Fig. 13b), as well as three pre-failure flow scenarios (base flow, 20-year flood and 50-year flood).

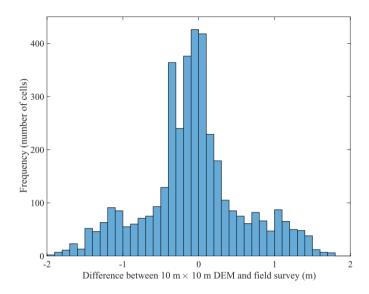
Figure 4. Elevation difference between the topography from field measurement and the resampled  $2 \text{ m} \times 2 \text{ m}$  DEM used for hydraulic modelling.

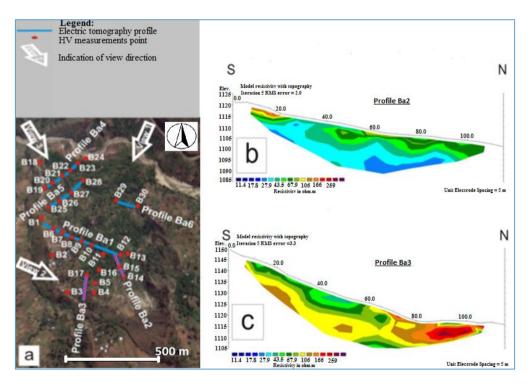
**Figure 5.** The 'Banana Tree Landslide' field measurements: overview of ERT and HV measurement locations (a), ERT profiles Ba2 (b) and Ba3 (c). In Fig. 5a, Ba2 and Ba3 profiles are highlighted in purple.

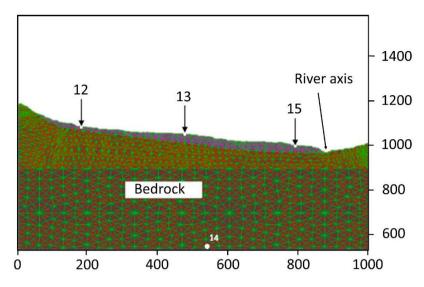
**Figure 7.** Materialization of blocks, joints and materials for the actual model. The history (measurement) points 12, 13 and 15 (white dots) located, respectively, on the upper, middle and lower block correspond to the surface area where parameters were monitored (e.g. the *x*-acceleration). The point 14 is located at the basis of the model, within the bedrock. The axis of the Kanyosha River is located to the right of the history point 15.

For the modelling with UDEC, the landslide was subdivided into three main blocks (see numerical measurement points 12, 13, 15, in Fig. 7, which are located on the upper, middle and lower block, respectively). Cracks (joints) included between the blocks (that represent also main geomorphic and geophysical units observed in the field) allow for the simulation of a more flexible movement of the mass. The same material (material 1 in Table 1) was attributed to all landslide blocks. It corresponds to the average type of the material found within the landslide. The original material of BTL is a gneiss which, by weathering, is partially transformed into a clay on the surface. The depth of the weathered layer is about 20 m. The study area experiences alternations between dry and rainy seasons. The long dry season (from June to September) is followed by the small rainy season (from October to December), then by the small dry season (during the months of January and February). The cycle ends with the strong rainy season from March to May, just before the return of the dry season. Since the photos in Fig. 2 were taken in October, the ground was relatively wet, but not as wet as it is usually the case in December and during the strong rainy season. Especially for the lower parts of the landslide, the humidity is never very low due to the recharge of the water table by the ponds of water located on the landslide. On the other hand, the groundwater recharge follows the dynamics of the seasons. In the context mentioned above, the action of the rainy season in the body of the landslide is quickly sensible, due to the higher amounts of infiltrating water. Material 2 was attributed to the stable bedrock (Table 1 and Fig. 7).

**Table 6.** PGA and Ia in the profile for the 14 and 25 seconds. Locations 12\*, 13\* and 15\* refer to the upper, the middle and the lower bloc, as mentioned in Fig. 7

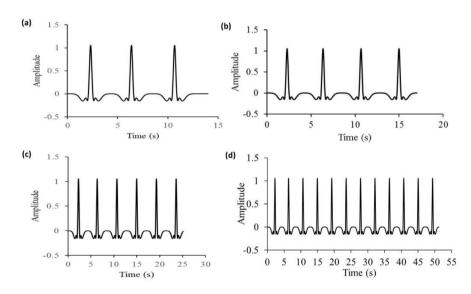
**Figure 8.** Four signals of changing duration and composed of Ricker wavelets (here with normalized amplitude), corresponding to: 14 s (a), 17 s (b), 25 s (c) and 51 s (d), were used as seismic inputs.

Actually, a partial contribution of earthquake shaking to the destabilization of the slope is highly probable as the site is located in a seismically active area (see last seismic hazard maps of the Western Branch of the East African Rift by Delvaux et al., 2016). Data availability helps to refer to an existing database and case studies within the study area. Unfortunately, in the context of data scarcity in the region (for instance, there are no strong motion records available for the target area), it is not easy to fix suitable unique values for predictions. This was handled by the use of 4 shaking duration values to well illustrate the behavior of the model corresponding to different scenarios. The seismic context was analyzed on the basis of earthquakes data from the Global Seismographic Network stations of the Incorporated Research Institutions for Seismology (IRIS) on the Lake Tanganyika Region. Therefore, based on that situation, we applied a Ricker wavelet with maximum amplitude of 0.105 g (about 1.05 m s<sup>-2</sup>) and central frequencies of 0.5 and 1.4 Hz. The loading was varied in terms of changing shaking duration. Four different values were considered: 14 seconds, 17 seconds, 25 seconds and 51 seconds. Figure 8 provides the corresponding signals.

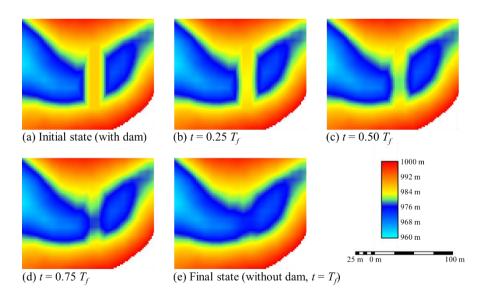
**Figure 9.** Plane view of the topography evolution in the near-field of the landslide dam as a function of time ( $T_f$  stands for the breach formation time).

As sketched in Fig. 9, the parametric breach model was implemented in the 2D flow model by means of a time varying topography. The breach outflow is thus explicitly computed by the flow model, enabling the representation of the hydraulic coupling between reservoir depletion, flow through the breach and possible backwater effects. This procedure requires a user-defined initial dam geometry (Fig. 9a) and a user-defined final geometry corresponding to the breached dam (Fig. 9e). Inbetween these two geometries, the algorithm performs a linear interpolation in time (Dewals et al. 2011). The breaching duration also needs to be prescribed by the user.

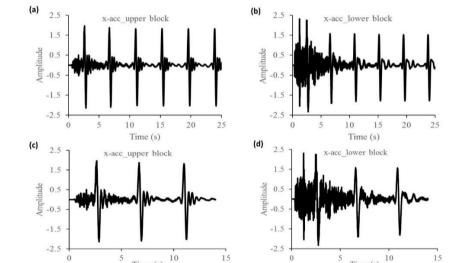
Figure 10. X-acceleration for 25 (a, b) and 14 (c, d) seconds computational time. Accelerations labelled as 'xacc lower block' and 'xacc upper block' correspond respectively to history points 15 and 12 mentioned in Fig. 7.

The results obtained from the elastic model with initial topography (scenarios 1 and 2 in Supplement 2, Fig. S1a) were first measured in terms of peak ground acceleration (PGA) and Arias Intensity (Ia, see Arias, 1970) in different parts of the profile. This was calculated from the acceleration recorded in x-direction for specific history points chosen within the model profile. Figure 10 and Table 4 provide x-acceleration, PGA and Ia for the upper and for the lower blocs considering 14 seconds and 25 seconds. As we were interested in finding how the landslide was triggered and evolved, we tracked the upper block displacement and its detachment from the later scarp, while the lower block movements needed to be analysed in detail to assess the damming potential (also in comparison with the present situation).

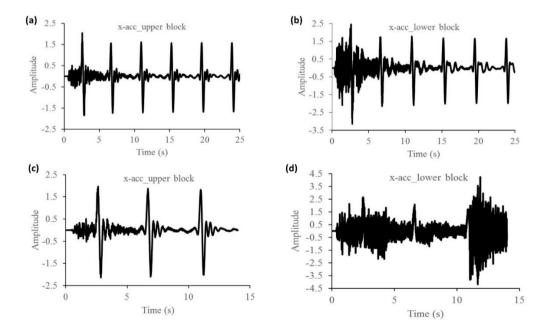
Figure 11. Actual- X-acceleration for 25 seconds (a, b) and 14 seconds (c, d) computational time.

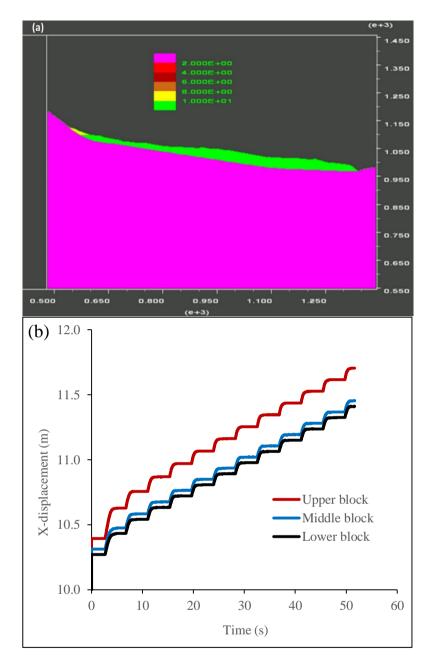
**Figure 12.** Plots of blocks (a) and displacements (b) as given in the UDEC output for run 13 (see Supplement 2, Fig. S1b: using a cohesion of 0.01 MPa and a seismic shaking of 51 seconds).

Figure 12 describes the landslide situation after scenario 13 (detailed in Fig. S1b), showing that increasing the shaking duration would result in a displacement increase over 12 m. The model sometimes provided disproportionate displacements between the three main blocks (Fig. 12b). This leads to compression and shear zones between the blocks and could even probably be the main cause of the spurts of ground water to form the small lakes hanging up the Kanyosha River.

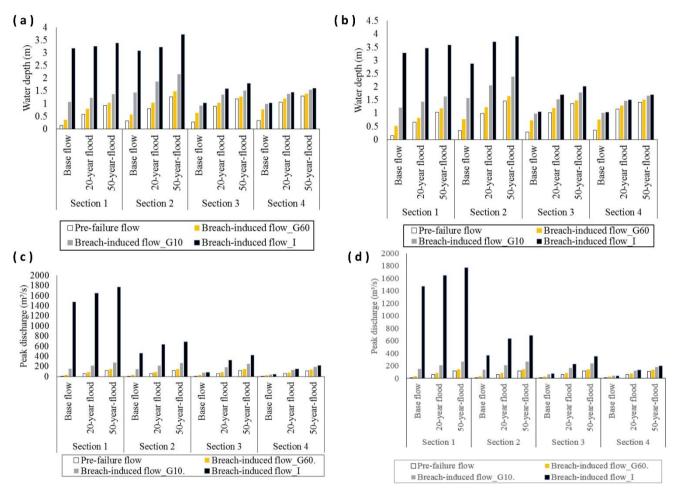
**Figure 13.** Computed maximum water depths (a, b) and peak discharges (c, d) in cross-sections 1 to 4, for various pre-failure flow conditions (base flow, 20- and 50-year floods) and for a roughness height  $k_s = 0.1$  m (a, c) or 0.3 m (b, d). 'Breach-induced flow\_G60', 'Breach-induced flow\_G10' and 'Breach-induced flow\_I' stand for 'flow induced by the failure of the landslide dam with, respectively, a breaching time of 60 minute, a breaching time of 10 minute and an instantaneous failure.

The results strongly depend on the assumed breaching time, pre-failure flow scenario and distance to the dam, whereas the values of  $k_s$  has a more limited influence on the results.

In the extreme case of an instantaneous failure, the computed water depth in section 1 is about 24 times higher when instantaneous dam breaching is assumed compared to a base flow situation without dam breaching. This value is reduced to about 5 and 4 respectively for pre-failure flow conditions corresponding to a 20- and a 50-year flood. Similarly, the increase in water depths induced by the instantaneous dam breaching becomes more moderate for sections 2, 3 and 4 which are located respectively at about 2, 4 and 6 km downstream of the dam. In the case of a 20-year flood or a 50-year flood, the maximum water depth is less than doubled in section 3 (+ 50 - 70 %) and 4 (+ 20 - 30 %).

In the case of a gradual dam failure in 10 minutes, dramatic increases in water depths are obtained only in the case of a base flow as pre-failure flow scenario. In such a case, the computed water depths are multiplied by approximately 9, 5 4 and 3 in sections 1, 2, 3 and 4, respectively. In contrast, in the cases of a 20- or 50-year flood as initial flow conditions, the computed water depths are, at maximum, about doubled. In section 4, the increases are limited to 20 - 30 %. Hence, the severity of the amplification of water depths as a result of dam breaching is, in relative terms, significantly influenced by the assumed prefailure flow.

Finally, in the case of a gradual breaching in 60 minutes, the computed water depths are affected by a factor of 3.6 in section 1 and 2.1 - 2.6 in sections 2 to 4 if a base flow is assumed as initial condition. In contrast, if a 20- or a 50-year flood is assumed initially, the growth in the computed water depths as a result of dam breaching is generally no more than about 20 %.

Nonetheless, in all cases, the increases in water depth as a result of dam breaching remains highly significant from the perspective of flood risk. These results show that dam breaching exacerbates considerably the flood conditions in the downstream river. This conclusion remains robust despite the high uncertainties on the roughness parameter. Indeed, as shown in Table 7, changing the roughness has little influence on the relative effect of dam breaching on the water depths. This is also confirmed by the high similarity between Figs. 13a and 13b.

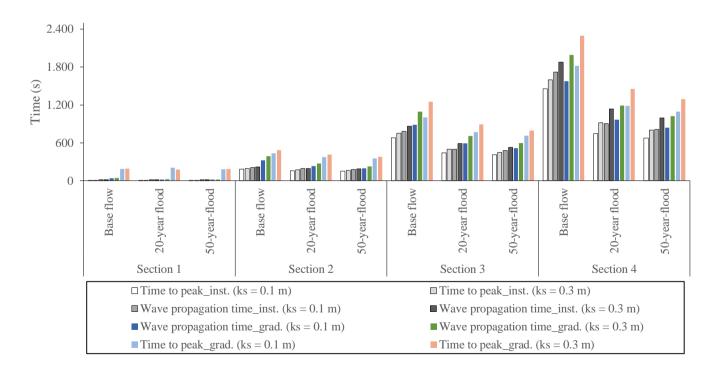
**Figure 14a.** Computed wave propagation time and time-to-peak in sections 1 to 4, for various pre-failure flow conditions (base flow, 20- and 50-year flood) and for two different roughness heights ( $k_s = 0.1 \text{ m}$  and  $k_s = 0.3 \text{ m}$ ). The gradual failure time is 10 minutes.

Figure 14 displays the wave propagation time in sections 1 to 4, i.e. the time elapsed between the dam failure and the moment the flood wave reaches the corresponding section of the river. The time-to-peak, i.e. the time between the dam breaching and the arrival of the peak discharge in the corresponding river sections is also displayed. Results are shown for two roughness heights,  $k_s = 0.1$  m and  $k_s = 0.3$  m.

In the upper part of the river, the wave propagation time remains mostly independent of the pre-failure flow. The flood wave takes between 2.5 and 3 min to reach section 2, which corresponds to a wave velocity of the order of 10 to 12 m s<sup>-1</sup>. Further downstream (urbanized area), the pre-failure flow has a strong influence on the wave propagation velocity. When the pre-failure conditions in the river correspond to base flow, the wave takes roughly 12 min to reach section 3 and 25 min to reach section 4. These values drop to 7-8 min and 12-14 min if the instantaneous dam breaching takes place during a river flood, corresponding to a rise in the mean wave velocity from 4-6 m s<sup>-1</sup> in base flow conditions up to 7-9 m s<sup>-1</sup>. In case of a 10-min

Hence, the higher the pre-failure discharge in the river, the shorter the wave propagation time and time-to-peak. Compared to a dam failure occurring when the river discharge is low (base flow), the wave propagation time and time-to-peak are approximately reduced by a factor two if the failure occurs during a flood, which corresponds incidentally to the most likely scenario. Although dam breaching has a relatively weaker influence on maximum water depth and peak discharge when the pre-failure flow corresponds to flood conditions (sections 3.3.1 and 3.3.2), the results obtained here demonstrate that even in flood situations, dam breaching is particularly dangerous because of the shorter time between the occurrence of failure and the wave arrival. Overall, the velocity of the flood wave gives little chance for the population to take precautionary measures such as evacuation; unless the population is very well prepared and some early-warning system can be put in place.

Figure 14 shows also the diffusion of the flood wave as it propagates in the valley. While the difference between the wave arrival time and the time-to-peak is low in sections 1 and 2 (generally below 0.5 min), it reaches 1 to 2 min in section 3 and 2.5 to 4.5 min in section 4. This shows that the flood wave is considerably steeper in the upper part of the valley (sections 1 and 2). Also, the wave remains steeper when dam breaching occurs during a river flood than when it occurs during base flow.

The value chosen for the roughness height has virtually no influence on the computational results in sections 1 and 2, which are relatively close to the dam; whereas it has more influence at sections 3 and 4. Nonetheless, the main observations detailed above remain valid for both values of the roughness height ( $k_s = 0.1 \text{ m}$  and  $k_s = 0.3 \text{ m}$ ).

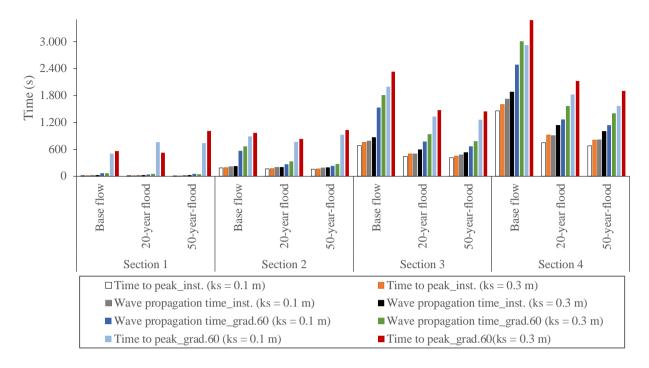
**Figure 14b.** Computed wave propagation time and time-to-peak in sections 1 to 4, for various pre-failure flow conditions (base flow, 20- and 50-year flood) and for two different roughness heights ( $k_s = 0.1 \text{ m}$  and  $k_s = 0.3 \text{ m}$ ). The gradual failure time is 60 minutes.

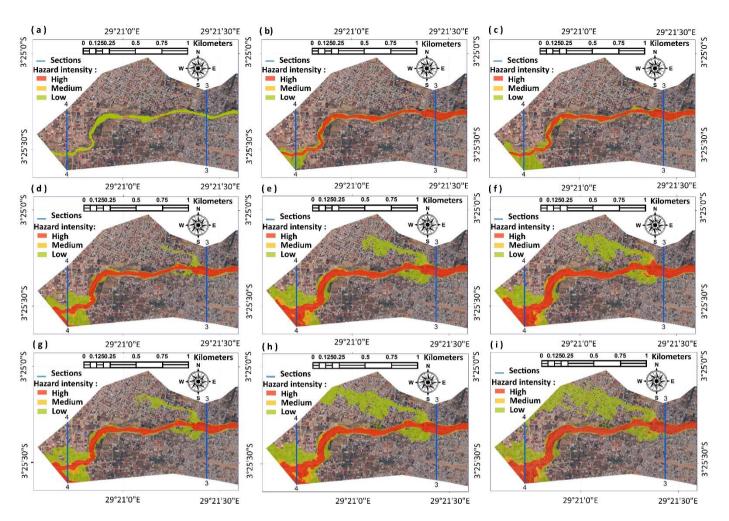
Figure 15a. Flood intensity maps for various initial steady discharges and roughness: the first column (a, d, g) corresponds to the pre-failure scenarios while the second (b, e, h) and third (c, f, i) columns relate to the gradual (10 minutes as breaching time) and instantaneous breaching. The first line (a, b, c) is based on the base flow and a roughness height of 0.1 m. The scenarios of the second line (d, e, f) are simulated using a 50 years-flow and a roughness of 0.1 m. The third line (g, h, i) is similar to the second one, but considers a roughness height of 0.3 m.

The maps in Fig. 15a and Fig. 15b show the spatial distribution of the flood intensity. Values are calculated on the basis of the water depth and velocity. Then, they are classified according to the methodology described in Section 2.5. The maps show the impact of the dam failure on the flood intensity. These maps relate to the lower parts of the watershed, between sections 3 and 4 of Fig. 3, in the city of Bujumbura. For both Fig. 15a and Fig. 15b, maps in the first column (left column) represent the scenarios without dam breaching while those in the third column relate to the corresponding instantaneous failure scenarios.

The maps in the second column correspond to the intermediate situation: gradual failure in 10 min for Fig. 15a and 60 min for Fig. 15b. Subfigures (a), (b) and (c) relates to pre-failure flow conditions corresponding to base flow, while the subfigures (d) to (f) are related to a pre-failure 50-year flood with a roughness height of 0.1 m. Subfigures (g), (h) and (i) differ from those in the second rows by the fact that a roughness of 0.3 m is applied instead of 0.1 m. The comparison between maps of the first and second rows helps to analyse changes related to the initial flow, while the differences between the second and the third rows are the result of the change in roughness within the bottom of the river. Each time, the maps in the second and third columns highlight changes due to the dam breaching.

The maps in the first row correspond to the base flow case. Their comparison allows to realize a significant change especially downstream with a lateral extension of the flooded area. Thus, notable changes are observed and consist of a change in the flood intensity level. According to subfigures (a), (b) and (d), almost all zones classified in the low level flood intensity category in the non-failure case migrated directly into the high flood intensity category in case of a failure scenario [(a) and (b)]. This is also the case from the base flow to a 50-year flow [(a) and (d)] but here, the change due to the increase of prefailure flow is more important than that resulting from the dam breaching. The vertical comparison between the first two rows highlights the variations of the flood intensity depending on the initial flow rate, as well as in a failure and in a non-failure case, under a roughness height of 0.1 m. Unlike the previous ones [(a) and (b)], the no-breach scenario (Fig. 15d) already includes zones under the high-category flood intensity. However, the lateral extension of flooding is much more obvious than previously, especially near cross-section 3. The corresponding failure scenario [map (e)] shows significant increases in flood intensity both on the south and north river banks. Comparison between (d), (e) and (f) to maps (g), (h) and (i) reveals that a higher roughness height increases substantially the estimated flood intensity, due to the corresponding increase in water depth. These observations apply to both Figs. 15a and 15b. The main difference observed between Figs. 15a and 15b relates to subfigures (b), (e) and (h) corresponding to the gradual failure. The flood intensity is higher for a breaching time of 10 min (Fig. 15a) than for a breaching time of 60 min (Fig. 15b). Overall, the flood intensity increases as the pre-failure flow increases and as breaching time becomes shorter.

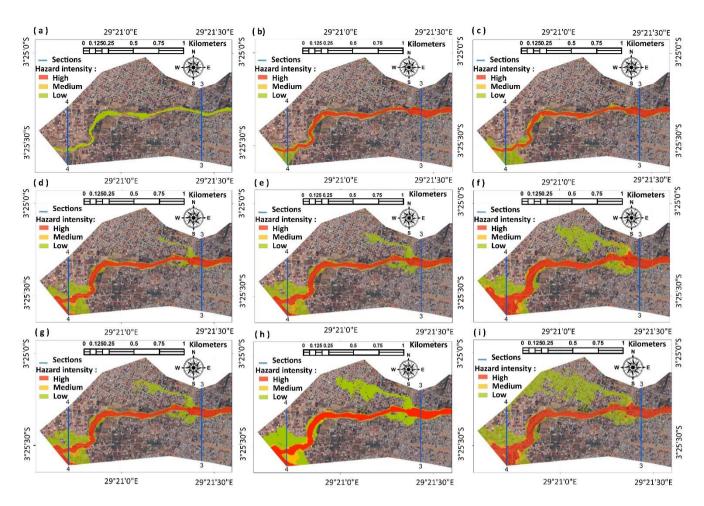
Figure 15b. Flood intensity maps for various initial steady discharges and roughness: the first column (a, d, g) corresponds to the pre-failure scenarios while the second (b, e, h) and third (c, f, i) columns relate to the gradual (60 minutes as breaching time) and instantaneous breaching. The first line (a, b, c) is based on the base flow and a roughness height of 0.1 m. The scenarios of the second line (d, e, f) are simulated using a 50 years-flow and a roughness of 0.1 m. The third line (g, h, i) is similar to the second one, but considers a roughness height of 0.3 m.

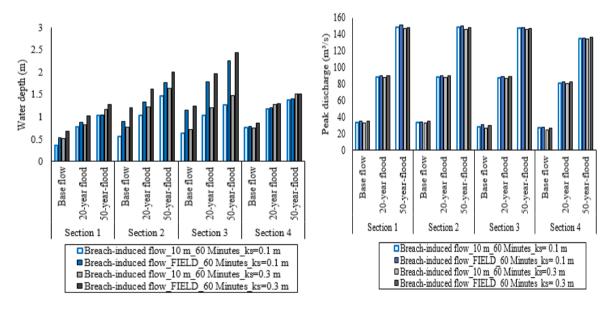
**Figure 16.** Water depth and peak discharge obtained from simulations based on the  $10 \text{ m} \times 10 \text{ m}$  DEM and from a topographic field survey. The breaching duration is 60 minutes.

To assess the sensitivity of water depth and peak discharge to the DEM, we compared the results of simulations based on the initial  $10 \text{ m} \times 10 \text{ m}$  DEM and those based on the topographic field survey (Section 2.2). The results given in Fig. 16 allow the comparison of computed water depths and peak discharges in both cases, for various initial flow in the river and roughness heights of 10 cm or 30 cm.

Some significant deviations are found for the computed water depths, indicating that the values of water depths are strongly influenced by local details in the topographic data. These influences are highly variable in space. This is an expected result and, for instance, the water level would show a more limited sensitivity to the topographic details than the water depths do. The differences may result from the limited accuracy of the topographic datasets, from planform variations of the river channel since the riverbanks are not stabilized and frequently undergo changes due to erosion and anthropogenic disturbances. Changes may have occurred between the production of the  $10 \text{ m} \times 10 \text{ m}$  DEM (2012) and the field survey (2014-2015).

In contrast, the differences in the peak discharges remain very limited, since they are equal to 3 % in average and they never exceed 10 % (this value is obtained for an initial base flow and a relatively high roughness height). The higher the initial flow in the river, the lower the sensitivity of the peak discharge. This suggests a reduced influence of the topographic details on the peak discharge, as also confirmed in Table S4 (Supplement 7).
