# Formation, breaching and flood consequences of a landslide dam near Bujumbura, Burundi

Abstract. This paper investigates the possible formation of a landslide dam on the Kanyosha River near Bujumbura, the capital of Burundi, as well as the interplay between the breaching of this landslide dam and the flooding along the river. We present an end-to-end analysis, ranging from the origin of the landslide up to the computation of flood waves induced by the dam breaching. The study includes three main steps. First, the mass movement site was investigated with various geophysical methods that allowed us to build a general 3D model and detailed 2D sections of the landslide. Second, this model was used for dynamic landslide process modelling with the Universal Distinct Element Code. The results showed that a fifteen-meter-high landslide dam may form on the river. Finally, a 2D hydraulic model was setup to find out the consequences of the breaching of the landslide dam on flooding along the river, especially in an urban area located downstream. Based on 2D maps of maximum water depth, flow velocity and wave propagation time, the results highlight that neglecting the influence of such land

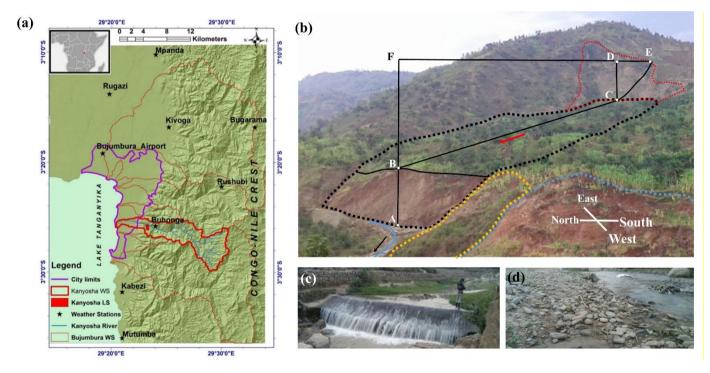
**Figure 1.** (a) Map of Bujumbura region (see also location in equatorial Africa marked by a red point in the general map in the left upper corner) with indication of watersheds for the main rivers, the limits of the city and the Lake Tanganyika. The watershed of the Kanyosha River is highlighted in the central part, with the river network inside. The weather stations in and around Bujumbura, the Kanyosha Landslide (in the text called 'Banana Tree Landslide', also referred to as BTL, in red contours) and the Congo- Nile crest are also shown. 'LS' and 'WS' stand for 'Landslide' and 'Watershed', respectively. (b) View of BTL (black dotted contour) and the main scarp (red dotted contour) as well as other instabilities (orange and light blue dotted contours). The landslide sliding direction and the river flow direction are indicated by the red and the black arrows, respectively. AB indicates the height (=26 m) of the landslide frontal part near the river; BC outlines the BTL length in the sliding direction (~750 m); CD shows the height of the main scarp (~75m) along profile BCE. The blue line indicates the river channel axis. (c) Waterfall over a former flood control structure. (located 270 m downstream of cross-section 3 shown in Fig. 3) (d) View of the river bed during the dry season with presence of cobbles and fine boulders that are deposited after floods during the wet season.

Our recent observations show that the western part of the landslide (in the foreground of Fig. 1b), with relatively soft slopes, is marked by very local slope instabilities (yellow and light blue dotted contours) that do not contribute to the general movement. However, the eastern part (black dot outlines in Fig. 1b) presents steep slopes near the river; this active zone is 250 m wide and could soon move to form a landslide dam. The presence of water ponds in this eastern part (Fig. 2a) is likely to contribute to future instability that could develop along the main sliding axis BC (shown in Fig. 1b).

- Details on the Udden-Wentworth grain-size scale nomenclature are provided in Supplement 1 (Table S1). Globally, the first group is hydraulically predominant. Here, the variability of the grain size was accounted for by means of sensitivity analysis (Section 3.3). In 2006, hydraulic structures were constructed to regulate the river; but they were quickly damaged by floods during the following rainy seasons. Nonetheless, isolated coarse materials resulting from the destruction of these structures are observed. They join the second group described above. The accumulation of material upstream of the remains of the structures often form horizontal platforms, generating small waterfalls (Fig. 1c).

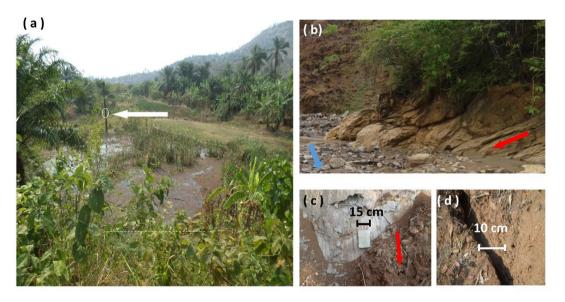
Figure 2. Field observations highlighting the critical stability state of BTL: (a) Pond on the landslide with an oil palm designated by the white arrow. This shows that these ponds are recent (oil palm trees do not grow in water; its particular foliage compared to others shows that its growth was stopped recently). (b) View of the rock structures at the foot of the landslide, generally dipping towards the north (left side), parallel to the sliding direction (red arrow). The blue arrow indicates the river flow direction. (c) View of a crack on the sliding interface in a clay layer. The red arrow shows the direction of sliding of the right part along the clay layer. (d) A crack found on the landslide surface.
