*Response to EC:*

*Response to nhess-2017-44-referee-report-1:*

# A method for using unmanned aerial vehicles for emergency investigation of single geo-hazards and sample applications of this method

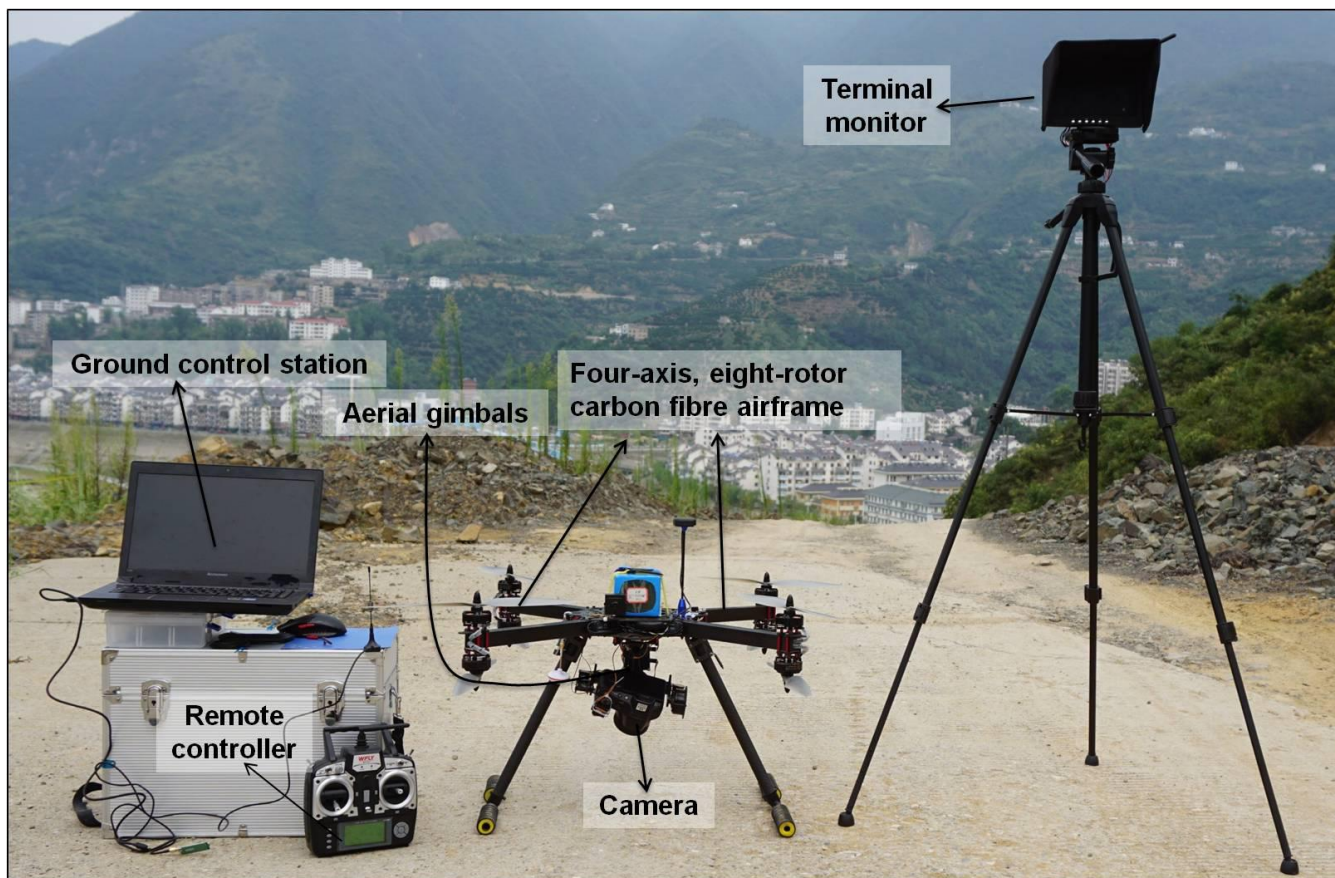
**Fig.1.** A photograph showing the customized UAV system used for emergency investigation of single geo-hazards in the Three Gorges Reservoir area, China.

**Fig. 1.** A photograph showing the customized UAV system used for emergency investigation of single geo-hazards in the Three Gorges Reservoir area, China.

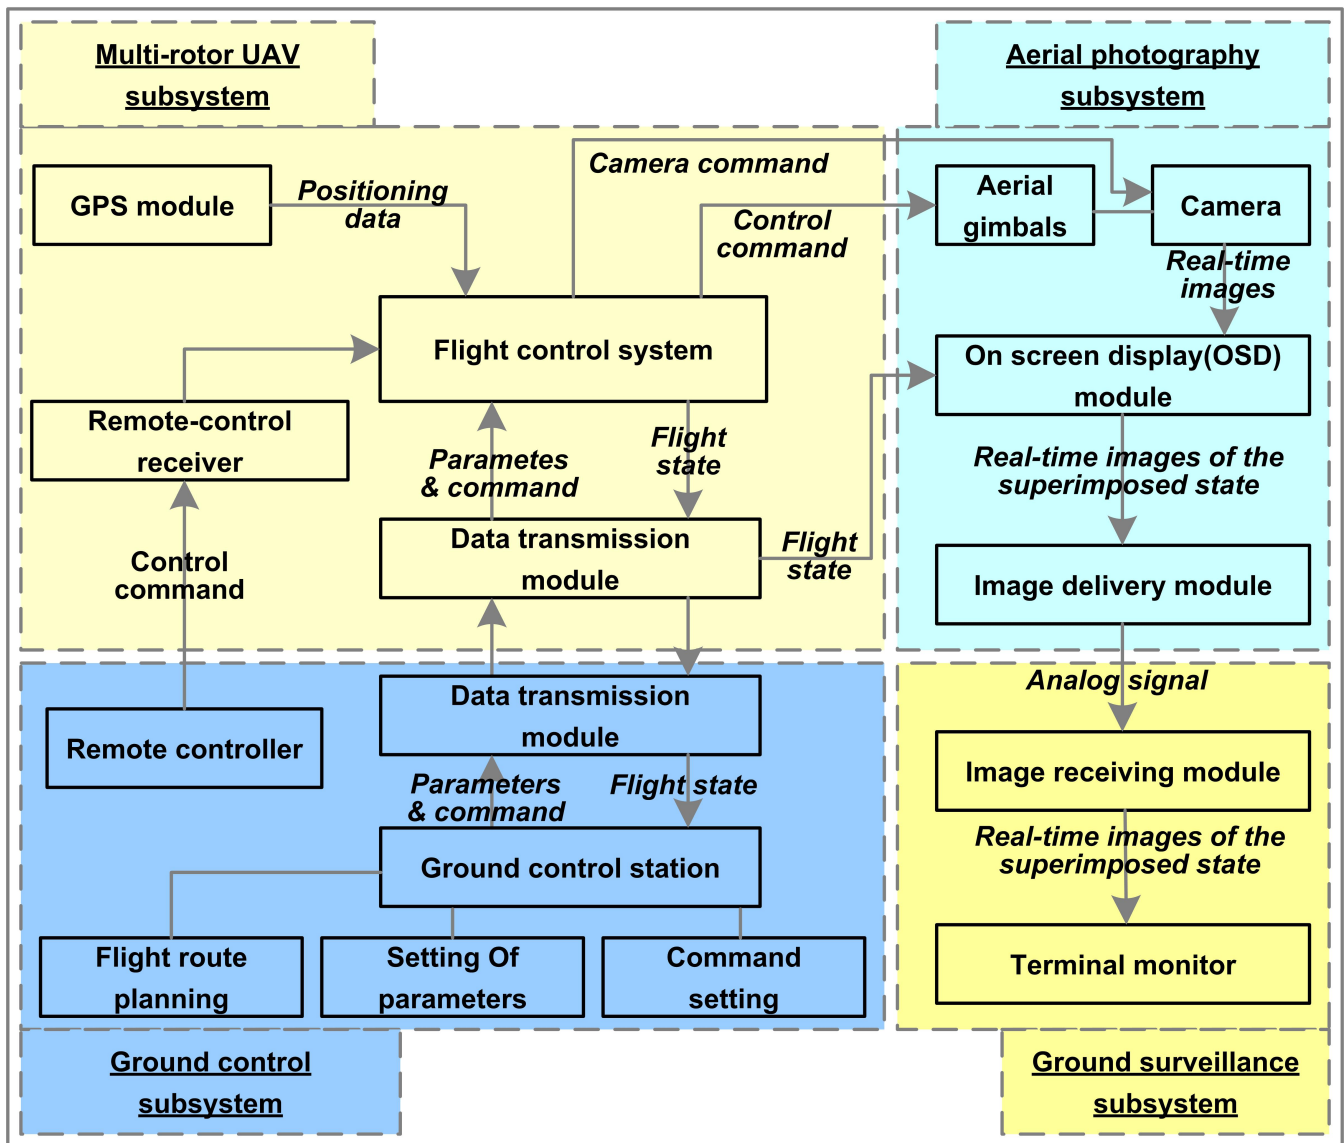
**Fig.2.** A diagram showing the architecture and main function modules of the customized UAV system.

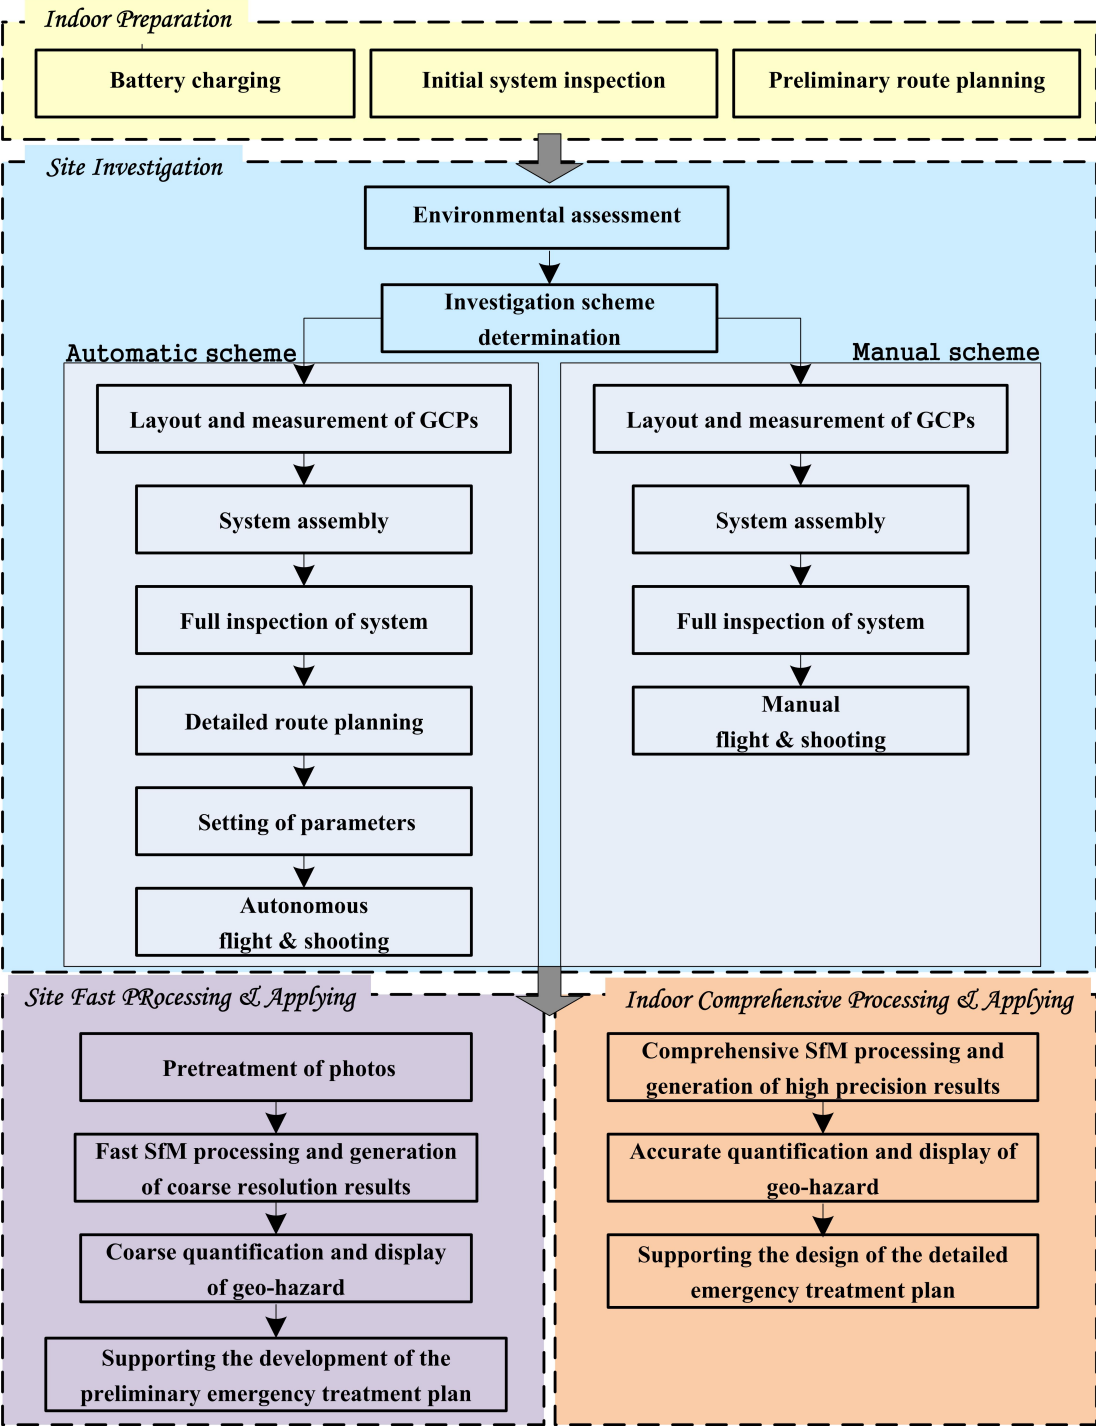
785 **Fig.3.** The process of using UAVs to emergency investigate single geo-hazards.

Using the automatic scheme, the UAV system is capable of autonomous flight in accordance with the routes established during detailed planning, as well as automatic photo image collection, using the UAV's own GNSS, compass and barometer.  
200 This scheme requires no manual intervention under normal conditions and is therefore safer and more reliable than manual methods. At the same time, the acquisition of high quality photographs is more likely in this mode, which can automatically meet some requirements of the subsequent photogrammetric processing, e.g., the frontal and side overlap ratios between photographs. In view of this, as long as there are more than five stable GNSS satellite signals in the geo-hazard area, the vast majority of emergency investigations should use the automatic investigation scheme. In addition, this scheme is divided into  
205 six steps (Fig. 3), which are described below.

In the manual scheme, the entire UAV flight and the process of photo image collection has to be manually controlled using the remote control. This scheme requires no route planning, which can save time in site investigation. However, it requires 240 excellent piloting skills, and the flight safety and image quality are frequently degraded; accordingly, the flight process should be monitored intensively. Therefore, use of the manual scheme should be avoided, although, in some places, such as mountainous areas or canyons, where the GNSS signals are unstable or even absent, or the scope of the geo-hazard is extremely limited, the manual scheme may be more suitable. In addition, this scheme is divided into 4 steps (Fig. 3), which

the emergency investigation of single geo-hazards, it is divided into on-site fast processing and indoor comprehensive processing (Fig. 3). In addition, the results of the SfM photogrammetric processing should also be targeted to the different types or characteristics of the geo-hazard; e.g., for the type of event shown in Fig. 5a, the main results should be a digital terrain model and an orthophoto; for the type of event shown in Fig. 5b, the core results will likely be a facade orthophoto and a 3D model; for the type of event shown in Fig. 3c, the results should include a digital terrain and orthophoto, as well as a facade orthophoto and a 3D model.

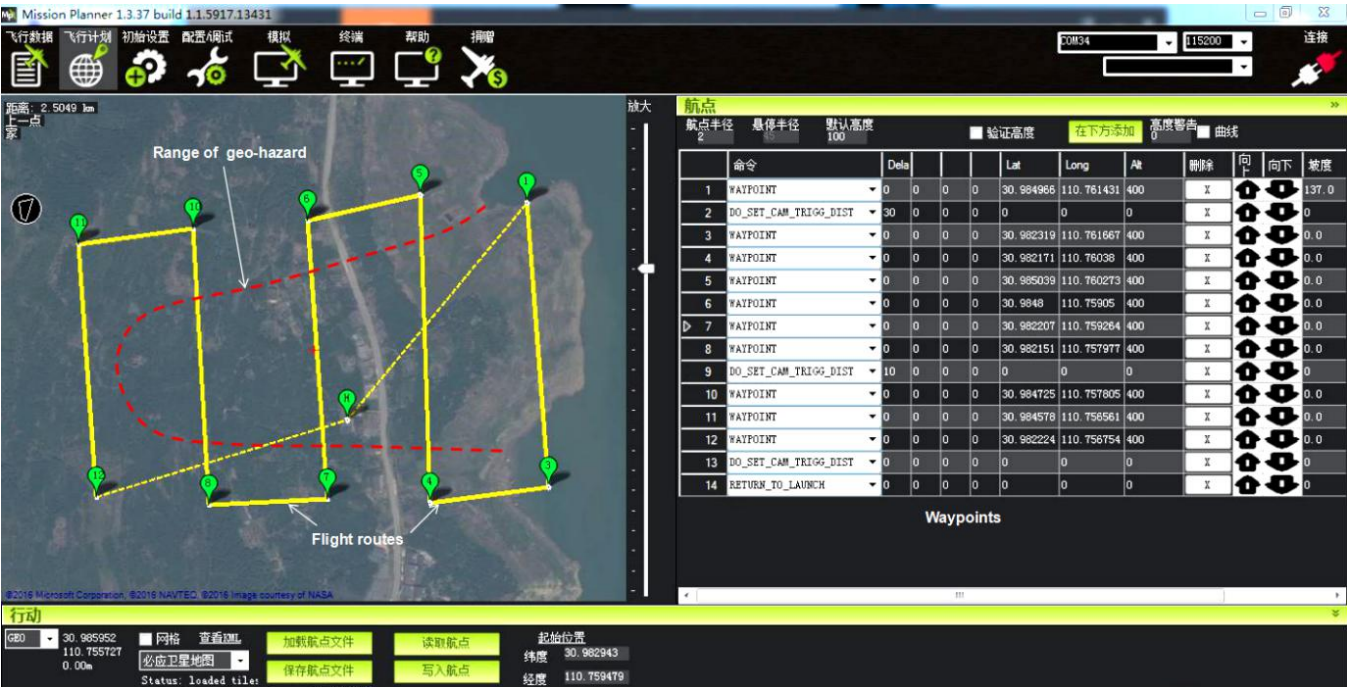
Fig.4. The planning of a route involving a typical regular grid pattern in plane view using Mission Planner software.

175 software package. Typically, the preliminary flight routes are simply designed as a regular grid pattern in plane view that covers the whole area affected by the geo-hazard (Fig. 4). In a word, preliminary route planning can help to save time spent on detailed route planning on-site. Of course, if the location cannot be determined in advance, the indoor preliminary route planning cannot be performed, but it does not affect the subsequent on-site investigation using the UAV.

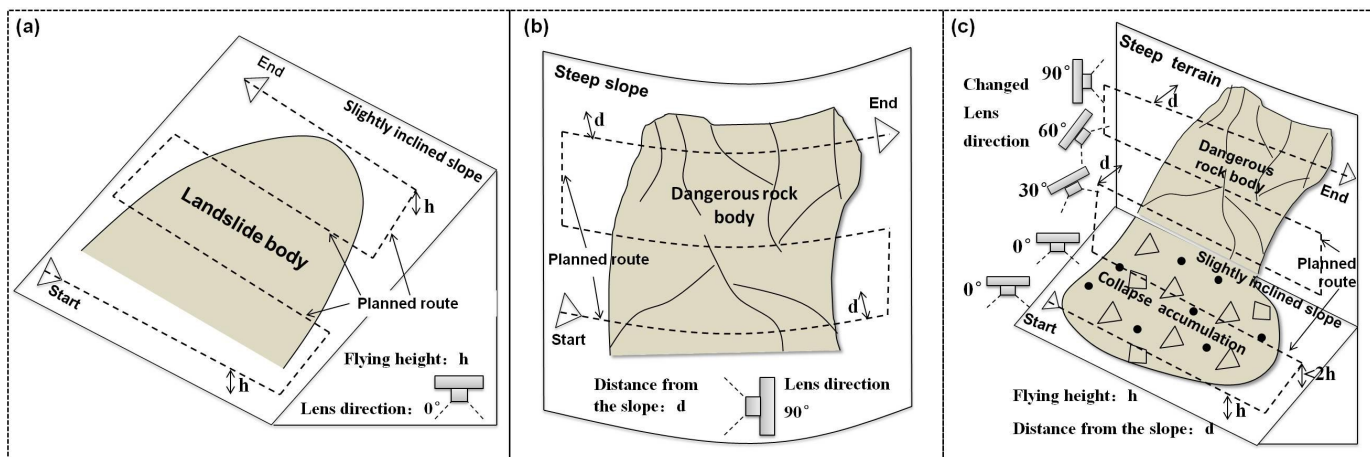
**Fig.5.** Three typical route types for UAV-based emergency investigation of single geo-hazards. (a) Planar grid pattern for slightly inclined slopes; (b) vertical grid pattern for steep slopes; (c) combined grid pattern for transitional terrain.

345 According to the characteristics of individual geo-hazards, proper route type selection and accurate motion design are key in ensuring the safety and efficiency of UAV-based emergency investigation. Based on a number of examples, three typical route types are summarized as follows (Fig. 5).

(1) Planar grid pattern for slightly inclined slopes (Fig. 5a). This pattern is suitable for geo-hazards that cover large areas (typically several million square metres) on the gentle slopes (typically less than  $40^\circ$ ), such as gently inclined landslide bodies. The primary purpose of the emergency investigation for this kind of disaster is to obtain a digital terrain model and an orthophoto. Therefore, the planned route consists of a regular planar grid that covers the whole planar area of the geo-hazard. In addition, the camera lens always points vertically down to the ground (i.e., the lens orientation is held at  $0^\circ$ ). It is worth noting that the flying height of the route should be dynamically adjusted to meet the elevation changes of the disaster and slope. In principle, it is advisable to maintain the UAV's flying height at a constant distance (i.e., the  $h$  in Fig. 5a) from the ground, and practice shows that  $h$  in 50 m ~ 100 m is proper. Lower flights require longer routes and increased flight time, and flight safety decreases; conversely, higher flights increase the mean ground sampling distance (GSD) of the acquired images, thus providing for lower spatial resolution of the final photogrammetric products, educe the resolution of photographs and the processing results.

(2) Vertical grid pattern for steep slopes (Fig. 5b): This pattern is suitable for geo-hazards that are developed on steep slopes (typically greater than  $60^\circ$ ), such as dangerous rock masses on cliffs. Emergency investigations of this kind of disaster should aim at obtaining orthophotos of the facade and 3D models, rather than digital terrain and vertically downward orthophotos. In this case, the planned route consists of a regular vertical grid which that covers the whole facade area of the geo-hazard. In addition, the camera lens always points horizontally to the disaster body (i.e., lens orientation is held at  $90^\circ$ ). The plane positions of all of the horizontal routes can overlap, but they are at different altitudes. In addition, it is advisable to keep the UAV flying at a constant distance (i.e., the  $d$  in Fig. 5a) from the area affected by the disaster (practice shows that a  $d$  of 40 m ~ 80 m is proper).

(3) Combined grid pattern for transitional terrain (Fig. 5c): This pattern is suitable for geo-hazards that are located on transitional terrain and include both gentle and steep slopes, such as a dangerous rock mass on a cliff and the corresponding collapse accumulation mass on the gentle slope below. The main purposes of emergency investigation for this kind of disaster are to obtain a digital terrain model and an orthophoto, as well as a facade orthophoto and a 3D model. Therefore, the combined grid pattern should be adopted for the planned route. That is, a regular planar grid is used to cover areas with gentle slopes, and a vertical grid is used to cover areas with steep slopes. Accordingly, the camera lens points vertically down to the ground within the part with the planar grid (i.e., the lens orientation remains at  $0^\circ$ ), and gradually rises from the low position to the high position in the part with the vertical grid (i.e., the lens orientation changes from  $0^\circ$  to  $90^\circ$ ). The flying height  $h$  and flying distance  $d$  in Fig. 5c can be set as in the planar and vertical grid patterns, respectively.

**Fig.5.** Three typical route types for UAV-based emergency investigation of single geo-hazards. (a) Planar grid pattern for slightly inclined slopes; (b) vertical grid pattern for steep slopes; (c) combined grid pattern for transitional terrain.

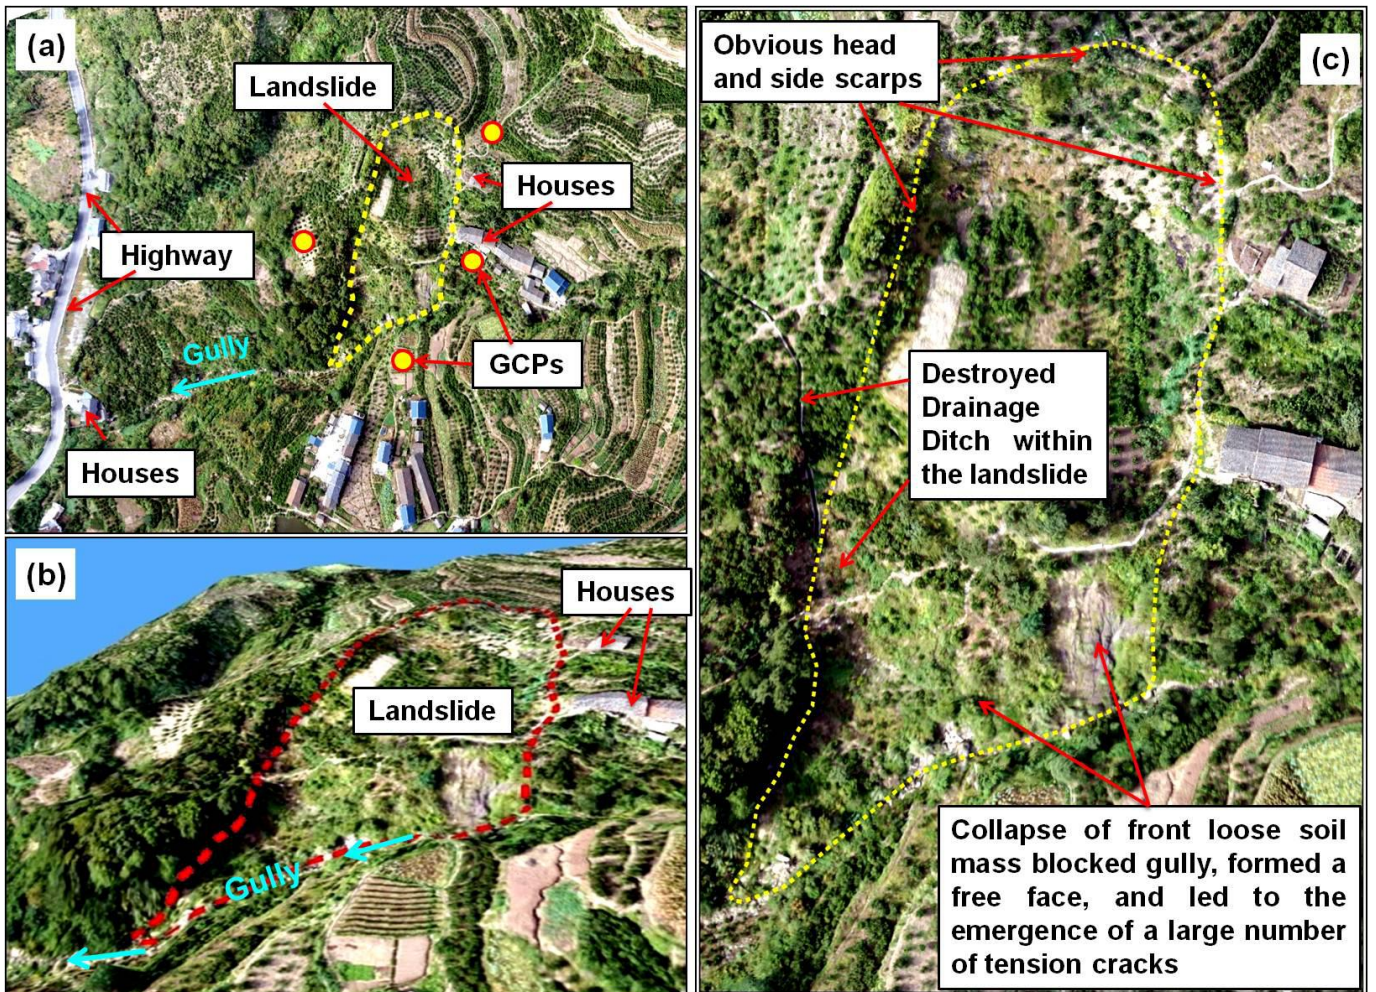
**Fig.6.** The results of a UAV-based emergency investigation of a slightly inclined landslide. (a) the digital orthophoto; (b) the 3D texture model; (c) interpretation of the destruction.

455 effects of the landslide were quickly interpreted (Fig. 6c) and evaluated. These products revealed the formation of obvious head and side scarps. Moreover, the drainage ditch that was located within the landslide was completely destroyed, and the front loose soil mass collapsed and blocked the gully, forming a free face and leading to the emergence of a large number of tension cracks. All of these indications suggested that the landslide represented an obvious mass movement, and that the landslide was in an unstable state. In addition, the landslide was a direct threat to the houses which were located adjacent to the right boundary of the landslide. Moreover, as the loose soil mass at the front of the landslide continuously accumulated in the gully, a debris flow would be easily triggered by heavy rainfall, then seriously threatened the house and highway. Based on the conclusions above, emergency response measures were put forward, including using professional monitoring techniques such as GNSS, extensometers, rain gauges, and ground-based inspection to continuously track the process of deformation and induction of the landslide; establishing a citizen science-based monitoring and prevention system, which means to encourage the surrounding population to watch for signs of deformation within the landslide body, e.g., cracks, collapses, and cracks in houses, especially in association with heavy or continuous rainfall; and developing an emergency evacuation programme to ensure the orderly avoidance and reduction of losses before additional movement occurs.

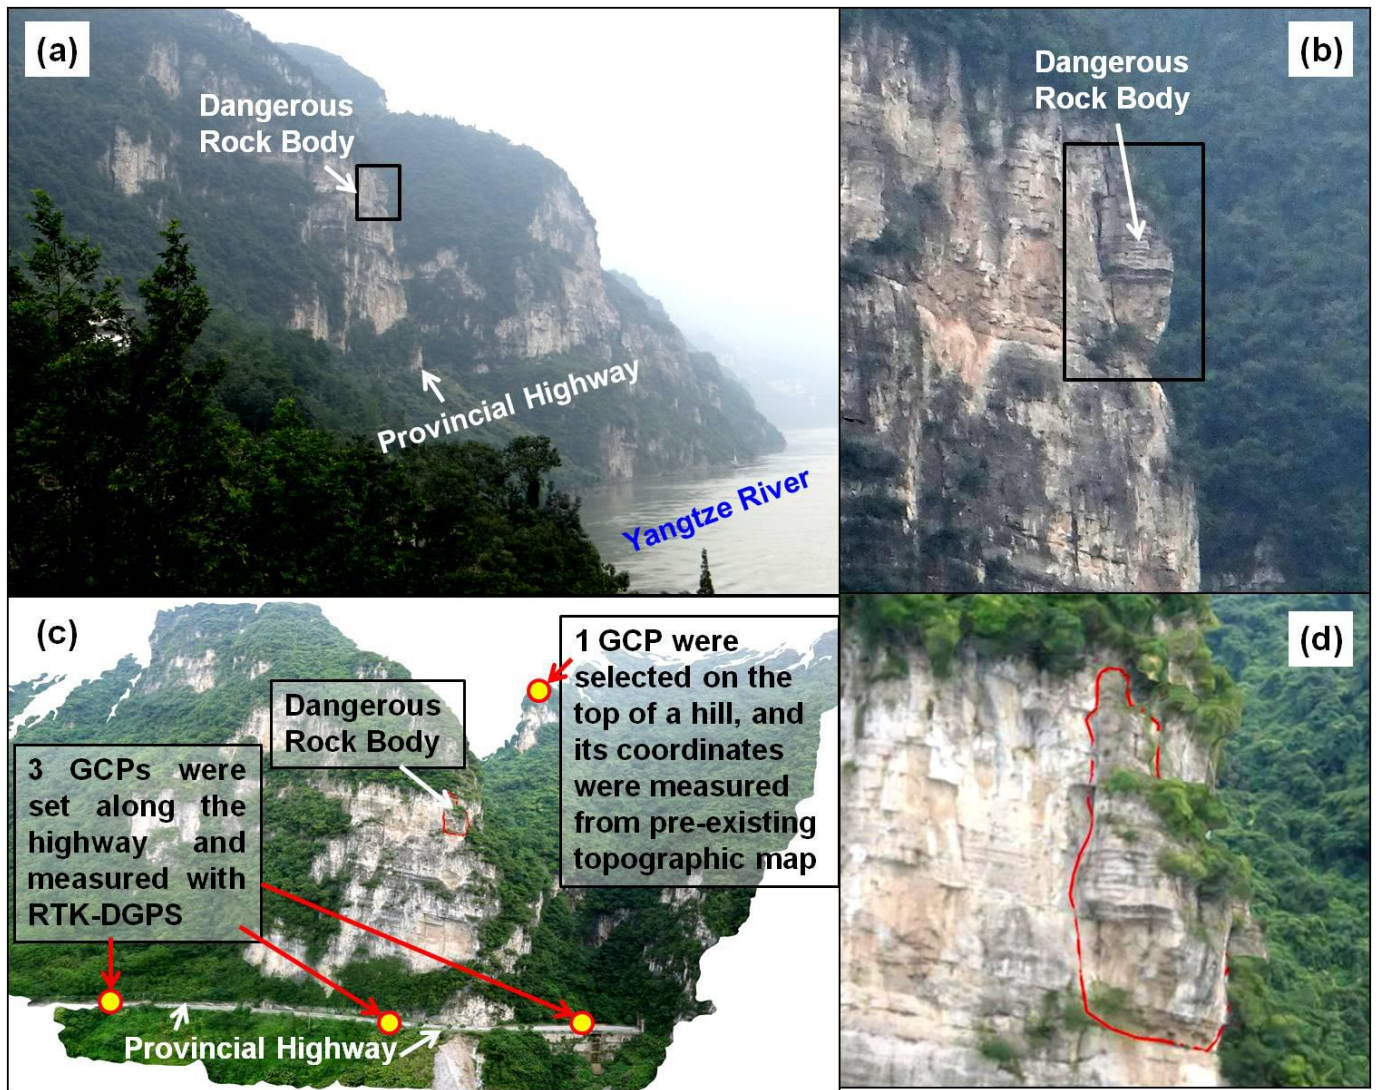
**Fig.7.** The results of a UAV-based emergency investigation for a dangerous rock mass on steep cliff. (a) Overview photo; (b) right side photo of the dangerous rock mass; (c) 3D texture model of the whole scene; (d) 3D texture model of the dangerous rock mass.

480 First, route planning was performed according to the pattern shown in Fig. 5b. At the same time, 3 GCPs were established along the highway and measured with the RTK-DGPS technique (Fig. 7c). In addition, it should be noted that, because the three GCPs were located in nearly a straight line, given the limited environment, which could not meet the processing requirements, another GCP was established on top of a hill behind the cliff (Fig. 7c), and its coordinates were measured according to the pre-existing topographic map. The layout and measurement of the 3 GCPs took only approximately 25 minutes. The camera lens direction was then set at approximately 45 ° to the steep cliff. Through autonomous flight and automatic photo image collection, 104 photographs were captured, and the mean GSD of the original images was 4.92 cm/pixel. Together with route planning and UAV preparation, the entire working time using the UAV took 35 minutes.

In view of the DSM and the 3D model, the results showed that the dangerous rock mass was 24 m high, 12 m wide, and 12 m thick and had a volume of 3456 m<sup>3</sup>, and its exact distance from the highway was 110 m. The lower and upper part of the rock mass had fallen, so it was completely unsupported. The left and right boundary cracks were fully connected. All of these signs indicated that the dangerous rock mass was in an unstable state. Therefore, the relevant emergency investigation results described above were submitted to the technical department to support the design of a detailed emergency response plan.

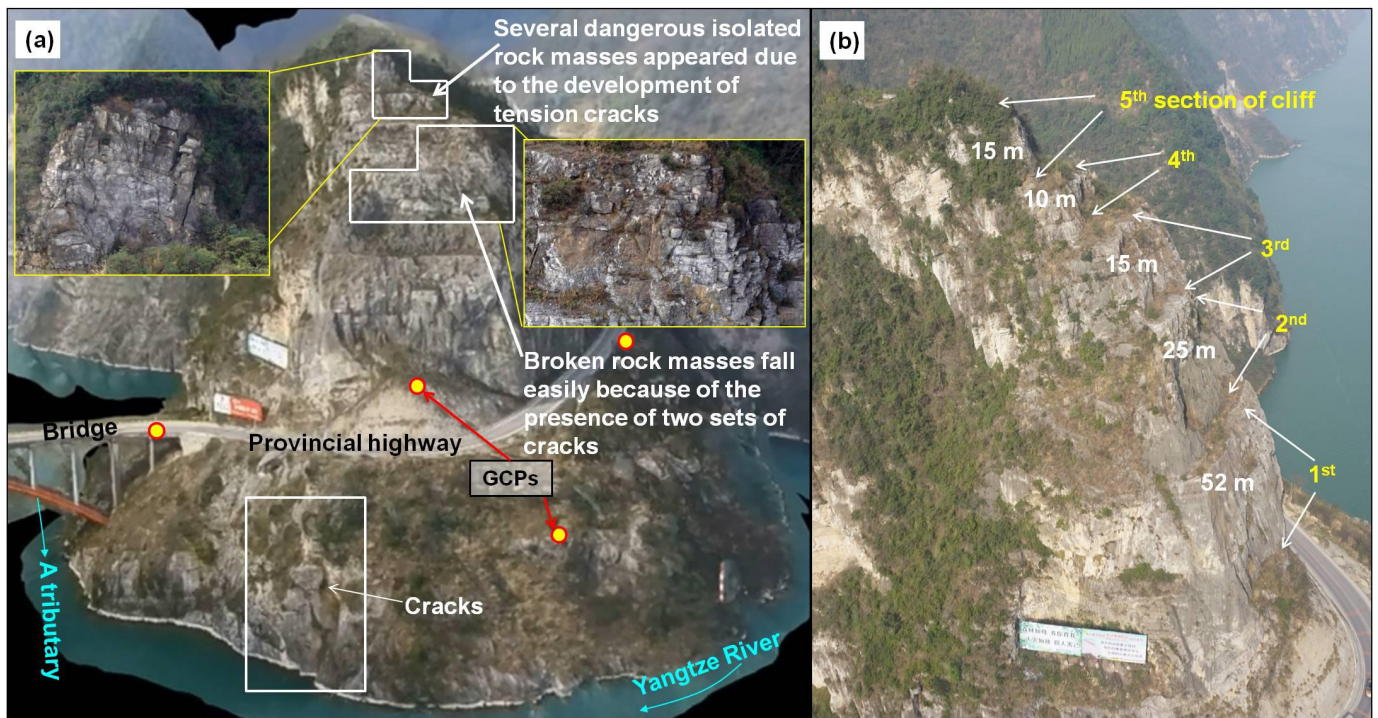
**Fig.8.** The results of a UAV-based emergency investigation for a combined slope on transitional terrain. (a) The 3D texture model and the identified potential geo-hazards; (b) the quantitative characteristics of the steep slope above the highway.

Based on all of the results, mainly the high-resolution 3D texture model, three potential geo-hazards were identified on  
this slope (Fig. 8). Above the highway, within the 4th section of the cliff and the left part of the 5th section of the cliff,  
several dangerous isolated rock masses had formed because of the continuous development of tension cracks. In the upper  
530 part of the 2nd section of the cliff and the left part of the 3rd section of the cliff, a large number of broken rock masses that  
could fall easily had developed due to the continuous development of two sets of tension cracks. Below the highway, a  
tension crack existed on the right side of the slope. In addition, the detailed characteristics of each section of the cliff could  
be accurately measured (Fig. 8b). The relevant results from the emergency investigation were submitted to the relevant  
departments for risk assessment and the design of control measures.

**Fig.8.** The results of a UAV-based emergency investigation for a combined slope on transitional terrain. (a) The 3D texture model and the identified potential geo-hazards; (b) the quantitative characteristics of the steep slope above the highway.
