# A method for using unmanned aerial vehicles for emergency investigation of single geo-hazards and sample applications of this method

**Abstract.** In recent years, unmanned aerial vehicles (UAVs) have become widely used in emergency investigations of major natural hazards over large areas; however, UAVs are less commonly employed to investigate single geo-hazards. Based on a number of successful investigations in the Three Gorges Reservoir area, China, a complete UAV-based method for performing emergency investigations of single geo-hazards is described. First, a customized UAV system that consists of a multi-rotor UAV subsystem, an aerial photography subsystem, a ground control subsystem and a ground surveillance subsystem is described in detail. The implementation process, which includes four steps, i.e., indoor preparation, site investigation, on-site fast processing and application, and indoor comprehensive processing and application, is then elaborated, and two investigation schemes, automatic and manual, that are used in the site investigation step are put forward. Moreover, some key techniques and methods, e.g., the layout and measurement of ground control points (GCPs),

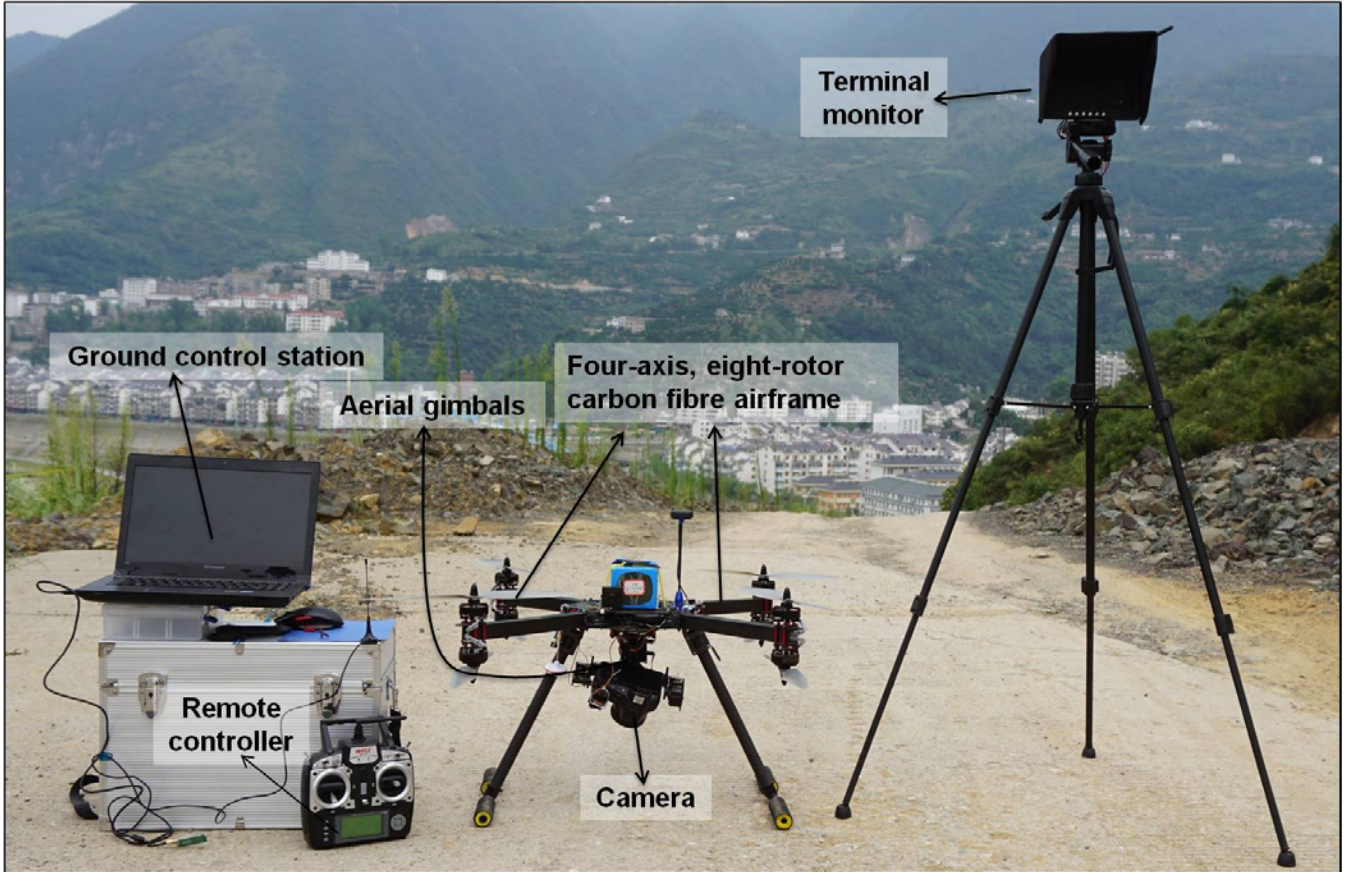
**Fig.1.** A photograph showing the customized UAV system used for emergency investigation of single geo-hazards in the Three Gorges Reservoir area, China.

670 **Fig. 1.** A photograph showing the customized UAV system used for emergency investigation of single geo-hazards in the Three Gorges Reservoir area, China.

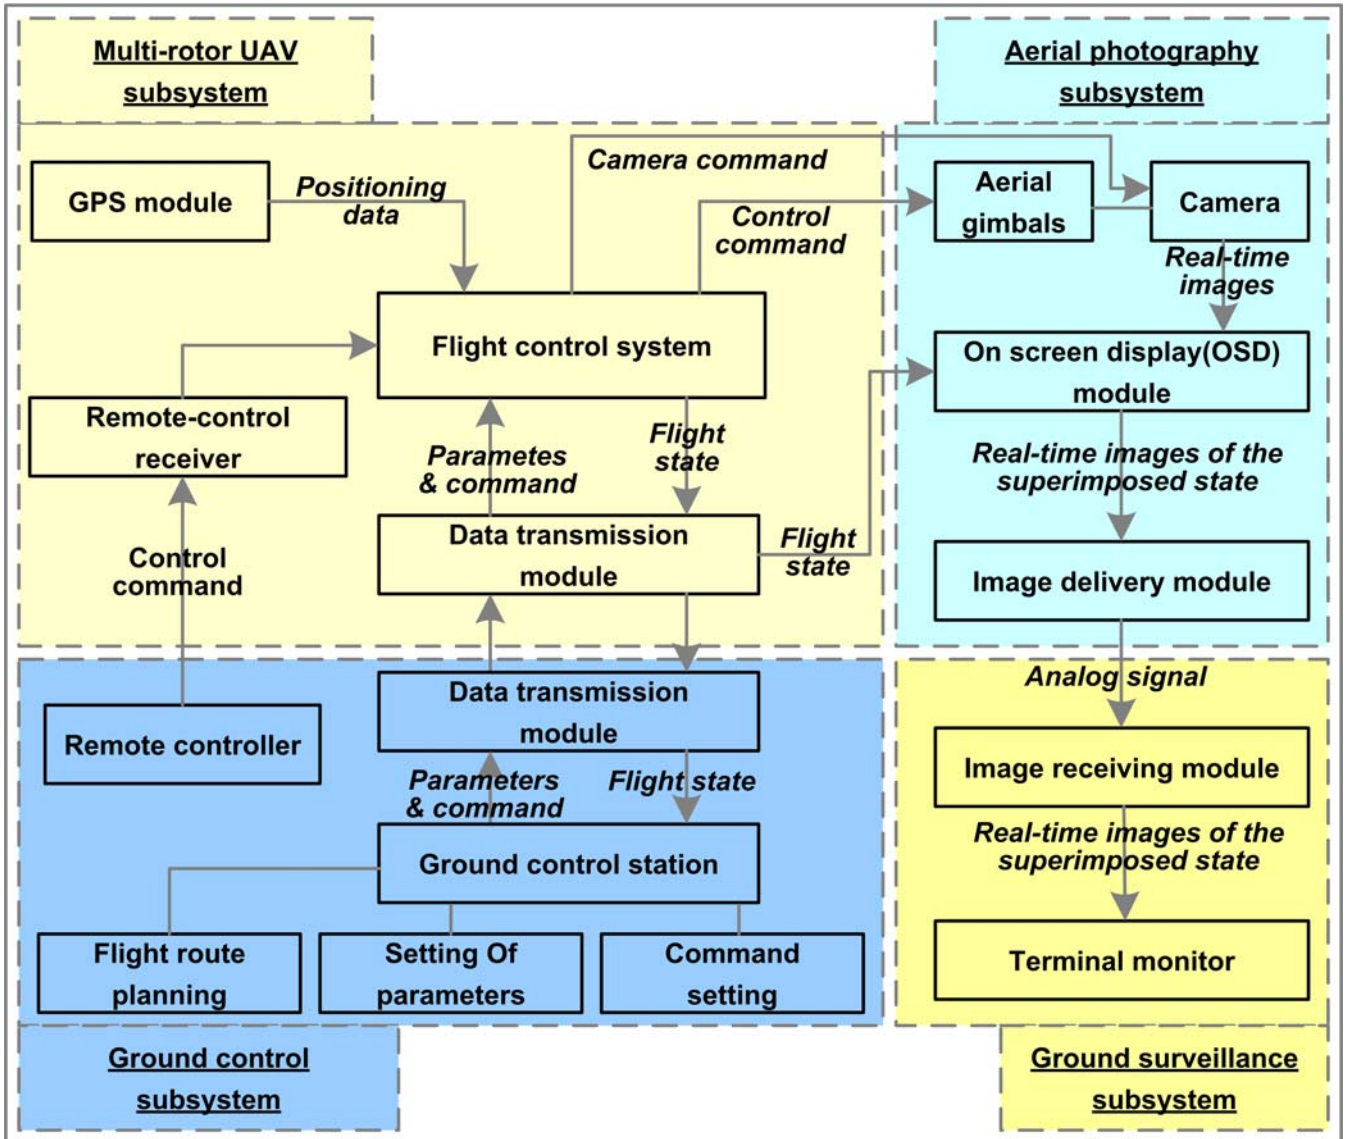
**Fig.2.** A diagram showing the architecture and main function modules of the customized UAV system.

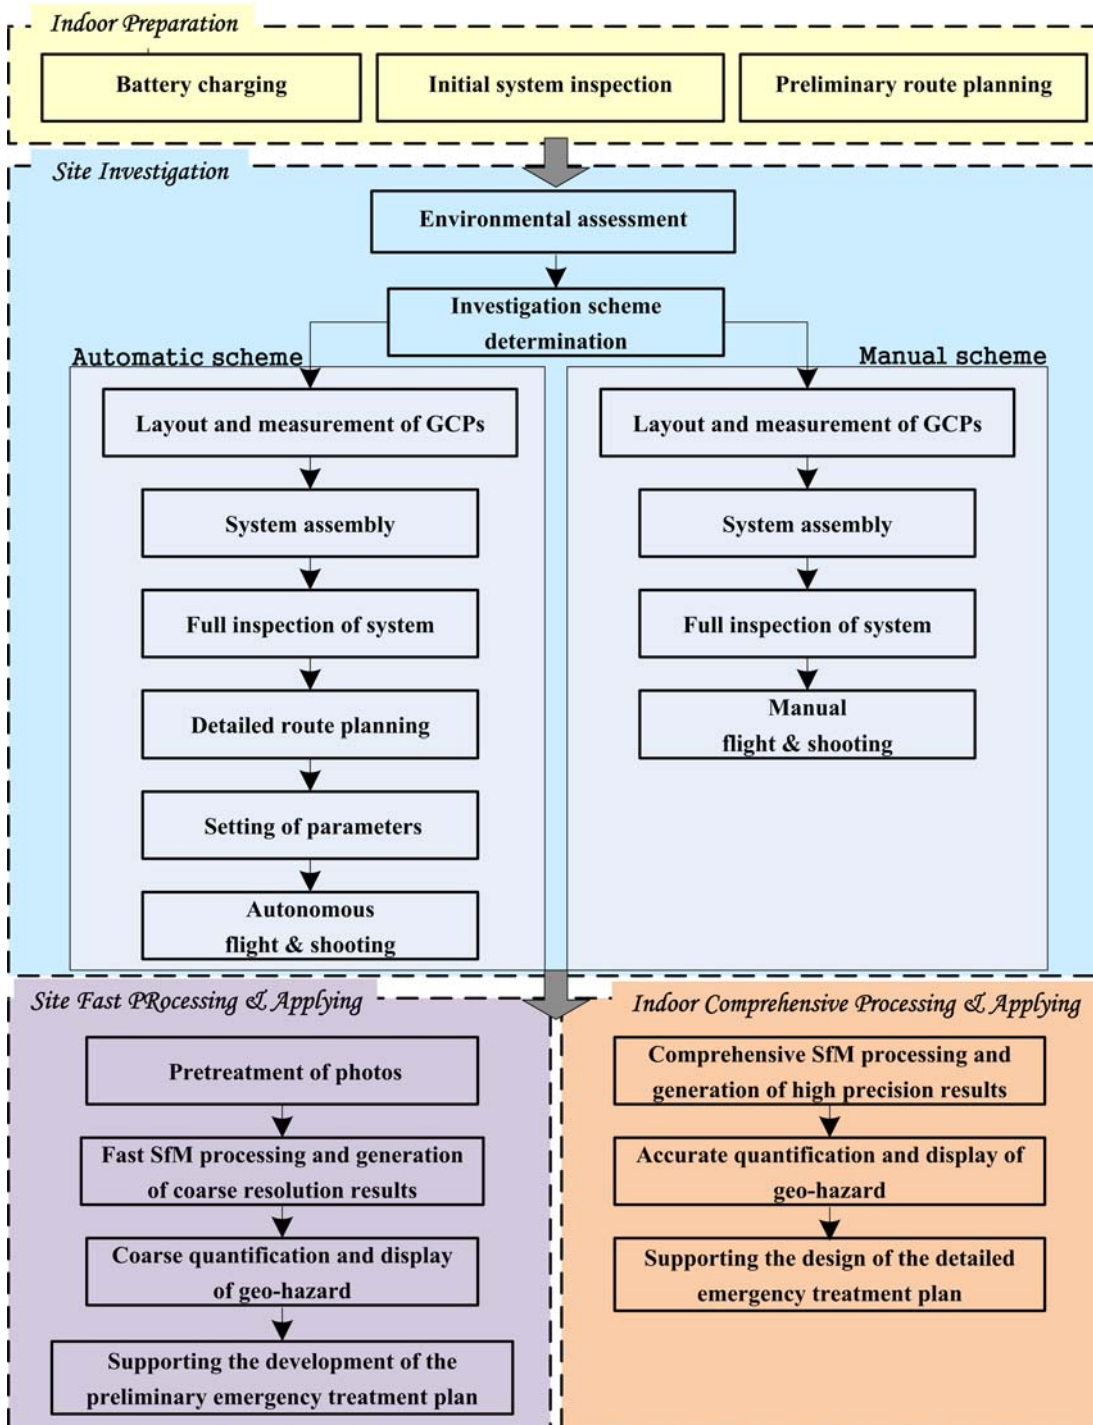
Fig.3. The process of using UAVs to emergency investigate single geo-hazards.

Using the automatic scheme, the UAV system is capable of autonomous flight in accordance with the routes established  
during detailed planning, as well as automatic photo image collection, using the UAV's own GNSS, compass and barometer.  
This scheme requires no manual intervention under normal conditions and is therefore safer and more reliable than manual  
200 methods. At the same time, the acquisition of high quality photographs is more likely in this mode, which can automatically  
meet some requirements of the subsequent photogrammetric processing, e.g., the frontal and side overlap ratios between  
photographs. In view of this, as long as there are more than five stable GNSS satellite signals in the geo-hazard area, the vast  
majority of emergency investigations should use the automatic investigation scheme. In addition, this scheme is divided into  
six steps (Fig. 3), which are described below.

In the manual scheme, the entire UAV flight and the process of photo image collection has to be manually controlled using the remote control. This scheme requires no route planning, which can save time in site investigation. However, it requires excellent piloting skills, and the flight safety and image quality are frequently degraded; accordingly, the flight process should be monitored intensively. Therefore, use of the manual scheme should be avoided, although, in some places, such as mountainous areas or canyons, where the GNSS signals are unstable or even absent, or the scope of the geo-hazard is extremely limited, the manual scheme may be more suitable. In addition, this scheme is divided into 4 steps (Fig. 3), which are briefly described below.

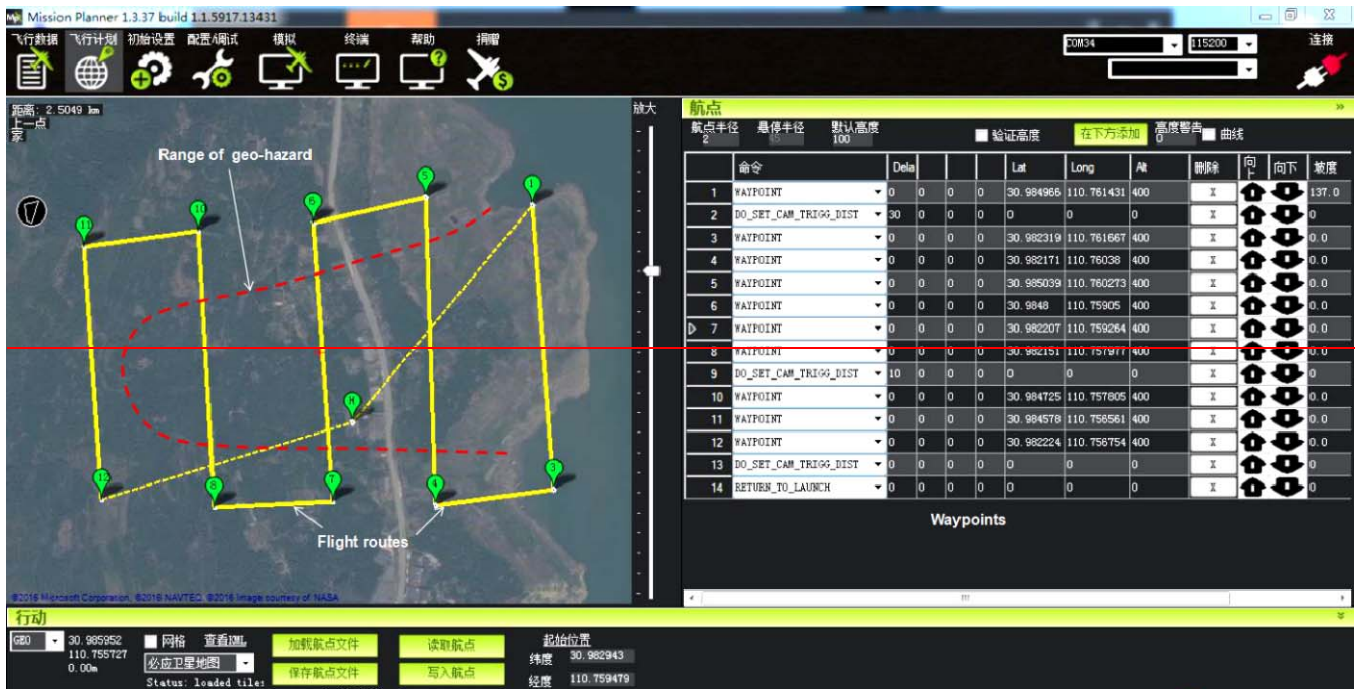
Fig.4. The planning of a route involving a typical regular grid pattern in plane view using Mission Planner software.

In addition, if the location of a geo-hazard can be determined, it is necessary to carry out preliminary route planning indoors based on publicly available satellite maps, e.g., Google Earth, Bing Maps, AutoNavi Maps, etc., in the Mission Planner software package. Typically, the preliminary flight routes are simply designed as a regular grid pattern in plane view that

175 covers the whole area affected by the geo-hazard (Fig. 4). In a word, preliminary route planning can help to save time spent  
on detailed route planning on-site. Of course, if the location cannot be determined in advance, the indoor preliminary route  
180 planning cannot be performed, but it does not affect the subsequent on-site investigation using the UAV.

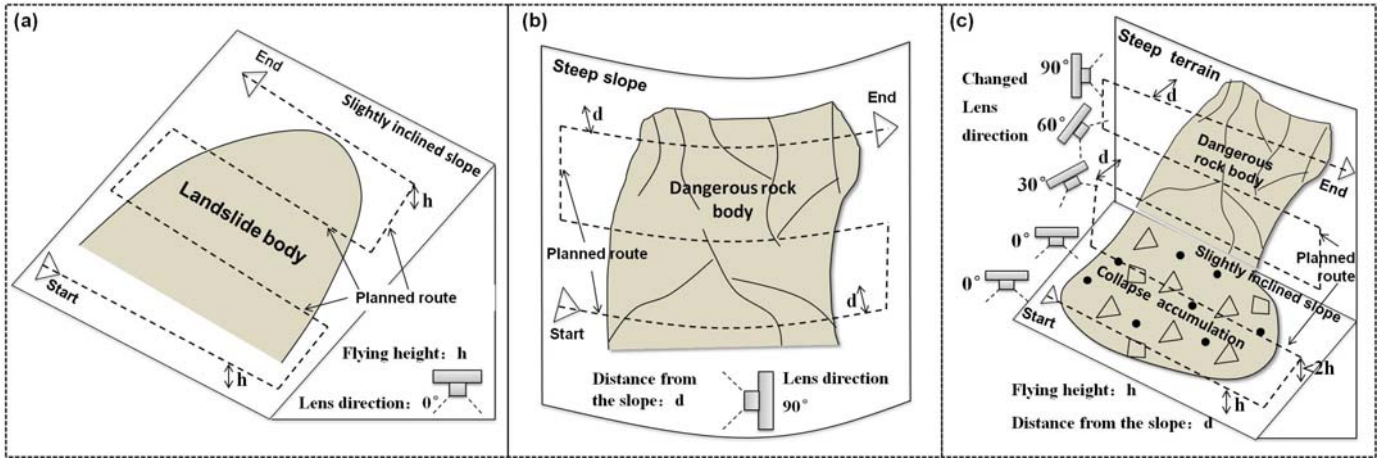
**Fig.5.** Three typical route types for UAV-based emergency investigation of single geo-hazards. (a) Planar grid pattern for slightly inclined slopes; (b) vertical grid pattern for steep slopes; (c) combined grid pattern for transitional terrain.

According to the characteristics of individual geo-hazards, proper route type selection and accurate motion design are key in ensuring the safety and efficiency of UAV-based emergency investigation. Based on a number of examples, three typical route types are summarized as follows (Fig. 5).

345 (1) Planar grid pattern for slightly inclined slopes (Fig. 5a). This pattern is suitable for geo-hazards that cover large areas (typically several million square metres) on the gentle slopes (typically less than 40 °), such as gently inclined landslide bodies. The primary purpose of the emergency investigation for this kind of disaster is to obtain a digital terrain model and

an orthophoto. Therefore, the planned route consists of a regular planar grid that covers the whole planar area of the geo-hazard. In addition, the camera lens always points vertically down to the ground (i.e., the lens orientation is held at  $0^\circ$ ). It is worth noting that the flying height of the route should be dynamically adjusted to meet the elevation changes of the disaster and slope. In principle, it is advisable to maintain the UAV's flying height at a constant distance (i.e., the  $h$  in Fig. 5a) from the ground, and practice shows that  $h$  in 50 m ~ 100 m is proper. Lower flights require longer routes and increased flight time, and flight safety decreases; conversely, higher flights increase the mean ground sampling distance (GSD) of the acquired images, thus providing for lower spatial resolution of the final photogrammetric products.

(2) Vertical grid pattern for steep slopes (Fig. 5b): This pattern is suitable for geo-hazards that are developed on steep slopes (typically greater than  $60^\circ$ ), such as dangerous rock masses on cliffs. Emergency investigations of this kind of disaster should aim at obtaining orthophotos of the facade and 3D models, rather than digital terrain and vertically downward orthophotos. In this case, the planned route consists of a regular vertical grid which that covers the whole facade area of the geo-hazard. In addition, the camera lens always points horizontally to the disaster body (i.e., lens orientation is held at  $90^\circ$ ). The plane positions of all of the horizontal routes can overlap, but they are at different altitudes. In addition, it is advisable to keep the UAV flying at a constant distance (i.e., the  $d$  in Fig. 5a) from the area affected by the disaster (practice shows that a  $d$  of 40 m ~ 80 m is proper).

(3) Combined grid pattern for transitional terrain (Fig. 5c): This pattern is suitable for geo-hazards that are located on transitional terrain and include both gentle and steep slopes, such as a dangerous rock mass on a cliff and the corresponding collapse accumulation mass on the gentle slope below. The main purposes of emergency investigation for this kind of disaster are to obtain a digital terrain model and an orthophoto, as well as a facade orthophoto and a 3D model. Therefore, the combined grid pattern should be adopted for the planned route. That is, a regular planar grid is used to cover areas with gentle slopes, and a vertical grid is used to cover areas with steep slopes. Accordingly, the camera lens points vertically down to the ground within the part with the planar grid (i.e., the lens orientation remains at  $0^\circ$ ), and gradually rises from the low position to the high position in the part with the vertical grid (i.e., the lens orientation changes from  $0^\circ$  to  $90^\circ$ ). The flying height  $h$  and flying distance  $d$  in Fig. 5c can be set as in the planar and vertical grid patterns, respectively.

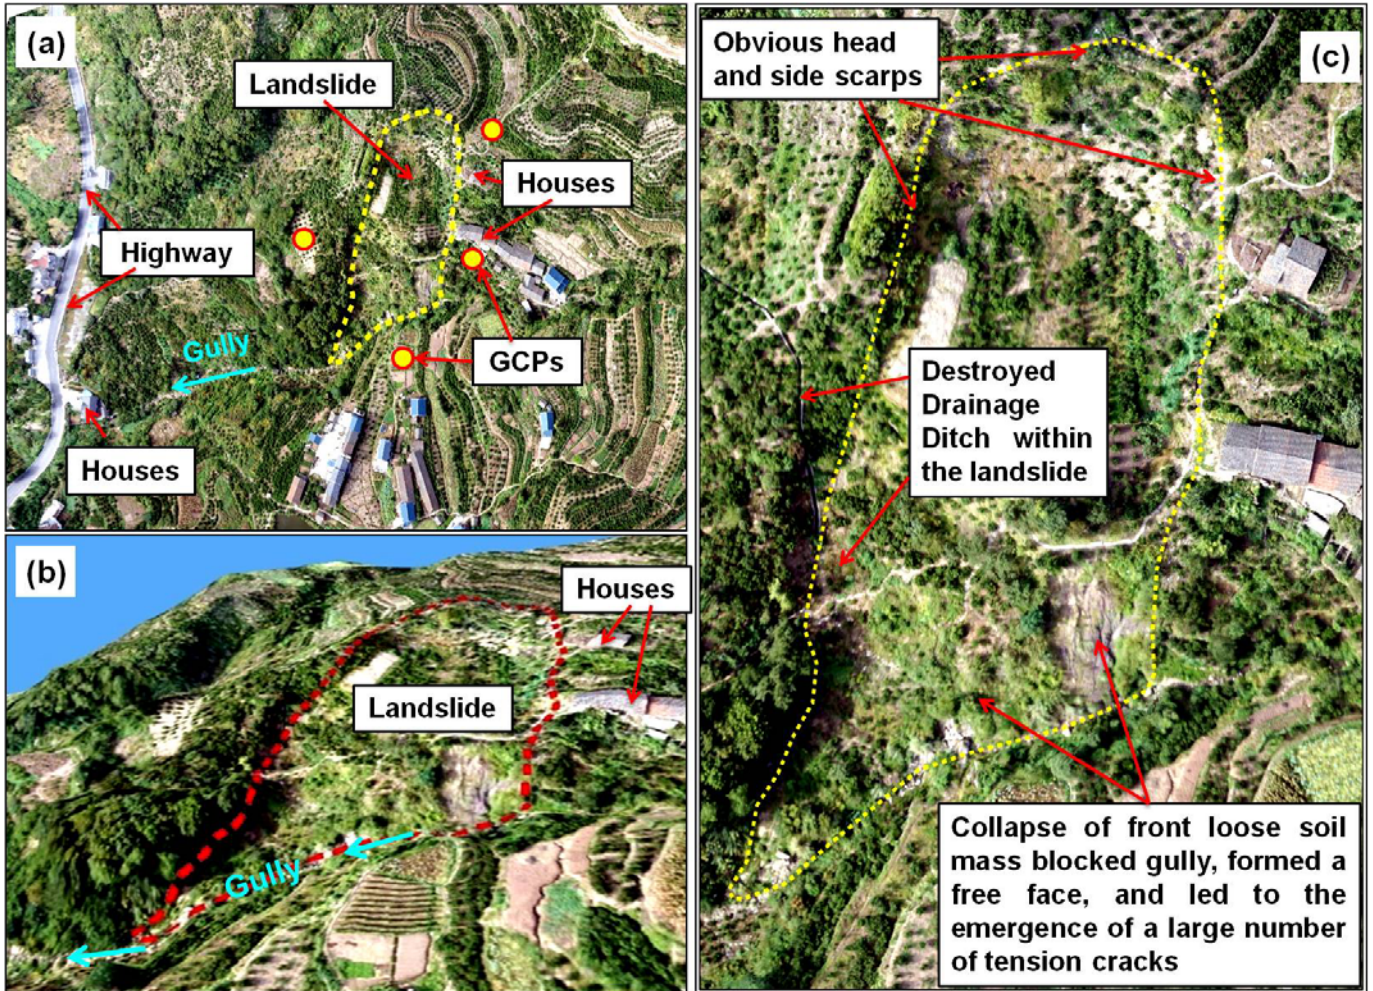
**Fig.6.** The results of a UAV-based emergency investigation of a slightly inclined landslide. (a) the digital orthophoto; (b) the 3D texture model; (c) interpretation of the destruction.

Based on the results of the above emergency investigation, combined with ground investigations, the characteristics and effects of the landslide were quickly interpreted (Fig. 6c) and evaluated. These products revealed the formation of obvious head and side scarps. Moreover, the drainage ditch that was located within the landslide was completely destroyed, and the front loose soil mass collapsed and blocked the gully, forming a free face and leading to the emergence of a large number of tension cracks. All of these indications suggested that the landslide represented an obvious mass movement, and that the landslide was in an unstable state. In addition, the landslide was a direct threat to the houses which were located adjacent to

455 the right boundary of the landslide. Moreover, as the loose soil mass at the front of the landslide continuously accumulated in  
the gully, a debris flow would be easily triggered by heavy rainfall, then seriously threatened the house and highway. Based  
on the conclusions above, emergency response measures were put forward, including using professional monitoring  
460 techniques such as GNSS, extensometers, rain gauges, and ground-based inspection to continuously track the process of  
deformation and induction of the landslide; establishing a citizen science-based monitoring and prevention system, which  
means to encourage the surrounding population to watch for signs of deformation within the landslide body, e.g., cracks,  
collapses, and cracks in houses, especially in association with heavy or continuous rainfall; and developing an emergency  
evacuation programme to ensure the orderly avoidance and reduction of losses before additional movement occurs.

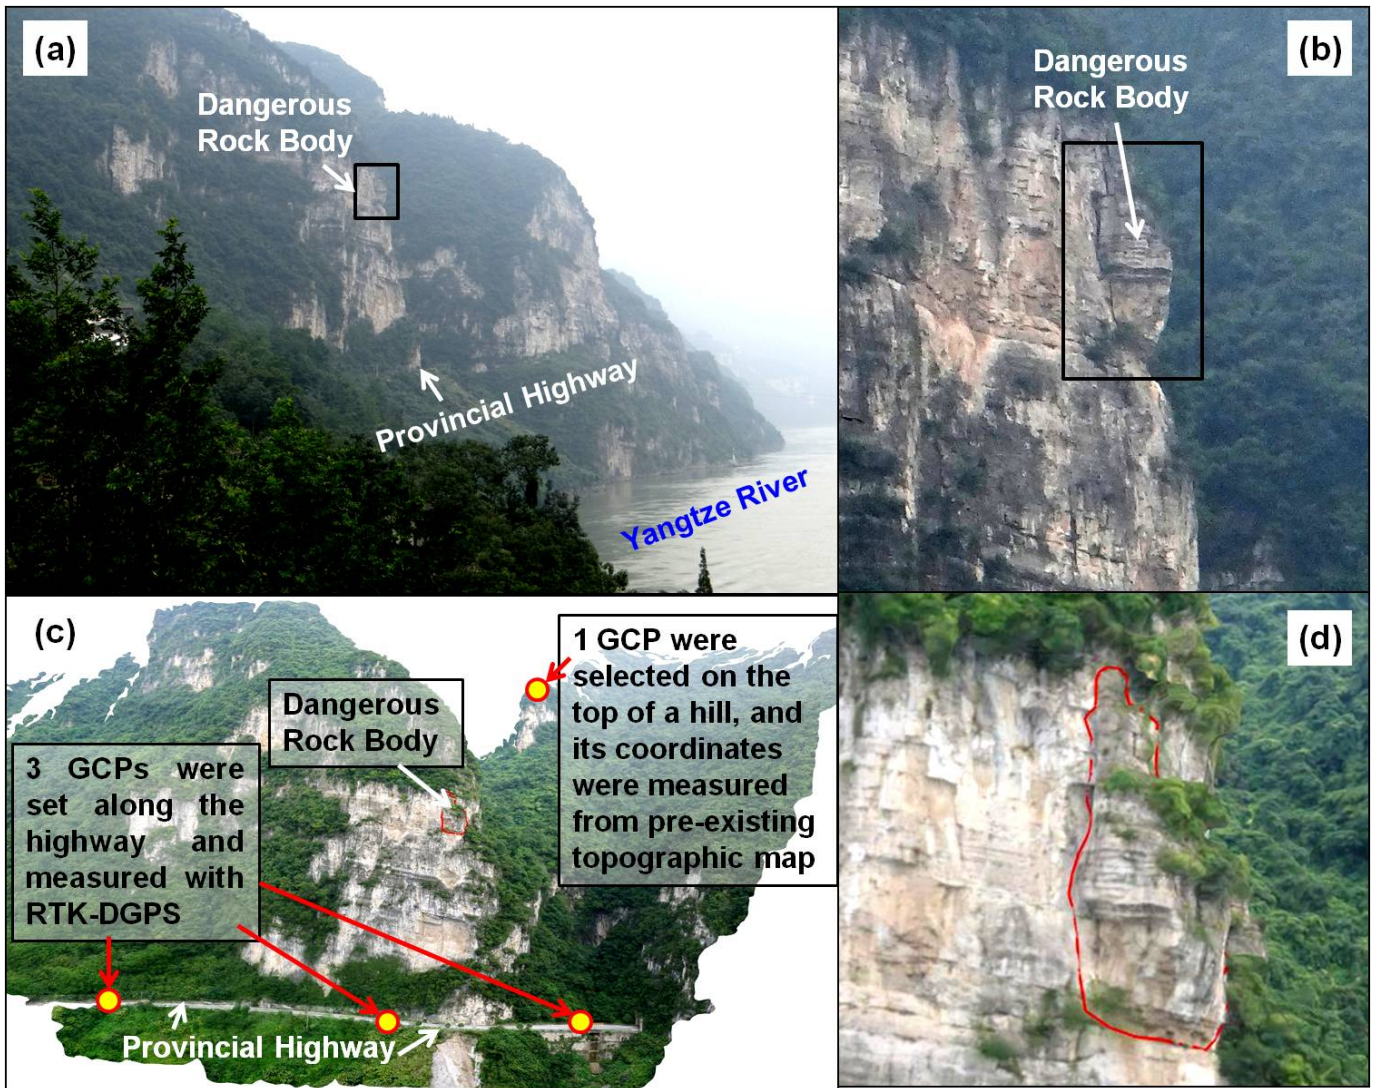
780 **Fig.7.** The results of a UAV-based emergency investigation for a dangerous rock mass on steep cliff. (a) Overview photo; (b)  
 right side photo of the dangerous rock mass; (c) 3D texture model of the whole scene; (d) 3D texture model of the dangerous  
 rock mass.

First, route planning was performed according to the pattern shown in Fig. 5b. At the same time, 3 GCPs were established  
along the highway and measured with the RTK-DGPS technique (Fig. 7c). In addition, it should be noted that, because the  
three GCPs were located in nearly a straight line, given the limited environment, which could not meet the processing  
475 requirements, another GCP was established on top of a hill behind the cliff (Fig. 7c), and its coordinates were measured  
according to the pre-existing topographic map. The layout and measurement of the 3 GCPs took only approximately 25  
minutes. The camera lens direction was then set at approximately  $45^\circ$  to the steep cliff. Through autonomous flight and  
automatic photo image collection, 104 photographs were captured, and the mean GSD of the original images was 4.92  
cm/pixel. Together with route planning and UAV preparation, the entire working time using the UAV took 35 minutes.

In view of the DSM and the 3D model, the results showed that the dangerous rock mass was 24 m high, 12 m wide, and 12 m thick and had a volume of 3456 m<sup>3</sup>, and its exact distance from the highway was 110 m. The lower and upper part of the rock mass had fallen, so it was completely unsupported. The left and right boundary cracks were fully connected. All of these signs indicated that the dangerous rock mass was in an unstable state. Therefore, the relevant emergency investigation results described above were submitted to the technical department to support the design of a detailed emergency response plan.

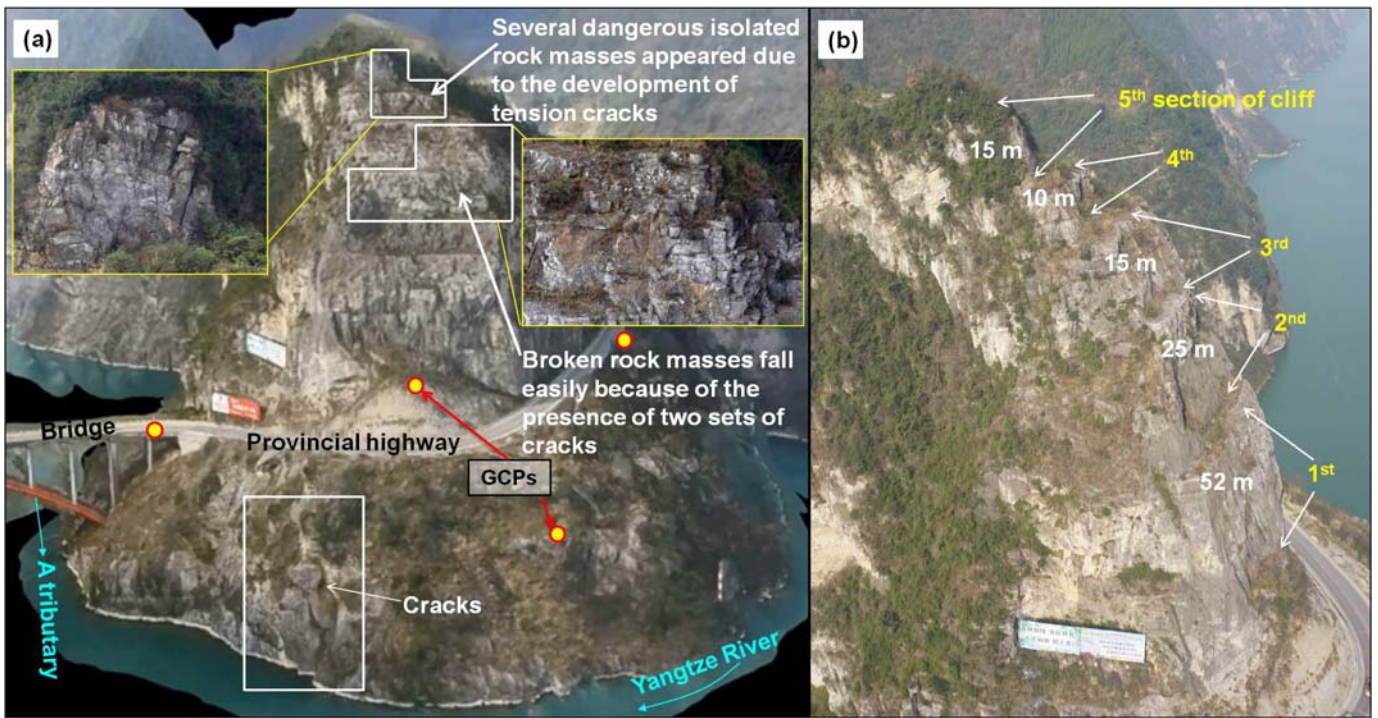
**Fig.8.** The results of a UAV-based emergency investigation for a combined slope on transitional terrain. (a) The 3D texture model and the identified potential geo-hazards; (b) the quantitative characteristics of the steep slope above the highway.

Based on all of the results, mainly the high-resolution 3D texture model, three potential geo-hazards were identified on this slope (Fig. 8). Above the highway, within the 4th section of the cliff and the left part of the 5th section of the cliff, several dangerous isolated rock masses had formed because of the continuous development of tension cracks. In the upper

525 part of the 2nd section of the cliff and the left part of the 3rd section of the cliff, a large number of broken rock masses that could fall easily had developed due to the continuous development of two sets of tension cracks. Below the highway, a tension crack existed on the right side of the slope. In addition, the detailed characteristics of each section of the cliff could be accurately measured (Fig. 8b). The relevant results from the emergency investigation were submitted to the relevant departments for risk assessment and the design of control measures.
