A method for using unmanned aerial vehicles for emergency investigation of single geo-hazards and sample applications of this method

Haifeng Huang^{1,2,3}, Jingjing Long^{2,3}, Wu Yi^{3,4}, Qinglin Yi^{3,4}, Guodong Zhang^{3,4}, Bangjun Lei¹

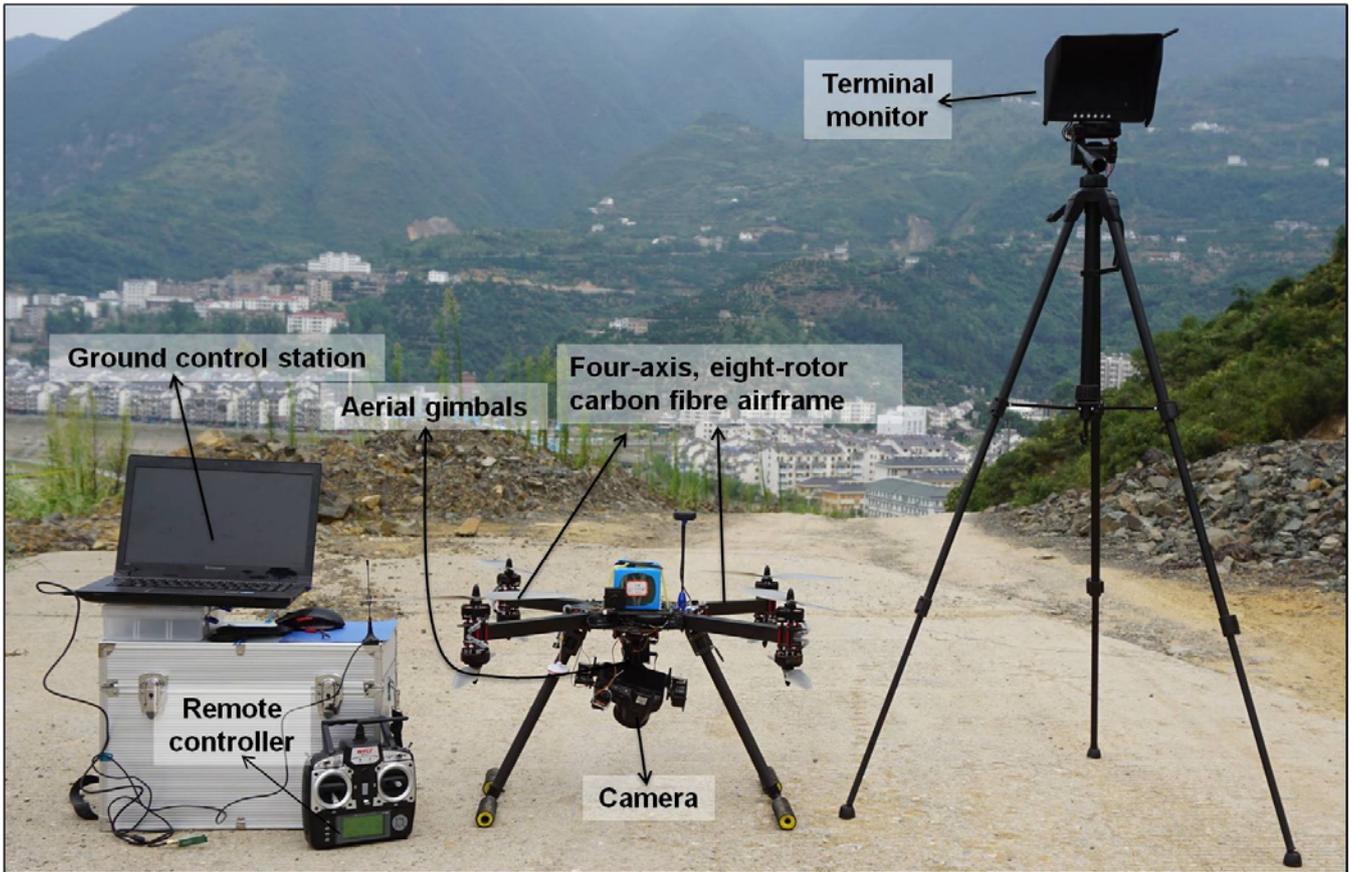
Fig.1. A photograph showing the customized UAV system used for emergency investigation of single geo-hazards in the Three Gorges Reservoir area, China.

- 670 **Fig. 1.** A photograph showing the customized UAV system used for emergency investigation of single geo-hazards in the Three Gorges Reservoir area, China.

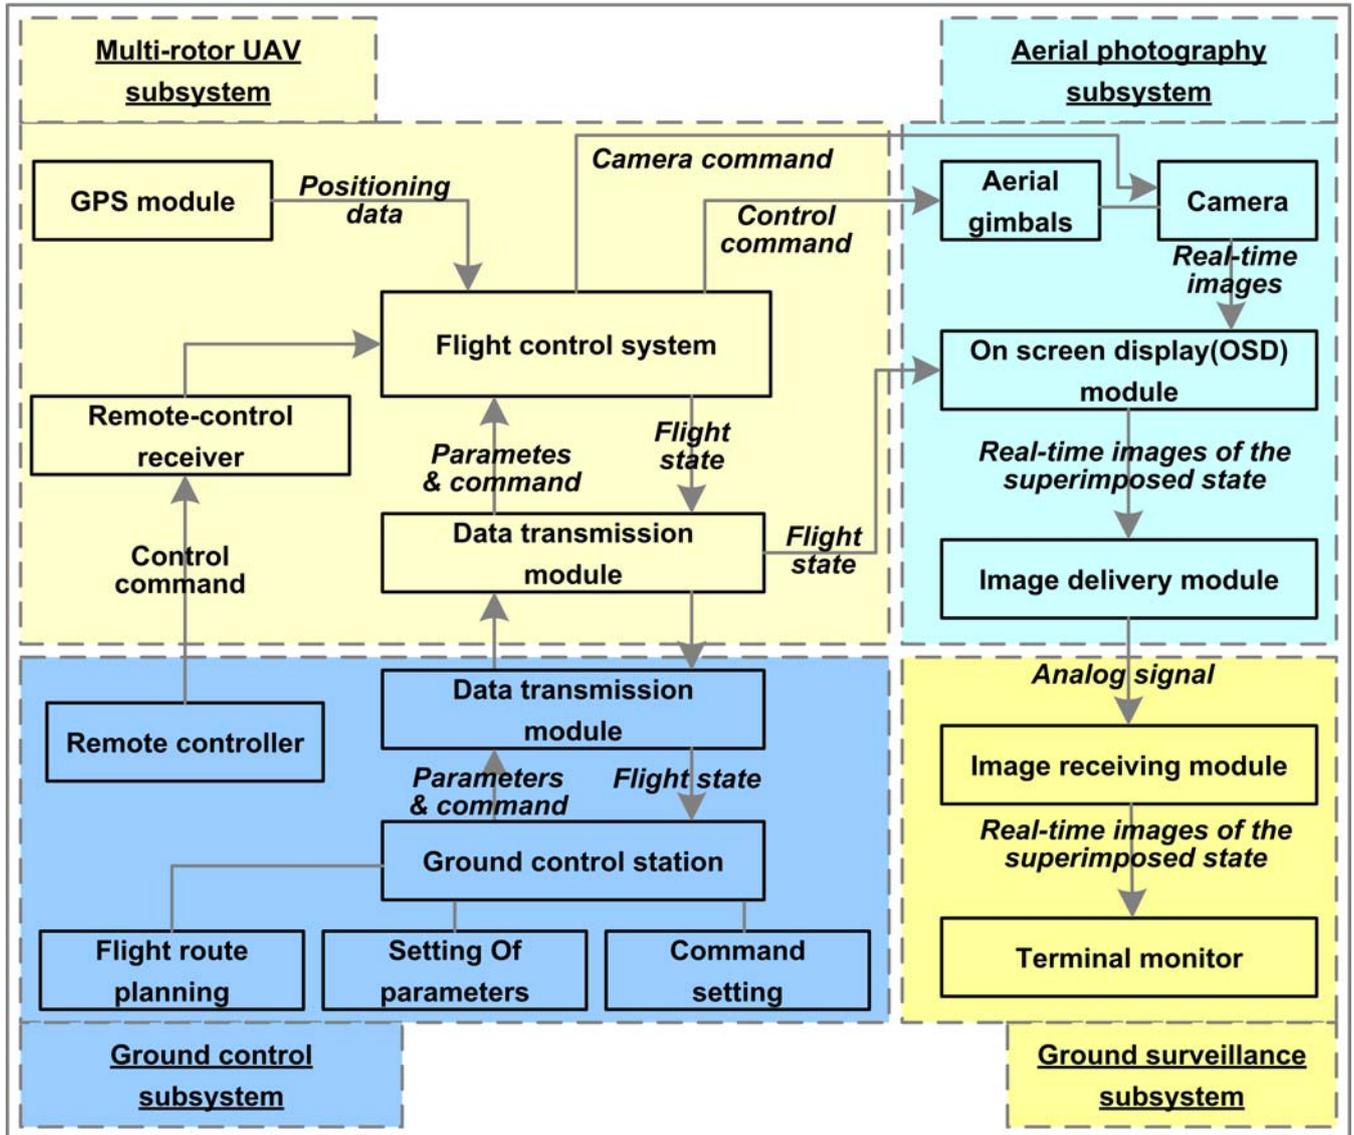
Fig.2. A diagram showing the architecture and main function modules of the customized UAV system.

- Fig.2.** A diagram showing the architecture and main function modules of the customized UAV system.
- 675 **Fig.3.** The process of using UAVs to emergency investigate single geo-hazards.

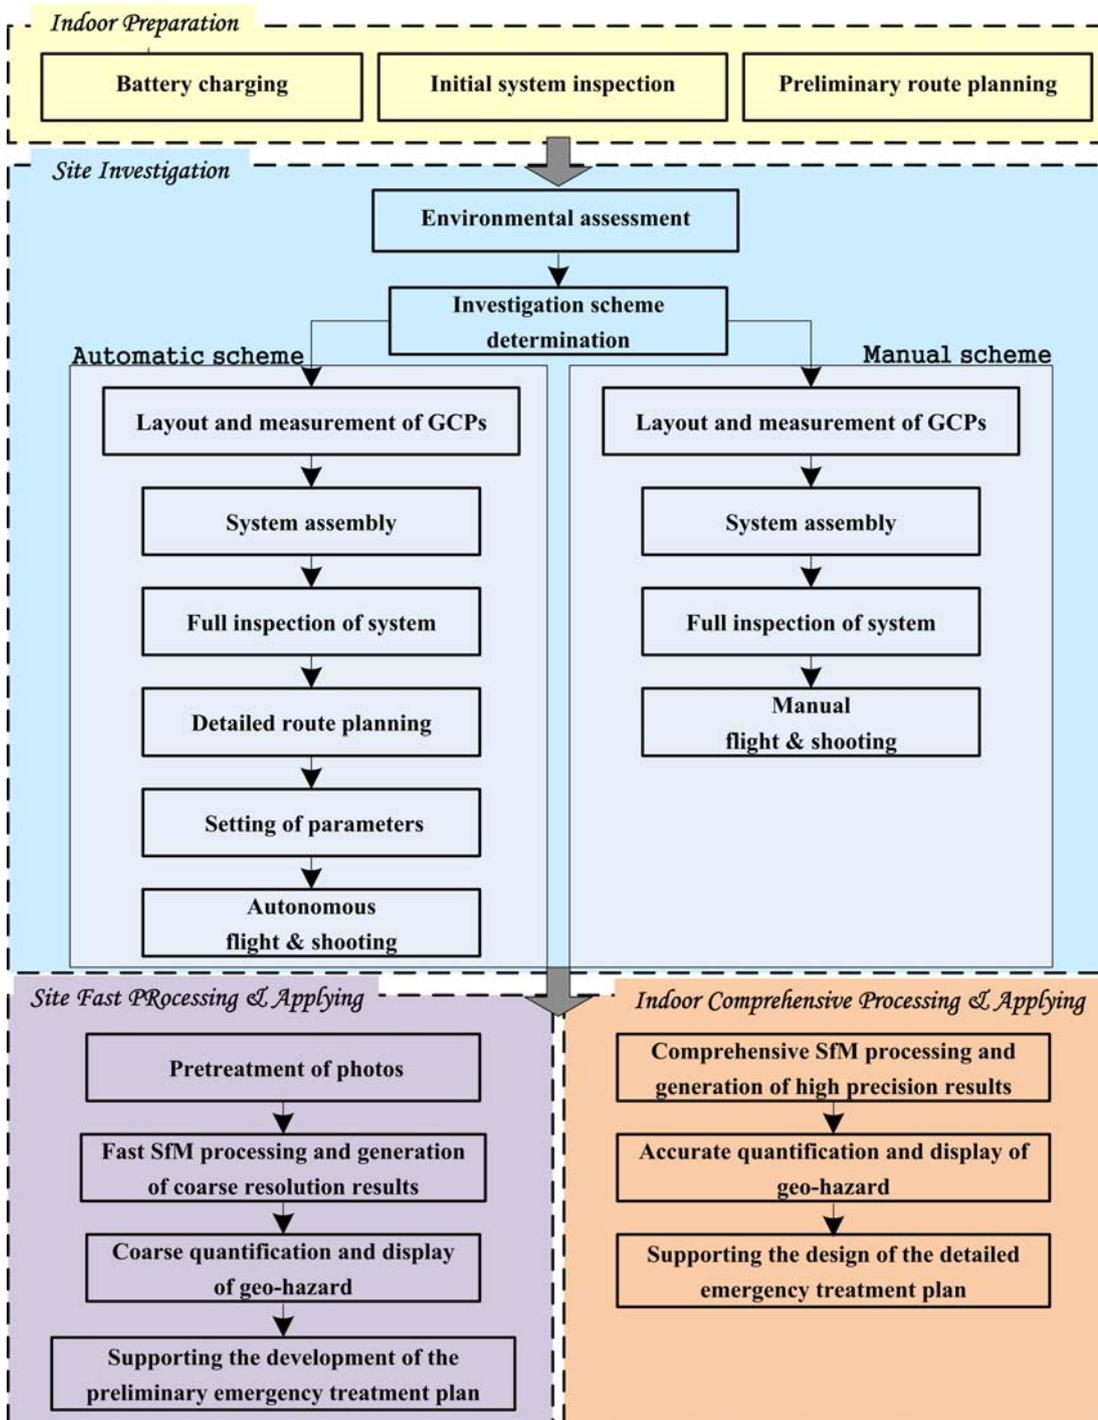
Fig.3. The process of using UAVs to emergency investigate single geo-hazards.

Using the automatic scheme, the UAV system is capable of autonomous flight in accordance with the routes established
during detailed planning, as well as automatic photo image collection, using the UAV's own GNSS, compass and barometer.
This scheme requires no manual intervention under normal conditions and is therefore safer and more reliable than manual
200 methods. At the same time, the acquisition of high quality photographs is more likely in this mode, which can automatically
meet some requirements of the subsequent photogrammetric processing, e.g., the frontal and side overlap ratios between
photographs. In view of this, as long as there are more than five stable GNSS satellite signals in the geo-hazard area, the vast
majority of emergency investigations should use the automatic investigation scheme. In addition, this scheme is divided into
six steps (Fig. 3), which are described below.

In the manual scheme, the entire UAV flight and the process of photo image collection has to be manually controlled using the remote control. This scheme requires no route planning, which can save time in site investigation. However, it requires excellent piloting skills, and the flight safety and image quality are frequently degraded; accordingly, the flight process should be monitored intensively. Therefore, use of the manual scheme should be avoided, although, in some places, such as mountainous areas or canyons, where the GNSS signals are unstable or even absent, or the scope of the geo-hazard is extremely limited, the manual scheme may be more suitable. In addition, this scheme is divided into 4 steps (Fig. 3), which are briefly described below.

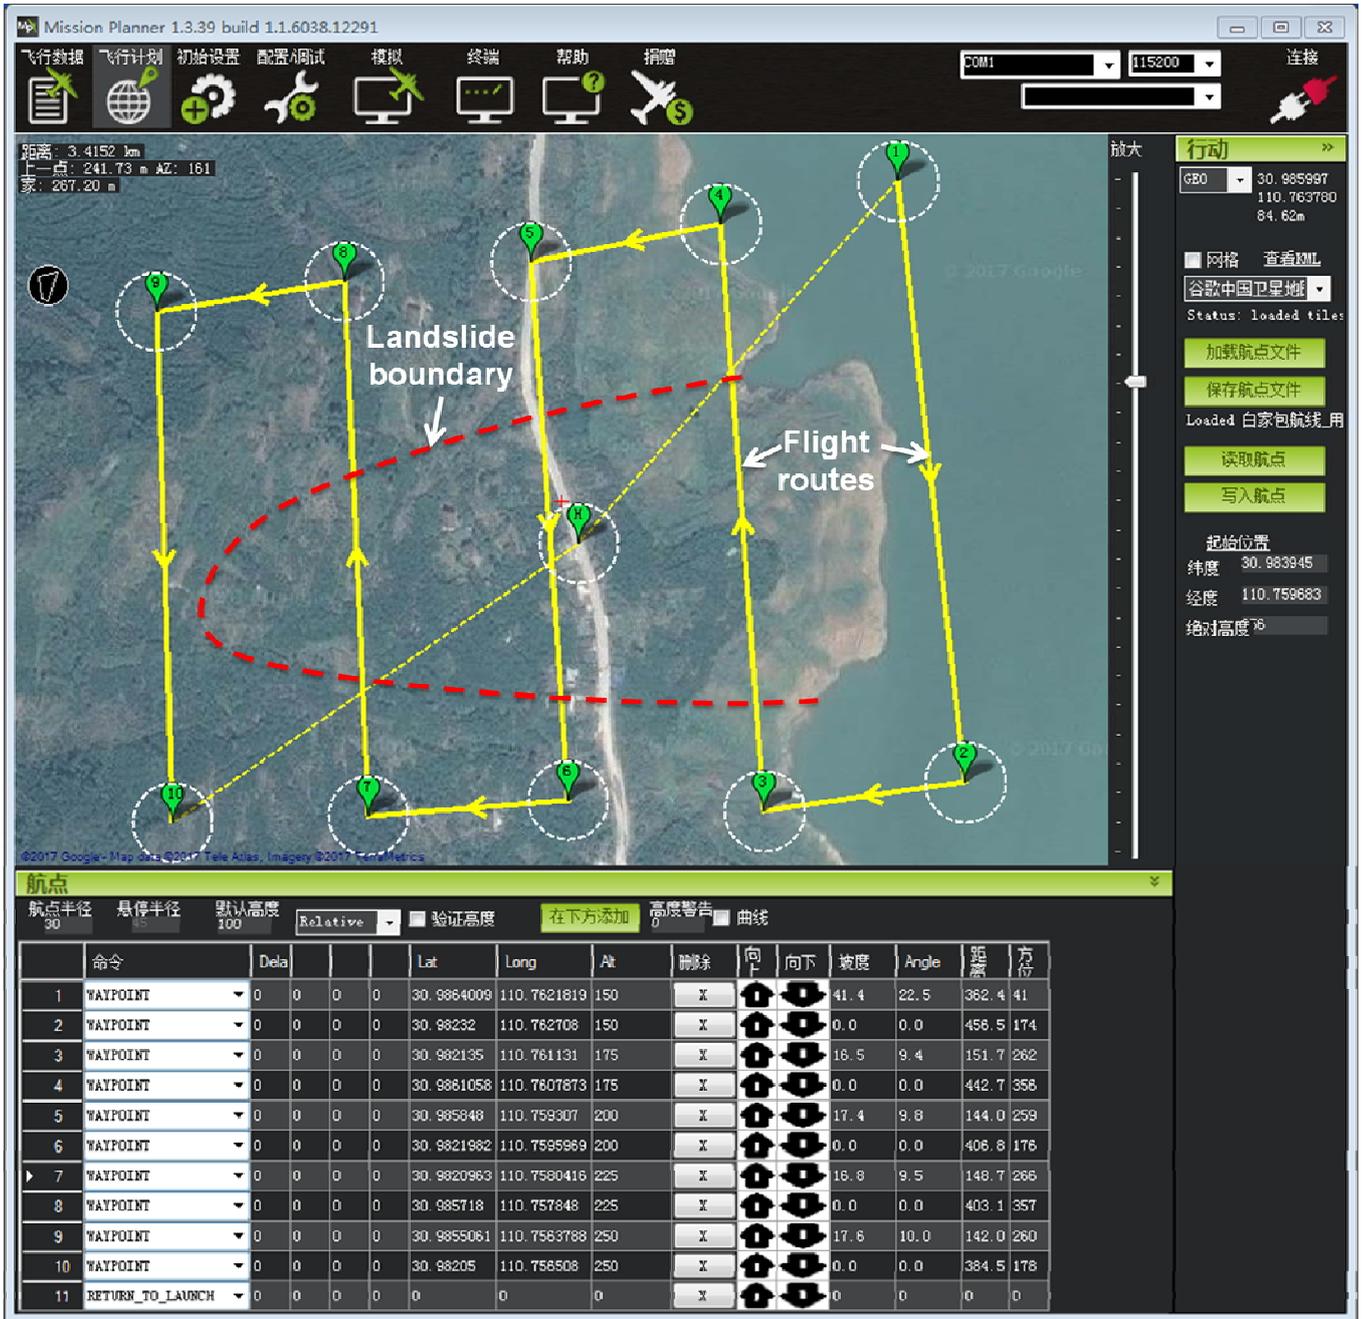
755 Fig.4. The planning of a route involving a typical regular grid pattern in plane view using Mission Planner software.

In addition, if the location of a geo-hazard can be determined, it is necessary to carry out preliminary route planning indoors based on publicly available satellite maps, e.g., Google Earth, Bing Maps, AutoNavi Maps, etc., in the Mission Planner software package. Typically, the preliminary flight routes are simply designed as a regular grid pattern in plane view that

175 covers the whole area affected by the geo-hazard (Fig. 4). In a word, preliminary route planning can help to save time spent
on detailed route planning on-site. Of course, if the location cannot be determined in advance, the indoor preliminary route
180 planning cannot be performed, but it does not affect the subsequent on-site investigation using the UAV.

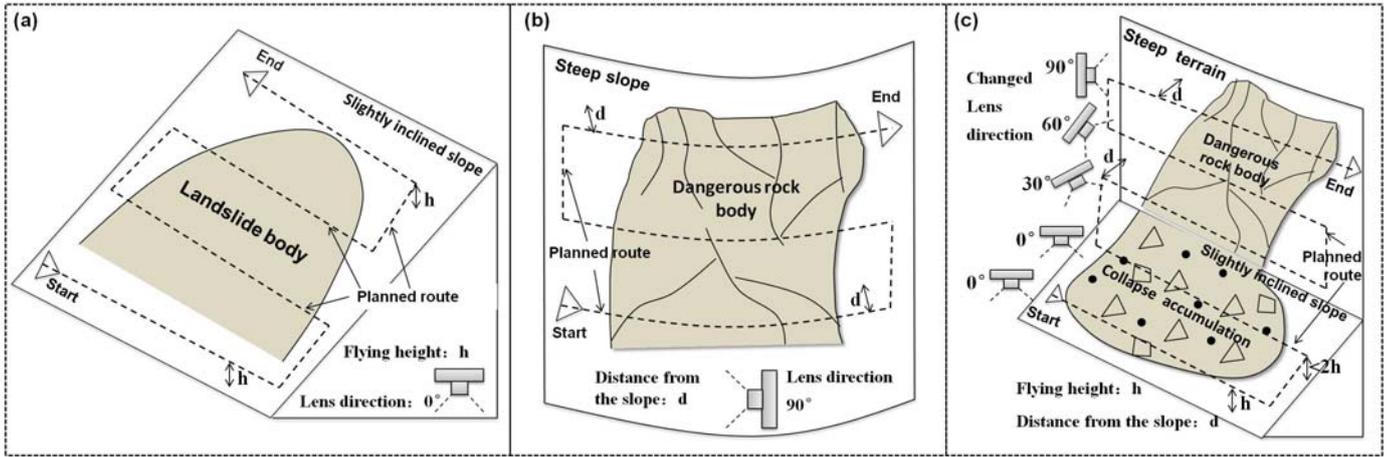
760 **Fig.5.** Three typical route types for UAV-based emergency investigation of single geo-hazards. (a) Planar grid pattern for slightly inclined slopes; (b) vertical grid pattern for steep slopes; (c) combined grid pattern for transitional terrain.

According to the characteristics of individual geo-hazards, proper route type selection and accurate motion design are key in ensuring the safety and efficiency of UAV-based emergency investigation. Based on a number of examples, three typical route types are summarized as follows (Fig. 5).

(1) Planar grid pattern for slightly inclined slopes (Fig. 5a). This pattern is suitable for geo-hazards that cover large areas (typically several million square metres) on the gentle slopes (typically less than 40°), such as gently inclined landslide bodies. The primary purpose of the emergency investigation for this kind of disaster is to obtain a digital terrain model and

an orthophoto. Therefore, the planned route consists of a regular planar grid that covers the whole planar area of the geo-hazard. In addition, the camera lens always points vertically down to the ground (i.e., the lens orientation is held at 0°). It is worth noting that the flying height of the route should be dynamically adjusted to meet the elevation changes of the disaster and slope. In principle, it is advisable to maintain the UAV's flying height at a constant distance (i.e., the h in Fig. 5a) from the ground, and practice shows that h in 50 m ~ 100 m is proper. Lower flights require longer routes and increased flight time, and flight safety decreases; conversely, higher flights increase the mean ground sampling distance (GSD) of the acquired images, thus providing for lower spatial resolution of the final photogrammetric products.

(2) Vertical grid pattern for steep slopes (Fig. 5b): This pattern is suitable for geo-hazards that are developed on steep slopes (typically greater than 60°), such as dangerous rock masses on cliffs. Emergency investigations of this kind of disaster should aim at obtaining orthophotos of the facade and 3D models, rather than digital terrain and vertically downward orthophotos. In this case, the planned route consists of a regular vertical grid which that covers the whole facade area of the geo-hazard. In addition, the camera lens always points horizontally to the disaster body (i.e., lens orientation is held at 90°). The plane positions of all of the horizontal routes can overlap, but they are at different altitudes. In addition, it is advisable to keep the UAV flying at a constant distance (i.e., the d in Fig. 5a) from the area affected by the disaster (practice shows that a d of 40 m ~ 80 m is proper).

(3) Combined grid pattern for transitional terrain (Fig. 5c): This pattern is suitable for geo-hazards that are located on transitional terrain and include both gentle and steep slopes, such as a dangerous rock mass on a cliff and the corresponding collapse accumulation mass on the gentle slope below. The main purposes of emergency investigation for this kind of disaster are to obtain a digital terrain model and an orthophoto, as well as a facade orthophoto and a 3D model. Therefore, the combined grid pattern should be adopted for the planned route. That is, a regular planar grid is used to cover areas with gentle slopes, and a vertical grid is used to cover areas with steep slopes. Accordingly, the camera lens points vertically down to the ground within the part with the planar grid (i.e., the lens orientation remains at 0°), and gradually rises from the low position to the high position in the part with the vertical grid (i.e., the lens orientation changes from 0° to 90°). The flying height h and flying distance d in Fig. 5c can be set as in the planar and vertical grid patterns, respectively.

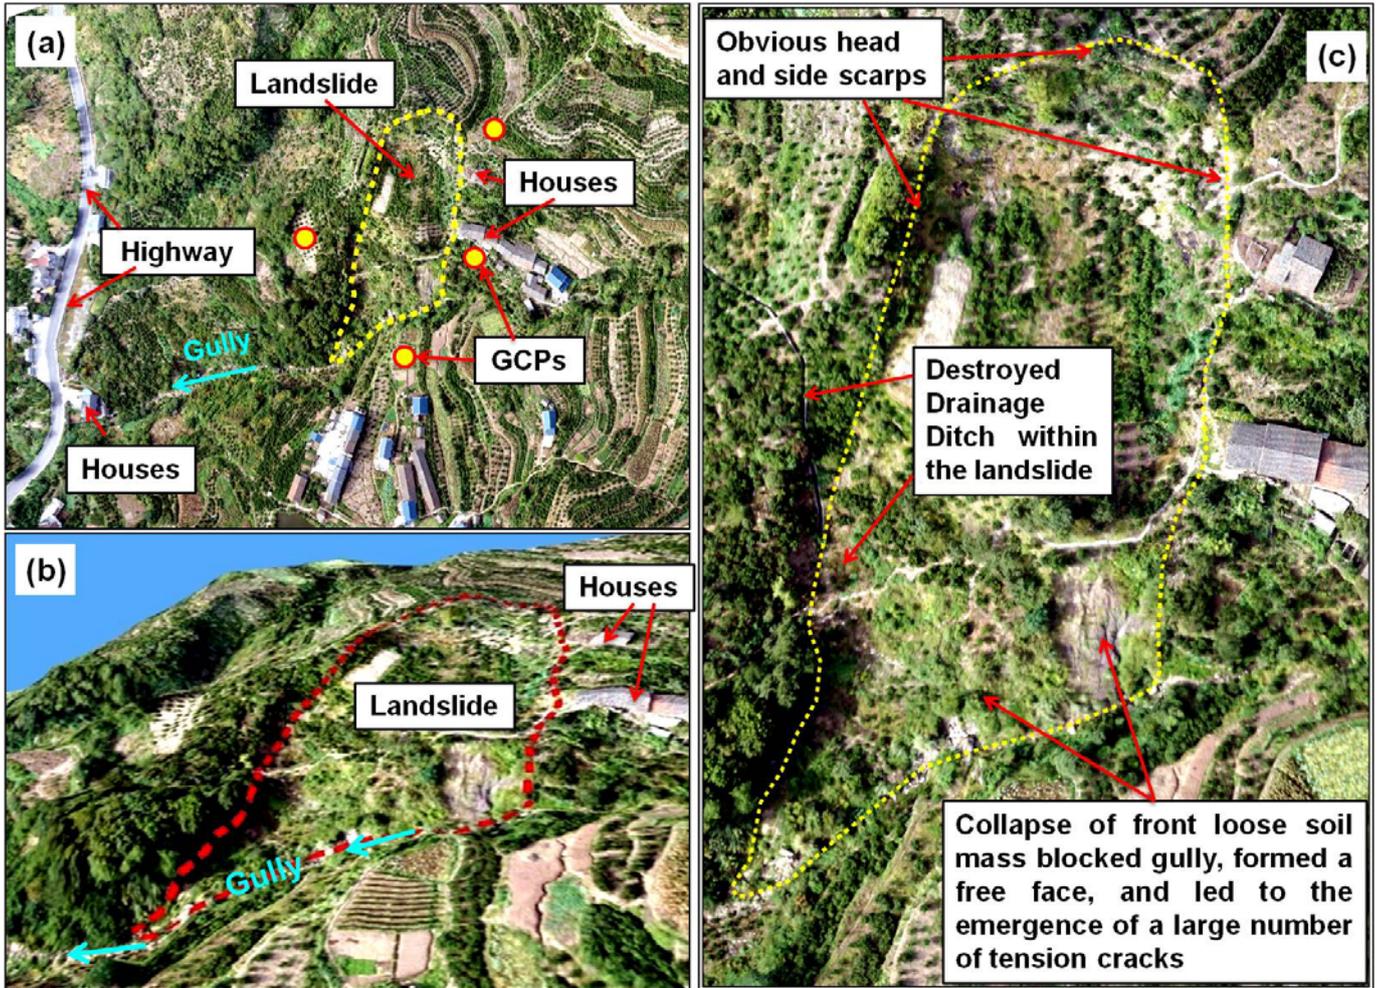
Fig.6. The results of a UAV-based emergency investigation of a slightly inclined landslide. (a) the digital orthophoto; (b) the 3D texture model; (c) interpretation of the destruction.

Based on the results of the above emergency investigation, combined with ground investigations, the characteristics and effects of the landslide were quickly interpreted (Fig. 6c) and evaluated. These products revealed the formation of obvious head and side scarps. Moreover, the drainage ditch that was located within the landslide was completely destroyed, and the front loose soil mass collapsed and blocked the gully, forming a free face and leading to the emergence of a large number of tension cracks. All of these indications suggested that the landslide represented an obvious mass movement, and that the landslide was in an unstable state. In addition, the landslide was a direct threat to the houses which were located adjacent to

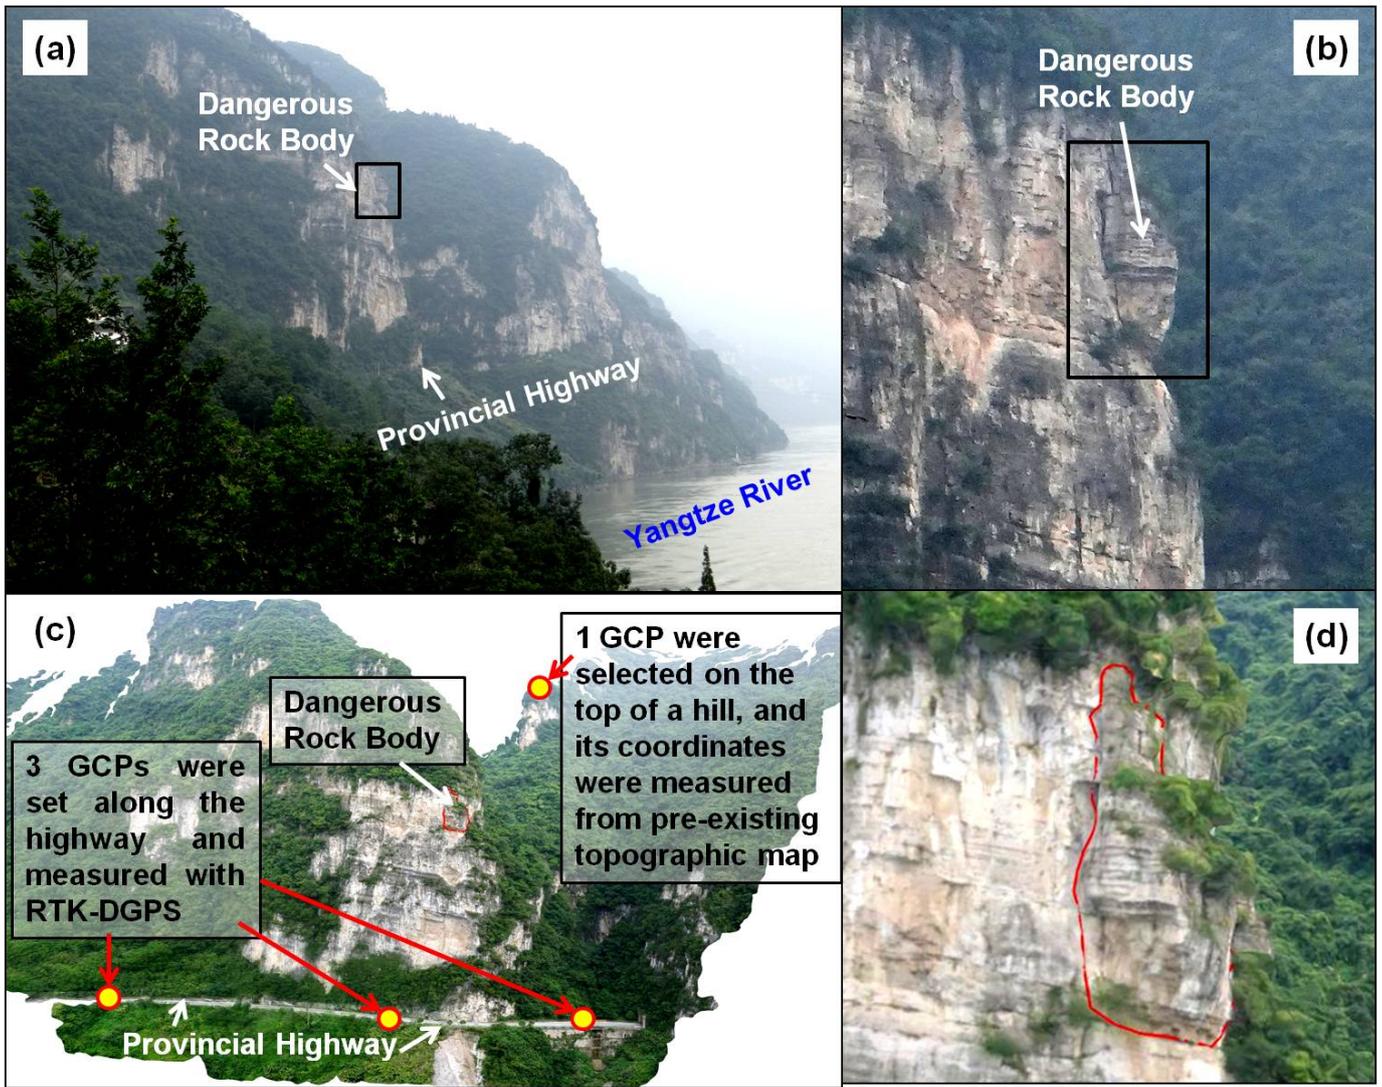
Fig.7. The results of a UAV-based emergency investigation for a dangerous rock mass on steep cliff. (a) Overview photo; (b) right side photo of the dangerous rock mass; (c) 3D texture model of the whole scene; (d) 3D texture model of the dangerous rock mass.

First, route planning was performed according to the pattern shown in Fig. 5b. At the same time, 3 GCPs were established
along the highway and measured with the RTK-DGPS technique (Fig. 7c). In addition, it should be noted that, because the
three GCPs were located in nearly a straight line, given the limited environment, which could not meet the processing
475 requirements, another GCP was established on top of a hill behind the cliff (Fig. 7c), and its coordinates were measured
according to the pre-existing topographic map. The layout and measurement of the 3 GCPs took only approximately 25
minutes. The camera lens direction was then set at approximately 45 ° to the steep cliff. Through autonomous flight and
automatic photo image collection, 104 photographs were captured, and the mean GSD of the original images was 4.92
cm/pixel. Together with route planning and UAV preparation, the entire working time using the UAV took 35 minutes.

In view of the DSM and the 3D model, the results showed that the dangerous rock mass was 24 m high, 12 m wide, and 12 m thick and had a volume of 3456 m³, and its exact distance from the highway was 110 m. The lower and upper part of the rock mass had fallen, so it was completely unsupported. The left and right boundary cracks were fully connected. All of these signs indicated that the dangerous rock mass was in an unstable state. Therefore, the relevant emergency investigation results described above were submitted to the technical department to support the design of a detailed emergency response plan.

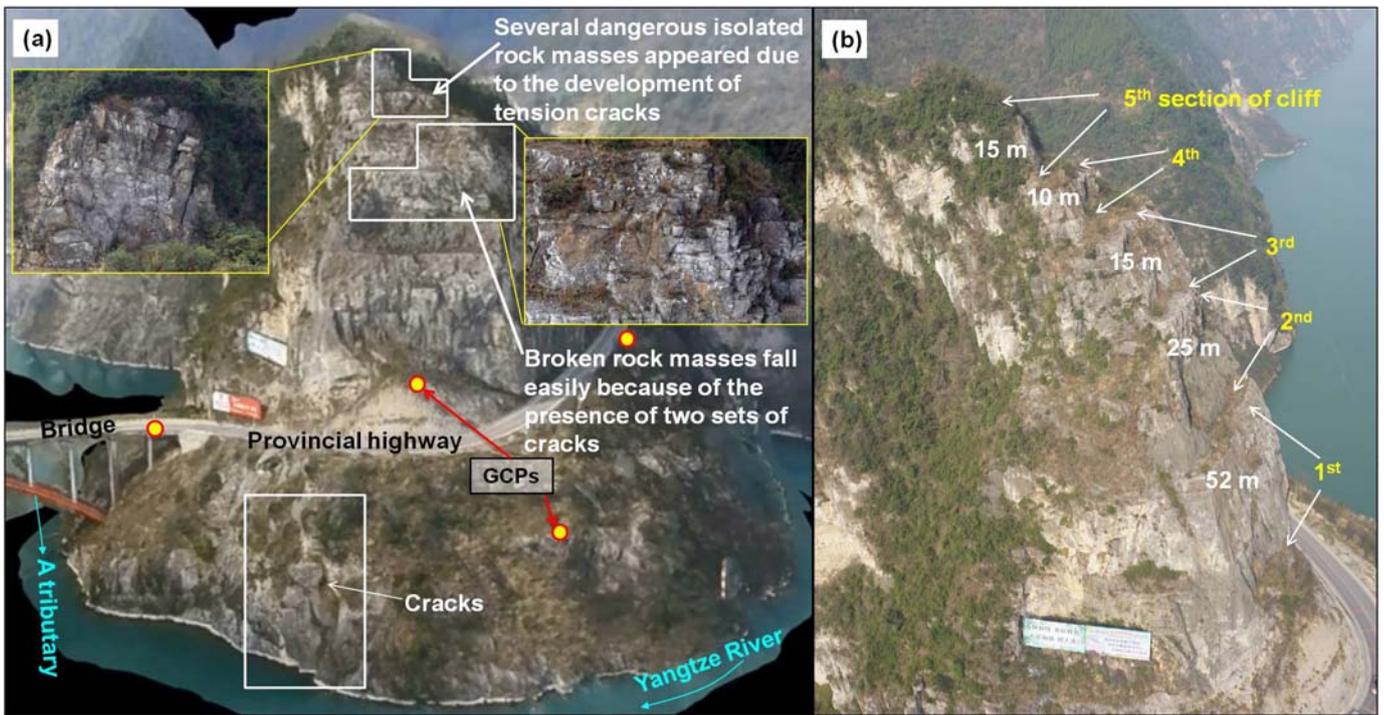
Fig.8. The results of a UAV-based emergency investigation for a combined slope on transitional terrain. (a) The 3D texture model and the identified potential geo-hazards; (b) the quantitative characteristics of the steep slope above the highway.

Based on all of the results, mainly the high-resolution 3D texture model, three potential geo-hazards were identified on this slope (Fig. 8). Above the highway, within the 4th section of the cliff and the left part of the 5th section of the cliff, several dangerous isolated rock masses had formed because of the continuous development of tension cracks. In the upper

525 part of the 2nd section of the cliff and the left part of the 3rd section of the cliff, a large number of broken rock masses that
could fall easily had developed due to the continuous development of two sets of tension cracks. Below the highway, a
530 tension crack existed on the right side of the slope. In addition, the detailed characteristics of each section of the cliff could
be accurately measured (Fig. 8b). The relevant results from the emergency investigation were submitted to the relevant
departments for risk assessment and the design of control measures.

- 685 **Fig.8.** The results of a UAV-based emergency investigation for a combined slope on transitional terrain. (a) The 3D texture model and the identified potential geo-hazards; (b) the quantitative characteristics of the steep slope above the highway.
