# A method for using unmanned aerial vehicles for emergency investigation of single geo-hazards and sample applications of this method

**Keywords.** single geo-hazard; landslide; emergency investigation; unmanned aerial vehicle (UAV); emergency response

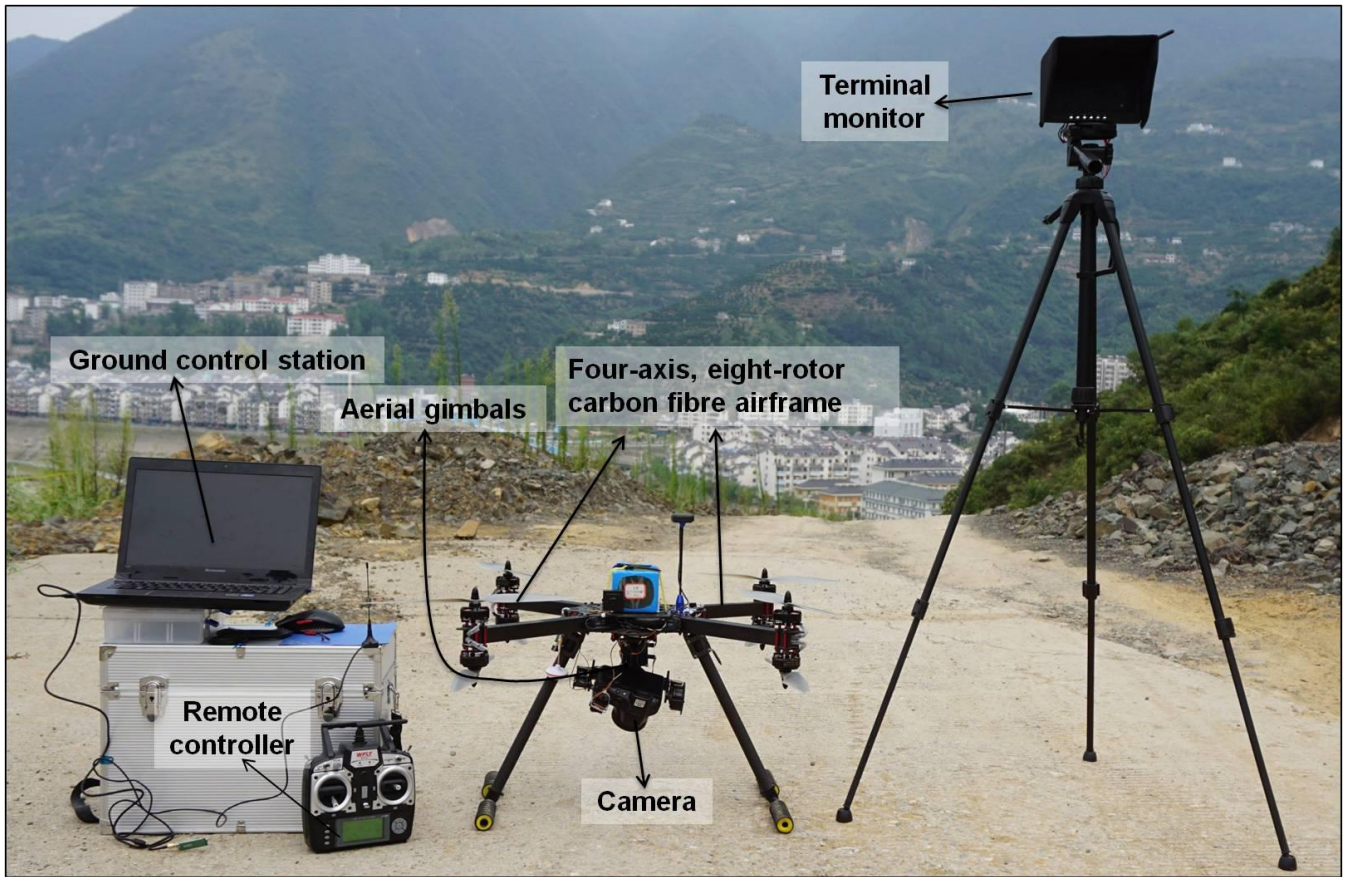
**Fig.1.** A photograph showing the customized UAV system used for emergency investigation of single geo-hazards in the Three Gorges Reservoir area, China.

(1) A customized four-axis and eight-rotor carbon fibre airframe is used. The outstanding advantages of this design include

105 its high strength and power and light weight (the whole aircraft with its camera and the aerial gimbal system is less than 5  
kg). In addition, compared with fixed wing aircraft, it is smaller, has better manoeuvrability and enhanced fixed-point  
110 hovering capability. In particular, special sites for taking off and landing are not required, which is very important for using  
UAVs to quickly investigate single geo-hazards, which are usually located in complex environments. Although the battery  
life is poor (it provides approximately 20 minutes of flight time), if an average flight speed of 5 m/s is considered, the  
resulting flight distance of approximately 5 km guarantees that one flight is sufficient to cover the whole area of most single  
geo-hazards. Even if multiple flights are required, only the battery needs to be replaced.

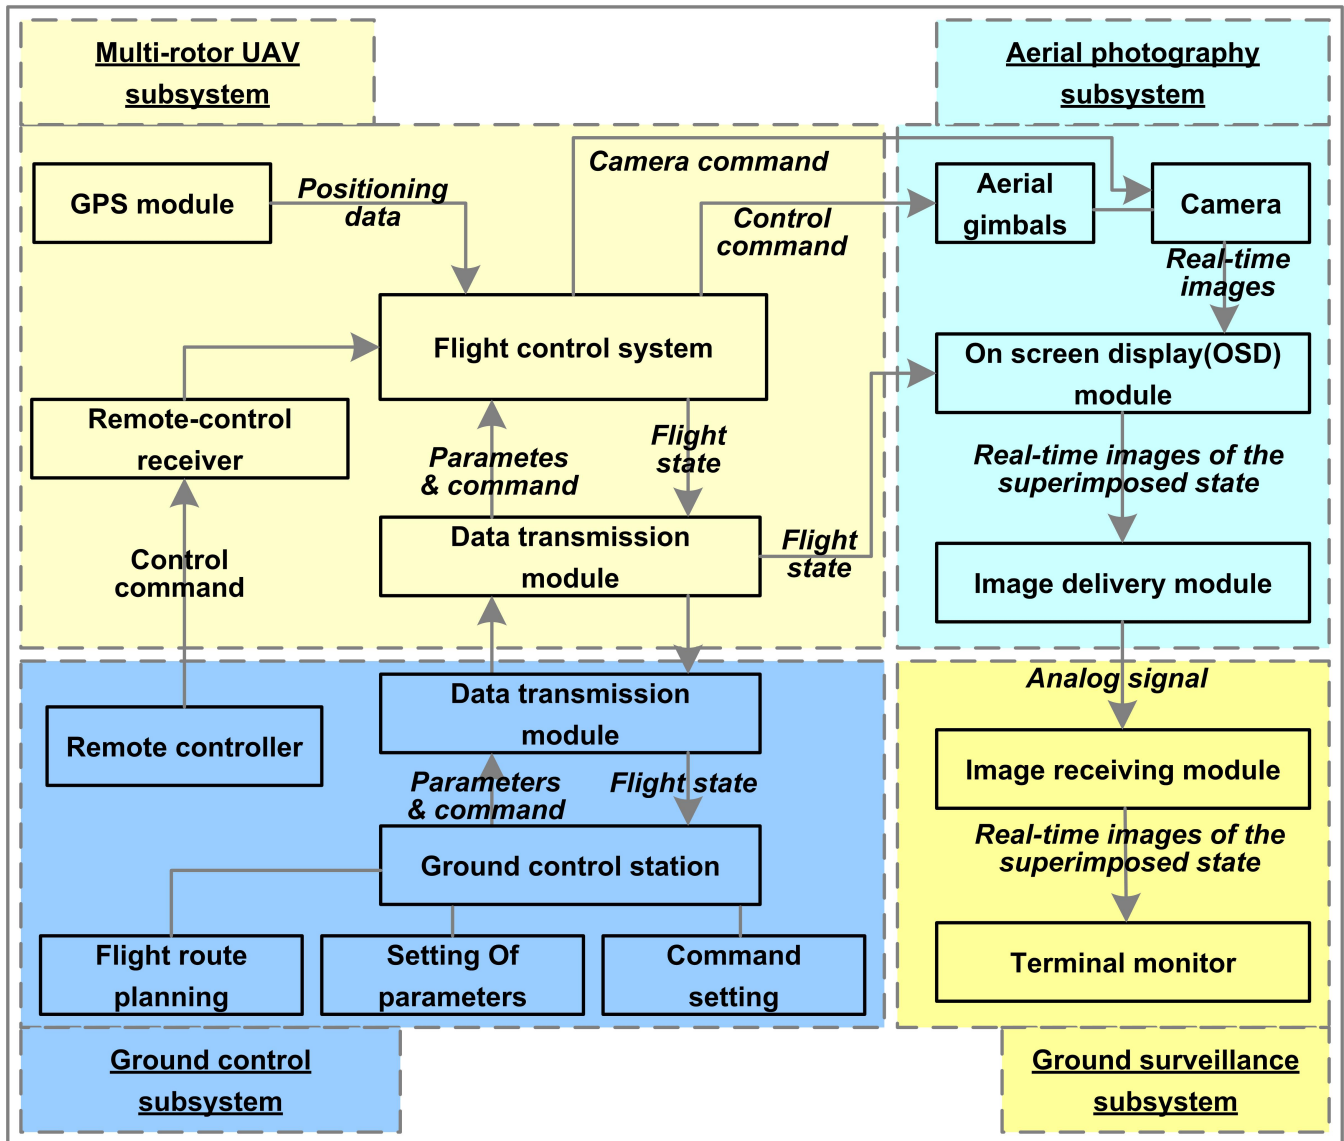
Fig.2. A diagram showing the architecture and main function modules of the customized UAV system.

(2) The flight control system, which directly controls the processes of flight and image collection, is the "brain" of the  
UAV system, and its performance and stability directly determine the functioning and the security of the whole system.  
Currently, many mature commercial flight control systems exist; however, they are closed-source systems. Thus, in the event  
115 of failure, the unit must be returned to the factory for repair or re-purchased, resulting in high costs in money and time.  
Therefore, a widely used open source flight control system, i.e., Pixhawk 2.4.5 (Meier et al., 2012) that has dual processors,  
is used. The high robustness and powerful data processing capacity of this unit have been recognized. Equipped with a  
high-performance Global Navigation Satellite System (GNSS) module, data and image transmission modules, etc., this flight  
control system provides complete support for several necessary functions, such as route planning, flight positioning,

(3) The aerial photography subsystem, which is used to collect overhead or oblique high-resolution images of geo-hazards,  
serves as the core data source of the emergency investigation information. Thanks to the rapid development of tools for  
semi-automated photogrammetric processing, especially Structure from Motion (SfM) photogrammetry (Westoby et al.,  
2012; Li et al., 2013; Förstner and Wrobel, 2016; Özyeşil et al., 2017), which is based on computer vision algorithms, the  
125 requirements of early aerial photography equipment have been greatly reduced. Therefore, only a Sony HX200 digital  
camera with 18 effective megapixels and a Vario Sonnar T\* 4.8-144 mm F/2.8–5.6 lens is used to take the photographs. In  
addition, in order to keep the camera stable to ensure the collection of clear images or accurately adjust the lens orientation  
according to actual needs, a three-axis brushless aerial gimbal system is used to carry the camera. The camera shutter and the

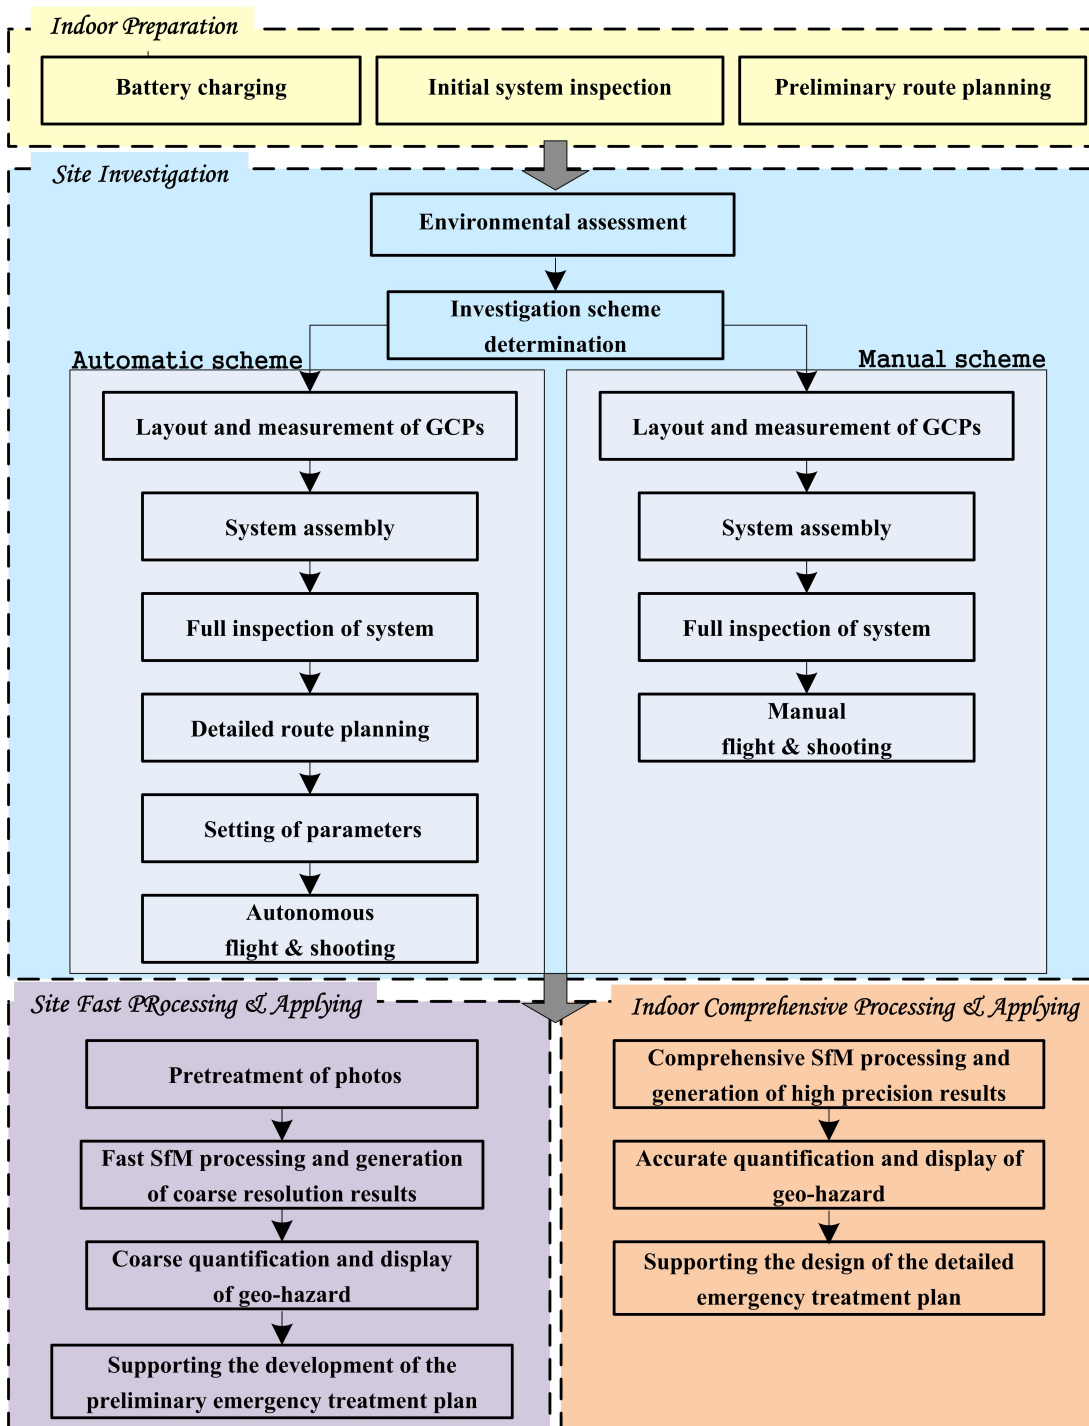
Fig.3. The process of using UAVs to emergency investigate single geo-hazards.

Using the automatic scheme, the UAV system is capable of autonomous flight in accordance with the routes established  
during detailed planning, as well as automatic photo image collection, using the UAV's own GNSS, compass and barometer.  
This scheme requires no manual intervention under normal conditions and is therefore safer and more reliable than manual  
200 methods. At the same time, the acquisition of high quality photographs is more likely in this mode, which can automatically  
meet some requirements of the subsequent photogrammetric processing, e.g., the frontal and side overlap ratios between  
photographs. In view of this, as long as there are more than five stable GNSS satellite signals in the geo-hazard area, the vast  
majority of emergency investigations should use the automatic investigation scheme. In addition, this scheme is divided into  
six steps (Fig. 3), which are described below.

In the manual scheme, the entire UAV flight and the process of photo image collection has to be manually controlled using the remote control. This scheme requires no route planning, which can save time in site investigation. However, it requires excellent piloting skills, and the flight safety and image quality are frequently degraded; accordingly, the flight process should be monitored intensively. Therefore, use of the manual scheme should be avoided, although, in some places, such as mountainous areas or canyons, where the GNSS signals are unstable or even absent, or the scope of the geo-hazard is extremely limited, the manual scheme may be more suitable. In addition, this scheme is divided into 4 steps (Fig. 3), which are briefly described below.

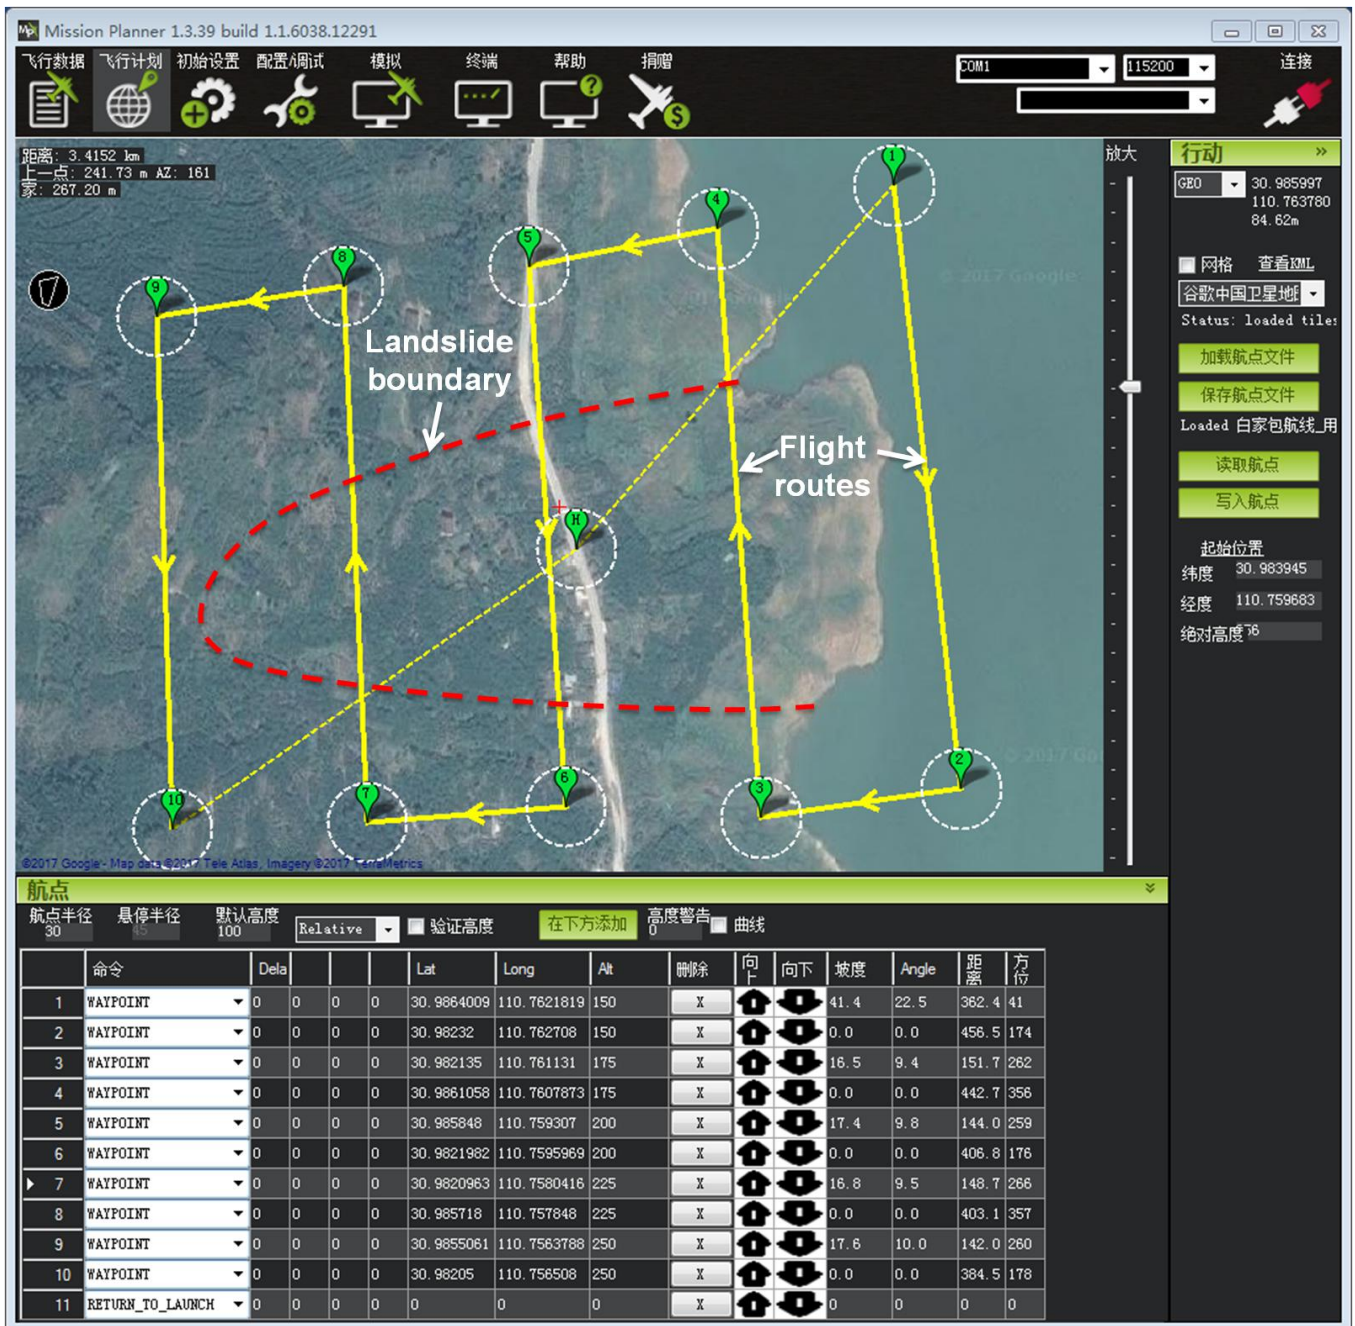
755 Fig.4. The planning of a route involving a typical regular grid pattern in plane view using Mission Planner software.

In addition, if the location of a geo-hazard can be determined, it is necessary to carry out preliminary route planning indoors based on publicly available satellite maps, e.g., Google Earth, Bing Maps, AutoNavi Maps, etc., in the Mission Planner software package. Typically, the preliminary flight routes are simply designed as a regular grid pattern in plane view that

175 covers the whole area affected by the geo-hazard (Fig. 4). In a word, preliminary route planning can help to save time spent  
180 on detailed route planning on-site. Of course, if the location cannot be determined in advance, the indoor preliminary route  
planning cannot be performed, but it does not affect the subsequent on-site investigation using the UAV.

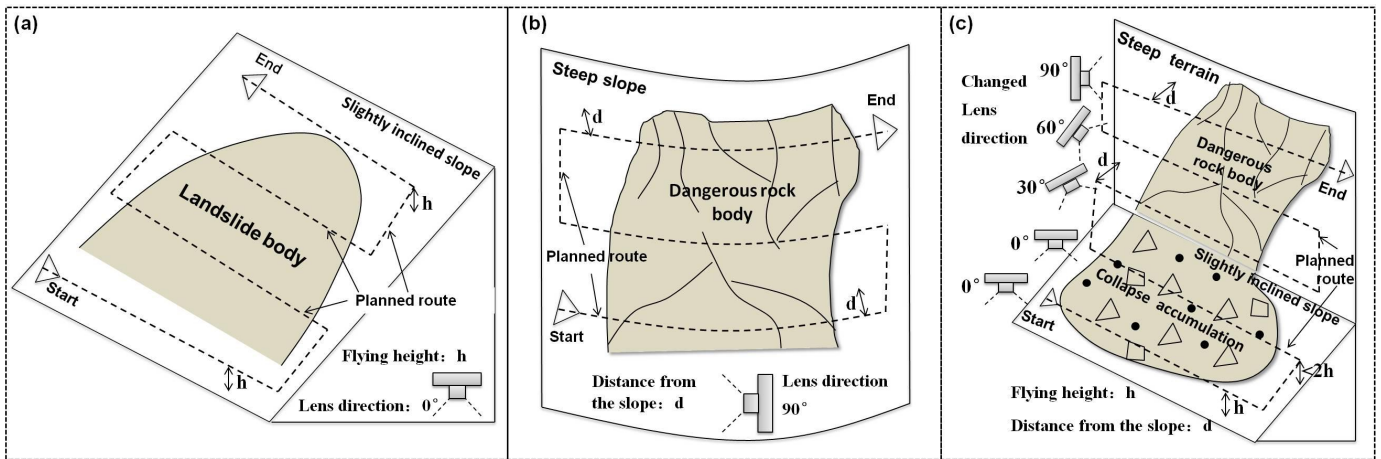
760 **Fig.5.** Three typical route types for UAV-based emergency investigation of single geo-hazards. (a) Planar grid pattern for slightly inclined slopes; (b) vertical grid pattern for steep slopes; (c) combined grid pattern for transitional terrain.

According to the characteristics of individual geo-hazards, proper route type selection and accurate motion design are key in ensuring the safety and efficiency of UAV-based emergency investigation. Based on a number of examples, three typical route types are summarized as follows (Fig. 5).

(1) Planar grid pattern for slightly inclined slopes (Fig. 5a). This pattern is suitable for geo-hazards that cover large areas (typically several million square metres) on the gentle slopes (typically less than 40 °), such as gently inclined landslide bodies. The primary purpose of the emergency investigation for this kind of disaster is to obtain a digital terrain model and

an orthophoto. Therefore, the planned route consists of a regular planar grid that covers the whole planar area of the geo-hazard. In addition, the camera lens always points vertically down to the ground (i.e., the lens orientation is held at  $0^\circ$ ). It is worth noting that the flying height of the route should be dynamically adjusted to meet the elevation changes of the disaster and slope. In principle, it is advisable to maintain the UAV's flying height at a constant distance (i.e., the  $h$  in Fig. 5a) from the ground, and practice shows that  $h$  in 50 m ~ 100 m is proper. Lower flights require longer routes and increased flight time, and flight safety decreases; conversely, higher flights increase the mean ground sampling distance (GSD) of the acquired images, thus providing for lower spatial resolution of the final photogrammetric products.

(2) Vertical grid pattern for steep slopes (Fig. 5b): This pattern is suitable for geo-hazards that are developed on steep slopes (typically greater than  $60^\circ$ ), such as dangerous rock masses on cliffs. Emergency investigations of this kind of disaster should aim at obtaining orthophotos of the facade and 3D models, rather than digital terrain and vertically downward orthophotos. In this case, the planned route consists of a regular vertical grid which that covers the whole facade area of the geo-hazard. In addition, the camera lens always points horizontally to the disaster body (i.e., lens orientation is held at  $90^\circ$ ). The plane positions of all of the horizontal routes can overlap, but they are at different altitudes. In addition, it is advisable to keep the UAV flying at a constant distance (i.e., the  $d$  in Fig. 5a) from the area affected by the disaster (practice shows that a  $d$  of 40 m ~ 80 m is proper).

(3) Combined grid pattern for transitional terrain (Fig. 5c): This pattern is suitable for geo-hazards that are located on transitional terrain and include both gentle and steep slopes, such as a dangerous rock mass on a cliff and the corresponding collapse accumulation mass on the gentle slope below. The main purposes of emergency investigation for this kind of disaster are to obtain a digital terrain model and an orthophoto, as well as a facade orthophoto and a 3D model. Therefore, the combined grid pattern should be adopted for the planned route. That is, a regular planar grid is used to cover areas with gentle slopes, and a vertical grid is used to cover areas with steep slopes. Accordingly, the camera lens points vertically down to the ground within the part with the planar grid (i.e., the lens orientation remains at  $0^\circ$ ), and gradually rises from the low position to the high position in the part with the vertical grid (i.e., the lens orientation changes from  $0^\circ$  to  $90^\circ$ ). The flying height  $h$  and flying distance  $d$  in Fig. 5c can be set as in the planar and vertical grid patterns, respectively.

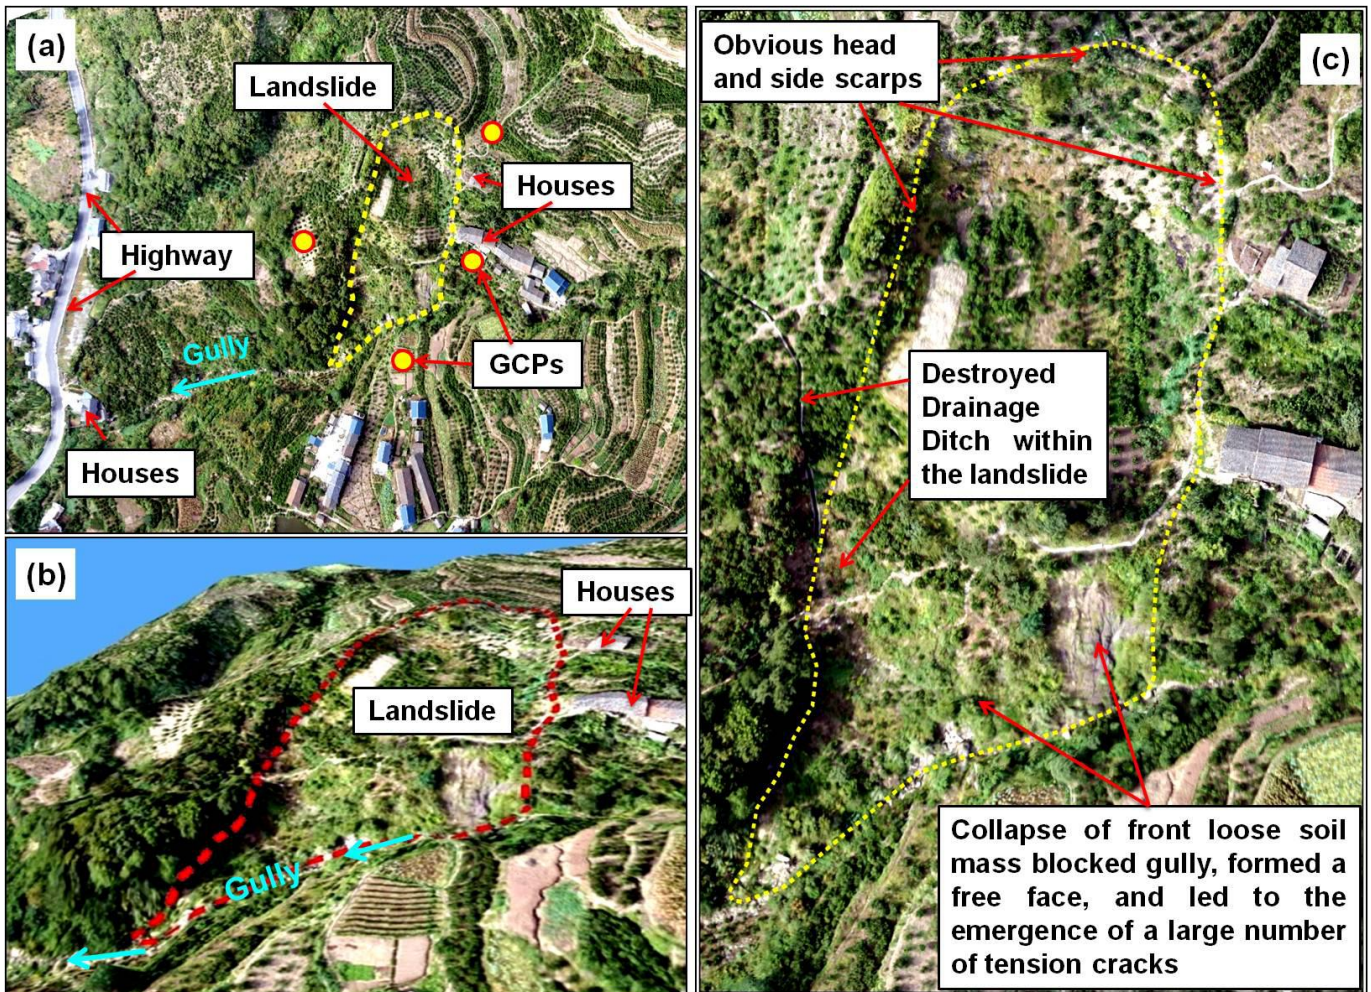
**Fig.6.** The results of a UAV-based emergency investigation of a slightly inclined landslide. (a) the digital orthophoto; (b) the 3D texture model; (c) interpretation of the destruction.

445 Based on the results of the above emergency investigation, combined with ground investigations, the characteristics and effects of the landslide were quickly interpreted (Fig. 6c) and evaluated. These products revealed the formation of obvious head and side scarps. Moreover, the drainage ditch that was located within the landslide was completely destroyed, and the front loose soil mass collapsed and blocked the gully, forming a free face and leading to the emergence of a large number of tension cracks. All of these indications suggested that the landslide represented an obvious mass movement, and that the landslide was in an unstable state. In addition, the landslide was a direct threat to the houses which were located adjacent to

455 the right boundary of the landslide. Moreover, as the loose soil mass at the front of the landslide continuously accumulated in  
the gully, a debris flow would be easily triggered by heavy rainfall, then seriously threatened the house and highway. Based  
on the conclusions above, emergency response measures were put forward, including using professional monitoring  
techniques such as GNSS, extensometers, rain gauges, and ground-based inspection to continuously track the process of  
deformation and induction of the landslide; establishing a citizen science-based monitoring and prevention system, which  
means to encourage the surrounding population to watch for signs of deformation within the landslide body, e.g., cracks,  
460 collapses, and cracks in houses, especially in association with heavy or continuous rainfall; and developing an emergency  
evacuation programme to ensure the orderly avoidance and reduction of losses before additional movement occurs.

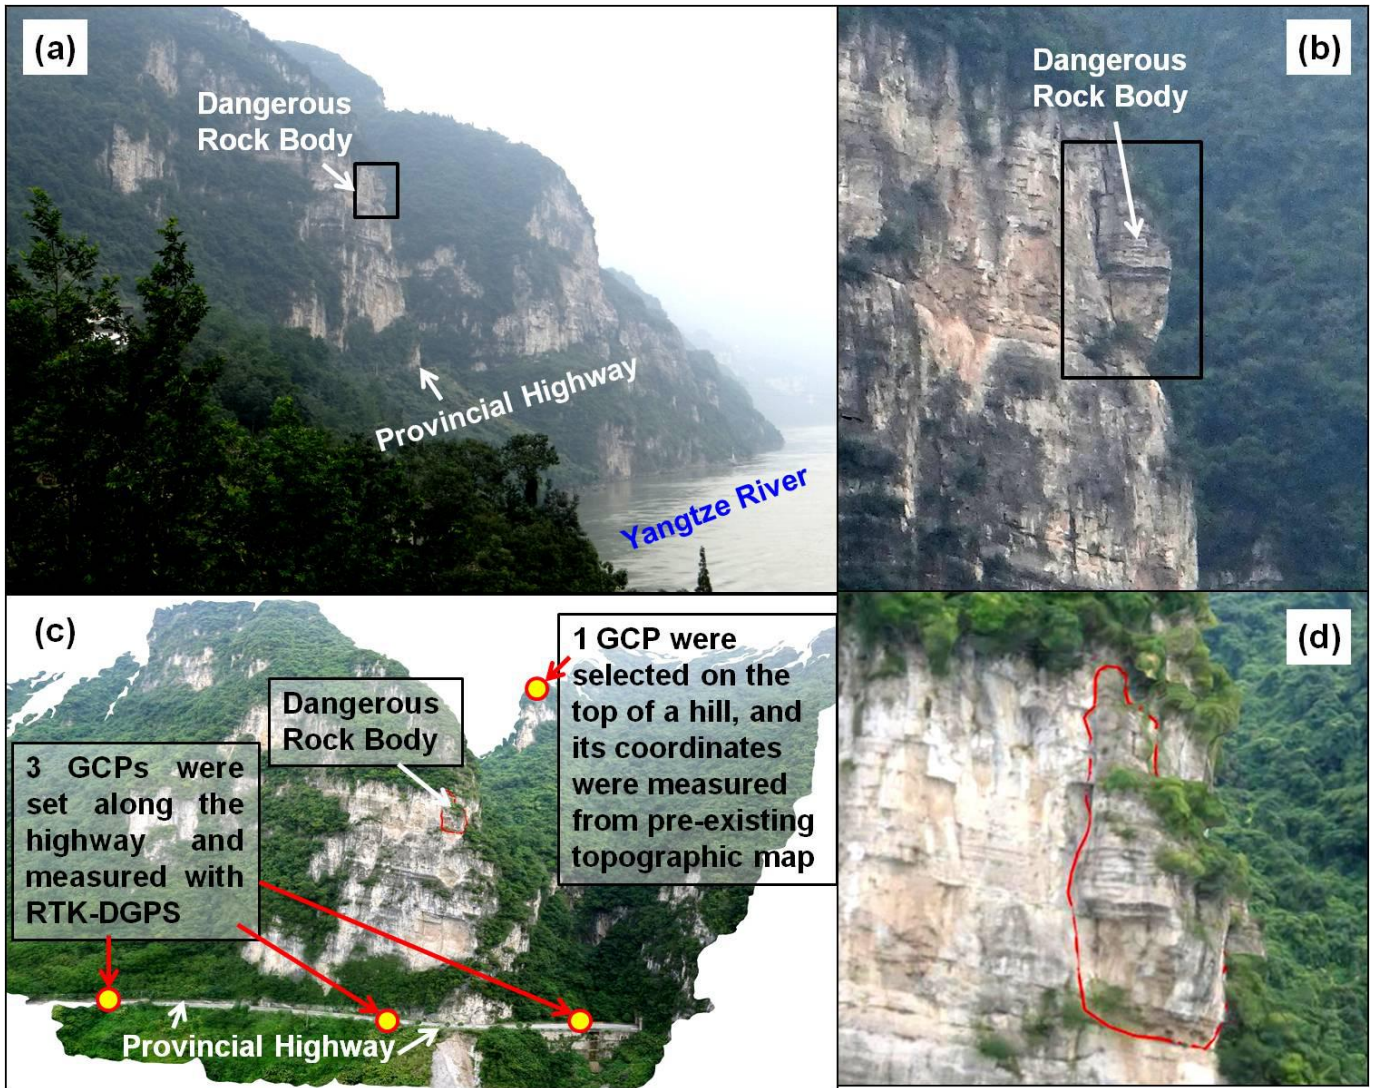
**Fig.7.** The results of a UAV-based emergency investigation for a dangerous rock mass on steep cliff. (a) Overview photo; (b) right side photo of the dangerous rock mass; (c) 3D texture model of the whole scene; (d) 3D texture model of the dangerous rock mass.

First, route planning was performed according to the pattern shown in Fig. 5b. At the same time, 3 GCPs were established  
along the highway and measured with the RTK-DGPS technique (Fig. 7c). In addition, it should be noted that, because the  
three GCPs were located in nearly a straight line, given the limited environment, which could not meet the processing  
requirements, another GCP was established on top of a hill behind the cliff (Fig. 7c), and its coordinates were measured  
475 according to the pre-existing topographic map. The layout and measurement of the 3 GCPs took only approximately 25  
minutes. The camera lens direction was then set at approximately 45 ° to the steep cliff. Through autonomous flight and  
automatic photo image collection, 104 photographs were captured, and the mean GSD of the original images was 4.92  
cm/pixel. Together with route planning and UAV preparation, the entire working time using the UAV took 35 minutes.

In view of the DSM and the 3D model, the results showed that the dangerous rock mass was 24 m high, 12 m wide, and 12 m thick and had a volume of 3456 m<sup>3</sup>, and its exact distance from the highway was 110 m. The lower and upper part of the rock mass had fallen, so it was completely unsupported. The left and right boundary cracks were fully connected. All of these signs indicated that the dangerous rock mass was in an unstable state. Therefore, the relevant emergency investigation results described above were submitted to the technical department to support the design of a detailed emergency response plan.
