Identification and classification of urban micro-vulnerabilities in tsunami evacuation routes for the city of Iquique, Chile

Gonzalo Álvarez^{1,3}, Marco Quiroz^{1,3}, Jorge León^{2,3}, and Rodrigo Cienfuegos^{1,3}

Abstract. Many coastal cities around the world are threatened by tsunamis; some of these events have caused great impacts in recent times. The loss of human lives [during these events](#) is the main cause of concern of the authorities, and evacuation planning has been recognized as one of the best tools for safeguarding the population. In this context, urban design appears to be critical for the execution of prompt and efficient evacuation processes to safe areas; however, evacuation assessment has 5 been traditionally carried out at a large urban scale, mostly taking into consideration urban morphology and connectivity. In the present work, urban spaces available for tsunami evacuation are explored in detail by developing a methodology to identify and classify urban micro-vulnerabilities that may reduce the capacity of the evacuation routes and hinder evacuees [to](#) safety. The method is applied to the Chilean city of Iquique, affected by an earthquake and subseque

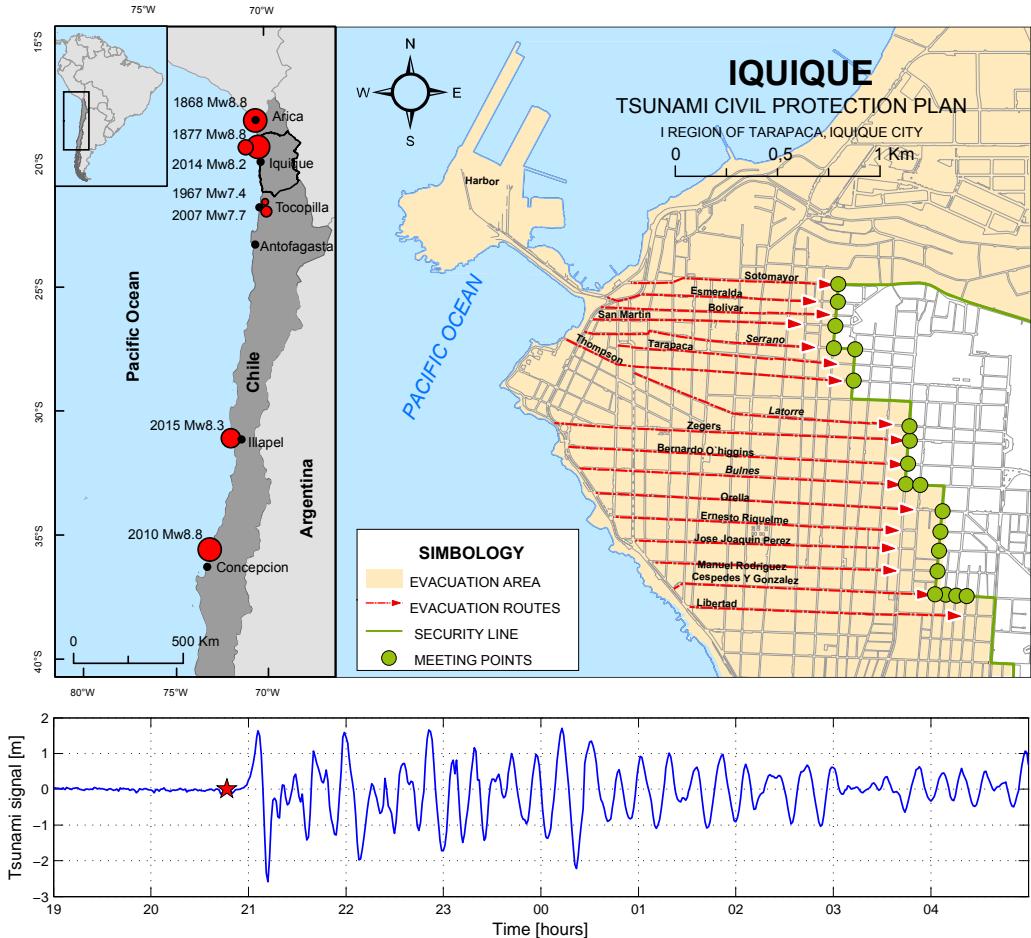
Figure 1. Upper left panel: Geographical location of the study area and a selection of major earthquakes (red circles) that have affected Central-North Chile since 1868 (epicenters based on the records of the National Seismological Center of the University of Chile and the United States Geological Survey). Upper right panel: Downtown Iquique and its tsunami evacuation routes (modified from [\(ONEMI and IMI, 2013\)](#)). Lower panel: The Iquique tide gauge tsunami signal for the 2014 event; the red star indicates the moment of earthquake occurrence.

The Norte Grande region in Chile (an area around 1,000 km long, comprising from the Arica Region to the south of the Antofagasta Region, Figure 1), has been the source of constant public and scientific concern due to the existence of a seismic gap that has produced an accumulation of elastic deformation (6 - 7 cm yr⁻¹) of high seismic hazard (Comte and Pardo, 1991; Métois et al., 2013). The last reported destructive tsunamis in this area occurred in 1868 (Mw~ 8.8), 1877 (Mw~ 8.8), and 2014 (Mw 8.2) (Hayes et al., 2014; Lay et al., 2014). Lower-magnitude earthquakes have also occurred in this area, such as the 1967 Mw 7.4 and the 2007 Mw 7.7 events near the city of Tocopilla; however, a large part of the shallow subduction zone did not experience ruptures for a long period (Hayes et al., 2014). Indeed, the release of energy in 2014 proved to be less than expected, amounting to only around 20% of the total accumulated energy since the 1877 earthquake (Lay et al., 2014; Aránguiz et al., 2015). This suggests the possibility that a larger-magnitude event could occur in the future, the epicenter of which could be located either south or north of Iquique (Hayes et al., 2014).

Tsunami hazard has not been adequately recognized in the urban development of Chilean cities. Only after the 2010 tsunami the government amended the ordinance of urbanism and construction by defining restricted areas to urban development in tsunami flood zones (MINVU, 2011), but there is still lack of national ~~policies~~ policies to mitigate the impact of tsunamis (Lunecke, 2015). Fortunately, as shown in Figure 1, Iquique has adequate urban morphological characteristics (on a macro level) for carrying out a fast evacuation, thanks to the orthogonal arrangement of its streets (León and March, 2016). This is a common factor in Latin American cities, which in coastal areas might lead to straight and redundant evacuation route layouts (Wyrobisz, 1980; Marshall, 2005), see Figure 1.

Records from the Iquique tide gauge (Figure 1) indicate that the first tsunami wave reached the coast at 20:56 (local time), 9 minutes from the nucleation of the earthquake; while the first peak, with a height of 1.6 m, was recorded at 21:06, thus only

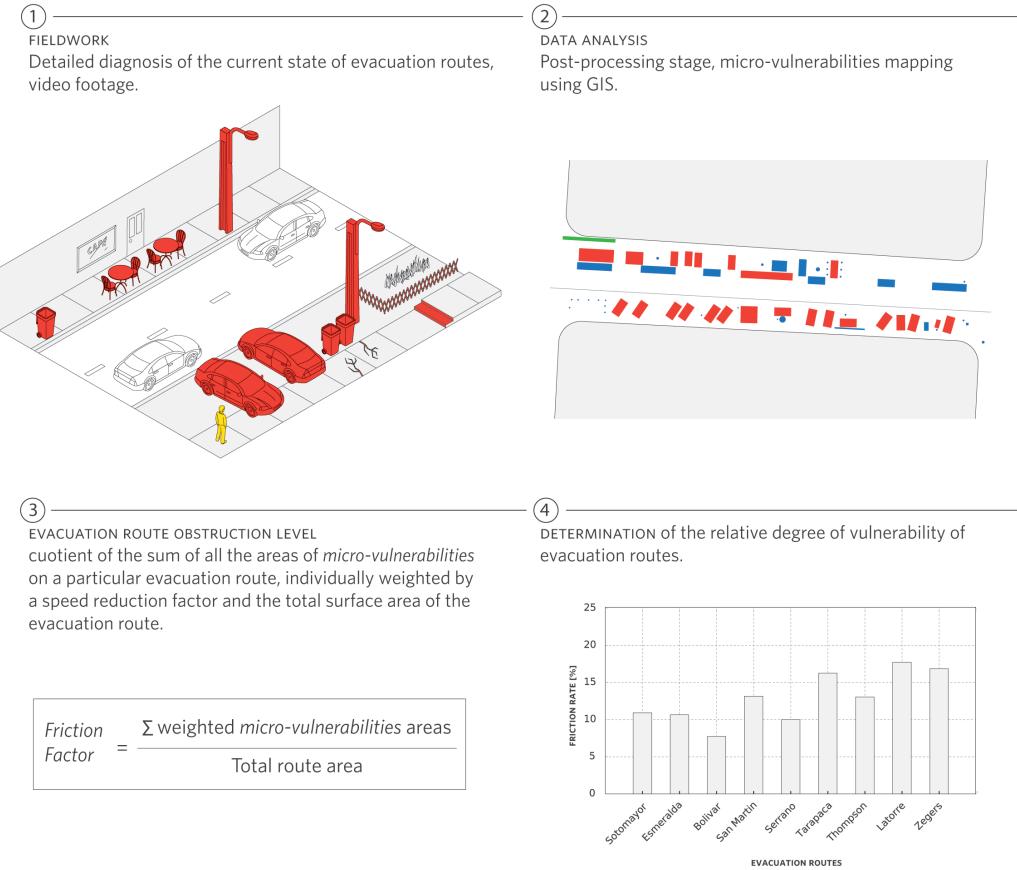
Figure 2. Summary of the proposed methodology to identify and classify urban micro-vulnerabilities.

R1: We acknowledge the suggestion made by Dr. Rahayu. We have prepared and additional figure to summarize the proposed methodology so that the reader could better appraise it in a graphical presentation as suggested by Dr. Rahayu. This figure is presented at the beginning of section 4, in page 7.

Our work was developed following sequential trajectories (Cullen, 1961; Clay, 1994) of analysis along the evacuation routes proposed by the municipality of Iquique in conjunction with the National Emergency Office in its plan for civil protection against tsunamis (ONEMI and IMI, 2013). These routes were defined as the shortest paths, oriented from west to east from the coastline that lead to high ground areas (30 meters above sea level). The methods used in this study comprise three steps. 20 First, extensive fieldwork is conducted to perform a diagnosis of evacuation routes, following the path of evacuees during their escape. Next, surveyed micro-vulnerabilities are geo-referenced and classified according to their complexity and consequences in evacuation, and finally, a friction rate that accounts for velocity reductions of pedestrians is proposed based on the literature review. A summary of the methodology that is described in detail in the following subsections is presented in Figure 2.

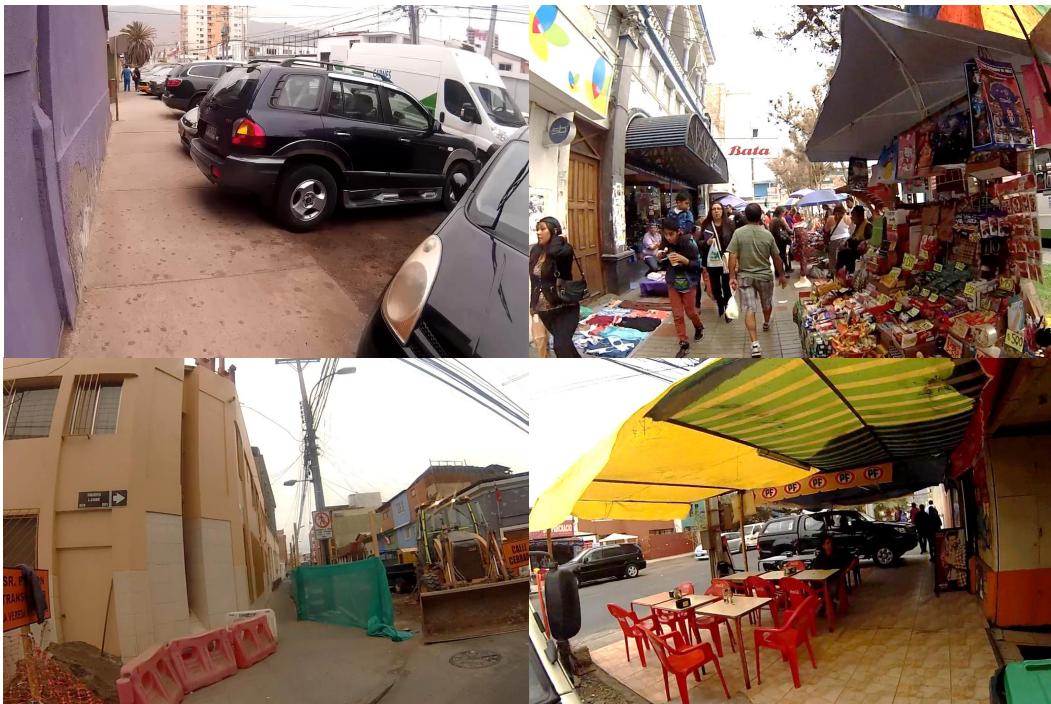
Figure 3. Still frames obtained from field recordings in the city Iquique. Improperly parked vehicles (top left), informal commerce (top right), road repairs (bottom left), restaurant tables on the sidewalk (bottom right).

informal commerce, and v) road works. The last is a temporary type of vulnerability; therefore, it represents a specific, non-regular condition in the city streets (see Figure 3). These observations give rise to the micro-vulnerability classification that is described in the following subsections.

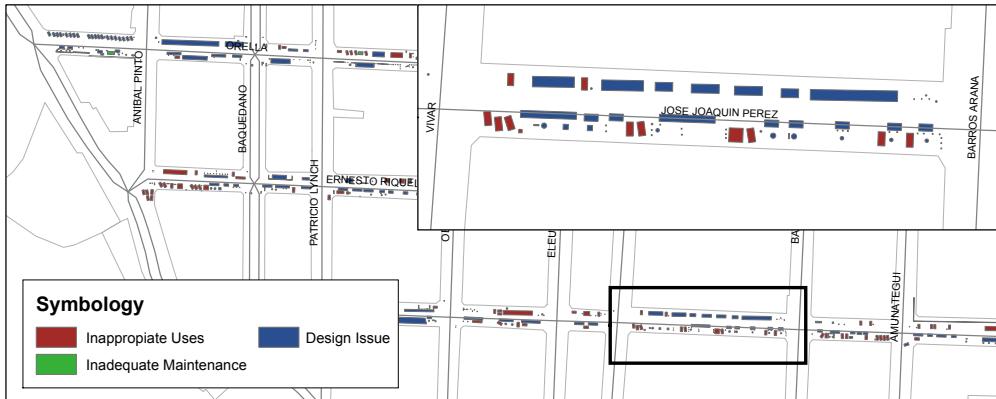
Figure 4. Mapping of identified micro-vulnerabilities, colored according to their taxonomy.

After the micro-vulnerabilities were identified, they were drawn on the map of the city using geographic information tools 10 (ArcGIS) in a planar projection system, attempting to faithfully reproduce their dimensions in order to generate a map that includes the micro-vulnerabilities existing along each of the evacuation routes in the study area. The mapping of micro-vulnerabilities using geographic information systems delivers information regarding the characteristics of the element, its location and the surface area it covers, facilitating the organization, manipulation and analysis of the large quantity of data obtained (Figure 4).

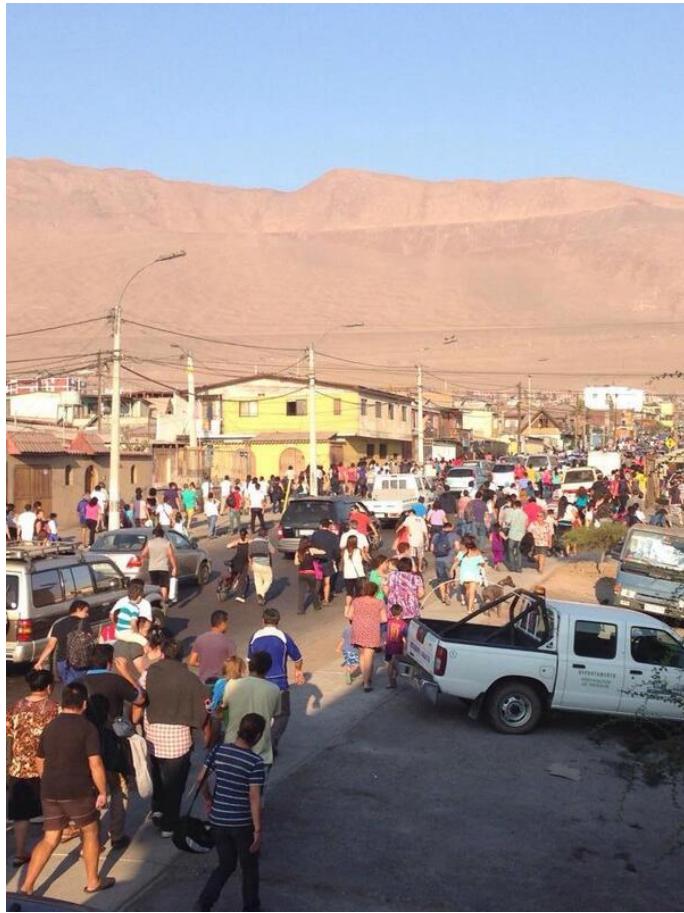
Figure 5. Preventive evacuation of 16 March 2014 (CNN Chile, 2014).

This index includes the sidewalk and street surfaces to represent the obstruction level of the evacuation routes, but it removes the cars circulating on the street from the identified micro-vulnerabilities, due to the variability of this condition. The high motorization rate in the city and the history of vehicles used in previous evacuations (Matus and Muñoz, 2014; Riveros, 2014) pose a negative precedent and undoubtedly increase the vulnerability of people during an evacuation, as they bound movement of pedestrians mostly to the sidewalk (see Figure 5).

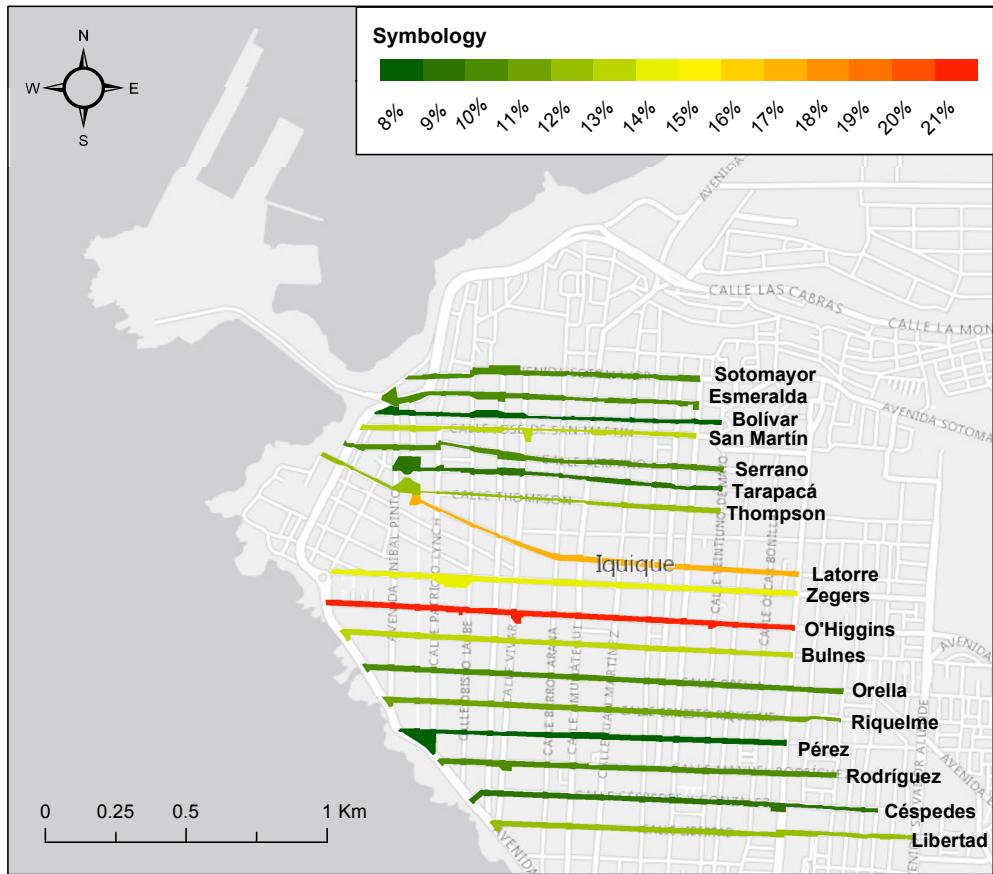
Figure 6. Friction rates obtained for the evacuation routes in the study area.

In Figure 6, the results of the friction rate calculations for the streets analyzed in this study are presented graphically. It is showed that the highest friction rates are concentrated in the central part of the study area, due to its status as the most active zone of Iquique's downtown, which is result of the high presence of educational institutions, office buildings and commercial facilities. The maximum friction rate value, for O'Higgins Street (an evacuation route that in some stretches at the moment of the study was affected by road work) verges on 20%. The second route with a high friction rate, Latorre Street, is object of concern due to the quantity of people that would arrive during an evacuation, especially since it provides the shortest means of access to the safe area for part of the population that resides on the peninsula south of the port (around 530 people). Continuing with this analysis, the rest of the population of the peninsula (around 780 people (INE, 2012)), must evacuate by Zegers Street, the third evacuation route that has a large number of micro-vulnerabilities along its entire length.
