Identification and classification of urban micro-vulnerabilities in tsunami evacuation routes for the city of Iquique, Chile

Gonzalo Álvarez^{1,3}, Marco Quiroz^{1,3}, Jorge León^{2,3}, and Rodrigo Cienfuegos^{1,3}

Abstract. Many coastal cities around the world are threatened by tsunamis; some of these events have caused great impacts in recent times. The loss of human lives during these events is the main cause of concern of the authorities, and evacuation planning has been recognized as one of the best tools for safeguarding the population. In this context, urban design appears to be critical for the execution of prompt and efficient evacuation processes to safe areas; however, evacuation assessment has been traditionally carried out at a large urban scale, mostly taking into consideration urban morphology and connectivity. In the present work, urban spaces available for tsunami evacuation are explored in detail by developing a methodology to identify and classify urban micro-vulnerabilities that may reduce the capacity of the evacuation routes and hinder evacuees' safety. The method is applied to the Chilean city of Iquique, affected by an earthquake and subsequent tsunami in

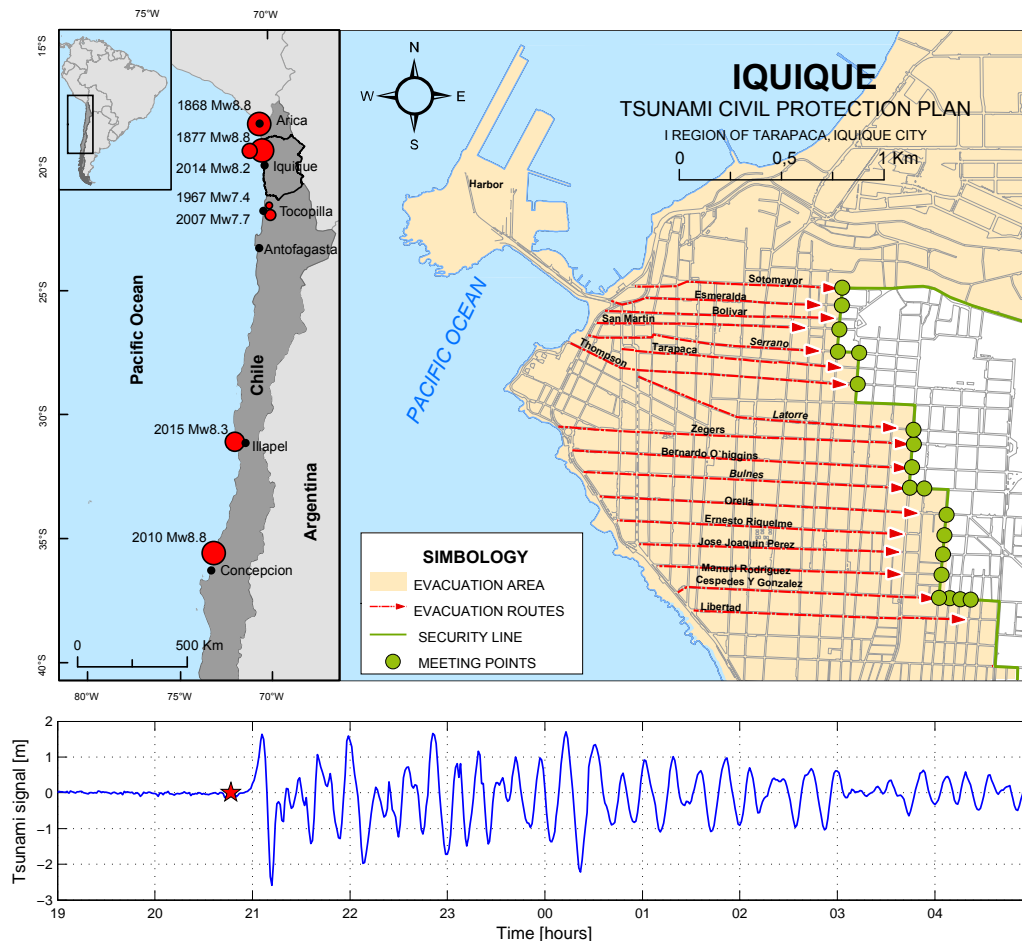
Figure 1. Upper left panel: Geographical location of the study area and a selection of major earthquakes (red circles) that have affected Central-North Chile since 1868 (epicenters based on the records of the National Seismological Center of the University of Chile and the United States Geological Survey). Upper right panel: Downtown Iquique and its tsunami evacuation routes (modified from ONEMI and IMI (2013)). Lower panel: The Iquique tide gauge tsunami signal for the 2014 event; the red star indicates the moment of earthquake occurrence.

The Norte Grande region in Chile (an area around 1,000 km long, comprising from the Arica Region to the south of the Antofagasta Region, Figure 1), has been the source of constant public and scientific concern due to the existence of a seismic gap that has produced an accumulation of elastic deformation ($6 - 7 \text{ cm yr}^{-1}$) of high seismic hazard (Comte and Pardo, 1991; Métois et al., 2013). The last reported destructive tsunamis in this area occurred in 1868 ($M_w \sim 8.8$), 1877 ($M_w \sim 8.8$), and 2014 ($M_w 8.2$) (Hayes et al., 2014; Lay et al., 2014). Lower-magnitude earthquakes have also occurred in this area, such as the 1967 Mw 7.4 and the 2007 Mw 7.7 events near the city of Tocopilla; however, a large part of the shallow subduction zone did not experience ruptures for a long period (Hayes et al., 2014). Indeed, the release of energy in 2014 proved to be less than

Records from the Iquique tide gauge (Figure 1) indicate that the first tsunami wave reached the coast at 20:56 (local time), 9 minutes from the nucleation of the earthquake; while the first peak, with a height of 1.6 m, was recorded at 21:06, thus only 19 minutes after the initiation of the seismic shaking (UNESCO/IOC, 2014). In addition, arrival times for the 2015 Illapel tsunami, were found to be less than 12 min in the field survey conducted by Aránguiz et al. (2016). This demonstrates that, depending on the location of the tsunami generation area, little time may be available for evacuating to safe areas; therefore, a rapid response and evacuation are essential as protective measures against near field tsunamis in Chilean coastal cities.

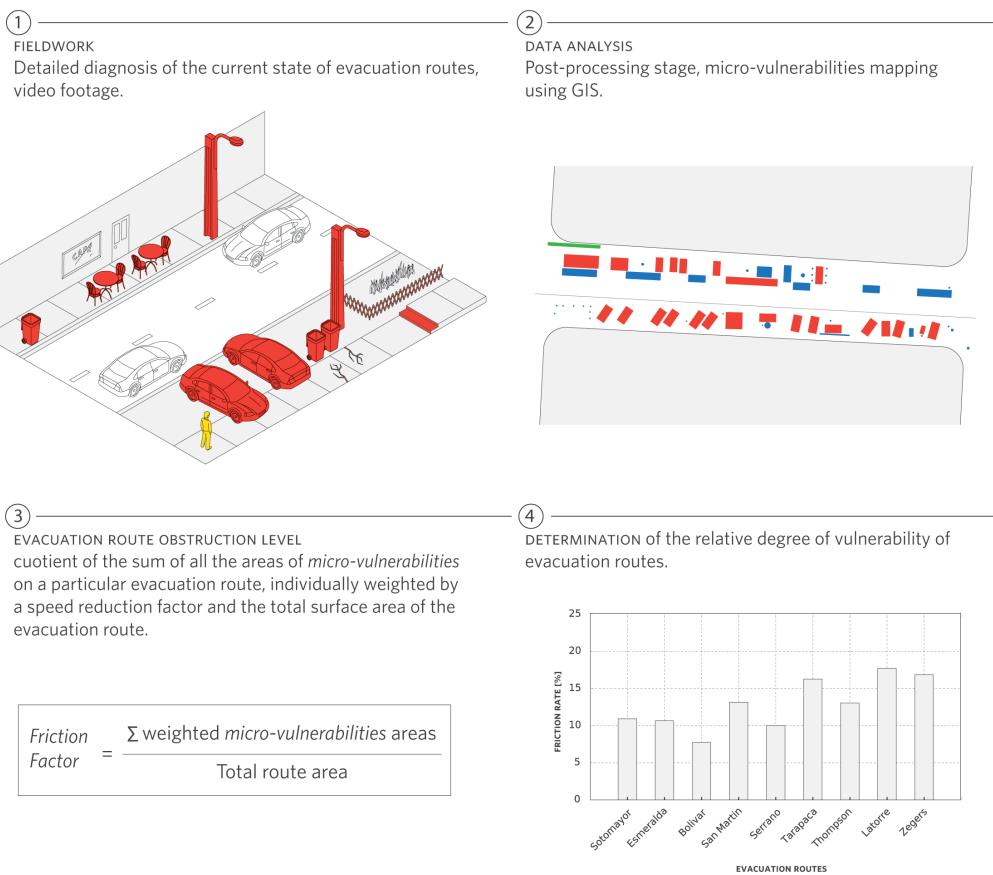
Figure 2. Summary of the proposed methodology to identify and classify urban micro-vulnerabilities.

Our work was developed following sequential trajectories (Cullen, 1961; Clay, 1994) of analysis along the evacuation routes proposed by the municipality of Iquique in conjunction with the National Emergency Office in its plan for civil protection against tsunamis (ONEMI and IMI, 2013). These routes were defined as the shortest paths, oriented from west to east from the coastline that lead to high ground areas (30 meters above sea level). The methods used in this study comprise three steps. First, extensive fieldwork is conducted to perform a diagnosis of evacuation routes, following the path of evacuees during their escape. Next, surveyed micro-vulnerabilities are geo-referenced and classified according to their complexity and consequences in evacuation, and finally, a friction rate that accounts for velocity reductions of pedestrians is proposed based on the literature review. A summary of the methodology that is described in detail in the following subsections is presented in Figure 2.

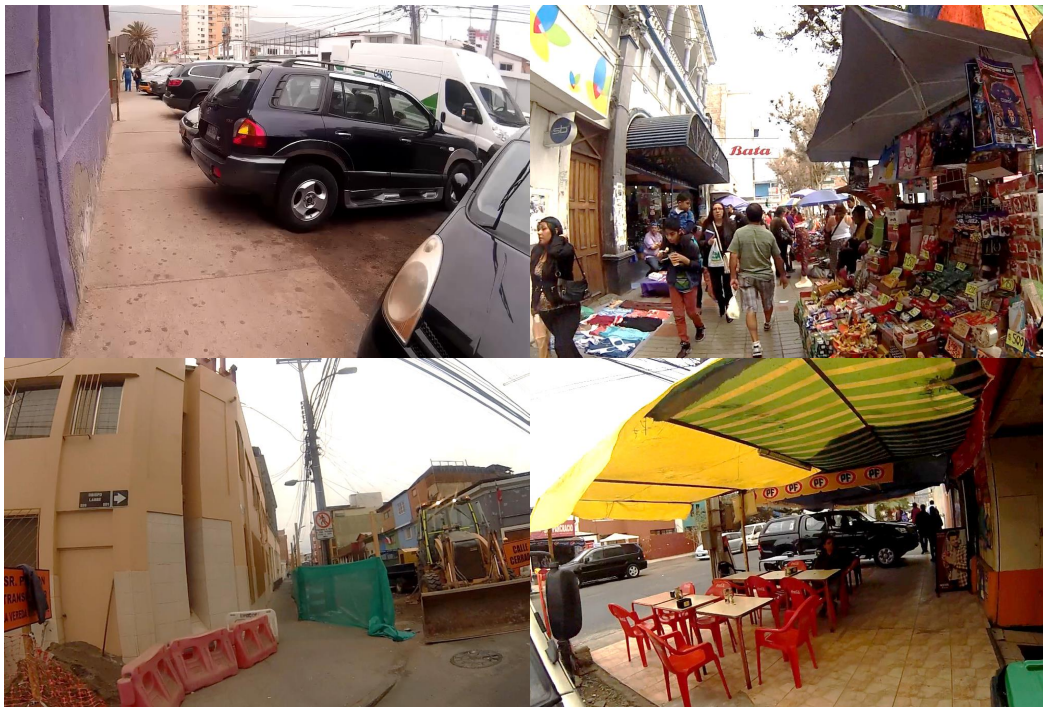
Figure 3. Still frames obtained from field recordings in the city Iquique. Improperly parked vehicles (top left), informal commerce (top right), road repairs (bottom left), restaurant tables on the sidewalk (bottom right).

During the fieldwork, the following types of micro-vulnerabilities were observed as the most common elements capable of hindering evacuation: i) presence of parked cars on sidewalks, ii) narrowing of sidewalks to make space for parking, iii) use of sidewalks to extend the service area of restaurants (only during the day and evening), iv) use of public spaces for informal commerce, and v) road works. The last is a temporary type of vulnerability; therefore, it represents a specific, non-regular condition in the city streets (see Figure 3). These observations give rise to the micro-vulnerability classification that is described in the following subsections.

Among the identified issues, that of greatest concern is the presence of parked cars on sidewalks. Due to the large dimensions of these obstructions, the useful walkable area is reduced and the capacity of the evacuation routes is considerably affected; in

some cases, the available width of the sidewalk is reduced to less than a meter, which in the event of an evacuation might lead to bottlenecks that could increase evacuation times. In addition, there are built parking areas that decrease the sidewalk width, called “narrowings” in this work. The presence of these elements is related to the public need for parking spaces due to the high motorization rate in the city, which is among the top 3% of Chilean communes with the highest number of vehicles (the value of which is comparable with communes in the capital of the country (INE, 2015)). It was observed that a large portion of households, mostly old buildings, do not have private parking spaces, forcing the residents to park their vehicles in public spaces.

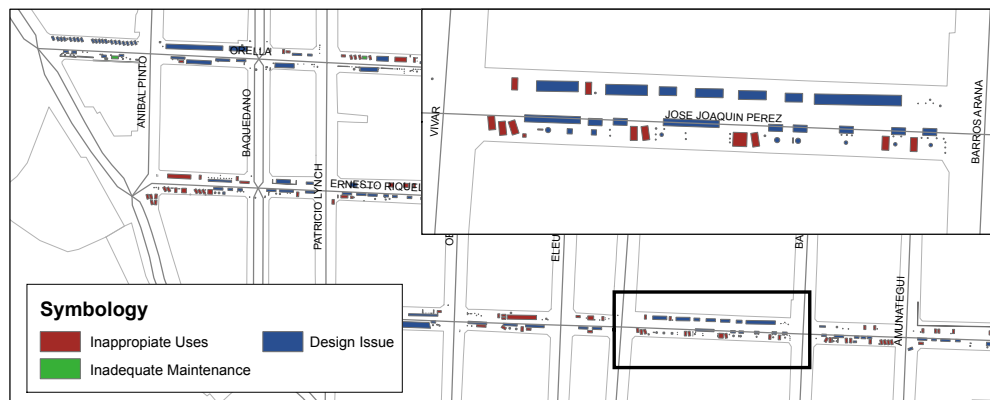
Figure 4. Mapping of identified micro-vulnerabilities, colored according to their taxonomy.

After the micro-vulnerabilities were identified, they were drawn on the map of the city using geographic information tools (ArcGIS) in a planar projection system, attempting to faithfully reproduce their dimensions in order to generate a map that includes the micro-vulnerabilities existing along each of the evacuation routes in the study area. The mapping of micro-vulnerabilities using geographic information systems delivers information regarding the characteristics of the element, its location and the surface area it covers, facilitating the organization, manipulation and analysis of the large quantity of data obtained (Figure 4).

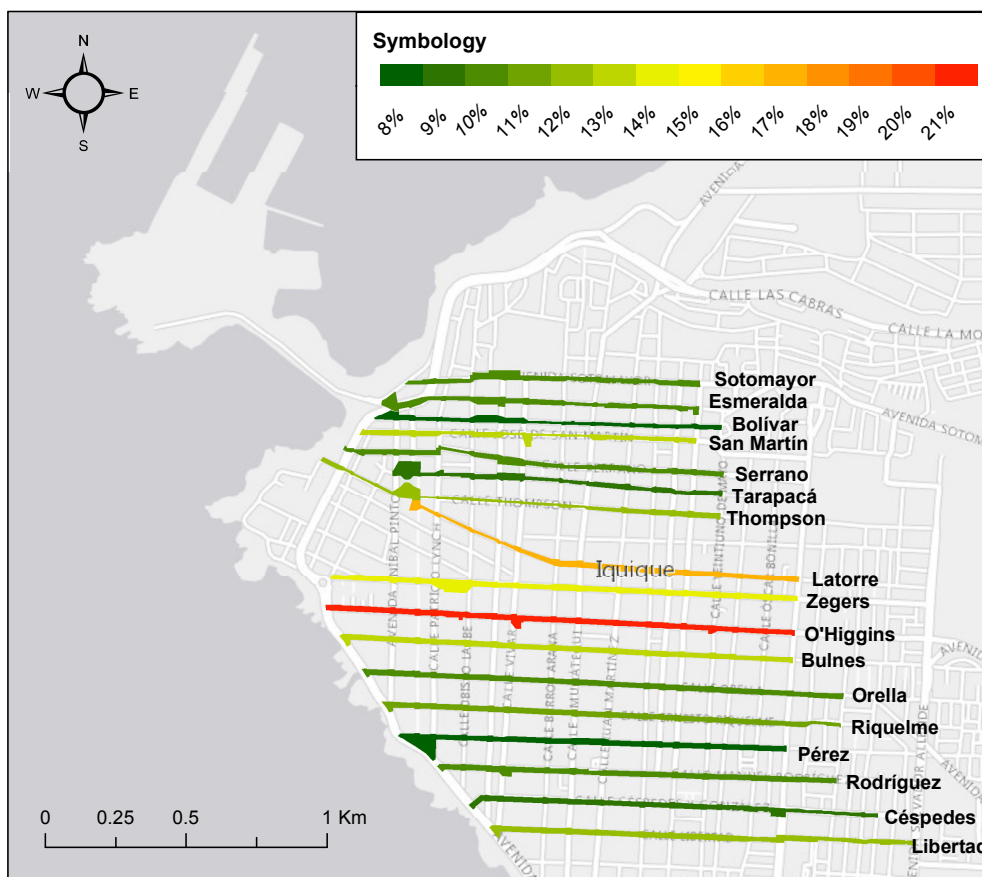
Figure 6. Friction rates obtained for the evacuation routes in the study area.

In Figure 6, the results of the friction rate calculations for the streets analyzed in this study are presented graphically. It is showed that the highest friction rates are concentrated in the central part of the study area, due to its status as the most active

zone of Iquique's downtown, which is result of the high presence of educational institutions, office buildings and commercial facilities. The maximum friction rate value, for O'Higgins Street (an evacuation route that in some stretches at the moment of the study was affected by road work) verges on 20%. The second route with a high friction rate, Latorre Street, is object of concern due to the quantity of people that would arrive during an evacuation, especially since it provides the shortest means of access to the safe area for part of the population that resides on the peninsula south of the port (around 530 people). Continuing with this analysis, the rest of the population of the peninsula (around 780 people (INE, 2012)), must evacuate by Zegers Street, the third evacuation route that has a large number of micro-vulnerabilities along its entire length,

The port area deserves a special attention due to its large distance to safe areas. In this respect, representatives of the Iquique Port estimated that in a worst case scenario there could be more than 1,500 workers. Fortunately, the evacuation routes accessible by the Iquique port's personnel, Esmeralda and Bolívar streets, have low friction rates. However, the greatest problem for workers is the time it takes to leave the port and reach the mainland safe area. Considering the aforementioned observations, the major concern in Iquique downtown is Zegers Street by its high friction rate and nearness to coast unlike Latorre Street;

on the other hand, O'Higgins Street must be removed from this analysis due to the temporal elements contributing to its friction rate during the fieldwork. The rest of the evacuation routes show lower friction rates, but some speed reductions and flow capacity decreasing of evacuation routes are to be expected. By gathering all the micro-vulnerabilities and adding its contribution to the friction rates in the study zone, it is possible to deduce that the main issue is the inappropriate use of urban space to parking on either the sidewalk or street, with around 74% of the whole friction contribution. One of the most illustrative outcomes of the developed methodology is to provide means to assess the drawbacks of using sidewalk for parking, generally perpendicular to the road, with the effective width of the sidewalk sometimes decreasing from 4 to practically 1 m. Through the presented methodology of micro-vulnerabilities identification is possible to pinpoint urban problems related to evacuees displacement, quantify its impacts and prioritize solutions with different complexity levels.
