Identification and classification of urban micro-vulnerabilities in tsunami evacuation routes for the city of Iquique, Chile

Gonzalo Álvarez^{1,3}, Marco Quiroz^{1,3}, Jorge León^{2,3}, and Rodrigo Cienfuegos^{1,3}

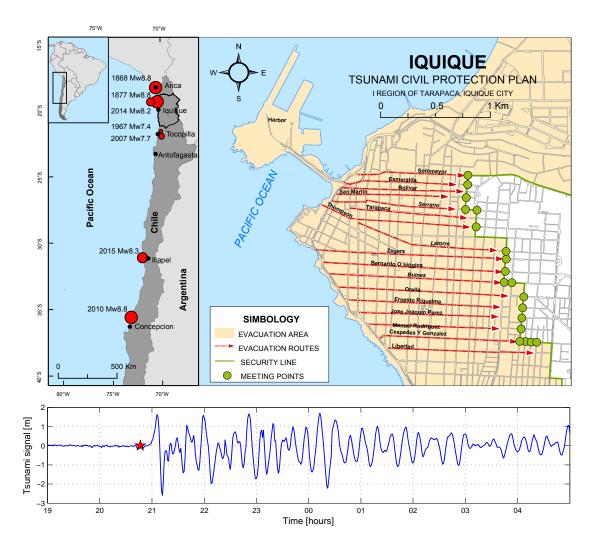
Figure 1. Upper left panel: Geographical location of the study area and a selection of major earthquakes (red circles) that have affected Central-North Chile since 1868 (epicenters based on the records of the National Seismological Center of the University of Chile and the United States Geological Survey). Upper right panel: Downtown Iquique and its tsunami evacuation routes (modified from (ONEMI and IMI, 2013)). Lower panel: The Iquique tide gauge tsunami signal for the 2014 event; the red star indicates the moment of earthquake occurrence.

Records from the Iquique tide gauge (Figure 1) indicate that the first tsunami wave reached the coast at 20:56 (local time), 9 minutes from the nucleation of the earthquake; while the first peak, with a height of 1.6 m, was recorded at 21:06, thus only 19 minutes after the initiation of the seismic shaking (UNESCO/IOC, 2014). In addition, arrival times for the 2015 Illapel tsunami, were found to be less than 12 min in the field survey conducted by Aránguiz et al. (2016). This demonstrates that, depending on the location of the tsunami generation area, little time may be available for evacuating to safe areas; therefore, a rapid response and evacuation are essential as protective measures against near field tsunamis in Chilean coastal cities.

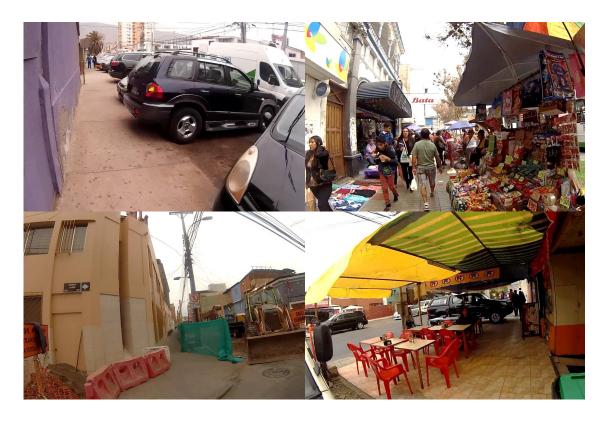
Figure 2. Still frames obtained from field recordings in the city Iquique. Improperly parked vehicles (top left), informal commerce (top right), road repairs (bottom left), restaurant tables on the sidewalk (bottom right).

During the fieldwork, the following types of micro-vulnerabilities were observed as the most common elements capable of hindering evacuation: i) presence of parked cars on sidewalks, ii) narrowing of sidewalks to make space for parking, iii) use of sidewalks to extend the service area of restaurants (only during the day and evening), iv) use of public spaces for informal commerce, and v) road works. The last is a temporary type of vulnerability; therefore, it represents a specific, non-regular condition in the city streets (see Figure 2).

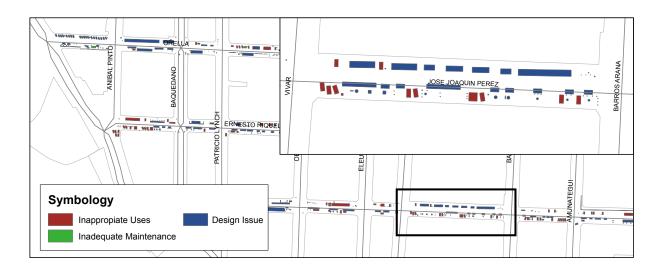
Figure 3. Mapping of identified micro-vulnerabilities, colored according to their taxonomy.

After the micro-vulnerabilities were identified, they were drawn on the map of the city using geographic information tools (ArcGIS) in a planar projection system, attempting to faithfully reproduce their dimensions in order to generate a map that includes the micro-vulnerabilities existing along each of the evacuation routes in the study area. The mapping of micro-vulnerabilities using geographic information systems delivers information regarding the characteristics of the element, its location and the surface area it covers, facilitating the organization, manipulation and analysis of the large quantity of data obtained (Figure 3).

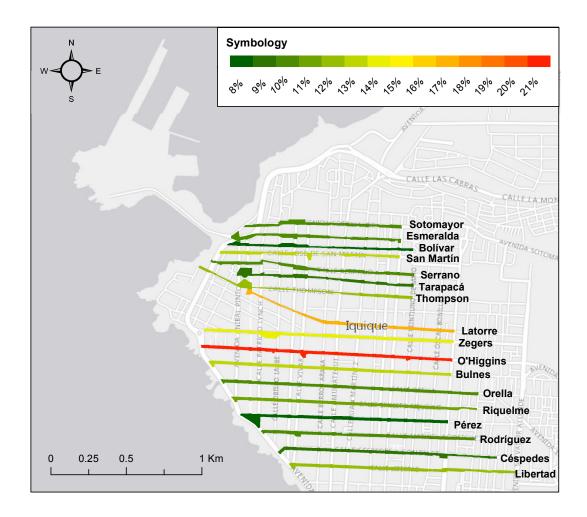
Figure 5. Friction rates obtained for the evacuation routes in the study area.

In Figure 5, the results of the friction rate calculations for the streets analyzed in this study are presented graphically. It is showed that the highest friction rates are concentrated in the central part of the study area, due to its status as the most active zone of Iquique's downtown, which is result of the high presence of educational institutions, office buildings and commercial facilities. The maximum friction rate value, for O'Higgins Street (an evacuation route that in some stretches at the moment of the study was affected by road work) verges on 20%. The second route with a high friction rate, Latorre Street, is object of concern due to the quantity of people that would arrive during an evacuation, especially since it provides the shortest means of access to the safe area for part of the population that resides on the peninsula south of the port (around 530 people). Continuing with this analysis, the rest of the population of the peninsula (around 780 people (INE, 2012)), must evacuate by Zegers Street, the third evacuation route that has a large number of micro-vulnerabilities along its entire length.
