Thank you very much again for the revision of your manuscript with the title "Integrated risk assessment due to slope instabilities at the roadway network of Gipuzkoa, Basque Country". The revised manuscript was reviewed by two reviewers. Both of the reviewers acknowledged the changes and improvements of the manuscript based on the suggestions of the reviewers reports. One of the reviewer has now no further comments, the second one suggested to highlight and make more explicit the limitations of the current approaches and data. The reviewer provided also a report. After reading the manuscript again, I agree with the referee and ask therefore for minor revision of the manuscript.

**Abstract.** Transportation corridors such as roadways are often subjected to both natural instability and cut slope failures, with substantial physical damage for the road infrastructure and threat to the circulating vehicles and passengers. In the early 2000s, the Gipuzkoa Regional Council of the Basque country in Spain, marked the need for assessing the risk related to the geotechnical hazards at its road network, in order to assess and monitor their safety for the road users. The Quantitative Risk Ass

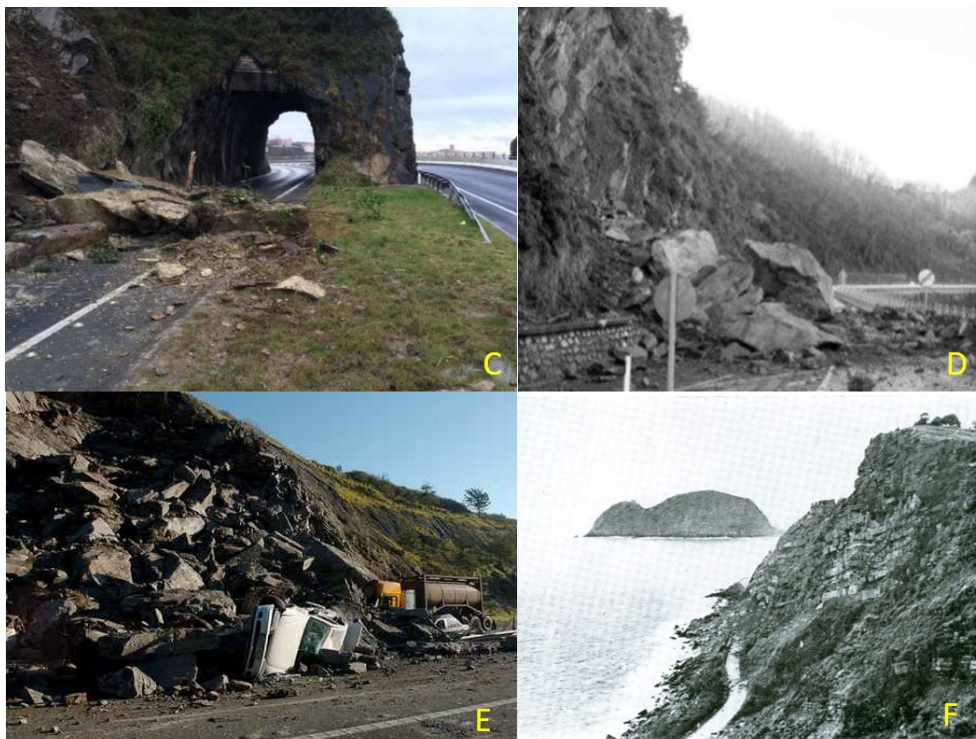
Figure 3: Examples of rockfall magnitudes (C, D, E, and F) in the study area, in relation to the classes of Table 2 (source: photo D, E: Javi Colmenero; F: Servicio Geológico de Obras Públicas)

Rockfalls are a major threat at the roads of Gipuzkoa. The rockfall hazard magnitude is classified according to the volume of the detached mass. Figure 3 shows representative examples of different rockfall magnitudes. A frequency or probability of occurrence is attributed to each volume class and the extent of disruption of the transportation corridor is determined.

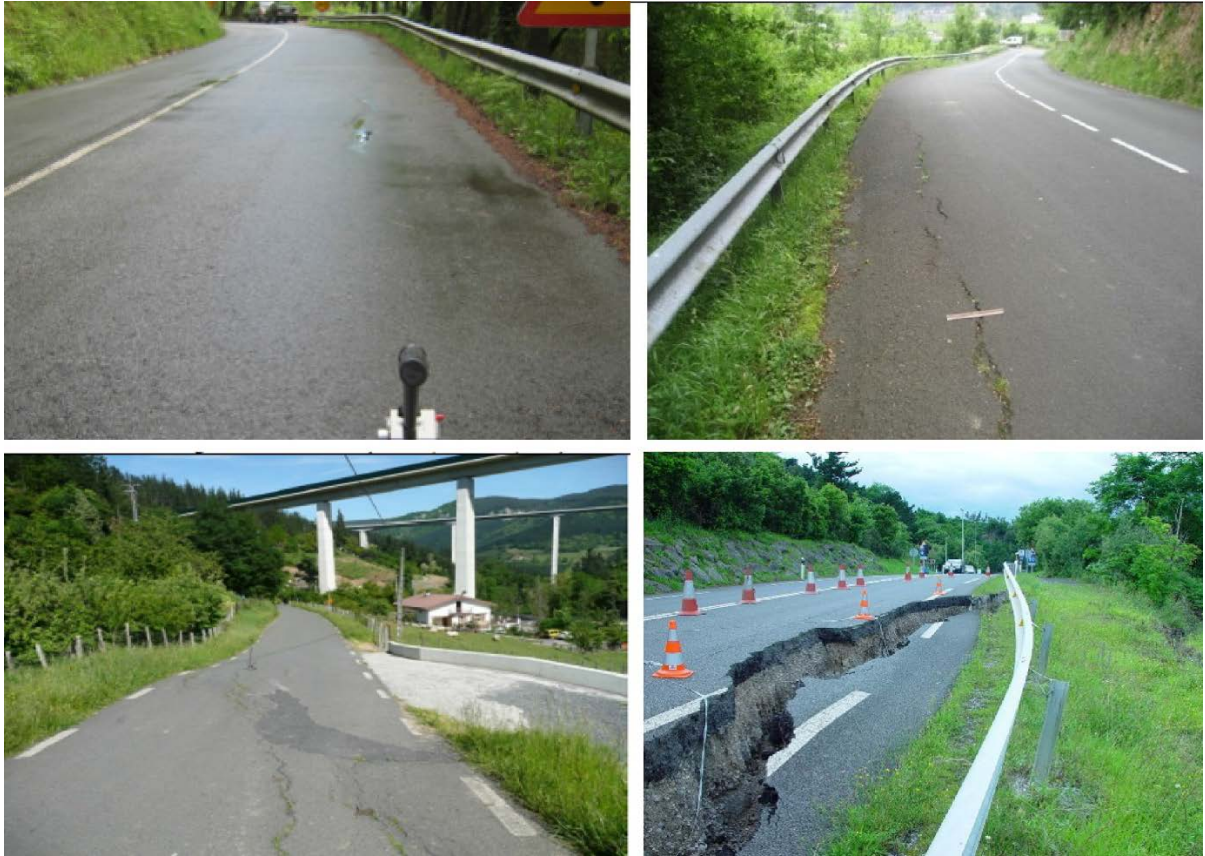
**Figure 5: The four damage levels identified at the roads of Gipuzkoa: (top-left) No/Slight damage, (top-right) Moderate damage, (down-left) Severe damage, and (down-right) Partial/total destruction.**

5 In the case study, horizontal velocity data is available from the inclinometer measurements. After 2010, deformation readings ~~are~~have been constantly taken, every 3 months. In that sense, although the monthly velocity measurements have a limited precision, they can provide certain information on the landslide movement patterns. We inspected the in-situ damage, in order to establish the relation between the velocity and the road damage. Four levels were identified, as shown in Figure 5 and described qualitatively in the following:

- 10 • Damage level A (landslides of low intensity): There are rarely cracks and deformations. No speed reduction is required while driving. Crack sealing and resurfacing is periodically performed for periods longer than 1 year.

- 20 • Damage level D (landslides of very high intensity): Displacements are of the same order of magnitude as for level C, however with the vertical component prevailing and giving place to complete destruction and loss of the pavement continuity. This situation is typical for roads situated on the crest or on the boundaries of

- 25 landslides. The ~~operation~~functioning of the road is seriously affected. There is a high likelihood of an accident due to vehicles falling into the generated depressions. Important stabilization works and reconstruction of the road are required.

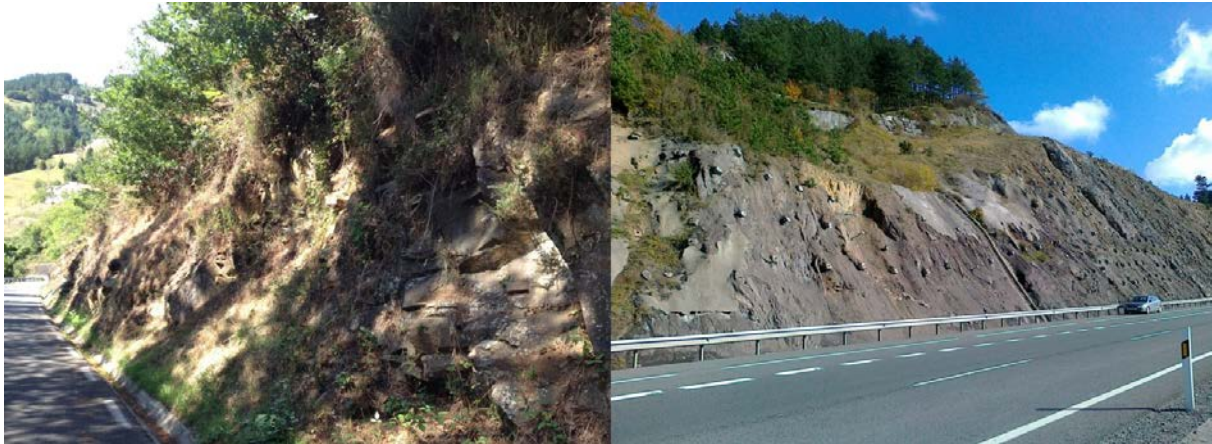
5 **Figure 7: (left) PoR L1C of the road GI-3324 (from km 0.700 to 1.450), without protection measures; (right) PoR P4C of the road N-1 (km 407.395 to 407.680) with protection measures.**

For the PoR P4C, a similar procedure was followed. For  $I_P$ : Moderate,  $I_{DC} >0.16$ ,  $I_E$ : No,  $I_{FP}$ : 4, and  $I_{SMR}$ : 0-40,  $I_F$  results equal to 5, which corresponds to an annual frequency of events equal to 0.2. This frequency is distributed to the magnitude classes: 0.08 for A, 0.09 for B, 0.01 for C, 0.01 for D and 0.01 for E. In this case, a correction is applied on the annual frequency. Considering that the slope is partially protected by gunite and bolts in a bad state of maintenance, and that a ditch with width smaller than 5 m exists, the summative frequency correction factors for the two types of measures from Table 6 are 0.45 and 0.2 for magnitudes A and B. For higher magnitudes, the existing protection measures are not considered to be efficient. The annual frequencies per size after correction are 0.03, 0.07, 0.01, 0.01, 0.01 for A, B, C, D and E, respectively, which after multiplication with the correspondent

UC and summing, they result in a higher total annual risk than the previous one, and equal to 3.05. The higher risk is ought to the existence of bigger rock blocks which cannot be retained by the actual protection measures.

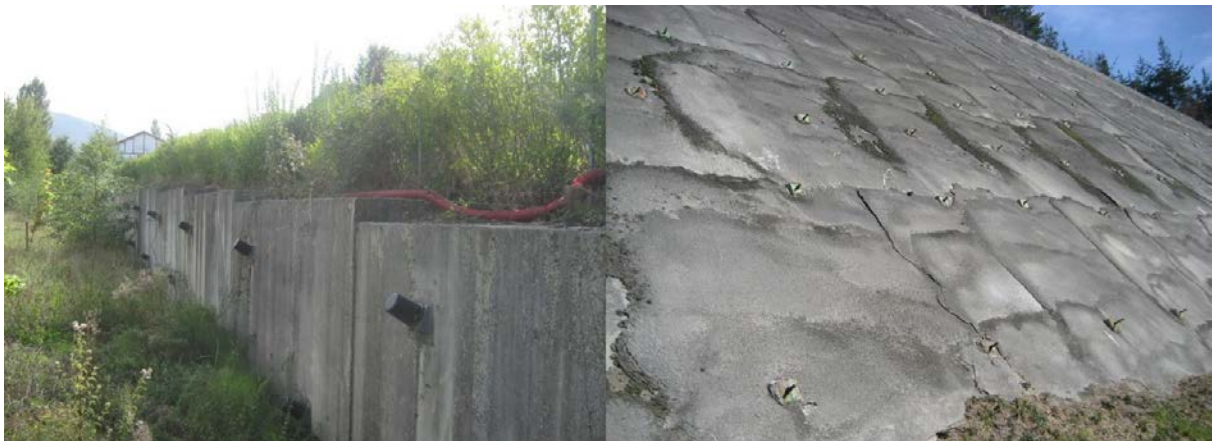
**Figure 8: (left) PoR P2A of the road AP-8-1-1 (from km 77.140 to 77.210) where the crest of the slope and the retaining wall with anchors is seen; (right) C8A of the road G-2634 (32.980 to 33.150) with gunite, rock bolts, and anchors.**

works for the reinforcement of this slope were performed between 1992 and 1993, with 8 strips of gunite, 5 m tall each one. Every strip includes 4 rows of bolts, except the lowest one which has 5 rows and the crest which does not have any. The load cells indicate that presently several bolts are overloaded. The rock mass is slightly to moderately weathered over the entire slope. The maximum volume that has been estimated to be unstable is 21,800 m<sup>3</sup>.

The parameters that have been used for the C8A are (Figure 7, right): Safety Factor <1.30 (it is not known for this case) (5 points), working load >65% of the ultimate load (5 points), grout length >1.2m/10 t (1 point) and anchorage on a slight to moderate weathered rock (3 points). Although data existexists for some anchors, it is not available for all of them, which is penalized assuming the respective value of “no” in Table 6. Construction was performed with technical assistance. The initially calculated HI is 3.67. As the bolt pressure increase is greater than 65% of the ultimate load (up to 80%), the HI is increased by 2 and it is 5.667 which corresponds to an estimated failure probability of 0.82. This value was calculated according to Table 7, after fitting a power law curve to the HI and the probability threshold values mentioned therein. As the wall height is  $H > 6$  m and the affected road length is 111 m the total cost is 1343.1 UC and the risk is 1,101.34, which is substantially higher than the previous one, as a consequence of the higher hazard in this section.

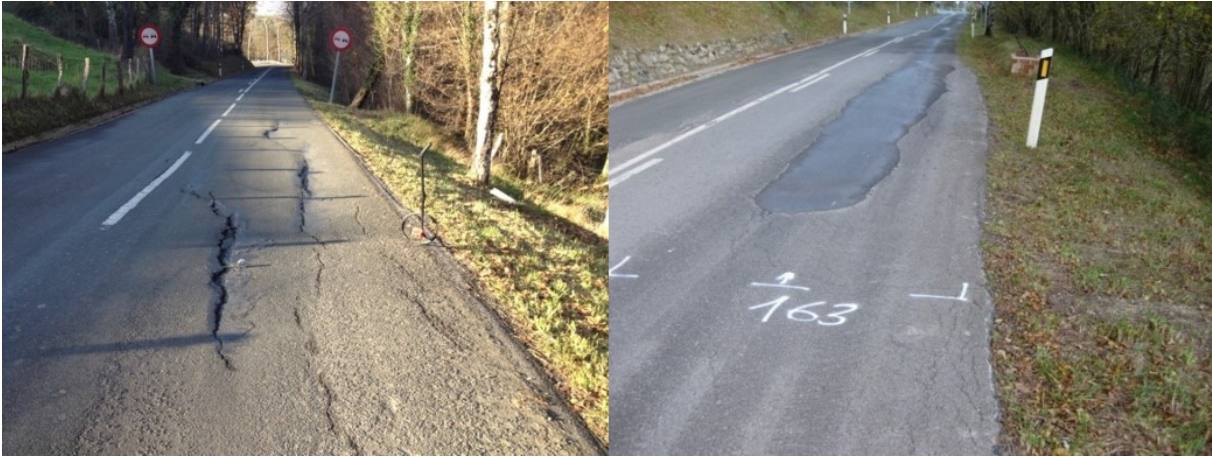
25 **Figure 9: Road sections situated within slow moving landslides, with damage: (left) PoR C3C of the road GI-2133 (from km 8.280) with observed deformations and cracks on the road pavement; (right) PoR C9G of the road GI2637 (from km 17.891 to 18.220) showing minor cracks already sealed.**

15 The soil instability affecting the C9G is ought as well to colluvial soil accumulations of 3-4 meters depth, over the bedrock. There are visible settlements and the ditches are deformed. The landslide is instrumented with two inclinometers that indicate that it is active.

The inclinometer measurements indicate vertical displacements lower than 2-3 mm and cumulative displacement lower than 30 mm, which points to a movement pattern of type X. There is not any scarp or developed shear displacements. Accordingly the probability of exceeding low damage is 1, moderate damage is 0.05 and high damage is 0.005. As previously, the probability is calculated for high damage: 0.005, for moderate damage: 0.045, and for low damage: 0.5, which for total a length of 300 m, and the same as previously costs, gives a total risk of 10.84.
