## Assessing the tsunami building vulnerability PTVA-3 and PTVA-4 models after the 16S 2015 event in the cities of Coquimbo – La Serena (Chile)

Eduardo Fritis<sup>1</sup>, Tatiana Izquierdo<sup>1</sup>, Manuel Abad<sup>1</sup>

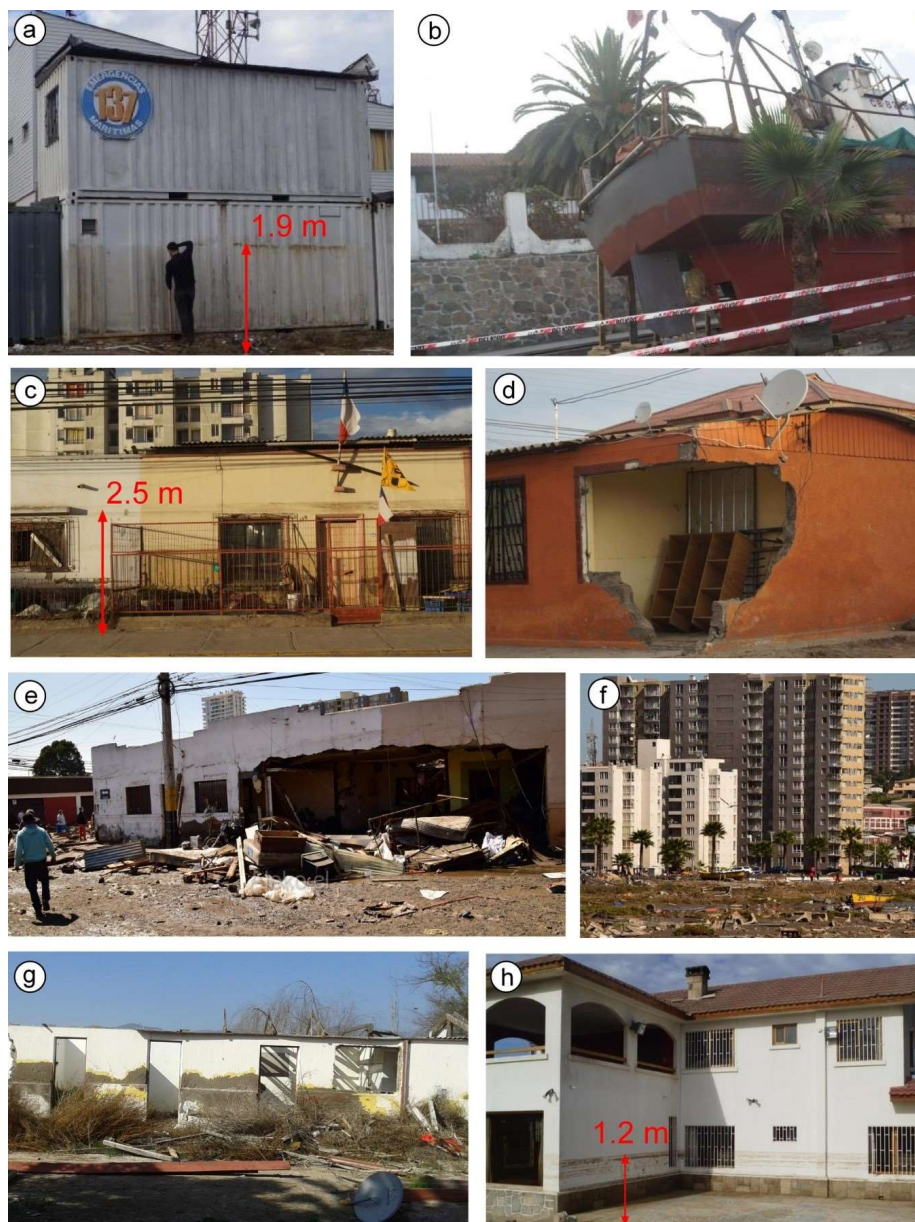
Figure 4: a) Building with average RVI score in the first coastline with flood heights of 1.9 m after the 2015 tsunami in Coquimbo Port (sector 1); b) Movable objects impacting residential buildings after the 2015 tsunami; c) High vulnerability building with more than 50% of its infrastructure flooded; d) High vulnerability building with its damaged infrastructure after the 2015 tsunami; e) Very high vulnerability building that resulted in non-repairable damage after the 2015 tsunami; f) Modern buildings with minor vulnerability RVI score; g) Very high vulnerability building highly affected by the tsunami in La Cantera sector; h) Not open plan ground floor.

La Cantera, located southeast of the Coquimbo Bay (Fig. 1 and 7) presents, as Sector 2 did, a moderate extension of marshland, i.e. a natural barrier, and no seawall protection, with an overall low topographic elevation. The flood scenario shows water depths that range from 0 to 3 m although in the urbanized area depths only reach up to 2 m. Most of the constructions in the sector are detached or bungalow houses isolated and separated several hundred of meters one from another. This circumstance increases the potential damage of the tsunami and movable objects impacts and therefore their vulnerability (Fig. 4g).

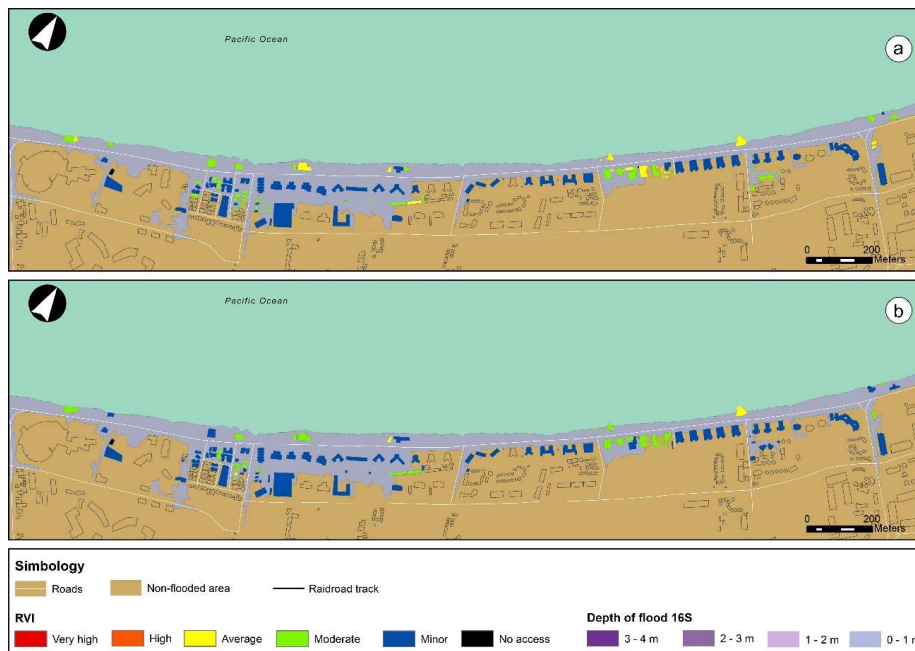
Figure 9: Relative Vulnerability Index for Sector 5 - La Pampa: a) PTVA-3 model; and d) PTVA-4 model.

construction materials, shallower foundations, and less floors being then, more vulnerable. A total of 120 buildings have been analysed in this sector (9.68% of the total). The results obtained (Fig. 9) classify the area as a relatively safe sector under the 2015 tsunami scenario, with most of the obtained RVI scores being minor in both models (Table 6). This last model obtains the largest number of minor RVI score as most of the polygons correspond to more than 5 stories buildings.

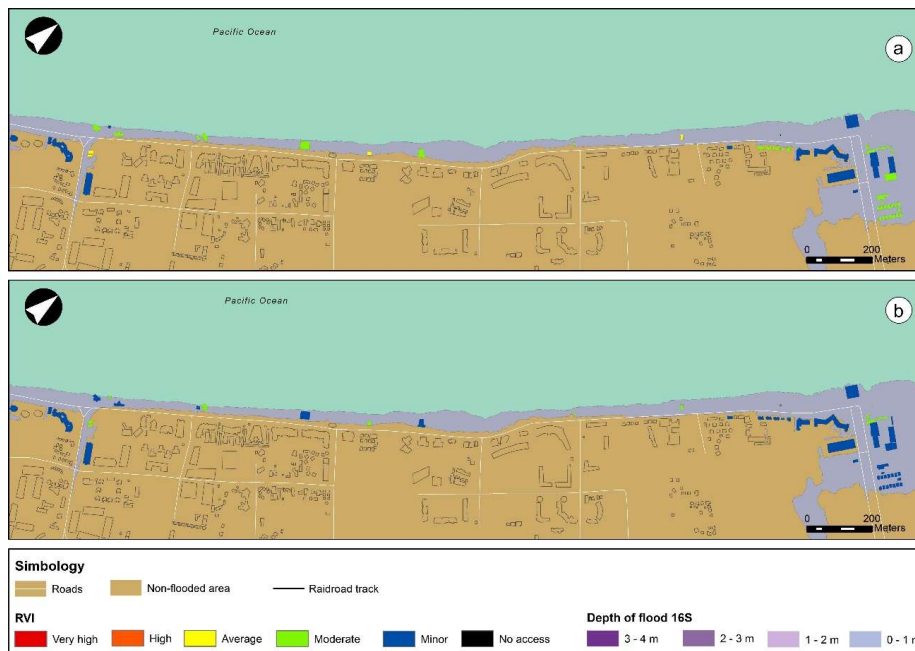
Figure 10: Relative Vulnerability Index for Sector 6 - La Serena: a) PTVA-3 model; and d) PTVA-4 model.

The last sector, La Serena, considers 4.6% of the studied polygons, i.e. 57 (Table 6). The flood depth in this area is <1 m with the smallest affected area. As in Sector 5, buildings in La Serena correspond to reinforced concrete structures with more than 5 floors. The RVI assessment shows that La Serena, is a sector with moderate - minor RVI scores for this tsunami scenario (89.48% and 98.25% for the PTVA-3 and PTVA-4 models, respectively) (Table 6). These circumstances are associated with the flood depth in the sector but mainly with the type of constructions (Fig. 10).
