The mudflow disaster at Villa Santa Lucía in Chilean Patagonia: understandings and insights derived from numerical simulation and post-event field surveys

5 Marcelo A. Somos-Valenzuela^{1,2}, Joaquín E. Oyarzún-Ulloa³, Ivo J. Fustos-Toribio^{3*}, Natalia Garrido-Urzu⁴, Chen Ningsheng^{5,6}

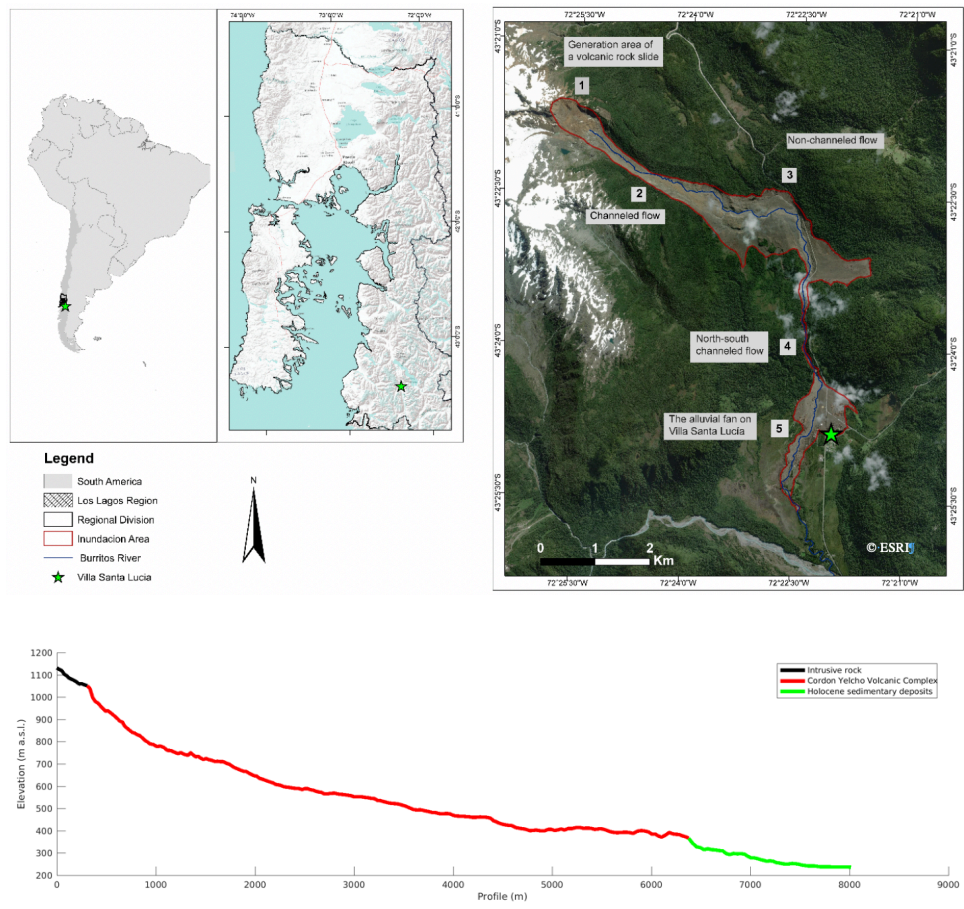
Figure 1: Top left: Study area and extension mudflow (South America and Los Lagos Region layer from <https://tapiquen-sig.jimdo.com>., Top right: Burritos River blue line layer from <http://datos.cedeus.cl/>, background © ESRI). Bottom: Elevation profile and geological formation along the mudflow path.

145 Through field observations, we identified five key sections that describe what happened in Villa Santa Lucía (Figures 1 and 3).

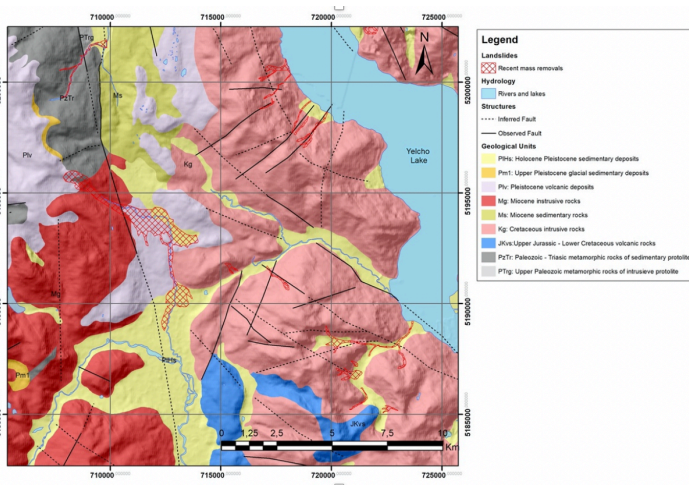
100 Figure 2: Geology of the study area (Modified from Sernageomin (1995))

The study area consists mainly of 9 geological units (Figure 2). The dominant geological unit corresponds to an intrusive rock (Cretaceous and Miocene age) composed of tonalites, granodiorites, granites, diorites, and others. Moreover, the basement material is an old metamorphic rock. This unit is composed of micaceous shales, amphibolite. Volcanic and volcanoclastic rocks represent, in part, the NW-SE volcanic arc, called the Cordón Yelcho Volcanic Complex (Sernageomin, 1995). Sedimentary rocks, mainly sandstone, shales, conglomerates are presented as intercalations. Recent sedimentary deposits are mainly associated with rivers, alluvial, colluvial, morainic and glaciolacustrine deposits (Aguilera et al., 2014) (Figure 2).

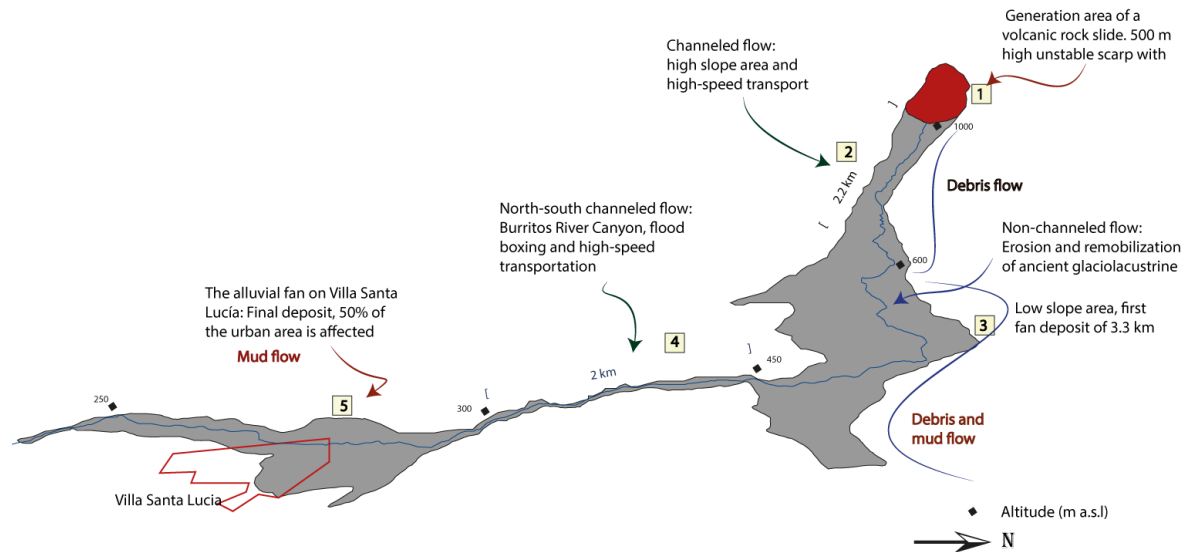
140 Figure 3: Flow trajectory scheme and details of the five key sections identified by Sernageomin and our fieldwork.

On December 16, 2017, a 7 million cubic meter volcanic rock slide detached (Figure 3, point 1), falling next to the Yelcho glacier toe that sits on an intrusive formation that has a drop of about 80 meters. The glacier shows a retreat of at least 250 meters during the last decade. Sernageomin (2018c) indicated that there might have been a small lake and water available on top of the intrusive formation, but there is no conclusive information. Satellite images before the events do not indicate a lake above the intrusive unit. Also, there were indications that ice contributed to the mudflow. Remote sensing data do not show that the landslide felt on top of the glacier unless detritus had covered the glacier, although we could see ice on top of the flank that collapsed. However, we do not have data to prove or disregard the covered ice on the intrusive and how much water it contributed to the mix. Two million cubic meters of the landslide material stayed above the intrusive, and five million cubic meters of material continued downstream, sliding on the intrusive unit at a slope of more than 70 degrees. At this point, the mudflow reaches the Burrito River with high topographic differences. The flow continued along with the drainage network at high speed (Figure 1 and Figure 3, point 2), adding a significant amount of sediment into the mudflow. The sediments are mainly associated with glaciolacustrine deposits (easy to mobilize) and ancient alluvials present in the valley and on the river walls.

1. Generation area: It has a range of peaks between 1,000 to 1,400 m a.s.l., with the main escarpment of 900 m long and 520 m wide. The north wall has maximum slopes between 77 to 81° (Figures 3 and 4a)
 As a result of the chain processes, the material deposited acts as a dam creating two small lakes. The largest lake has a length of 180 m and an average width of 50 m (Sernageomin, 2018).

2. Channeled flow: This corresponds to the upper segment at the foothills, the flow is channeled and travels 2 km. The flow width was between 200 to 400 m wide. Using photo-interpretation of the digital elevation models (SAF,

2017) and aerial photos, Sernageomin personnel (Sernageomin, 2018) estimated an approximate wave 20 m high (Figure 3 and 4 b).

160 3. Non-channeled flow: This section has a length of 2.3 km in a west to east direction until the Burritos River changes its orientation to a north-south direction. The elevation goes from 600 to 380 m a.s.l. The slopes decrease, slowing down the flow which deposited sediments. The non-channeled flow width reaches 1.4 km. In this sector, the flow goes over the road (Carretera Austral) to the east in 1.3 km, affecting an old wetland (Figure 3 and 4c-d).

165 4. North-south channeled flow: The flow descends through the enclosed channel at the Burritos River canyon from 380 to 250 m a.s.l. on a 2 km long section (Figure 3 and 4e-f).

5. The alluvial fan on Villa Santa Lucía: Due to the loss in confinement, the flow expands with a radial distribution in a southeast-southwest direction of 600 to 1,000 m (Figure 3 and 4g-h)

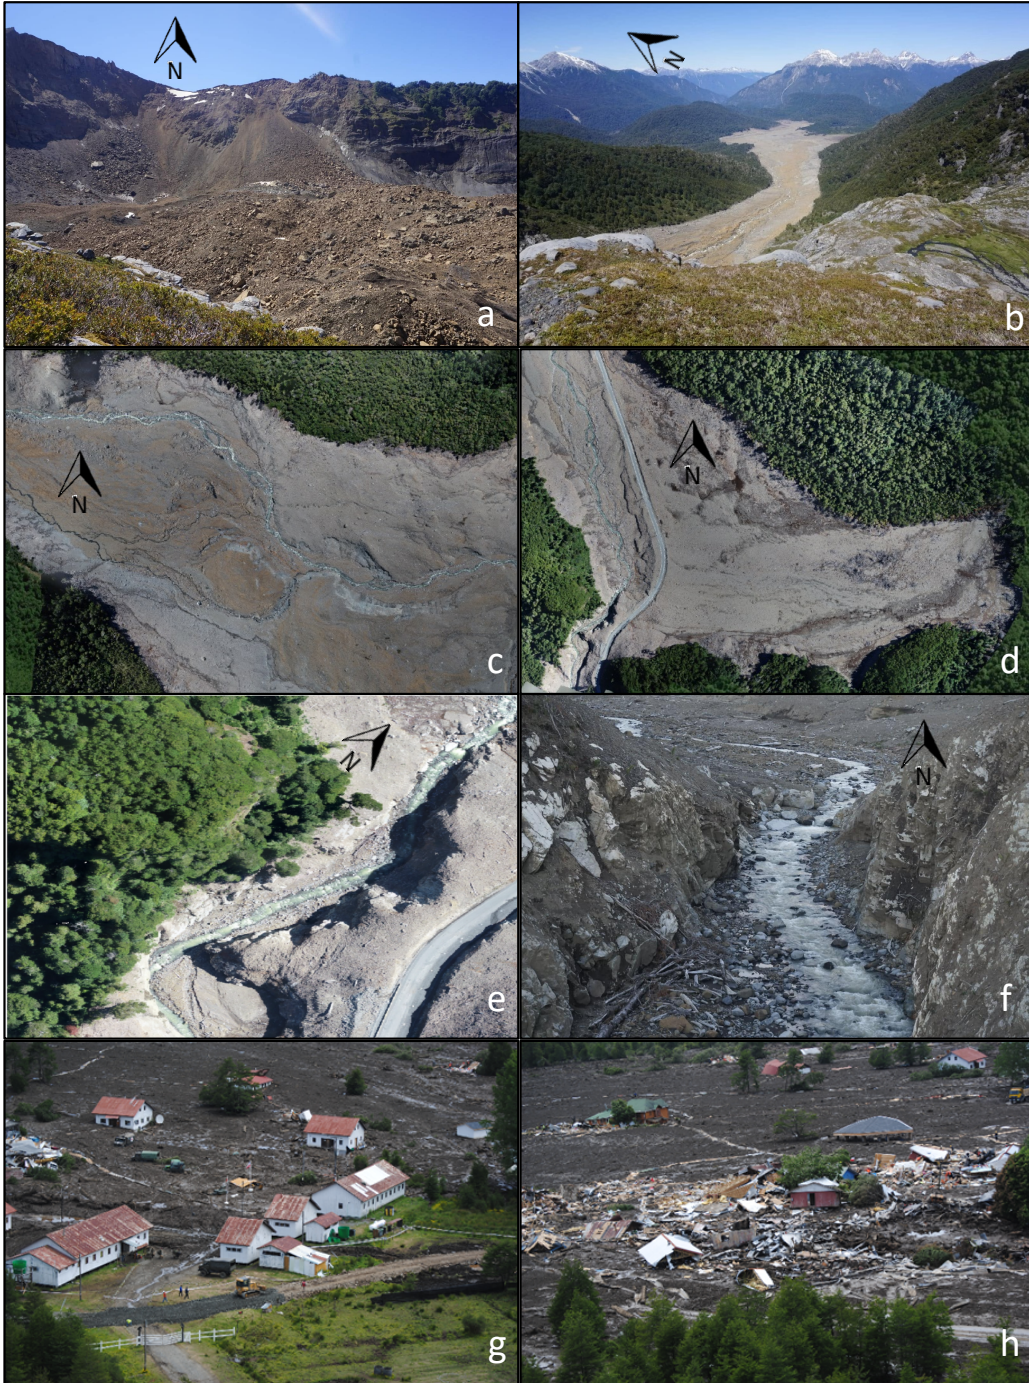
Figure 4: a) Area of slope failure slide and deposit; b) Channeled flow at the foothills; c and d) Aerial photo of non-channeled flood deposited in an old wetland captured with an InspireII UAV; e and f) photos of the channel in the last section before entering Villa Santa Lucia: left, captured with an InspireII UAV; right, picture of the channel facing downstream; h and i) Villa Santa Lucia after the mudflow (from Sernageomin (2018c)).

The speed of the flow at the Burritos River canyon (Figure 4e-f) and at the beginning of Villa Santa Lucía when the flow opens (Figure 4g-h) is approximately 20 m s⁻¹ (Sernageomin, 2018)

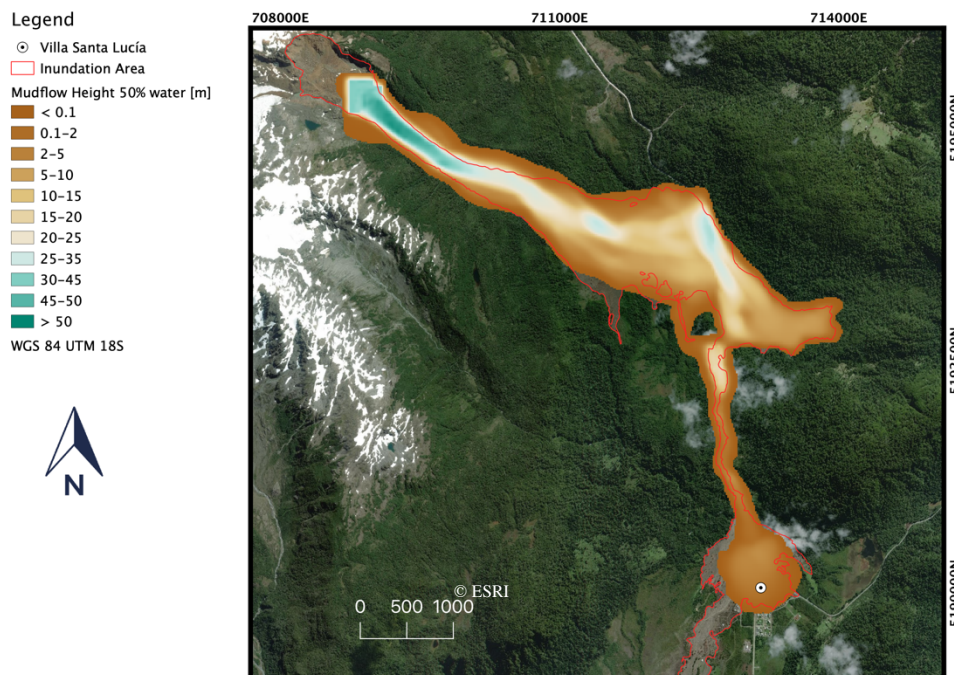
300 Figure 8: r.avaflow model results for a concentration by volume of 50% (Background © ESRI).

The best set of parameters is $10^{-5.75}$, 2, 0.022 and 0.0005 for the entrainment coefficient, basal friction angle, ambient drag coefficient and fluid friction coefficient, respectively, and the corresponding map result is in Figure 8.

Figure 8 shows good agreement with what was reported by (Sernageomin, 2018). However, the mixture is still largely fluidized, and it does not follow the edges of the inundation. For this reason, we performed simulations with the same input parameters but a varying percentage of initial water. We varied the percentage of water between 20% and 70%. The error for the heights, speeds calculated in each model are in Figure 9. Therefore, we propose that a mudflow with
305 a 30% water volume could reproduce best the VSL event (Figure 10).

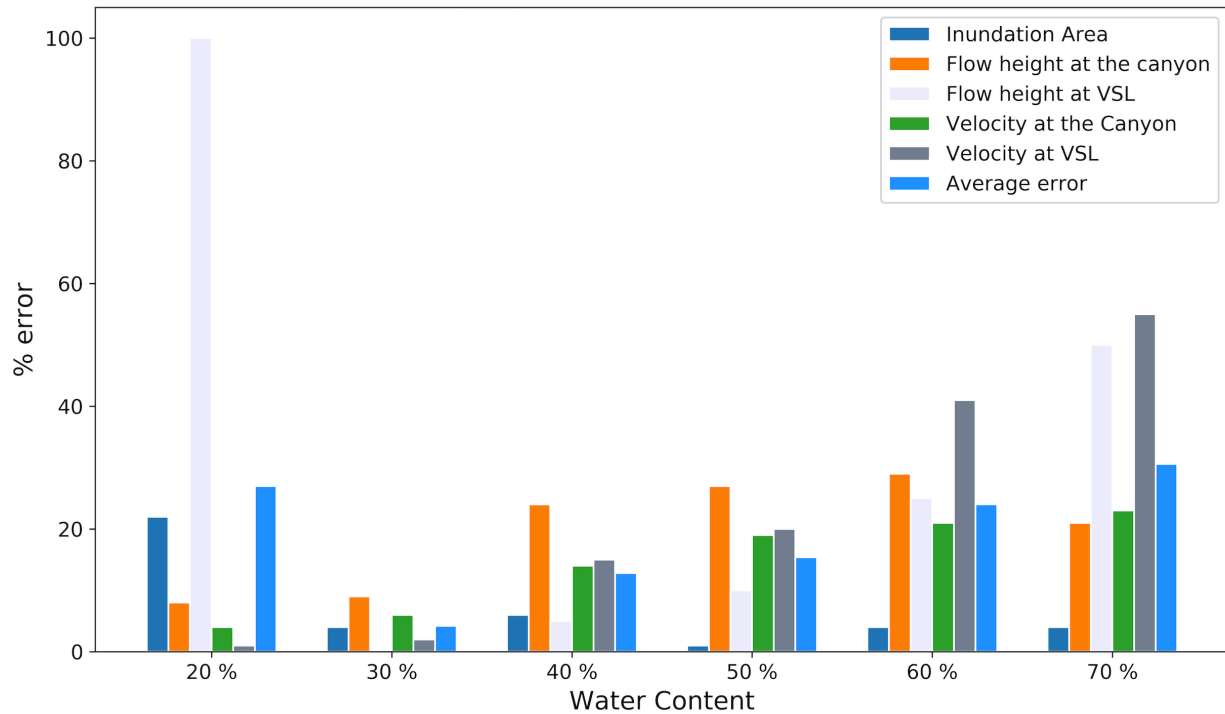
Figure 9: Error obtained with different water content and the best set of parameters obtained in the first calibration.

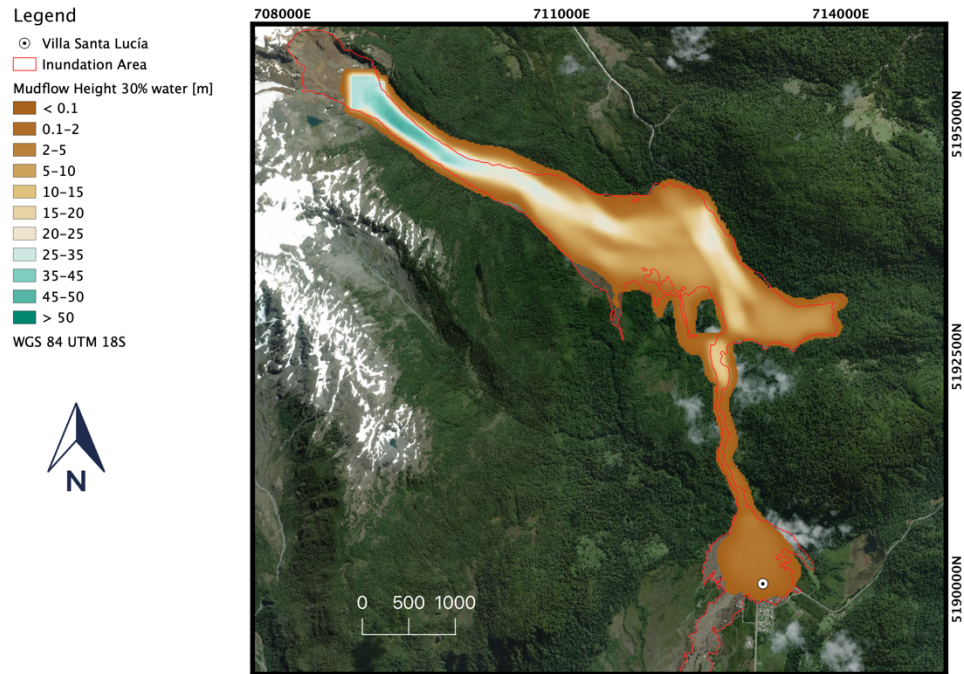
Figure 10: Simulation results using the calibrated parameters for r.avaflow and 30% water content (Background © ESRI)

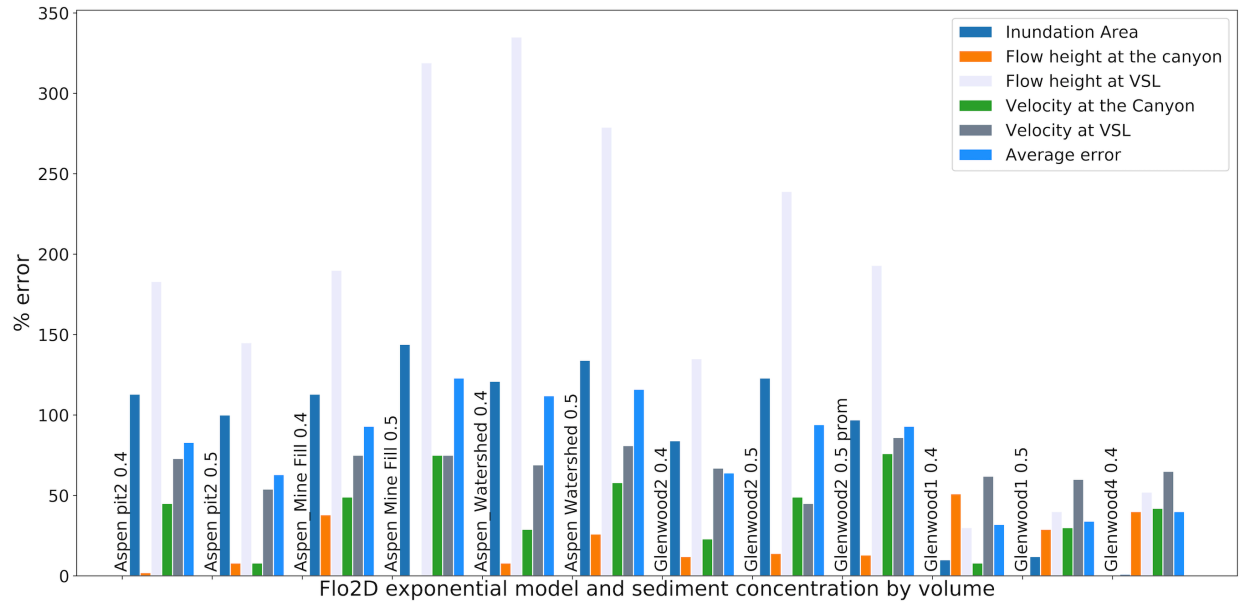
Figure 11: Sensitivity analysis for different dynamic viscosity and shear stress models (FLO-2D, 2018)

315 The main results from Flo-2D for the mudflow flow in Villa Santa Lucía are presented below. For the laminar resistance k , we used the default number 3000. The influence of the value of K does not affect simulations significantly compared to other parameters related to flow resistance (Hsu et al., 2010). The specific gravity of sediments G_s is equal to 2.65 g cm^{-3} . For the sediment concentration by volume, we used values between 40% to 50%, which correspond to mudflow flows. The error for the heights, speeds calculated in each model are in Figure 11. Figure 12

355 exaggerating the runout. The sensitivity analysis showed that r.avaflow is also sensitive to changes in the basal friction angle. These strongly condition the rheology of the flow, determining the height and speeds. The results obtained in the modeling in the FLO-2D software were diverse. We could not achieve the same level of r.avaflow's results. The inundation area was the most sensitive result in the concentration of sediments by volume and the rheology model (Figure 11). The best combination of parameters was the Glenwood 1 rheology model and a 40 % concentration
360 sediment, which has an error of 32%. We concluded that we could reproduce the mudflow satisfactorily using r.avaflow with water content in the mixture ranging from 30 to 40 % (Figure 11).

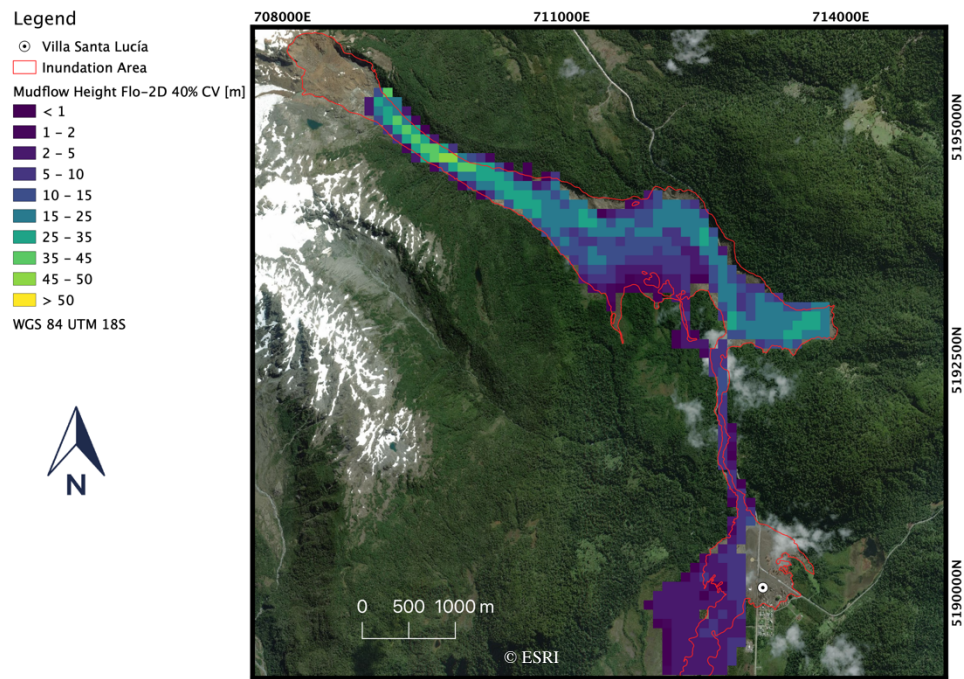
Figure 12: Result for Glenwood 1 using a 40% concentration of water by volume (Background © ESRI)
