# 1 CHILDA – Czech Historical Landslide Database

2 Michal Bíl<sup>1</sup>, Pavel Raška<sup>2</sup>, Lukáš Dolák<sup>3,4</sup>, Jan Kubeček<sup>1</sup>

8 **Abstract:** National and regional historical landslide databases are increasingly viewed as providing empirical  
9 evidence for the geomorphic effects of ongoing environmental change and for supporting adaptive territorial  
10 planning. In this work, we present the design and current content of the Czech Historical Landslide Database  
11 (CHILDA), the first of its kind for the territory of Czechia (the Czech Republic). We outline the CHILDA system,  
12 its functionality and technical solution. The database was established by merging and extending the fragmented  
13 regional datasets for highly landslide prone areas in Czechia. Currently, the database includes 699 records (619  
14 landslides, 75 rockfalls, and 5 other movement types) encompassing the period from the oldest determined records  
15 (1132) up to 1989 which represents an important cultural, political and socioeconomic divide.

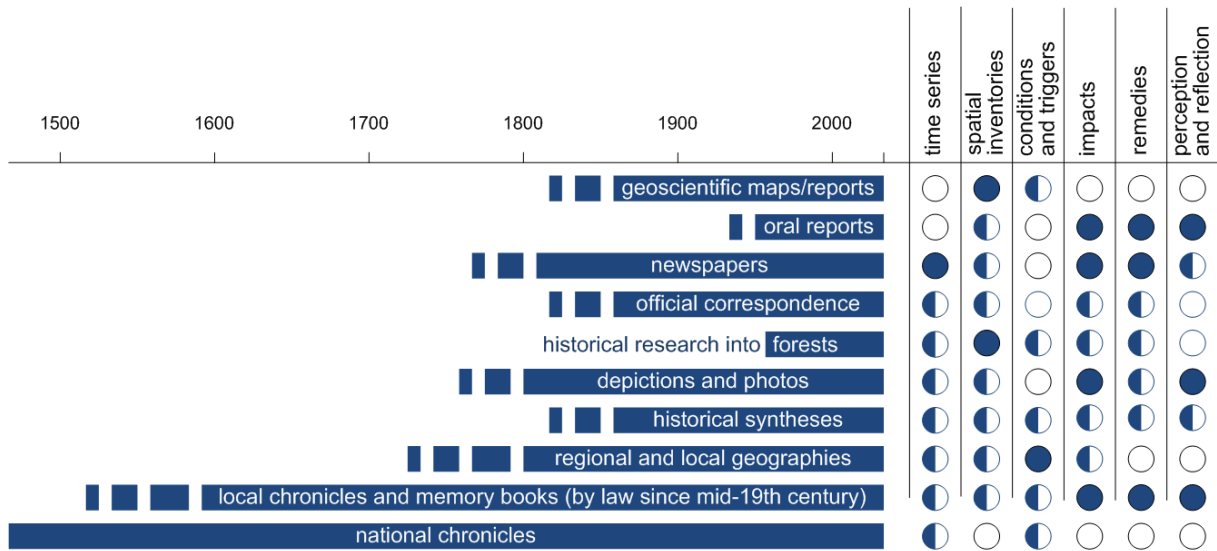
157 Informational content ○ exceptional ◐ partial ● prevailing

158 *Figure 2 An overview of available documentary data applicable for historical landslide research in Czechia with*  
 159 *respect to their time coverage and informational content*

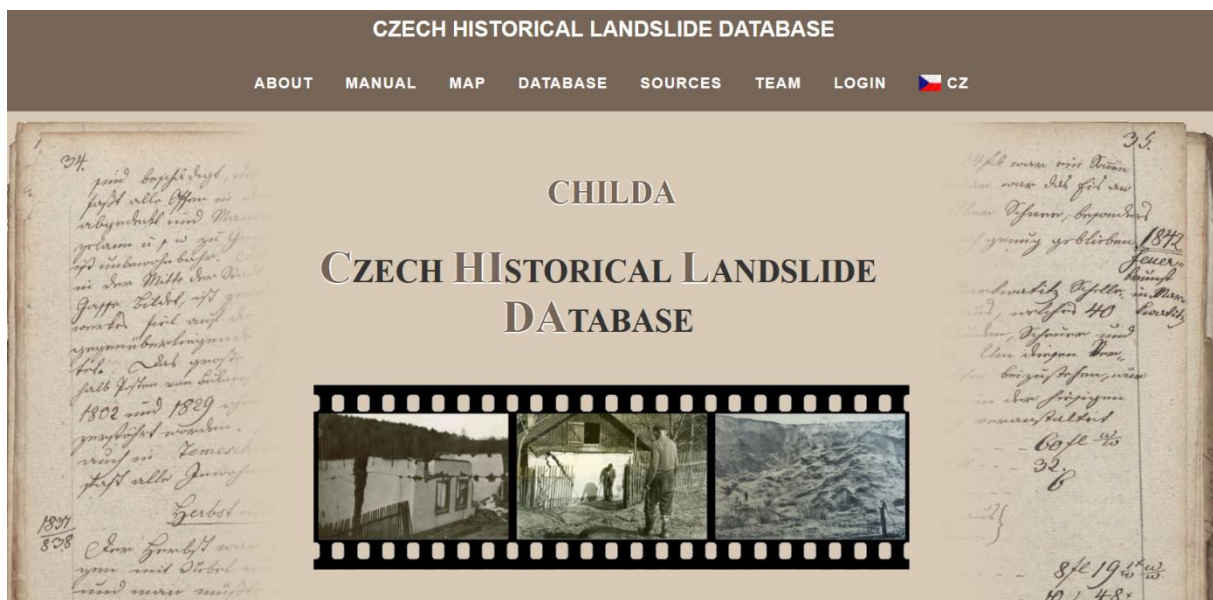
181 Figure 3: Title page of CHILDA ([www.childa.cz](http://www.childa.cz)).

177 The database can be accessed through a web-map application at <https://childa.cz> (Figure 3). CHILDA is  
178 administrated and hosted on the CDV – Transport Research Centre servers. The software requirement is as  
179 follows: PostgreSQL/PostGIS, php, php NetteFramework, HTML, CSS, JQuery.
