# Brief Communication: Critical Infrastructure impacts of the 2021 mid-July western European flood event

**Abstract.** Germany, Belgium and The Netherlands were hit by extreme precipitation and flooding in July 2021. This Brief Communication provides an overview of the impacts to large-scale critical infrastructure systems and how recovery has progressed during the first six months after the event. The results show that Germany and Belgium were particularly affected, with many infrastructure assets severely damaged or completely destroyed. Impacts range from completely destroyed bridges and sewage systems, to severely damaged schools and hospitals. We find that (large-scale) risk assessments, often focused on larger (river) flood events, do not find these local, but severe, impacts: [due to critical infrastructure failures](#). This may be the result of limited availability of validation material. As such, this [study Brief Communication](#) will not only help to better understand how critical infrastructure can be affected by flooding, but can also be used as validation material for future flood risk assessments.

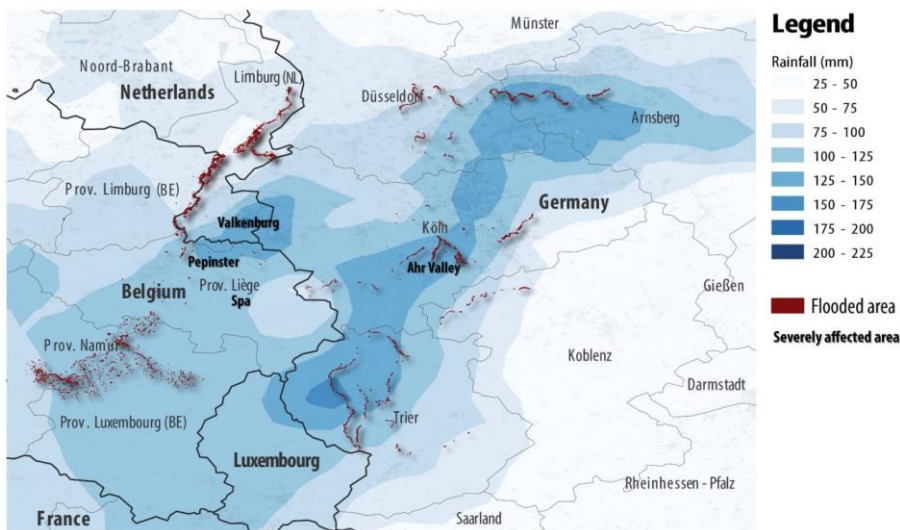
Figure 1. The affected area considered in this study. The figure shows accumulated rainfall over July 13-15 and the most severely flooded areas in red. Sources: Copernicus Emergency Management Services (2021) and the E-OBS dataset (Corns et al., 2018).

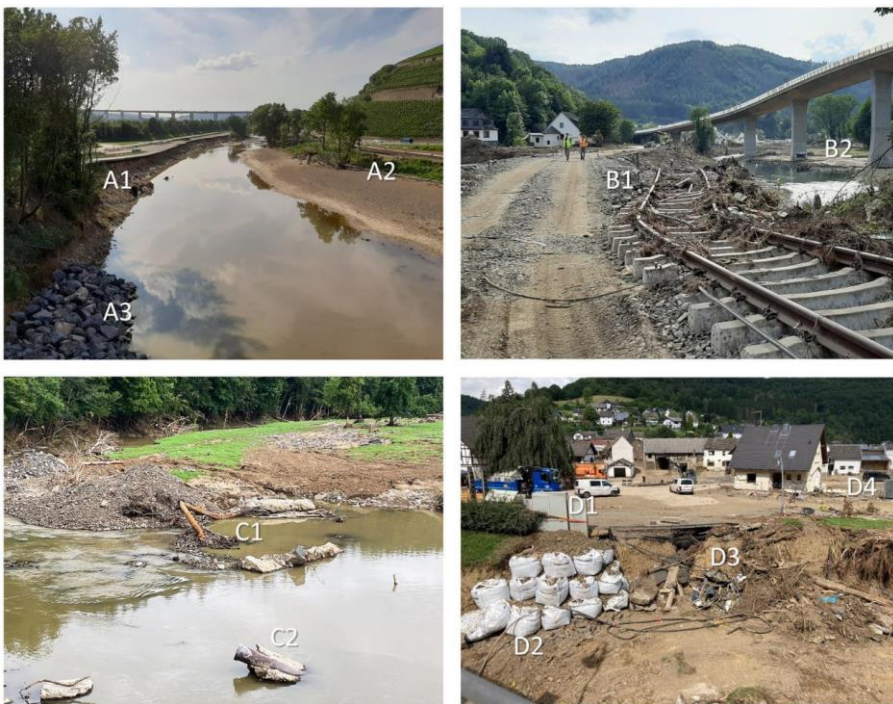
**Figure 2.** Damage in the Ahr Valley, Germany (11 August 2021). Top-left: destruction of federal highway B266 (A1) and railway 50 (A2) near Heimersheim, the bridge from which the photo was taken has been stabilized (A3). Top-right: further upstream in the Ahr valley (Altenburg), large stretches of the Ahrtalbahn railway have been destroyed (B1) and the few remaining road and rail bridges show signs of temporary repairs (B2). Bottom-left: river bed erosion uncovered and destroyed many cables supposed to lie more than 80 cm below surface level (C1) as well as sewers (C2). Bottom-right: inundated electricity distribution infrastructure (D1), road erosion and stabilisation (D2), uncovered cables (D3) and collapsed buildings in Schuld. Pictures by Margreet van 55—Marle/Deltares/GEERassociation, distributed under Creative Commons Attribution 4.0 license.

60 later, with an estimated repair cost of 100 million ~~euro~~Euro (Hauser, 2021). Of the 112 bridges in the flooded ~~40 km~~40 km of the Ahr Valley (Rheinland Pfalz), 62 bridges were destroyed, 13 were severely damaged, and only 35 were in operation a month after the flood event (~~Deutsche Welle~~Hochwasser Ahr, 2021; FAZ, 2021). Over 74 ~~kilometers~~km of roads, paths and bridges in the Ahr valley have been (critically) damaged. In some cases, repairs are expected to take months to years (Zeit Online, 2021). For example, major freeway sections, ~~such as including parts of the Autobahn A1/A62 intersection near Erftstadt-Blessem will be motorway were~~ closed ~~for repairs until at least~~ early 2022 (~~Wehmann~~24Rhein, 2022). In addition, about 50,000 cars were damaged, causing insurance claims of some 450 million Euro (ADAC, 2021). The German railway provider Deutsche Bahn expects asset damages of around 1.3 billion euros. Among other things, 180 level crossings, almost 40 signal boxes, over 1000 catenary and signal masts and 600 ~~kilometers~~km of tracks were destroyed, as well as energy supply systems, elevators and lighting systems (MDR, 2021b). ~~It is expected that~~ 9By April 2022, 11 of the 14 affected rail stretches ~~will be fully functional again. The less damaged stretches were~~ functional again within ~~six~~3 months, while ~~two years are needed before all~~some of the most damaged sections in the Ahr Valley are operational (~~Munchow, 2021~~), ~~expected to be finished by the end of 2025 (DB, 2022)~~. In Belgium, approximately 10 km of railway tracks and 3000 sleeper tracks have to be replaced, ~~50 km~~50 km of

160 Reconnaissance observations (August 2021) along the rivers Ahr and Erft (Lemnitzer et al., 2022) documented severe, as well as irreparable damage to bridges designed and constructed within the last two decades; and total destruction of almost all historical bridges, typically constructed on shallow foundations. Historical bridge designs concentrated primarily on freeboard cross-sectional requirements for expected water volumes. Triggered by flood events in the past four decades, bridge design research has ~~focused~~ broadened by focusing on risk-based scour assessment, hydrodynamic pier designs, reduction of  
 165 intermediate bridge support elements, impact and collision loading, implementation of bridge protection mechanisms such as from wood debris, as well as machine learning approaches from past failures (VAW 188, 2006, Bento et al., 2020, Majtan et

focus, as the interface stability between water, soil and foundation elements was found to be compromised at almost all bridge damage locations visited.

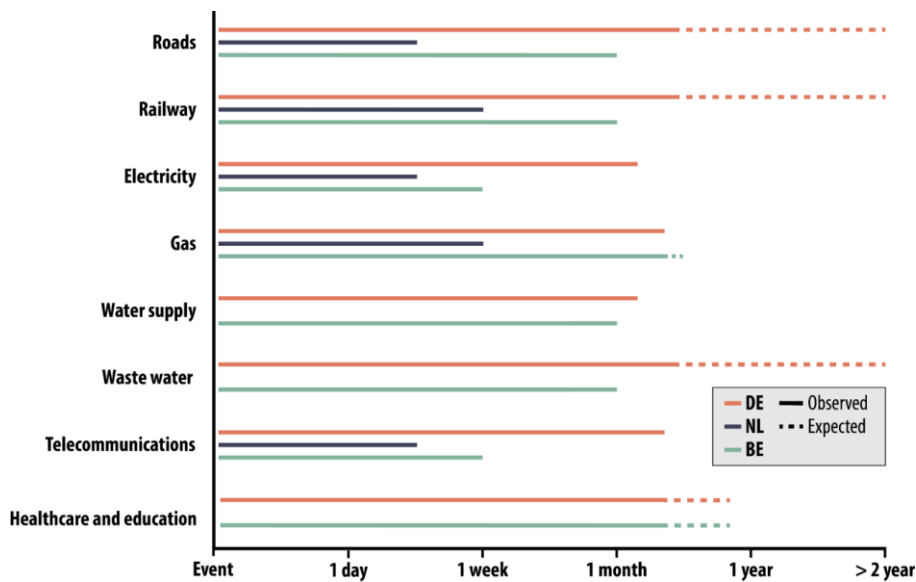
dered in this study. It should be noted that this figure presents reconstruction efforts of the system. No line indicates that no impacts are observed. Solid waste is not included in the figure, as no impacts were recorded within each country.
