# Brief Communication: Critical Infrastructure impacts of the 2021 mid-July western European flood event

10 **Abstract.** Germany, Belgium and The Netherlands were hit by extreme precipitation and flooding in July 2021. This Brief Communication provides an overview of the impacts to large-scale critical infrastructure systems and how recovery has progressed during the first six months after the event. The results show that Germany and Belgium were particularly affected, with many infrastructure assets severely damaged or completely destroyed. Impacts range from completely destroyed bridges and sewage systems, to severely damaged schools and hospitals. We find that (large-scale) risk assessments, often focused on  
15 larger (river) flood events, do not find these local, but severe, impacts due to critical infrastructure failures. This may be the result of limited availability of validation material. As such, this Brief Communication will not only help to better understand how critical infrastructure can be affected by flooding, but can also be used as validation material for future flood risk assessments.

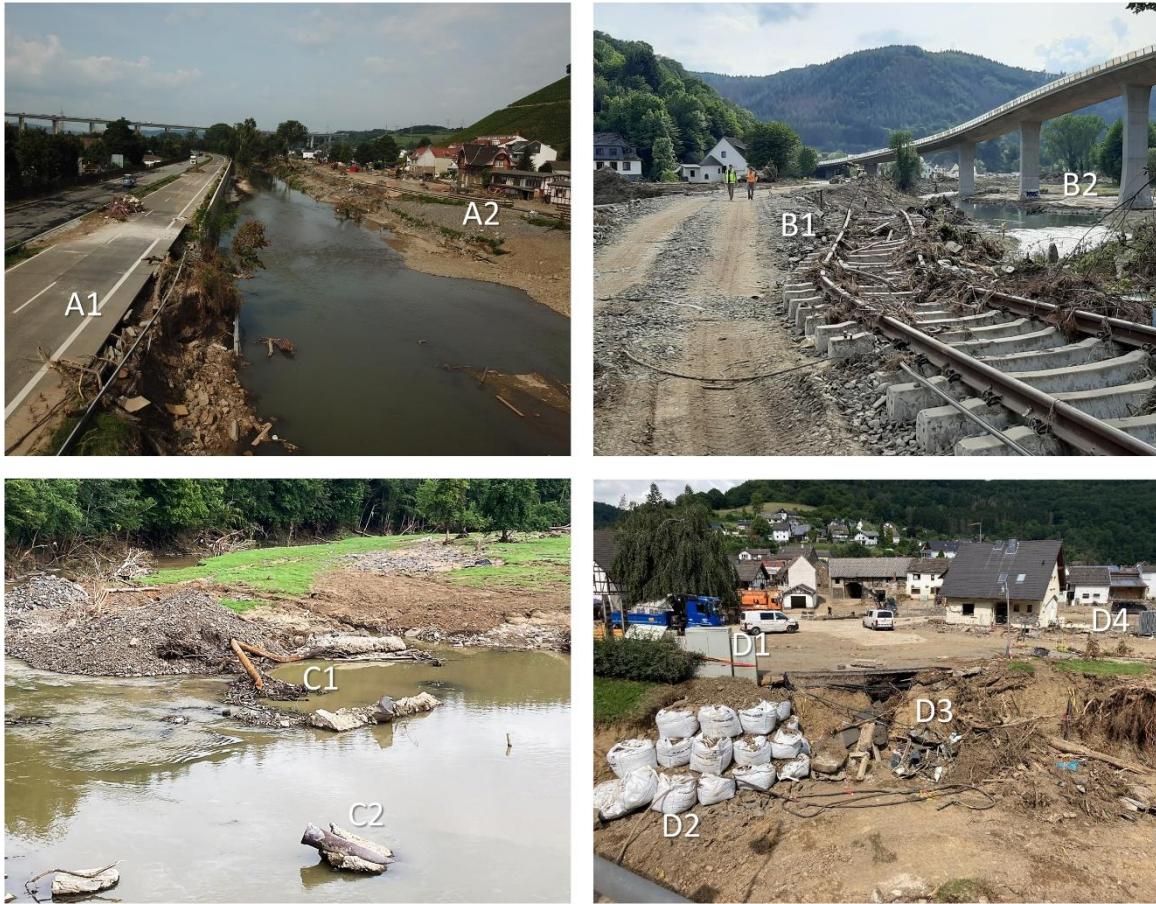
**Figure 1. Damage in the Ahr Valley, Germany (images taken on 11 August 2021).** Top-left: destruction of federal highway B266 (A1) and railway (A2) near Heimersheim. Top-right: further upstream in the Ahr valley (Altenburg), large stretches of the Ahrtalbahn railway have been destroyed (B1) and the few remaining road and rail bridges show signs of temporary repairs (B2). Bottom-left: river bed erosion uncovered and destroyed many cables supposed to lie more than 80 cm below surface level (C1) as well as sewers (C2). Bottom-right: inundated electricity distribution infrastructure (D1), road erosion and stabilisation (D2), uncovered cables (D3) and collapsed buildings in Schuld. Pictures by Margreet van Marle/Deltares/GEERassociation, distributed under Creative Commons Attribution 4.0 license.

In Germany, road and railway infrastructure has been severely damaged as documented exemplarily in Figure 1. Cost estimates reach up to 2 billion Euro (MDR, 2021a). More than 130 km of motorways were closed directly after the event, 50 km were still closed two months later, with an estimated repair cost of 100 million Euro (Hauser, 2021). Of the 112 bridges in the flooded 40 km of the Ahr Valley (Rheinland Pfalz), 62 bridges were destroyed, 13 were severely damaged, and only 35 were in operation a month after the flood event (Hochwasser Ahr, 2021). Over 74 km of roads, paths and bridges in the Ahr valley have been (critically) damaged. In some cases, repairs are expected to take months to years (Zeit Online, 2021). For example, major freeway sections, including parts of the A1 motorway were closed until early 2022 (24Rhein, 2022). In addition, about 50,000 cars were damaged, causing insurance claims of some 450 million Euro (ADAC, 2021). The German railway provider Deutsche Bahn expects asset damages of around 1.3 billion euros. Among other things, 180 level crossings, almost 40 signal boxes, over 1000 catenary and signal masts and 600 km of tracks were destroyed, as well as energy supply systems, elevators and lighting systems (MDR, 2021b). By April 2022, 11 of the 14 affected rail stretches are fully functional again. The less damaged stretches were functional again within 3 months, while some of the most damaged sections in the Ahr Valley are expected to be finished by the end of 2025 (DB, 2022). In Belgium, approximately 10 km of railway tracks and 3000 sleeper tracks have to be replaced, 50 km of catenary needs to be repaired and 70,000 tonnes of railway track bed needs to be placed, with estimated costs between 30-50 million Euro (Rozendaal, 2021a). Most damages have been repaired within two weeks. The most severely damaged railway line (between the villages of Spa and Pepinster) was reopened again on October 3, 2021 (Rozendaal, 2021b). In the Netherlands, no large-scale damage has been reported to transport infrastructure. A few national

170 Reconnaissance observations (August 2021) along the rivers Ahr and Erft (Lemnitzer et al., 2022) documented severe, as well  
as irreparable damage to bridges designed and constructed within the last two decades; and total destruction of almost all  
historical bridges, typically constructed on shallow foundations. Historical bridge designs concentrated primarily on cross-  
sectional requirements for expected water volumes. Triggered by flood events in the past four decades, bridge design research  
175 has broadened by focusing on risk-based scour assessment, hydrodynamic pier designs, reduction of intermediate bridge  
support elements, impact and collision loading, implementation of bridge protection mechanisms such as from wood debris,  
as well as machine learning approaches from past failures (VAW 188, 2006, Bento et al., 2020, Majtan et al., 2021, Naser,  
2021). Accounting for all these mechanisms, however, is complex (Haehnel and Daly, 2002) and no guarantee to avoid the

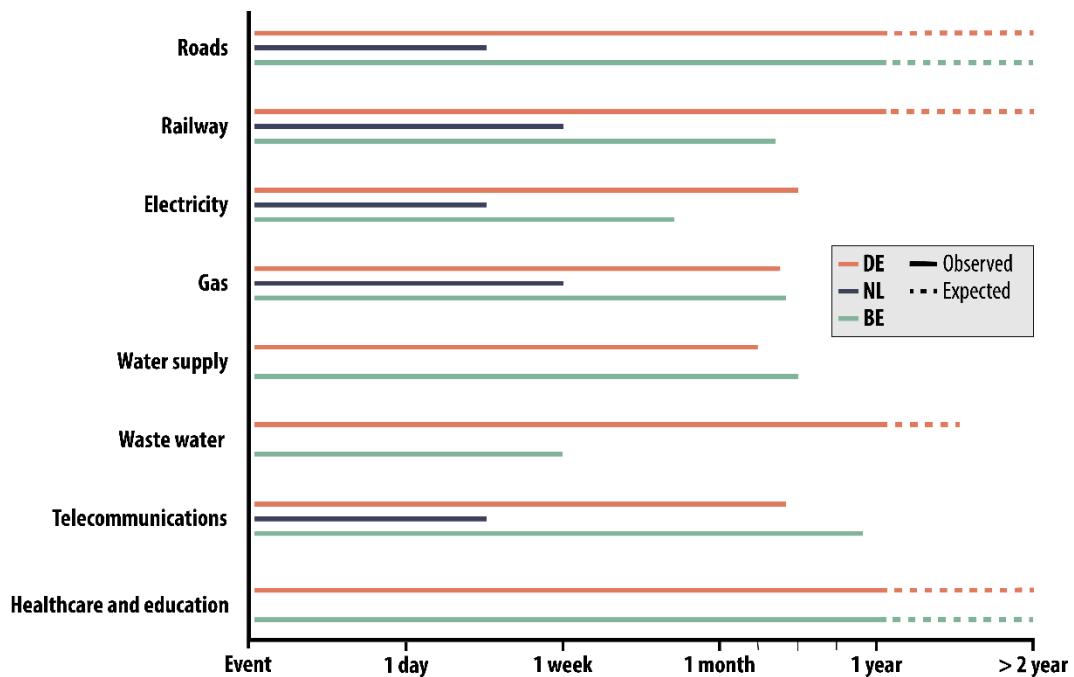
Figure 2. Overview of observed and expected reconstruction duration of each infrastructure sector considered in this study. It should be noted that this figure presents reconstruction efforts of the system. No line indicates that no impacts are observed. Solid waste is not included in the figure, as no impacts were recorded within each country.
