Rapid Landslide Risk Zoning toward Multi-Slope Units of the Neikuihui Tribe for Preliminary Disaster Management

Chih-Chung Chung¹, Zih-Yi Li²

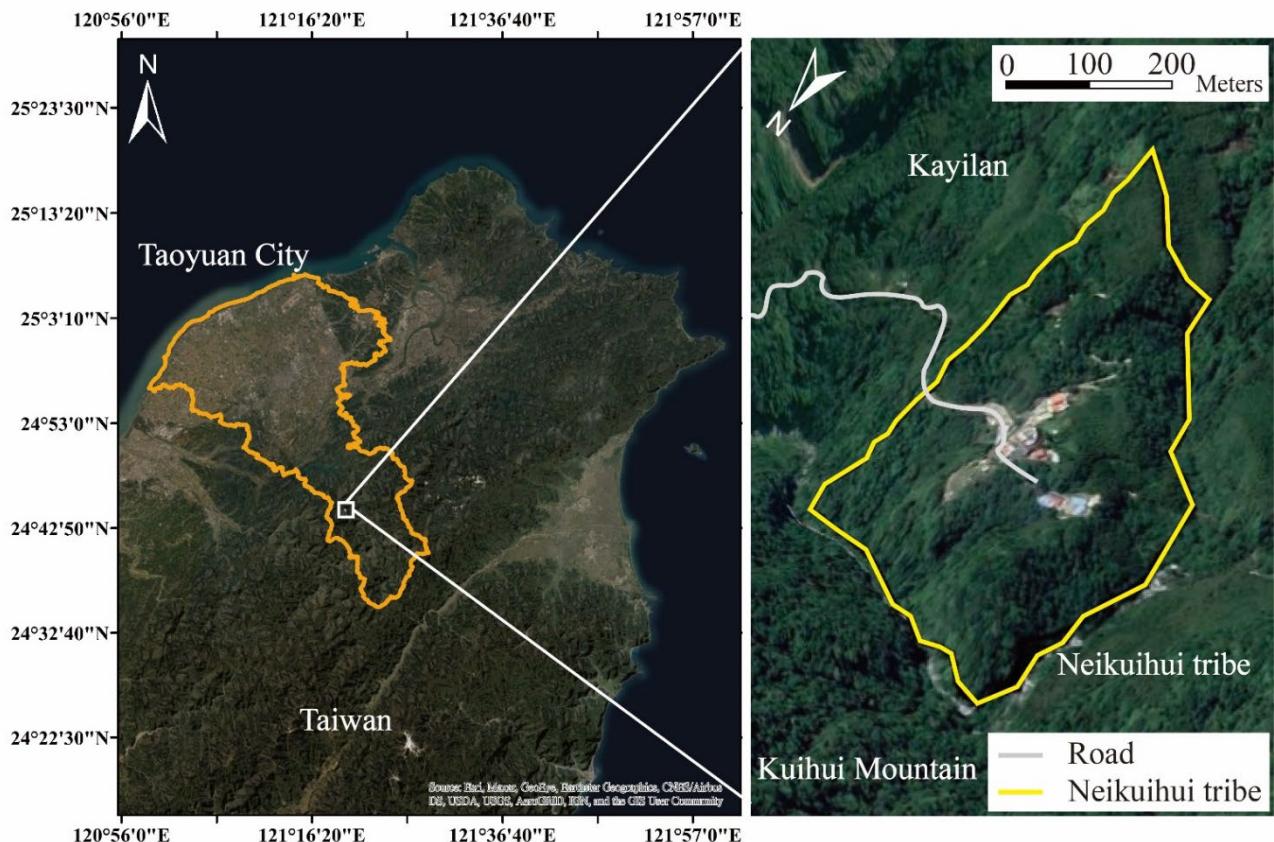
Figure 1 Location of the Neikuihui tribe (image source: Esri, DigitalGlobe, GeoEye, Earthstar Geographics, CNES/Airbus DS, USDA, USGS, AeroGRID, IGN, and the GIS User Community); Aerial: ESRI ArcGIS 10.4).

The administrative area of the Neikuihui tribe belongs to Taoyuan City, as shown in Fig. 1. The total area is around 21 hectares, 90 and most of the residents live in the northwest of the tribe. It is located on the southern slope of the Yanshan ridge of the Kuihui Mountain, looking to the Ronghua Valley, and two kilometers northwest of Kayilan. The most residents~~They are the inhabitants who lived here before, named~~ aborigines in Taiwan. Since the Neikuihui tribe has only one external road and frequent rockfall disasters, most residents have moved north to Kuihui Village, and only about 15 households are left in the Neikuihui tribe.

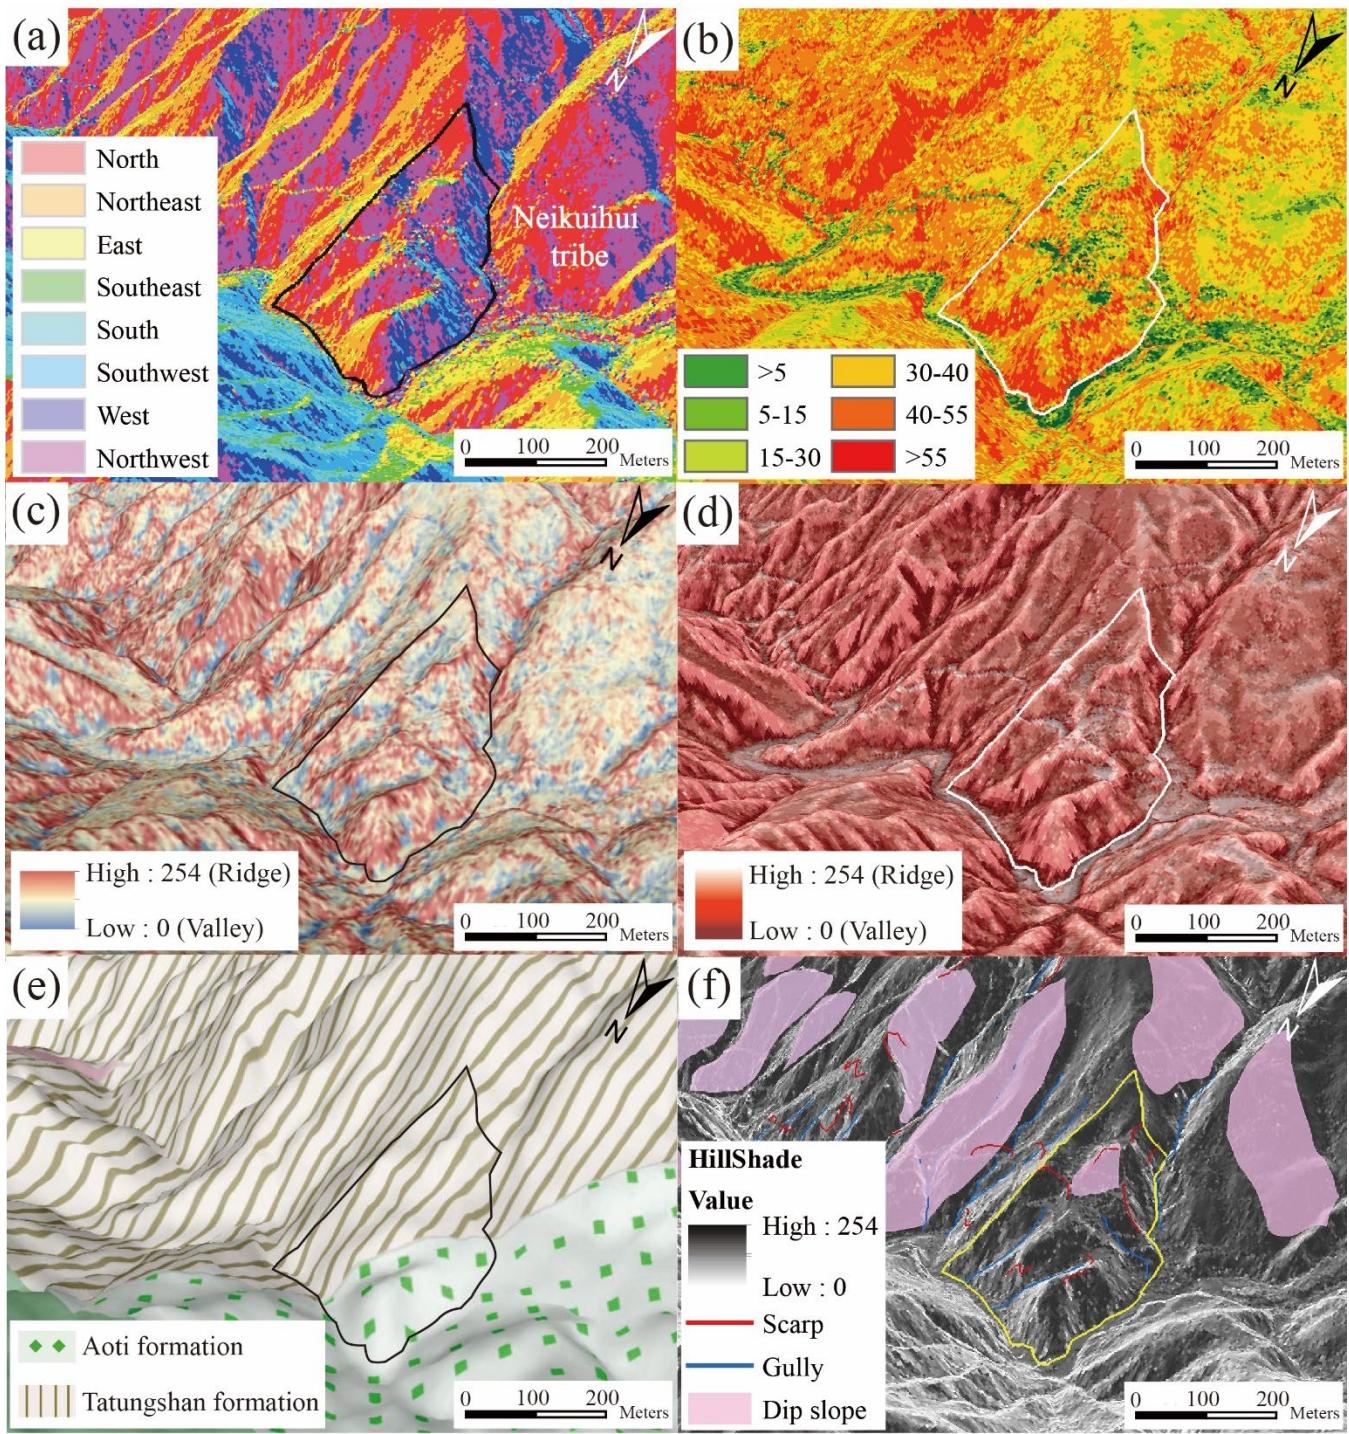
Figure 2 Basic geology and environment of the Neikuihui tribe **(a)** slope aspect (modified after Department of Lands, Ministry

of the Interior 2020); **(b)** slope map (modified after Department of Lands, Ministry of the Interior 2020); **(c)** CS map (modified after Department of Lands, Ministry of the Interior 2020); **(d)** Relief map (modified after Department of Lands, Ministry of the Interior 2020); **(e)** 1:250,000 geological map (modified after Central Geological Survey 2020); **(f)** Geologically sensitive area distribution map (modified after Department of Lands, Ministry of the Interior 2020) with a hillshade based map ; Aerial: 120 ESRI ArcGIS 10.4.

95 To better visualize the terrain features, the 1 m x 1 m Digital Elevation Model (DEM) is employed as a basement basis in Fig.2. The overall slope aspect of the tribe is mainly northwest (Fig. 2a), with an average slope degree of 43.9° (Fig. 2b). Fig.

2c and Fig.2d show the CS (Curvature-Slope) map and Relief map based on the 1 m x 1 m DEM, respectively. The 100 CSMaker plugin on QGIS produced by Asahi (2014) was applied to generate the CS map, where a CS topographic map is made of altitude, curvature, and slope degree (Asahi 2014). Fig. 2c is provided with color attributes suggested by Asahi 105 (2014) that Light Blue indicates valleys and Light Red indicates the ridge. Meanwhile, the Relief Visualization Toolbox application (Zakšek et al., 2011; Kokalj et al., 2019) is applied for generating the Relief map (Fig. 2d) with attributes that the darker the color, the closer the river valley, and the lighter color means the closer to the ridge. CS and RED These maps can support characterize the slope features quickly.

Figure 2e is a 1:25,000 geological map of the Central Geological Survey (2020). The strata include the Tatongshan and the 110 Aoti formations, of which the Tatongshan formation is composed of black hard shale and siltstone interbedded, often forming steep slopes along the river bed. Aoti formation is composed of sandstone with a coal seam. Besides, there is a Ronghua Stream flowing through the Neikuihui tribe region. Figure 2f is visualized based on a hillshade map from 1 m x 1 m DEM. Figure 2f also reveals the locations of dip slopes from the Central Geological Survey (2020), and these dip slopes are geologically sensitive to the safety of the local settlements.

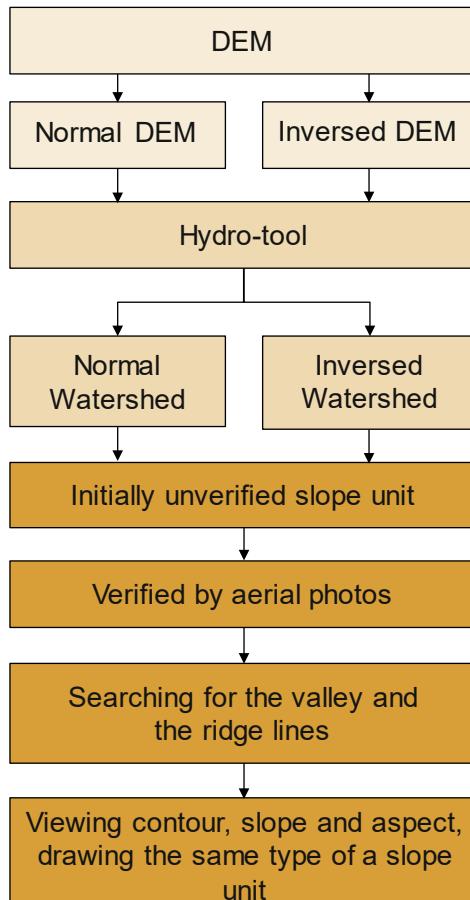
Figure 3 Process of delimited slope units (modified after Wang et al. 2016).

140 The size of the slope units can be tailored to the type and size of the landslides since a slope unit has more geomorphological and geological significance than a grid unit (Carrara et al., 1991; Alvioli et al., 2016). Accordingly, a modified method is introduced to delimit slope units and depict slope profiles based on high-resolution DEM (1 m x 1 m) via GIS in this study. The slope-unit delimiting method is supported by a GIS-based hydrological analysis and modeling tool, Arc Hydro, which originally incorporates DEM and reversed DEM approaches (Maidment, 2002; Xie et al., 2003; Wang et al., 2016). Based on 145 Xie et al. (2004) classification, GIS-based hydrological analysis and modeling tools are implemented to divide the watershed into slope units through the proposed processing chart of delimited slope units, as illustrated in Fig. 3.

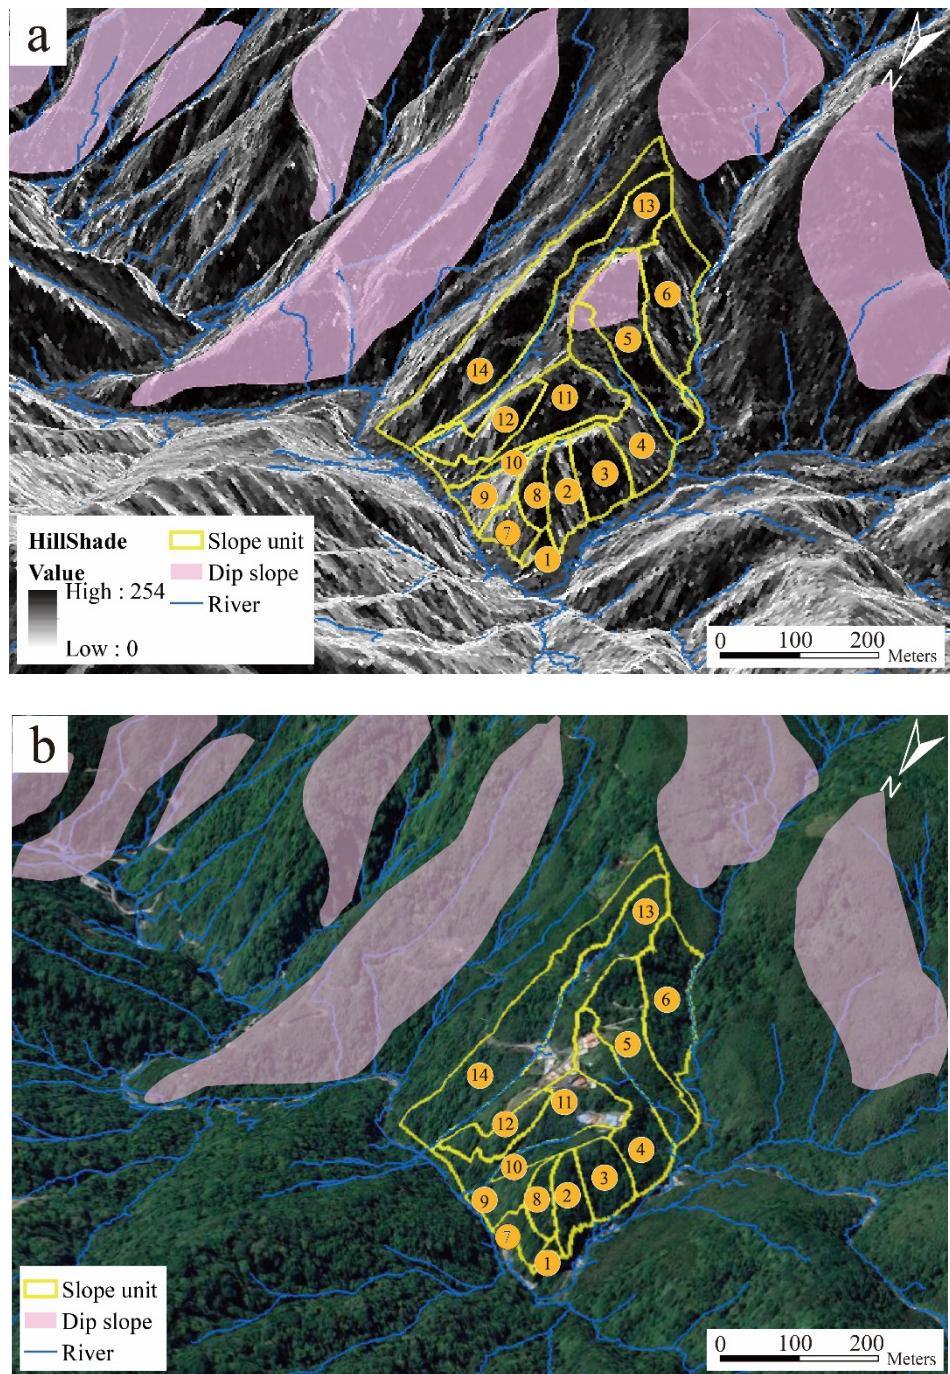
160 **Figure 4** (a) Distributions of 14 slope units around the Neikuihui tribe (Background: modified after Department of Lands, Ministry of the Interior 2020; Aerial: ESRI ArcGIS 10.4); (b) households distribution map (Background: modified after © Google Earth 2021; Aerial: ESRI ArcGIS 10.4)

Figure 4a depicts the 14 delimited slope units around the Neikuihui tribe based on 1 m × 1 m DEM via Hydro-tool in ArcGIS (Xie et al., 2004), and Fig.4b illustrates the slope units mapping to the aerial photo. Subsequently, related environmental factors and features were analyzed, including slope aspect, slope degree, valley, and ridge, as pointed out in Fig.2. Then 14 slope units accompanied with scarps and eroded gullies are manually drawn based on Fig. 2f and aerial photos. According to the improved framework of risk zoning as proposed in Fig. 5, the 14 slope units were graded regarding landslide Hazard, Exposure, and Vulnerability factors. The corresponding Risk scores of each slope unit were consequently obtained. These scores are expected to support revealing the Risk level and a disaster reduction strategy for the slope unit to reduce the impact of the disaster.

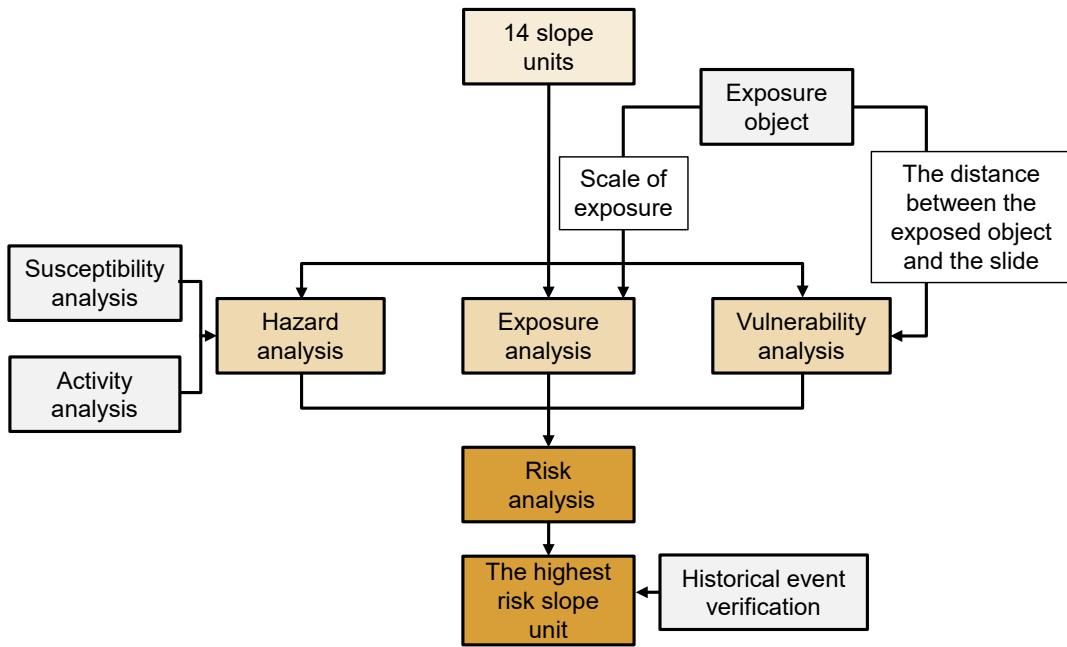
Figure 5 Improved framework of risk zoning for multi-slope units and the corresponding verification.

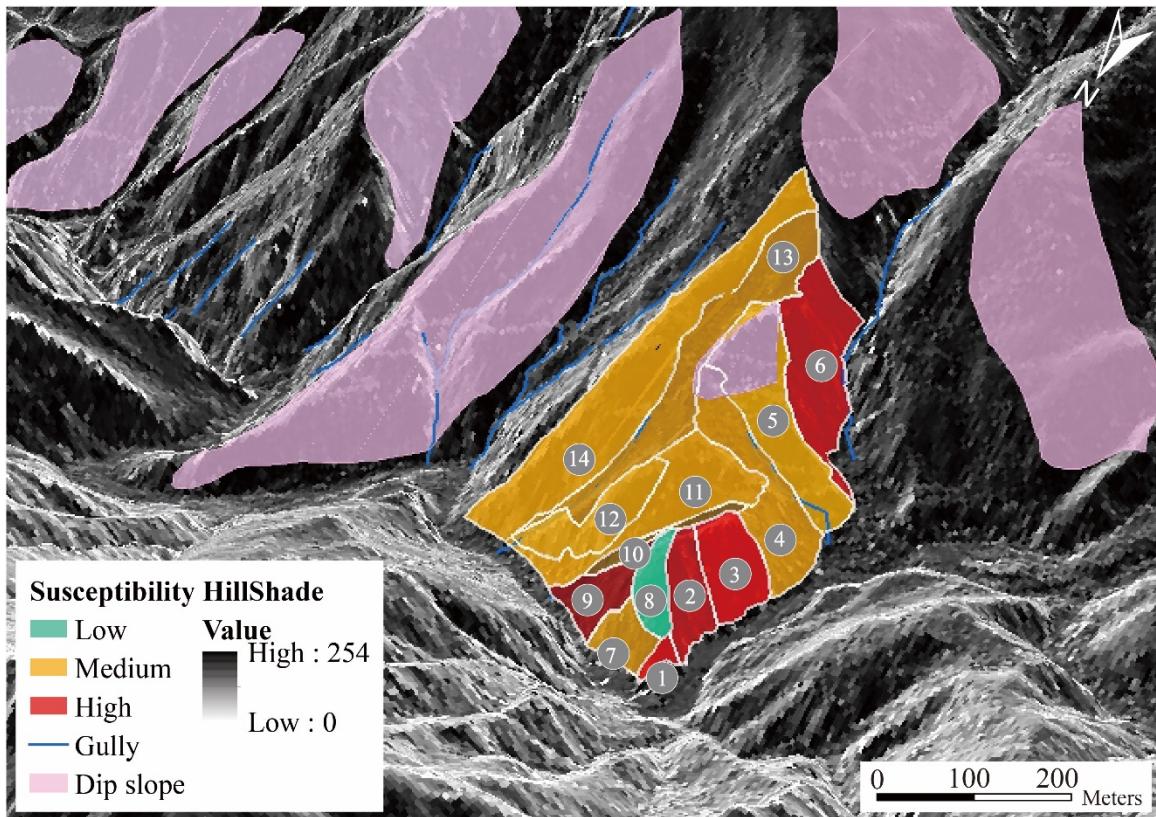
Figure 6 Susceptibility level referred to slope units around the Neikuihui tribe (Background: modified after Department of Lands, Ministry of the Interior 2020; Aerial: ESRI ArcGIS 10.4).

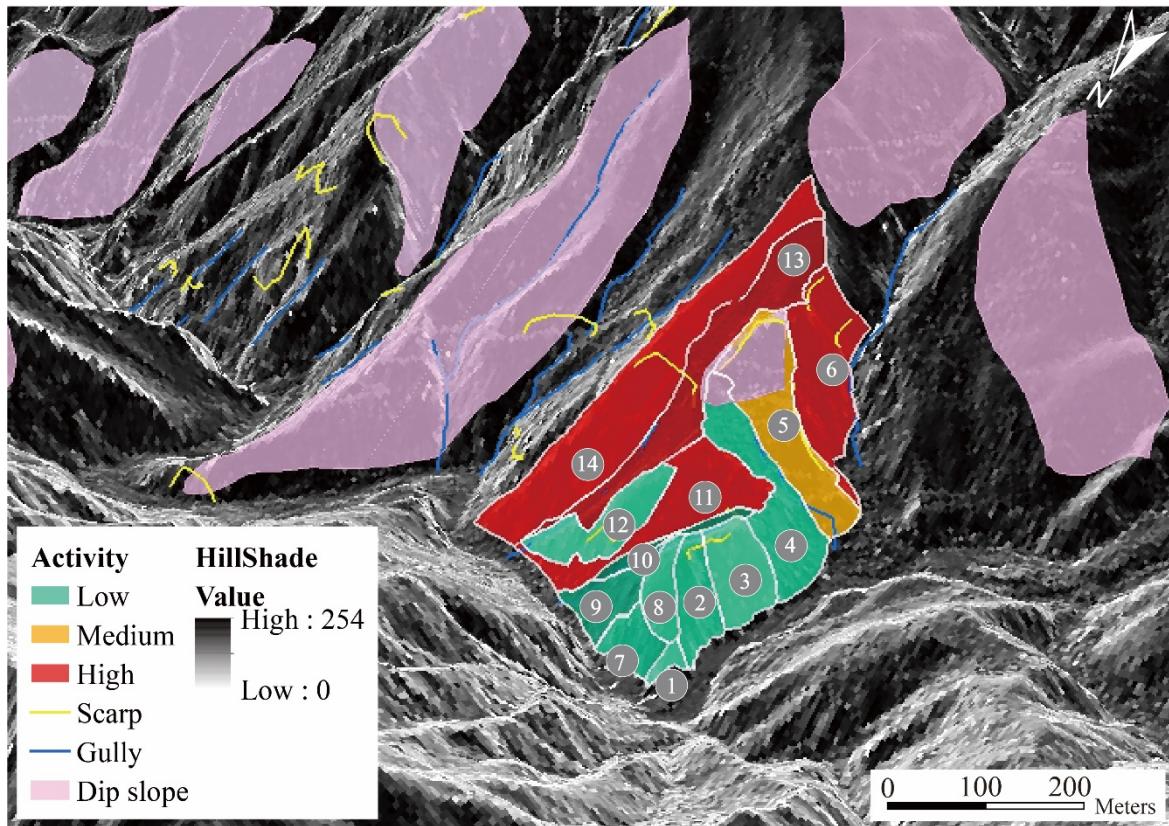
Figure 7 Activity level referred to slope units around the Neikuihui tribe (Background: modified after Department of Lands, Ministry of the Interior 2020; Aerial: ESRI ArcGIS 10.4).

Based on the classification of scarps, slope toes, rock formations, erosion gullies, and surface features as mentioned in Table 2, this study gives levels of Activity 1 and Activity 2 of 14 slope units around the Neikuihui tribe as detailed in Table 13 and Table 14, respectively. According to the comprehensive activity level as defined in Table 6. Because the scarp is slightly expanded and the river channel is significantly undercut, it leads to continuous erosion of the slope toe. Besides, aerial photo interpretation shows that rock layers would be exposed and have the susceptibility to slide forward. Based on these observations, No. 6, 11, 13, and 14 slope units have high Activity levels, as shown in Fig. 7.

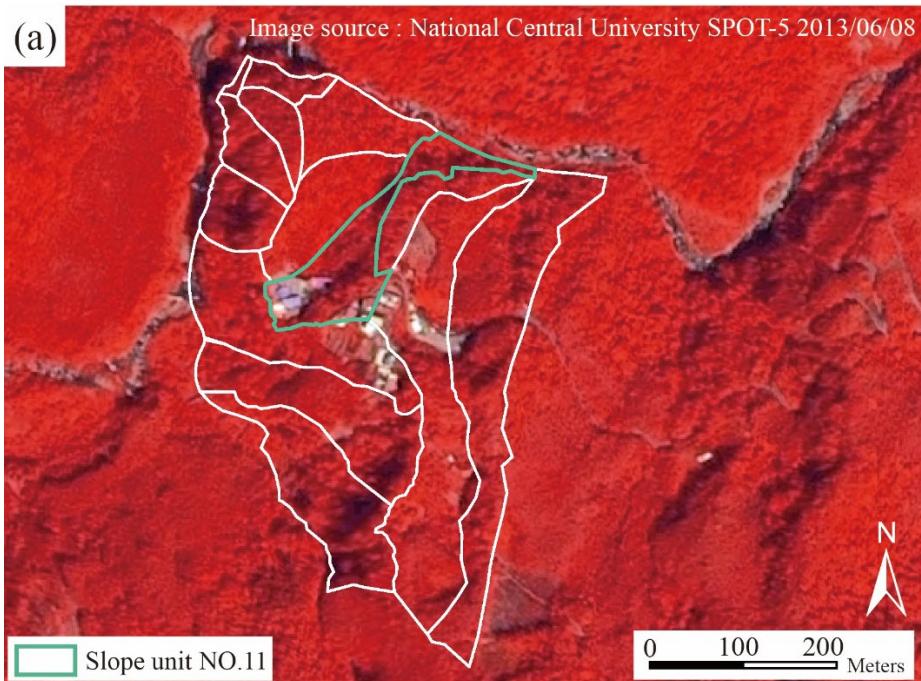
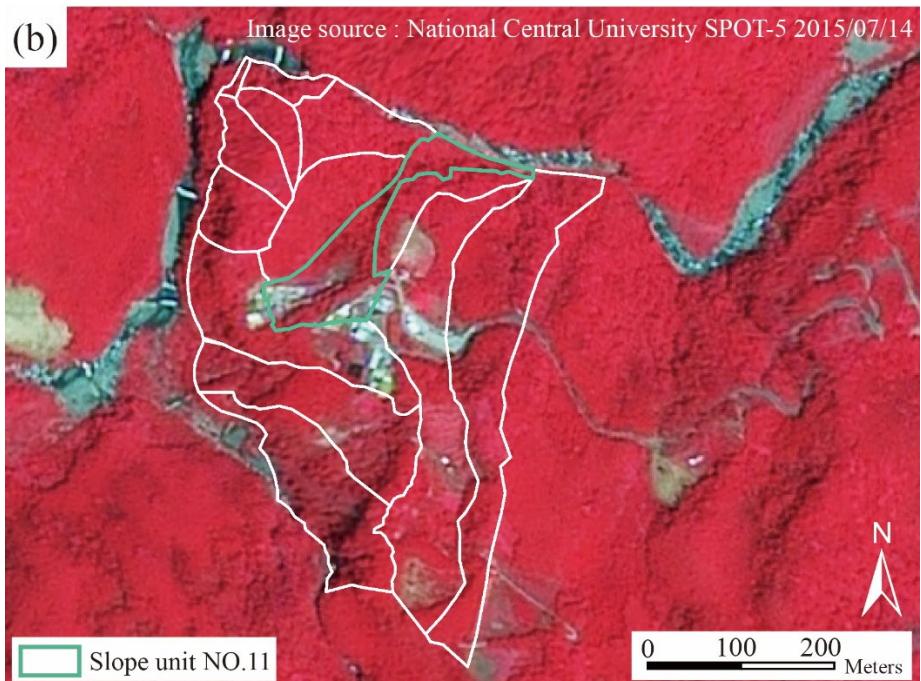
310 **Figure 8** Comparison of the terrain features in (a) 2013 and (b) 2015 orthophoto maps at No. 11 slope unit (modified after National Central University SPOT-5 2015); Aerial: ESRI ArcGIS 10.4.

This study employs slope unit No. 11 as an example to explain how to judge the degree of change of scarp through orthophoto images of different periods. The brighter and more saturated red in the orthophoto image, as in Fig. 8, means that the planting slope is complete and lush. Then this study examines the orthophoto images of June 8, 2013, and July 14, 2015, respectively. Since some vegetation has disappeared and the soil and rocks are exposed on July 14, 2015, the No.11 example is treated as a basis to give all the slope units in the Nekuihui tribe a score for Activity.

By combining the evaluation results of landslide Susceptibility and Activity levels as referred to Table 12, 13, and 14, the Hazard scores of each slope unit can be obtained as listed in Table 15, leading to analyzed results of landslide Hazard levels of 14 slope units around the Neikuihui tribe, as well as the corresponding illustration map as depicted in Fig. 9. The No. 6 slope unit has an Extremely High level of landslide Hazard, and No.11, 13, and 14 have High levels of landslide Hazard. It can be reasoned that No.6 is next to the river channel and significantly undercut, as shown in Fig. 8.

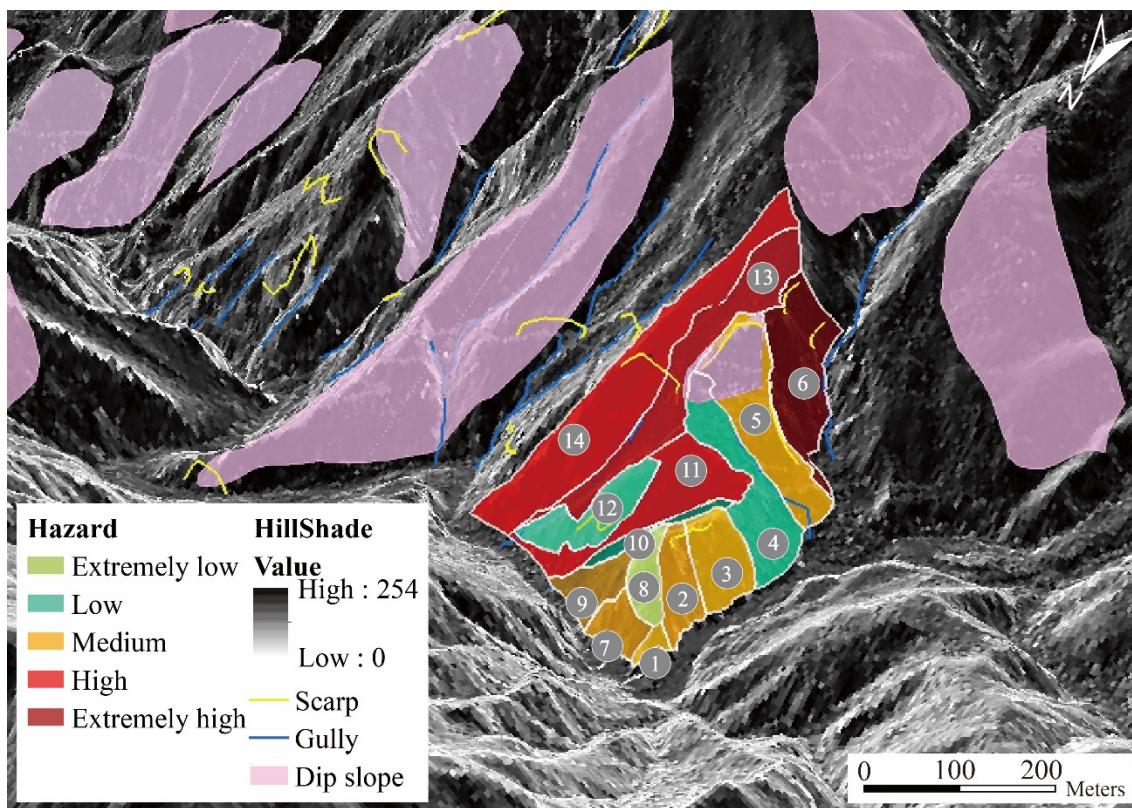
**Figure 9** Hazard level mapping of landslides referred to slope units around the Neikuihui tribe (Background: modified after

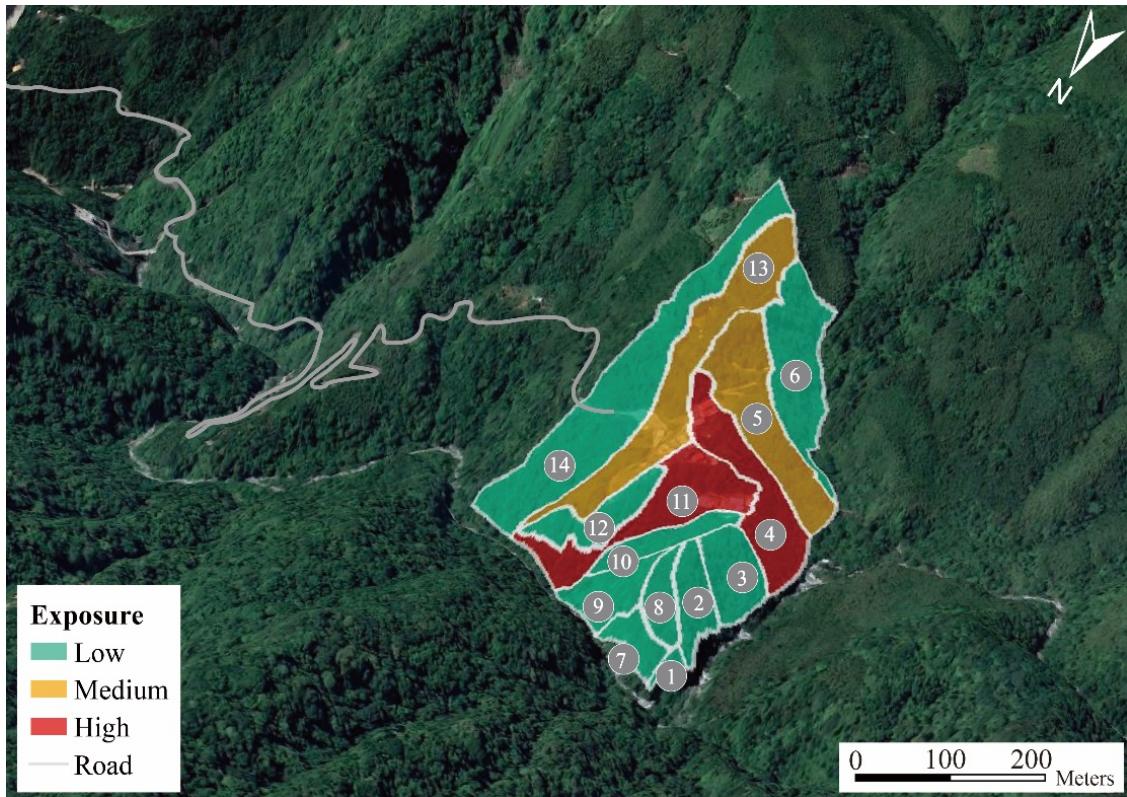
Figure 10 Exposure level mapping of landslide referred to units around the Neikuihui tribe (Background: modified after ©

355 Google Earth 2021; Aerial: ESRI ArcGIS 10.4).

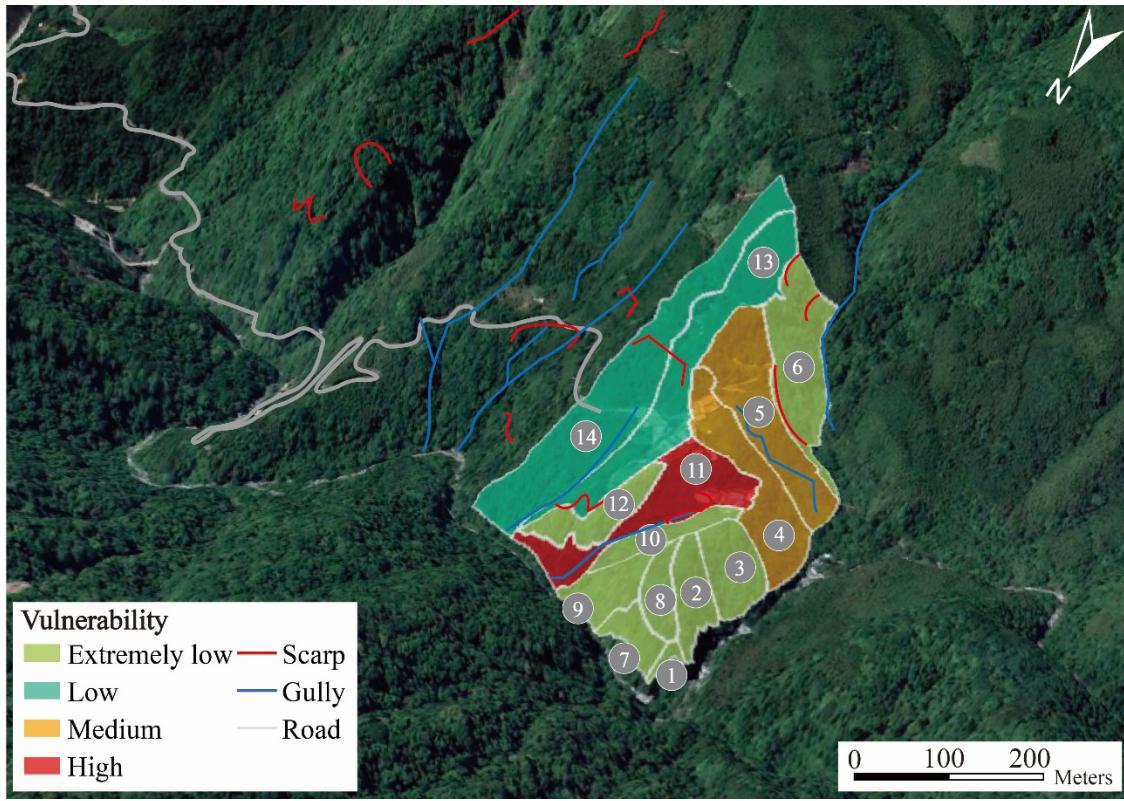
385 **Figure 11** Vulnerability level mapping of landslide referred to units around the Neikuihui tribe (Background: modified after modified after © Google Earth 2021; Aerial: ESRI ArcGIS 10.4).

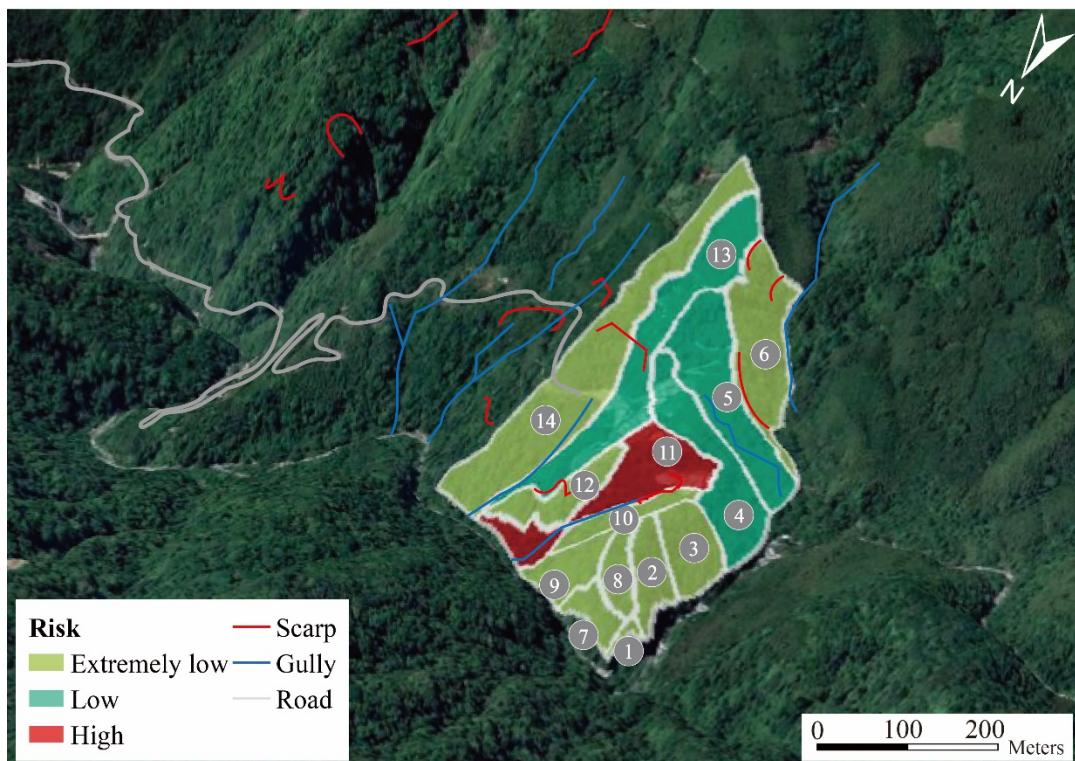
Figure 12 Risk level referred to slope units around the Neikuihui tribe (Background: modified after © Google Earth

390 By combining the scores of Hazard, Exposure, and Vulnerability of each slope unit around the Neikuihui tribe, Risk levels were then obtained by score summation as listed in Table 18. The No.11 slope unit is High Risk level, and No. 4, 5 and 13 slope units are Low Risk level. The corresponding mapping result of the landslide Risk is shown in Fig 12. Since slope unit No. 6 is steep and tangent to the river, it is apprised with the highest Hazard level as processing Hazard analysis at the beginning. However, no one lives there, and the landslide has few impacts on human lives and public facilities nearby. Thus, the Risk level is not as high as the No. 11 slope unit. Through Risk zoning toward slope units, this study can quickly identify which areas need to be prioritized in disaster prevention.

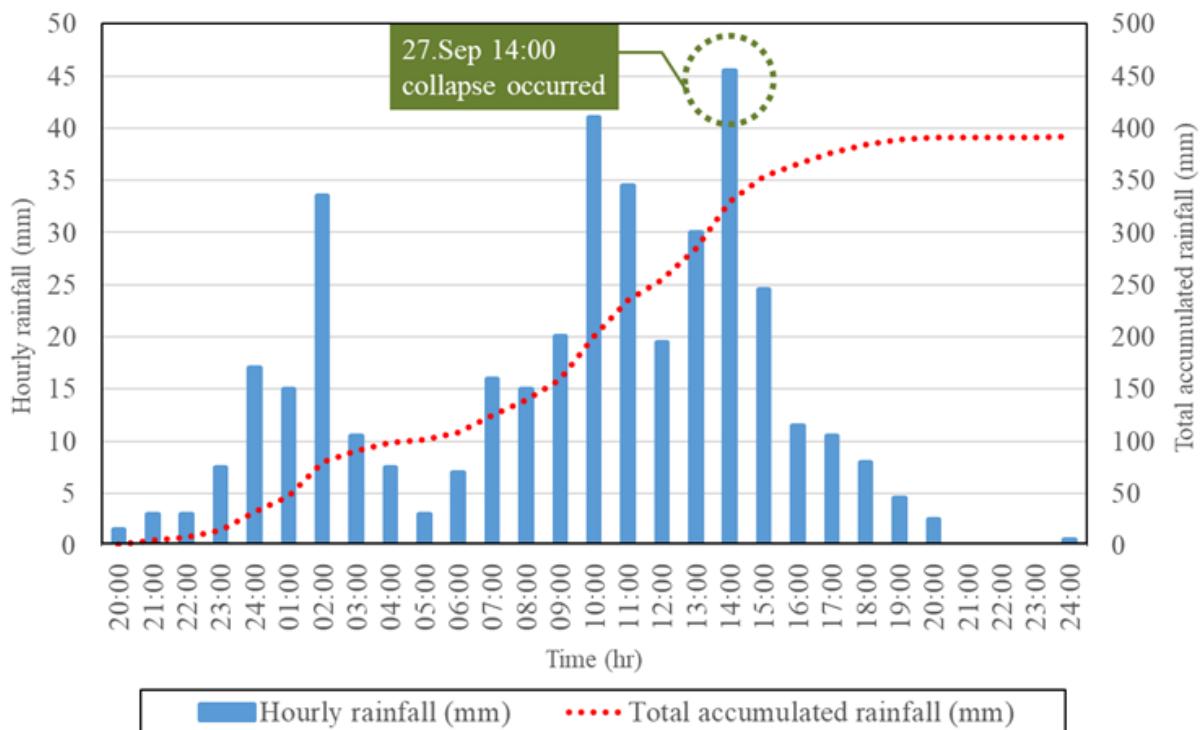
Figure 13 Rainfall records during Typhoon Meiji (September 26 to September 27, 2016).

Since the Risk level of the No.11 slope unit is High, as illustrated in Fig. 13, this study further compared the results with historical disaster events for validation. According to the 2016 report of Bureau of Soil and Water Conservation of the Agriculture, the No. 11 slope unit was affected by the torrential rainfall during Typhoon Meiji on September 27, 2016. A 405 landslide disaster occurred at 14:00 on the same day. Referring to the historical data of the Fuxing Rain Gauge Station closest to the disaster location, the hour rainfall record was 45.5 mm, as depicted in Fig. 13. The road's foundation was scoured by rainwater, resulting in a landslide with a length of 8-10 meters and a depth of 30-60 cm, as shown in Fig. 14a. The soil yields moved down and rushed into the residential house (Fig. 14b), and trees and telephone poles were seriously inclined at the No. 410 11 slope unit (Fig. 14c). Through the evidence of landslide disaster at No. 11 slope unit, the rapid risk zoning method toward multi slope units around the tribal region is confirmed preliminarily.

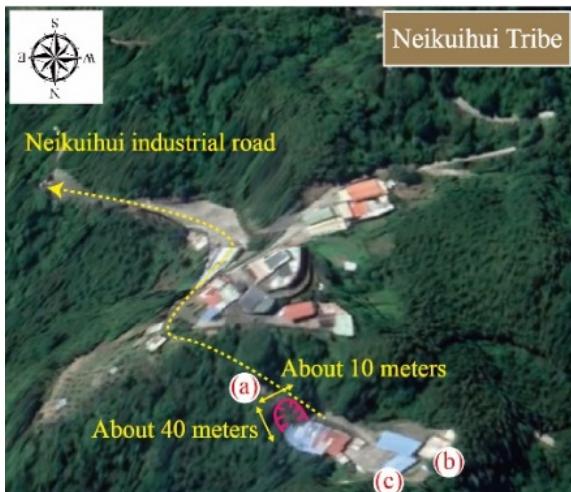
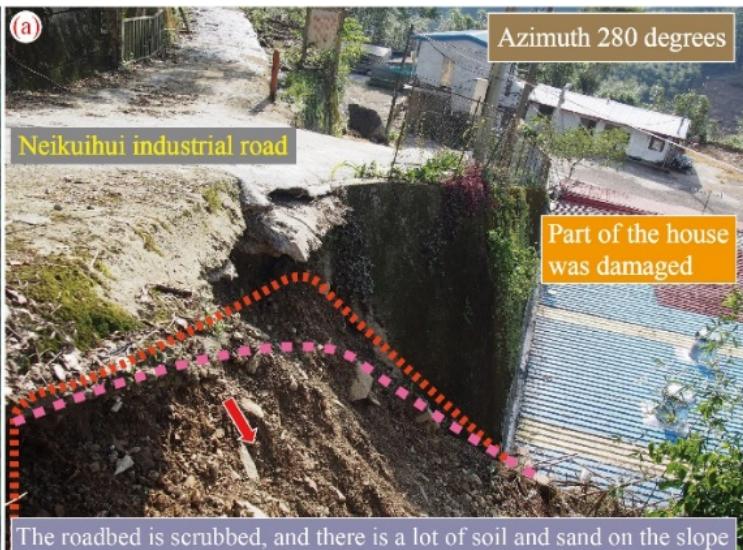
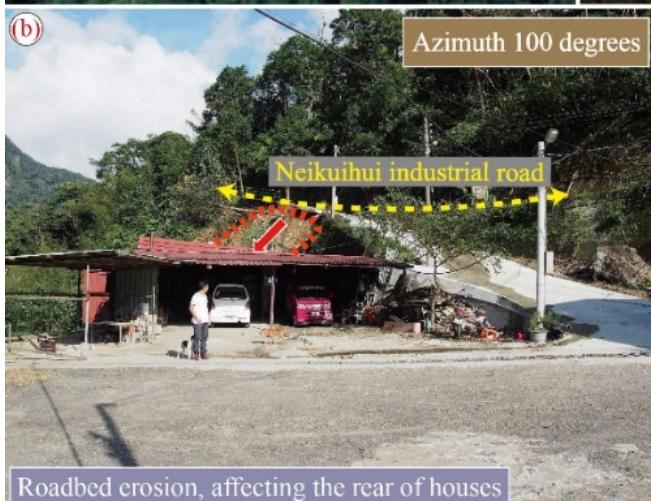
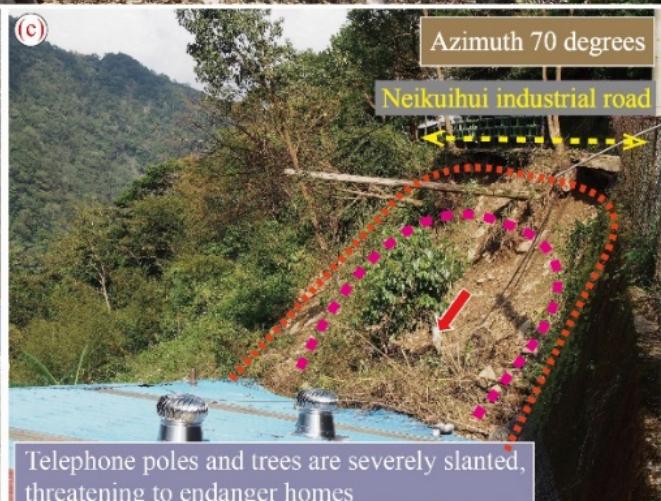
Figure 14 Historical disaster event at No.11 slope unit during Typhoon Meiji 2016 (Picture source: 2016 Water and Soil Conservation Bureau; Aerial: ESRI ArcGIS 10.4).
