# Rapid Landslide Risk Zoning toward Multi-Slope Units of the Neikuihui Tribe for Preliminary Disaster Management

Chih-Chung Chung<sup>1</sup>, Zih-Yi Li<sup>2</sup>

<sup>1</sup>Associate Professor, Dept. of Civil Engineering/Research Center for Hazard Mitigation and Prevention, National Central University, 300 Zhongda, Rd., Zhongli Dist., Taoyuan, 320, Taiwan.

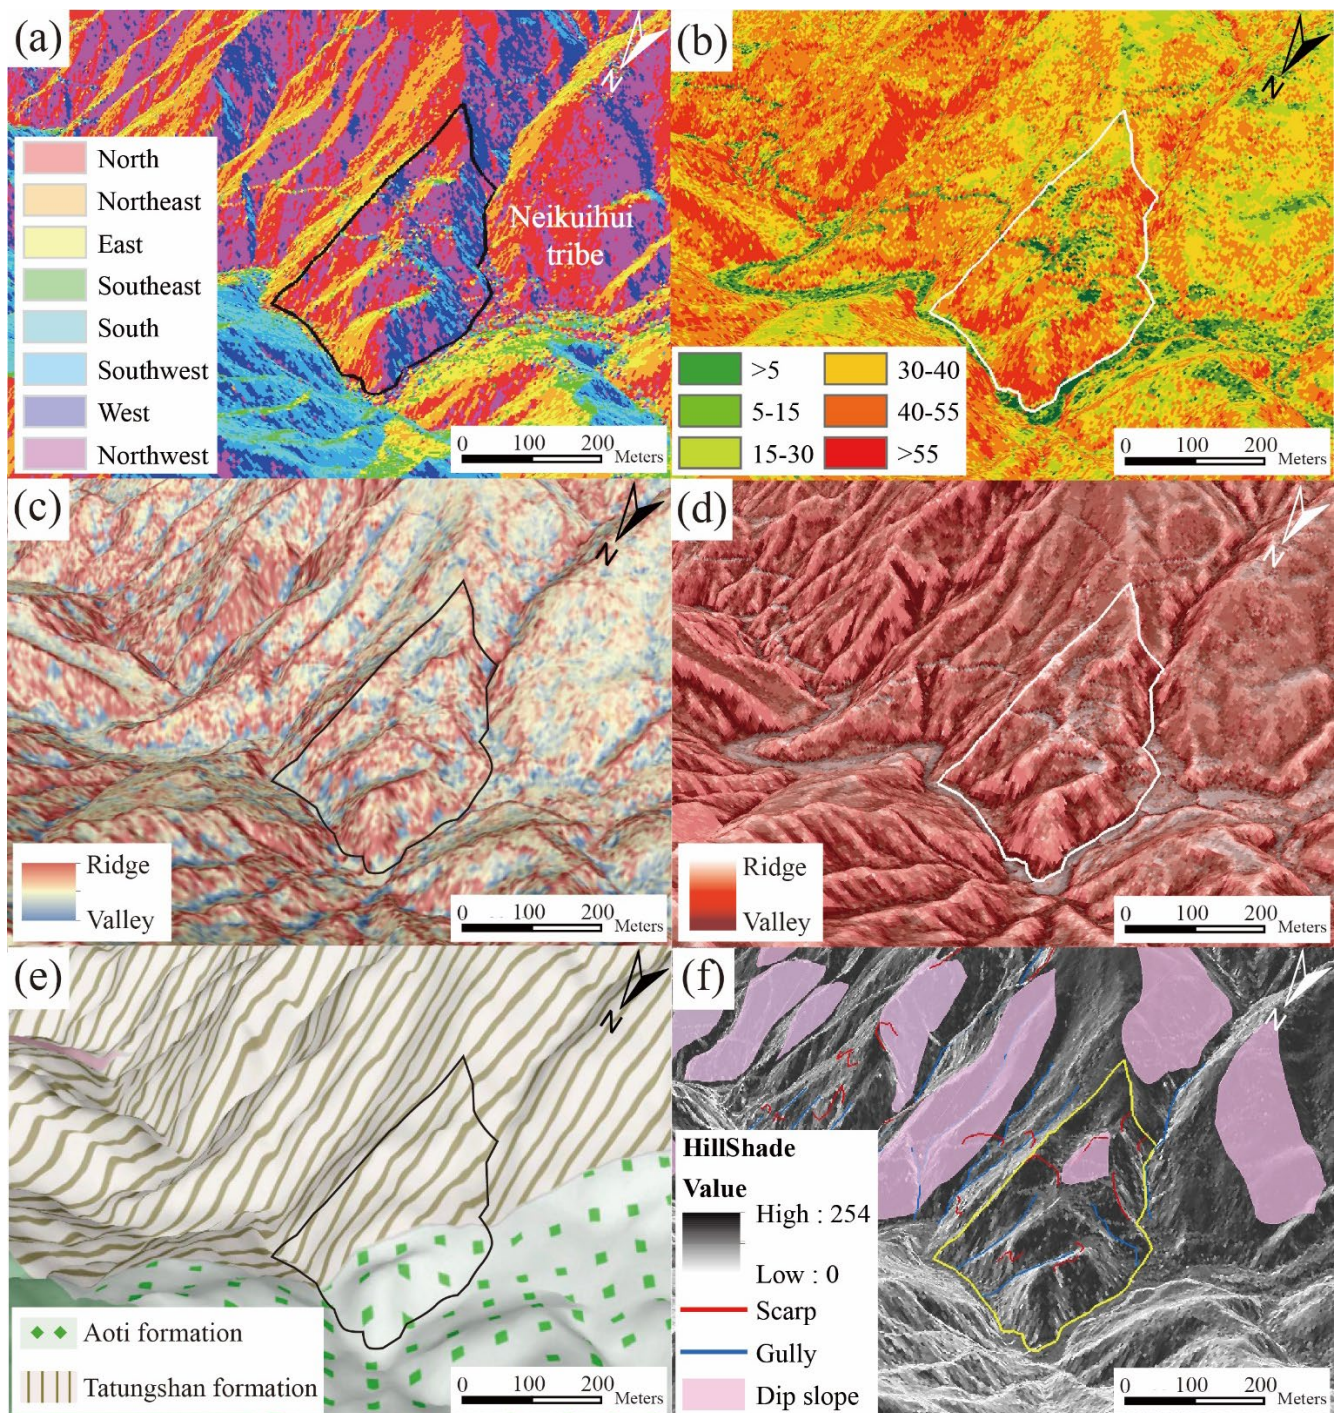
**Figure 2** Basic geology and environment of the Neikuihui tribe (a) slope aspect (modified after Department of Lands, Ministry of the Interior 2020); (b) slope map (modified after Department of Lands, Ministry of the Interior 2020); (c) CS map (modified

115 after Department of Lands, Ministry of the Interior 2020); **(d)** Relief map (modified after Department of Lands, Ministry of  
the Interior 2020); **(e)** 1:250,000 geological map (modified after Central Geological Survey 2020); **(f)** Geologically sensitive  
area distribution map (modified after Department of Lands, Ministry of the Interior 2020) with a hillshade based map ; Aerial:  
ESRI ArcGIS 10.4.

To better visualize the terrain features, the 1 m x 1 m Digital Elevation Model (DEM) is employed as a basement in Fig.2. The overall slope aspect of the tribe is mainly northwest (Fig. 2a), with an average slope degree of 43.9° (Fig. 2b). Fig. 2c and Fig.2d show the CS map and Relief map based on the 1 m x 1 m DEM, respectively. The CSMaP plugin on QGIS

produced by Asahi (2014) was applied to generate the CS map, where a topographic map is made of altitude, curvature, and slope degree. Fig. 2c is provided with color attributes that Light Blue indicates valleys and Light Red indicates the ridge. Meanwhile, the Relief Visualization Toolbox application (Zakšek et al., 2011; Kokalj et al., 2019) is applied for generating the Relief map (Fig. 2d) with attributes that the darker the color, the closer the river valley, and the lighter color means the closer to the ridge. These maps can support characterize the slope features quickly.

Figure 2e is a 1:25,000 geological map of the Central Geological Survey (2020). The strata include the Tatongshan and the Aoti formations, of which the Tatongshan formation is composed of black hard shale and siltstone interbedded, often forming steep slopes along the river bed. Aoti formation is composed of sandstone with a coal seam. Besides, there is a Ronghua Stream flowing through the Neikuihui tribe region. Figure 2f is visualized based on a hillshade map from 1 m x 1 m DEM. Figure 2f also reveals the locations of dip slopes from the Central Geological Survey (2020), and these dip slopes are geologically sensitive to the safety of the local settlements.

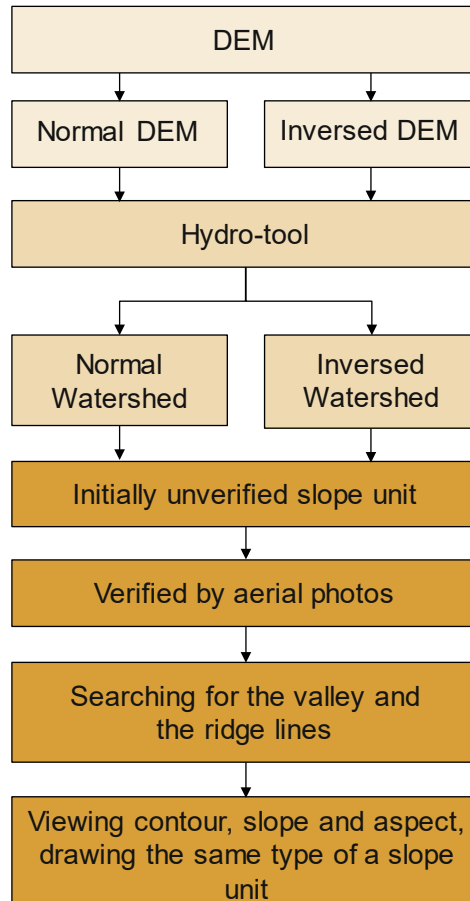
**Figure 3** Process of delimited slope units (modified after Wang et al. 2016).

The size of the slope units can be tailored to the type and size of the landslides since a slope unit has more geomorphological  
and geological significance than a grid unit (Carrara et al., 1991; Alvioli et al., 2016). Accordingly, a modified method is  
introduced to delimit slope units and depict slope profiles based on high-resolution DEM (1 m x 1 m) via GIS in this study.  
The slope-unit delimiting method is supported by a GIS-based hydrological analysis and modeling tool, Arc Hydro, which  
140 originally incorporates DEM and reversed DEM approaches (Maidment, 2002; Xie et al., 2003; Wang et al., 2016). Based on  
Xie et al. (2004) classification, GIS-based hydrological analysis and modeling tools are implemented to divide the watershed  
into slope units through the proposed processing chart of delimited slope units, as illustrated in Fig. 3.

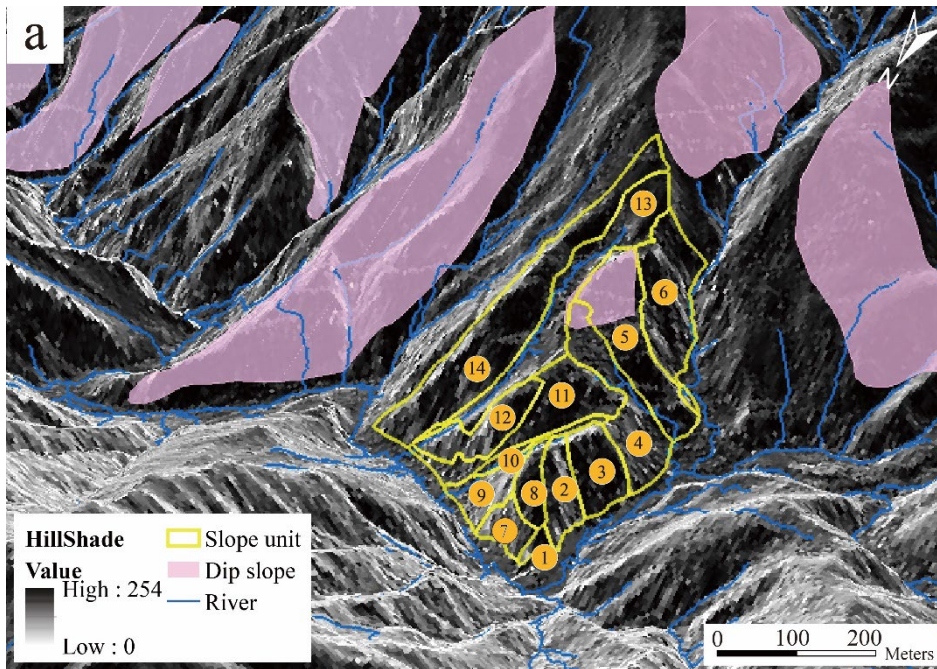
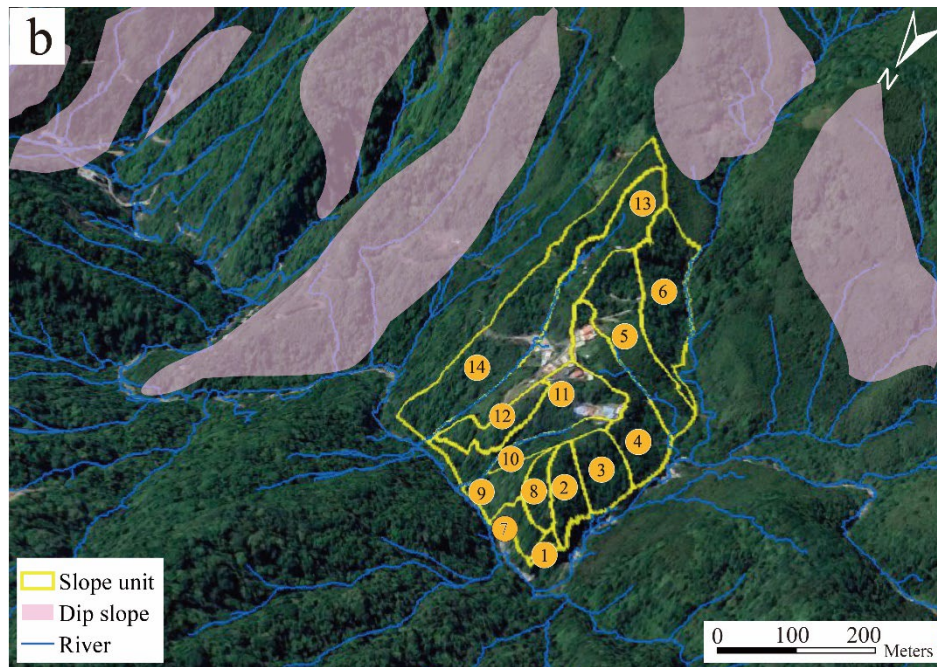
**Figure 4** (a) Distributions of 14 slope units around the Neikuihui tribe (Background: modified after Department of Lands, Ministry of the Interior 2020; Aerial: ESRI ArcGIS 10.4); (b) households distribution map (Background: modified after © Google Earth 2021; Aerial: ESRI ArcGIS 10.4)

Figure 4a depicts the 14 delimited slope units around the Neikuihui tribe based on 1 m × 1 m DEM via Hydro-tool in ArcGIS  
(Xie et al., 2004), and Fig. 4b illustrates the slope units mapping to the aerial photo. Subsequently, related environmental factors

145 and features were analyzed, including slope aspect, slope degree, valley, and ridge, as pointed out in Fig.2. Then 14 slope units accompanied with scarps and eroded gullies are manually drawn based on Fig. 2f and aerial photos. According to the improved framework of risk zoning as proposed in Fig. 5, the 14 slope units were graded regarding landslide Hazard, Exposure, and Vulnerability factors. The corresponding Risk scores of each slope unit were consequently obtained. These scores are expected to support revealing the Risk level and a disaster reduction strategy for the slope unit to reduce the impact of the disaster.

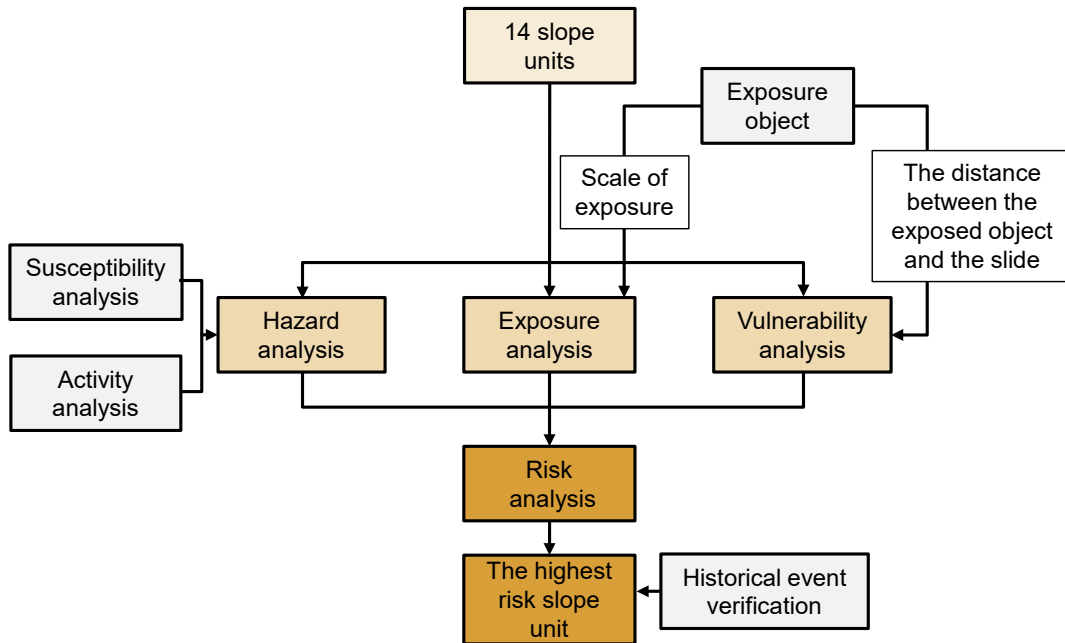
**Figure 5** Improved framework of risk zoning for multi-slope units and the corresponding verification.

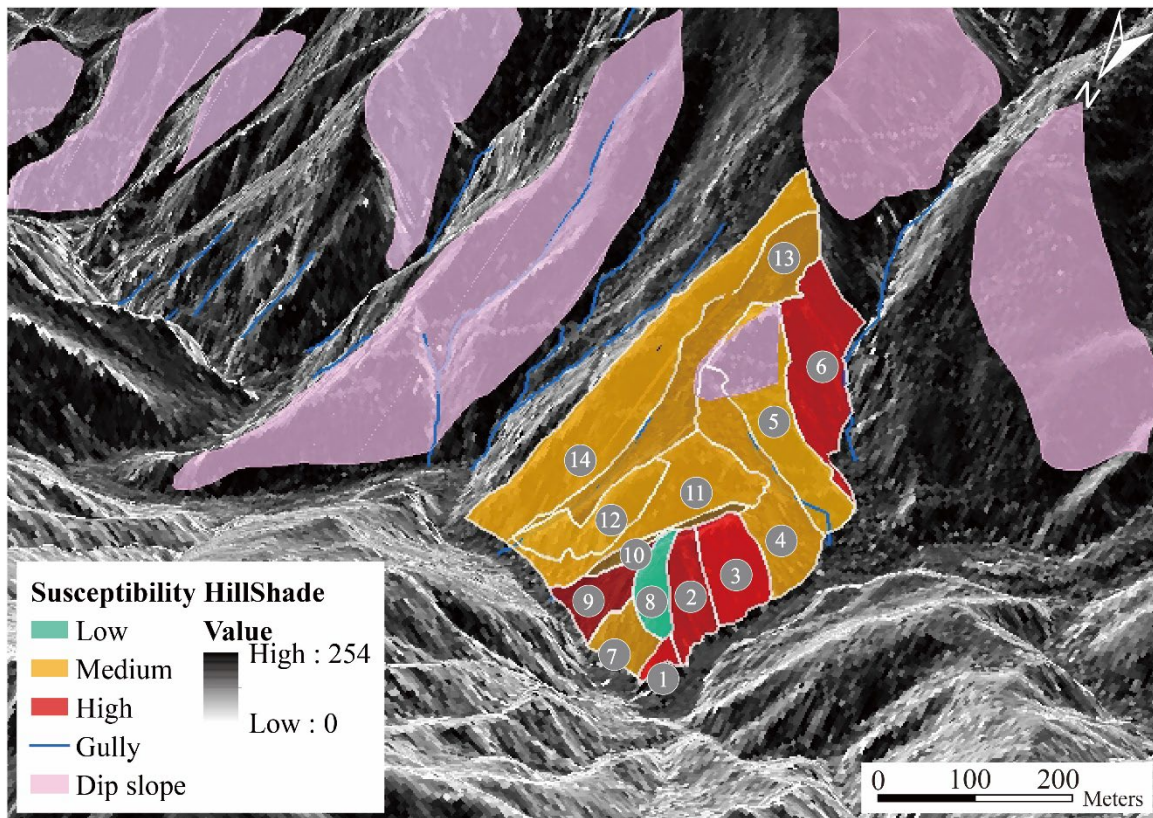
**Figure 6** Susceptibility level referred to slope units around the Neikuihui tribe (Background: modified after Department of Lands, Ministry of the Interior 2020; Aerial: ESRI ArcGIS 10.4).

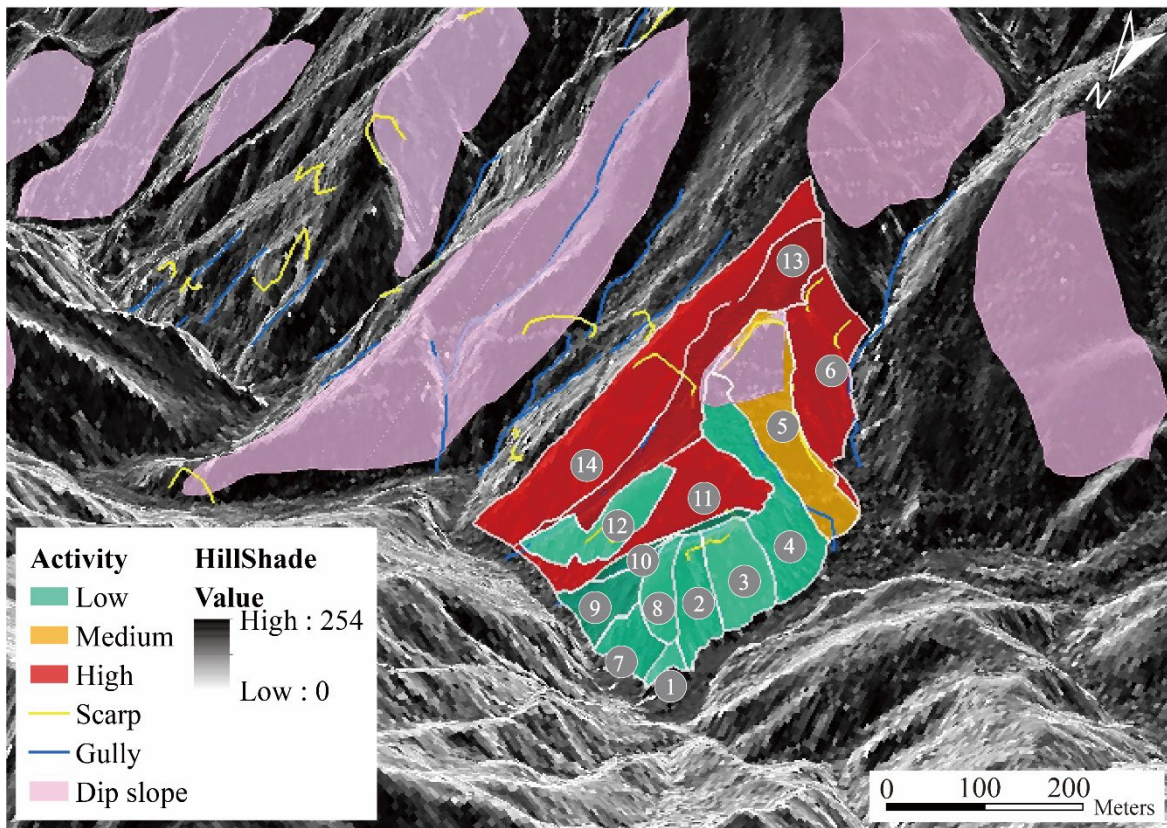
300 **Figure 7** Activity level referred to slope units around the Neikuihui tribe (Background: modified after Department of Lands, Ministry of the Interior 2020; Aerial: ESRI ArcGIS 10.4).

285 Based on the classification of scarps, slope toes, rock formations, erosion gullies, and surface features as mentioned in Table 2, this study gives levels of Activity 1 and Activity 2 of 14 slope units around the Neikuihui tribe as detailed in Table 13 and Table 14, respectively. According to the comprehensive activity level as defined in Table 6. Because the scarp is slightly expanded and the river channel is significantly undercut, it leads to continuous erosion of the slope toe. Besides, aerial photo interpretation shows that rock layers would be exposed and have the susceptibility to slide forward. Based on these observations, No. 6, 11, 13, and 14 slope units have high Activity levels, as shown in Fig. 7.

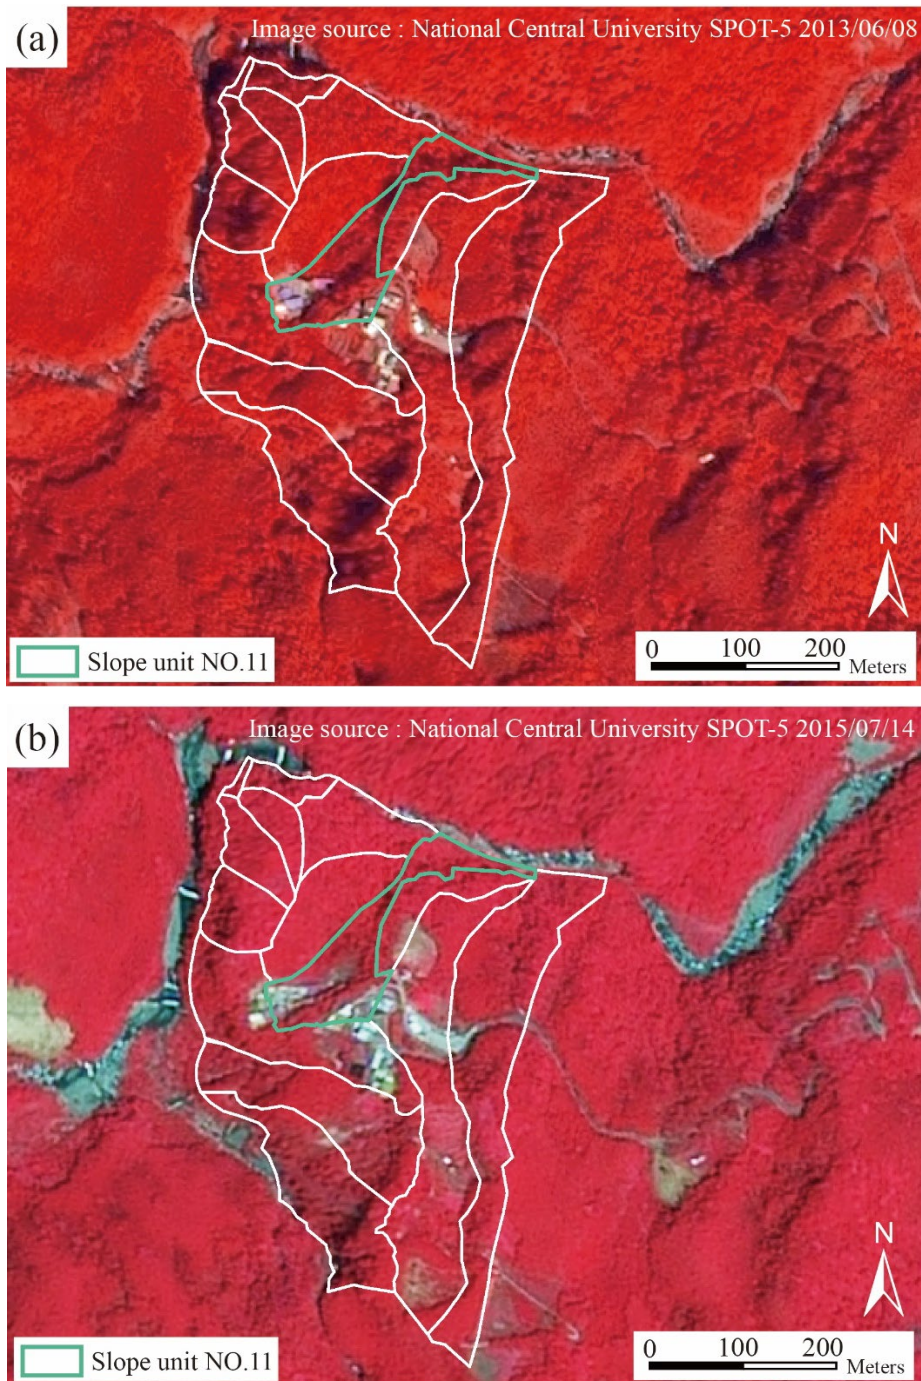
**Figure 8** Comparison of the terrain features in (a) 2013 and (b) 2015 orthophoto maps at No. 11 slope unit (modified after  
305 National Central University SPOT-5 2015); Aerial: ESRI ArcGIS 10.4.

290 This study employs slope unit No. 11 as an example to explain how to judge the degree of change of scarp through orthophoto images of different periods. The brighter and more saturated red in the orthophoto image, as in Fig. 8, means that the planting slope is complete and lush. Then this study examines the orthophoto images of June 8, 2013, and July 14, 2015, respectively. Since some vegetation has disappeared and the soil and rocks are exposed on July 14, 2015, the No.11 example is treated as a basis to give all the slope units in the Nekuihui tribe a score for Activity.

By combining the evaluation results of landslide Susceptibility and Activity levels as referred to Table 12, 13, and 14, the Hazard scores of each slope unit can be obtained as listed in Table 15, leading to analyzed results of landslide Hazard levels of 14 slope units around the Neikuihui tribe, as well as the corresponding illustration map as depicted in Fig. 9. The No. 6 slope unit has an Extremely High level of landslide Hazard, and No.11, 13, and 14 have High levels of landslide Hazard. It can be reasoned that No.6 is next to the river channel and significantly undercut, as shown in Fig. 8.

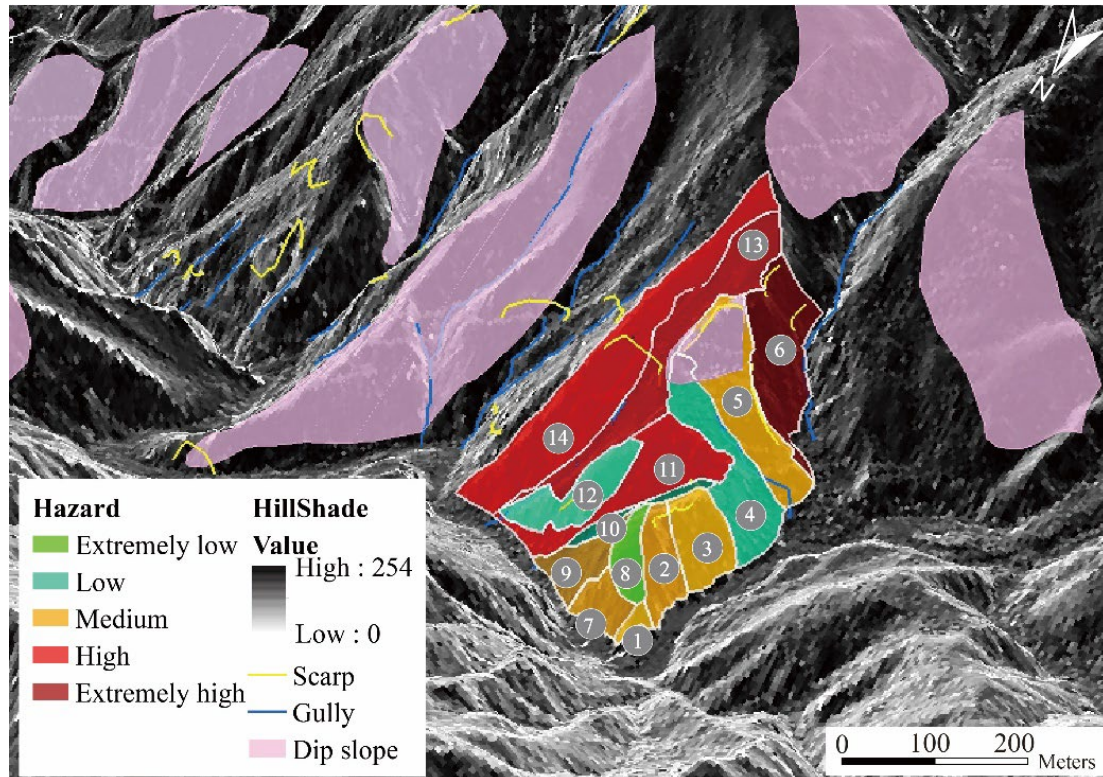
**Figure 9** Hazard level mapping of landslide referred to slope units around the Neikuihui tribe (Background: modified after Department of Lands, Ministry of the Interior 2020; Aerial: ESRI ArcGIS 10.4).

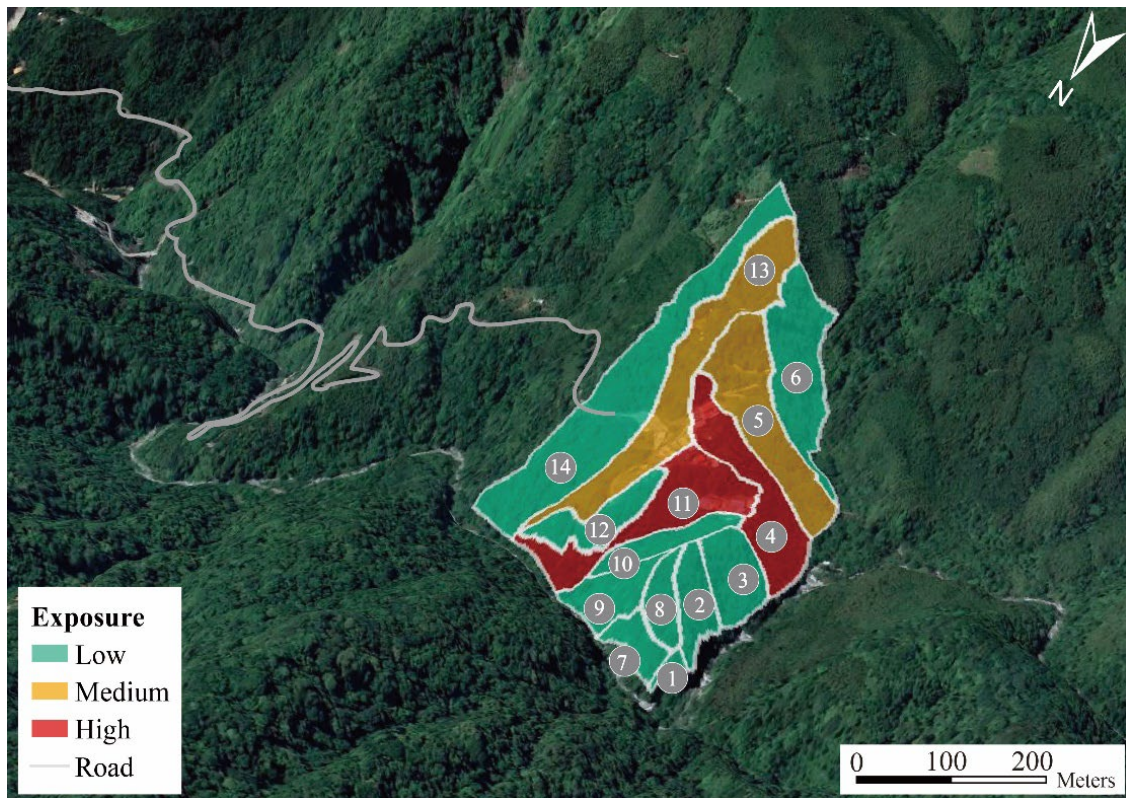
**Figure 10** Exposure level mapping of landslide referred to units around the Neikuihui tribe (Background: modified after © Google Earth 2021; Aerial: ESRI ArcGIS 10.4).

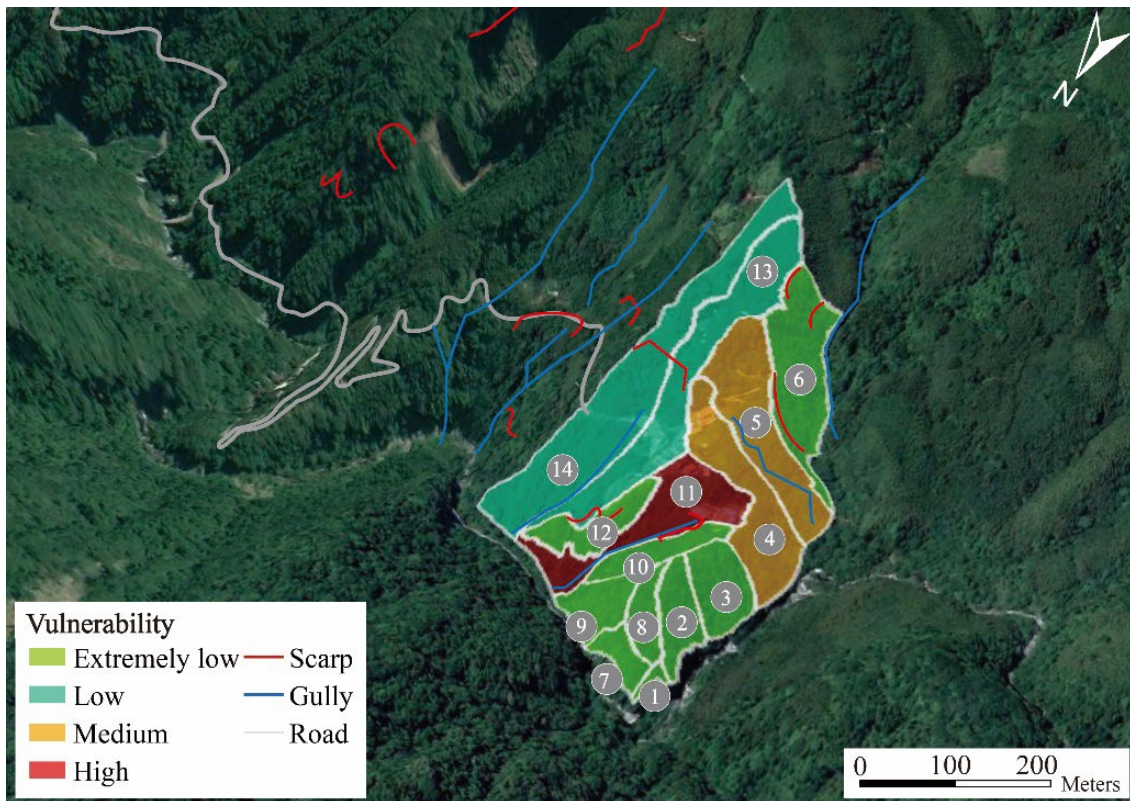
**Figure 11** Vulnerability level mapping of landslide referred to units around the Neikuihui tribe (Background: modified after modified after © Google Earth 2021; Aerial: ESRI ArcGIS 10.4).

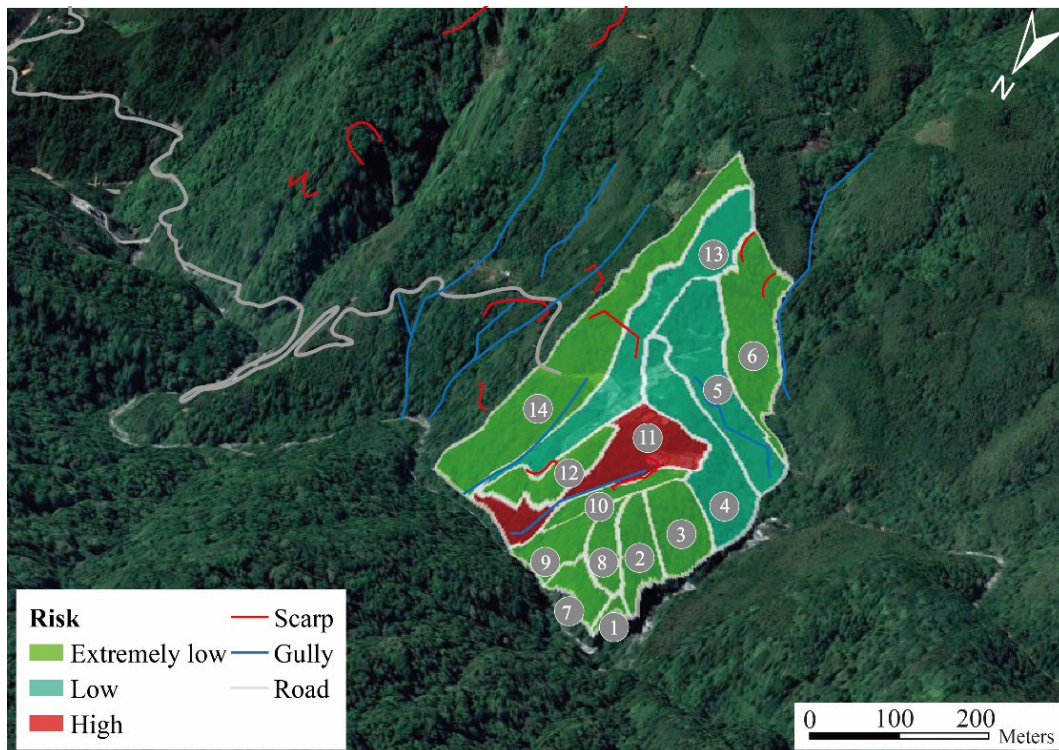
**Figure 12** Risk level referred to slope units around the Neikuihui tribe (Background: modified after © Google Earth 2021; Aerial: ESRI ArcGIS 10.4).

380 By combining the scores of Hazard, Exposure, and Vulnerability of each slope unit around the Neikuihui tribe, Risk levels were then obtained by score summation as listed in Table 18. The No.11 slope unit is High Risk level, and No. 4, 5 and 13 slope units are Low Risk level. The corresponding mapping result of the landslide Risk is shown in Fig 12. Since slope unit No. 6 is steep and tangent to the river, it is apprised with the highest Hazard level as processing Hazard analysis at the beginning. However, no one lives there, and the landslide has few impacts on human lives and public facilities nearby. Thus, the Risk level is not as high as the No. 11 slope unit. Through Risk zoning toward slope units, this study can quickly identify which areas need to be prioritized in disaster prevention.

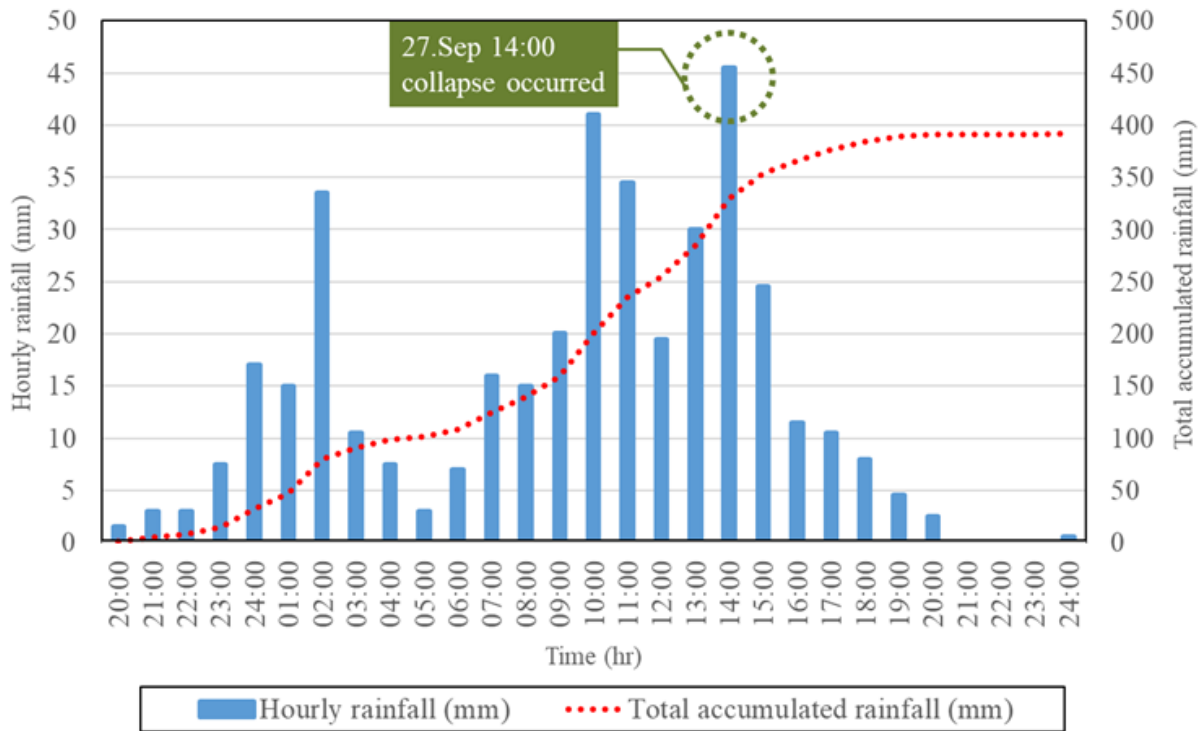
**Figure 13** Rainfall records during Typhoon Meiji (September 26 to September 27, 2016).

Since the Risk level of the No.11 slope unit is High, as illustrated in Fig. 13, this study further compared the results with historical disaster events for validation. According to the 2016 report of Bureau of Soil and Water Conservation of the Agriculture, the No. 11 slope unit was affected by the torrential rainfall during Typhoon Meiji on September 27, 2016. A landslide disaster occurred at 14:00 on the same day. Referring to the historical data of the Fuxing Rain Gauge Station closest to the disaster location, the hour rainfall record was 45.5 mm, as depicted in Fig. 13. The road's foundation was scoured by rainwater, resulting in a landslide with a length of 8-10 meters and a depth of 30-60 cm, as shown in Fig. 14a. The soil yields moved down and rushed into the residential house (Fig. 14b), and trees and telephone poles were seriously inclined at the No. 11 slope unit (Fig. 14c). Through the evidence of landslide disaster at No. 11 slope unit, the rapid risk zoning method toward multi slope units around the tribal region is confirmed preliminarily.
