# Debris Flow event on Osorno volcano, Chile, during summer 2017: New interpretations for chain processes in the Southern Andes.

Abstract. Debris flow generation on volcanic zones at the Southern Andes has not widely studied, despite the enormous  
economic and infrastructure damage that these events can generate. The present work contributes to the understanding of these  
20 dynamics based on a study of the 2017 Petrohué debris flow event from two complementary points of view. First, a  
comprehensive field survey allowed to delimitate that a rockfall initiated the debris-flow due to intense rainfall event. The  
rockfall lithology corresponds to lava blocks and autobrecciated lavas, predominantly over 1500 m.a.s.l. Second, the process  
was numerically modeled and constrained by in situ data collection and geomorphological mapping. The event was studied by  
back analysis using the height of flow measured in road CH-255 with errors of 5%. Debris flow volume has a high sensitivity  
25 with the initial water content in the block fall zone, ranging between  $4.7 \times 10^5$  up to  $5.5 \times 10^5$  m<sup>3</sup>, depending on the digital

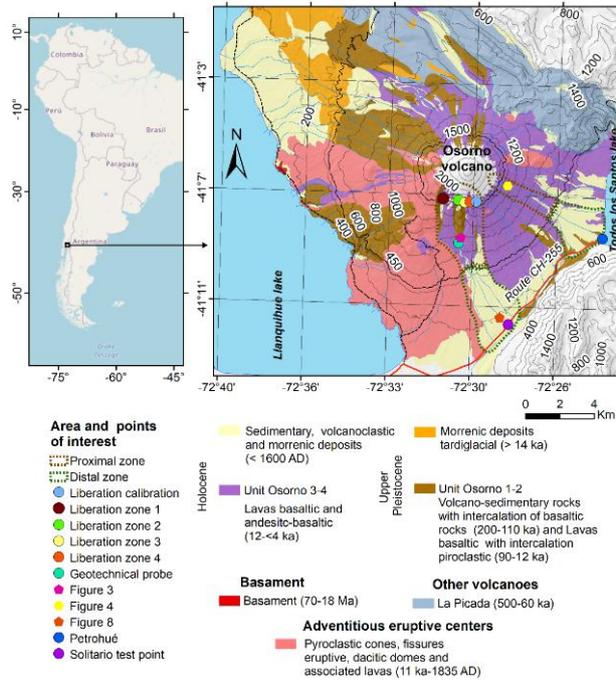
Figure 1 Geological map of Osorno volcano based on Moreno et al. (2010).

Osorno volcano is a mainly basaltic Pleistocene to Holocene composite volcano (Figure 1). Its part of an SW-NE volcanic alignment along with three other volcanoes: La Picada, Puntagudo, and Cordón Cenizos (Moreno et al., 2010), oriented obliquely to the main volcanic arc and the Liquiñe-Ofqui Fault System (LOFS). The chain orientation suggests that the area is an active transtensional zone of the crust, with mafic magma extrusion during the Quaternary (Cembrano & Lara, 2009; Moreno et al., 2010). The surrounding area shows pre-LGM (Last Glacial Maximum) Pleistocene volcanic rocks including tuffs, breccias, and lava originating from the northern zone of the volcano (Moreno et al., 1985).

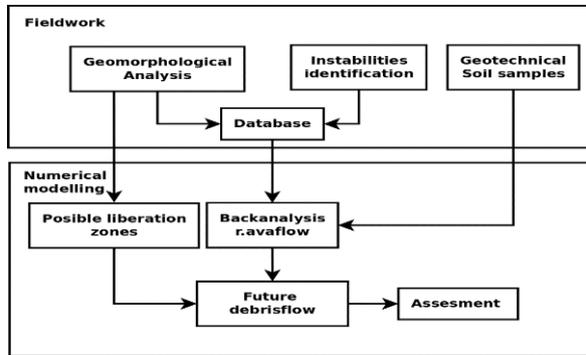
Figure 2 Short methodology.

The 2017 Petrohué event was studied to understand the factors which control the occurrence of debris flows in the Osorno volcano. We implement a methodological approach based on comprehensive numerical modelling constrained by field data and laboratory analysis (Figure 2). We considered the geomorphological factors that influence debris flow generation were studied by collecting data in the field work and defining the release zones. The field results were used as border conditions in numerical modelling of the event by back analysis, taking flow heights recorded in technical reports and photographs to define zones of comparison (Figure 2).

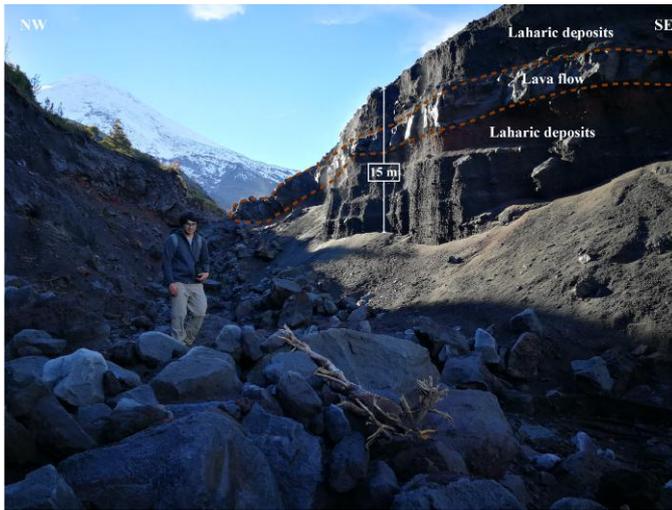
Figure 3 Set of scarps at approximately 1500 masl; the base breccia of the lava flows is heavily eroded.

The incision is favored by the presence of very thick lahar deposits (Figure 3Figure 2Figure 4), which facilitate the removal and contribution of material to the main channel. A sequence of lahar deposits was observed, overlain by lava flows in blocks up to 1.5 m thick. These occur in regular sequences, leaving alternate levels of erosion and hanging blocks, facilitating the collapse of the lava levels, and generating rockfalls. The material is characterized by lava with base autobrecciation, no more than 1 m thick (Figure 3Figure 2Figure 4). The autobrecciated zone is also heavily weathered (Figure 4Figure 4Figure 2); as a result, it can be easily removed, exposing the center-centre of the lava flow. The lava flow forms a hanging block that can easily fracture and break off. There is evidence of broken-off blocks associated with the central part of the lava flow, due to the instability of the base autobrecciation, with dimensions of up to 2 m. The blocks fracture continuously in the lava runs perpendicular to the slope of the main channel where these debris flows occur. This breaking off of material due to weathering contributes to the main channel, generating powerful debris flows as evidenced by the deposits further down the slope, as a consequence of the continuous rockfalls. The intermediate zone has narrow drainage channels and an increase in the incision to a depth of around 15 m (Figure 3Figure 3Figure 4).

The geomorphology of the Osorno volcano is characterized by the alternation of basaltic lava flows overlain by large volcanic deposits (Figure 3, Figure 4). The fractures identified in the lava flows were probably generated by gravitational effects. Water can then enter the rock/soil fractures, making them more likely to break off and transporting the material in debris flow form. Conditions are therefore favorable for chain processes culminating in debris flows when the soil is saturated by high altitude rainfall. Erosion of the deposits exposes the lava flows; material breaks away and is transported by gravity and/or swept down by the

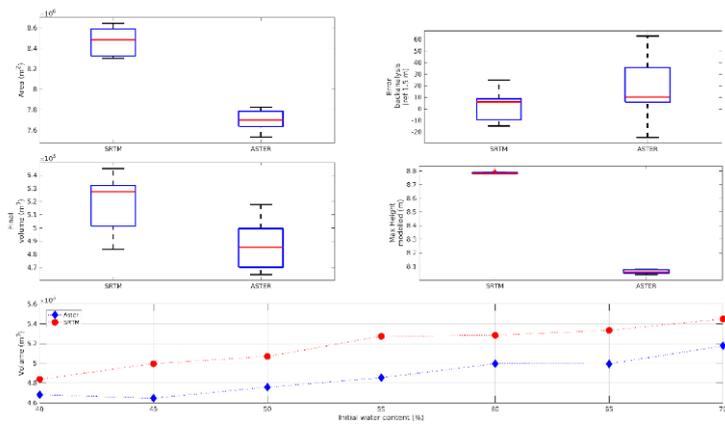
Figure 5 Back-analysis results.

The area affected by the debris flow was estimated at between 7.5 million m<sup>2</sup> and 7.8 million m<sup>2</sup> by DEM ASTER, and between 8.3 million m<sup>2</sup> and 8.6 million m<sup>2</sup> by DEM SRTM (Figure 5a). ~~Simulations using DEM SRTM produced a variation of the flow to the south, increasing the impact in Route CH-255. These results had differences with the simulations using DEM ASTER, which showed the flow towards the north DEM SRTM produced a variation in the flow to the south, increasing the impact in Route CH-255 and DEM ASTER showed the flow towards the north.~~ (Figure 6) The minimum runout was 55.74m by DEM ASTER and 63.79 meters by DEM SRTM. A progressive increase in the maximum height as the percentage of water in the release zone increased was noted in the simulations. DEM SRTM presented greater heights than DEM ASTER in all the simulations. The major 255 debris flow height is reached when the initial volume has 70% of the water in both DEMs. Finally, all the simulations reached

populated zones, regardless of the DEM used. The maximum height with DEM SRTM is 1.87 meters with a water content of 40% of the initial water content, while with DEM ASTER, it is 2.13 meters with a water content of 60%. The greatest heights are concentrated with a water content of 50%-60% of the total material released.

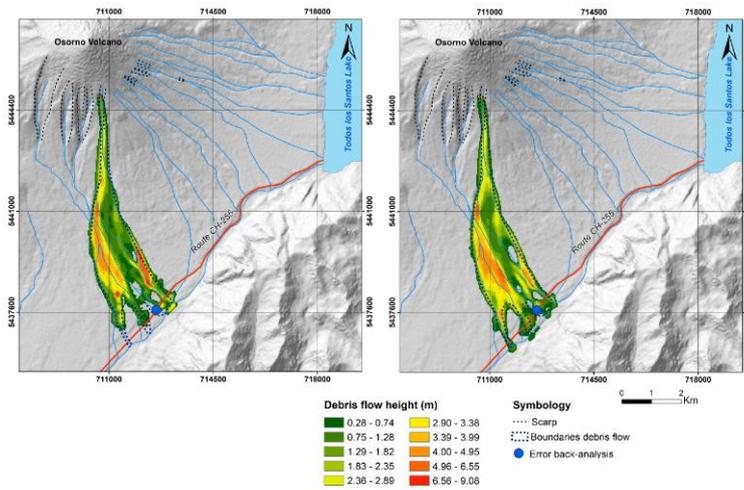
Figure 6 Simulation in El Solitario sector, taking the release zone from the results obtained in the field. Left: Model with 60% water content in DEM ASTER. Right: Model with 60% water content in DEM STRM.

in the sensitivity of the numerical model. In the present study, the drag coefficient was established at 0.020, based on Zwinger et al. (2003) and Oyarzún (2019); this value was adopted due to the degree of optimization in the back analysis. A larger or smaller coefficient could produce large deviations in the final height and direction of the flow (Mergili et al., 2018a). The angle of internal friction was determined by a geotechnical study. However, the heterogeneity of the zone could produce substantial changes in  $\phi$ , so this value must be assessed with great care in future cases. This introduces great uncertainty into the models due to the existence of an imminent bias in the results. It is clear from our results that the use of a DEM introduces a bias in the modelling, which may be directly linked with the methodology by which each product is created and the date of acquisition (e.g., Kääb et al., 2005; Bühler et al. 2011). It must be remembered that processes may occur, which produce changes in the relief that the DEM is unable to capture due to low spatial resolution (Figure 8A and Figure 8B). Alganci et al. (2018) report that SRTM has better vertical accuracy (8.5 m) vs ASTER GDEM (16 m). Vertical uncertainty provides wrong flow routing values, overestimating the final height in some cases. Therefore, DEM product could introduce an additional uncertainty which must be analyzed carefully during calibration and interpretation. Nonetheless, back analysis allows us to estimate variations in the volumes transported and their extreme values, with variation within the same order of magnitude (Figure 6).

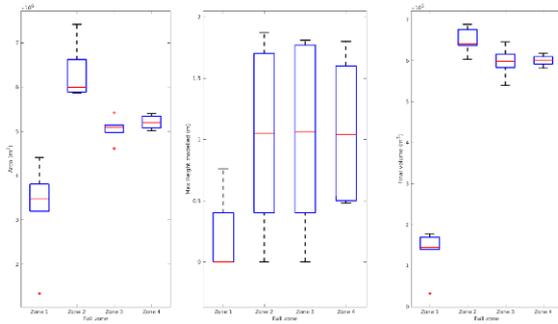
Figure 7 Impact of different debris flows.

In addition to the zone identified as the source of the Petrohué event of 2017, three zones with unstable autobrecciated lava were catalogued as possible debris flow generation zones (Figure 1 and Figure 4). The information collected in the field showed that the gullies in these zones are severely weakened, so debris flows produced by rockfalls can be expected imminently. Additional release zones to those in r.avaflow were estimated with calibration based on the parameters of the back analysis model. Our results indicate that the area potentially affected by the debris flow varies between 3.1 million m<sup>2</sup> and 3.8 million m<sup>2</sup> using DEM ASTER, and between 1.3 million m<sup>2</sup> and 4.4 million m<sup>2</sup> using DEM SRTM (Figure 7). DEM SRTM produces the largest area affected with 60% water content in the initial volume released and DEM ASTER with 70%.

According to the back analysis, a rockfall with 50% water content is capable of transporting a potential volume of 138,628 m<sup>3</sup>; the potential with 70% water is 148,830 m<sup>3</sup>. According to DEM SRTM, the potential volume with 50% water content is 32,039 m<sup>3</sup>, increasing to 177,399 m<sup>3</sup> with 70% water. In this case, the greatest volume is generated when the proportion of water is equal to 70% of the volume initially released, and the highest value is given by DEM SRTM simulation. The lowest value is obtained with a water content of 50%, using DEM SRTM. Finally, the maximum height for DEM SRTM is 0.76 meters, when the water content is 70% of the volume released. In this simulation in DEM ASTER, the debris flow would not reach Route CH-255 (Figure 7). Our results indicate that the flow released from zone 2 with 60% water content will reach a minimum

height of 1.82 meters in populated zones. Likewise, there are cases in which the debris flow will not necessarily reach the populated zones, suggesting that events of this type are not always recorded.

Our projections indicate that the danger to populated areas is strongly dependent on the release zone of debris flows (Figure 7). This suggests that debris flows may repeatedly occur, which are not observed because they are remote from populated areas, increasing the structural destabilization of the volcano in the long term. The release volumes calculated in the present study were defined according to the current stability conditions observed in the field; however, more intense precipitations could lead to more significant rainfall erosion of transportable material (Figure 8B), favouring increasingly violent debris flows. Such scenarios require the appropriate authorities to propose road design projects as a matter of urgency to evacuate the flows quickly and efficiently. This will improve the mitigation efforts to prevent the population from becoming cut off from the rest of the country. Finally, the geomorphology of the Osorno volcano is not unique in the Southern Andes. For example, Villarrica and Llaima volcanoes show similar conditions to Osorno. We thus have firm grounds for assuming that unexpected debris flows could occur elsewhere in southern Chile, with the difference that these volcanoes are in more densely populated zones, exposing the population to even more danger.

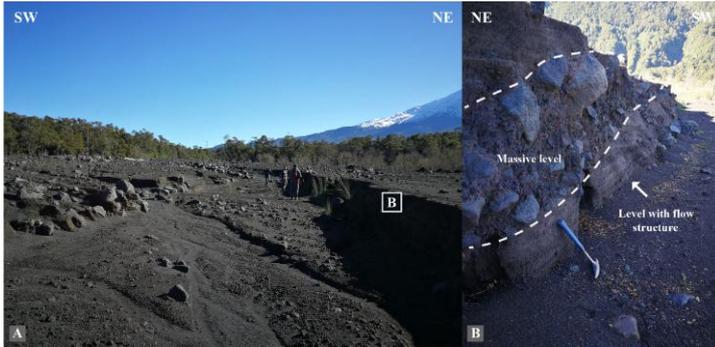
305 Figure 8 A. Distal zone in an alluvial deposit in the El Solitario sector. B. Alluvial deposit with thick of 1.2 m thick; the base level presents flow structures with fluvial erosion.

The evidence collected in the field showed a heterogeneous distribution of lava and slopes close to the debris flow release zones. In this way, the magnitude and force of the landslides processes may be affected by the spatial distribution of volcanic products, principally lava flows. The results show that above 600 masl, there are many exposed lava layers at the base of the principal fluvial channels. A bedrock channel could increase the velocity of the flow in comparison to an alluvial-type channel. This characteristic suggests that the base could act as a sliding surface for the material (Dufresne et al., 2019), which is very common in stratovolcanoes in Southern Andes. It could be a smooth surface with lower friction, especially under rainy conditions. This could have a critical influence on the velocity and acceleration of the flow from the higher reaches of the edifice. Lavigne & Suwa (2004), Sheridan et al. (2005), and Aaron & Hungr (2016) suggest that the dynamic of debris flows depends upon the friction of the base surface. Having said this, the distribution of the lava and its autobrecciation play an important role in the generation of landslides, rockfalls, and debris flows in the study zone (Figure 8).

The differences between the initial and final volumes suggest the incorporation of material into the debris flow due to the erosion, which causes movement of the flow (Figure 9). This is supported by evidence in the field, which showed that movable material is available between the distal and proximal zones (Figure 8B). Retreating scarps were observed, which continuously add material to the drainage networks, and this material is available when debris flows occur. Our field results indicate that the largest volume of the material comes from volcanic deposits (Figure 8A).

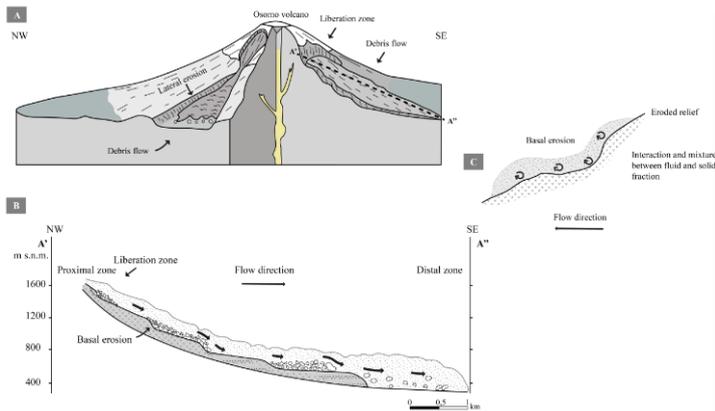
340 Figure 9 Conceptual model of chain processes in Osorno Volcano.

The 2017 Petrohué event was studied by back analysis to understand the impact of debris flows occurring on active volcanoes in the Southern Andes. We used comprehensive in-situ data to constrain a numerical model for understanding the debris flow event. We evaluate the liberation zone for Osorno Volcano, showing that debris flows occur due to the collapse of autobrecciated lava flows above 1500 m.a.s.l. for the first time (Figure 9A). Geomorphological in-situ data determined that the debris flow was a combination of factors such as fluvial erosion and the composition of the volcano, both of which together led to a loss of stability (Figure 9B). The succession of volcanic deposits and autobrecciated lava flows generate conditions for the development of debris flows. Geomorphological evidence has shown that block falls and slips occurring mainly above 1500 m a.s.l. becoming into debris flows, increasing the volume transported to the base of the volcano (Figure 9C).

395 ~~multifactorial influence of different durations of rain in high-latitude regions (Figure 9B). The results show an important lithological influence on debris flows in the study zone for the first time. The alternation of volcanic deposits with lava flows and volcanic deposits with autobrecciated lava flows generate ideal conditions for the continuous development of debris flows during periods when the 0° isotherm is at high altitude. The geomorphological evidence that block falls and slips occurring mainly above 1500 m a.s.l. becoming into debris flows, increasing the volume transported to the base of the volcano (Figure 9C). Each event incorporates the material present on the base and sides of the river channels, increasing the final volume. The erosive force associated with the event is conditioned by the amount of water available during the process.~~ using data collection in situ and modelling with sensitivity analysis using a two-phase model. Our conclusion is to urge the scientific community to focus efforts on generating scenarios for debris flows in the stratovolcanoes of the southern Andes. The population density around Osorno volcano is low but receives a high number of tourists every year. However, the areas of stratovolcanoes like Villarrica and Calbuco contain higher population densities, and these volcanoes must not be ignored in future territorial plans. The present study shows evidence that the debris flows identified are recurrent events, even though they do not always reach populated areas. Our results show that this threat is inherent to volcanic activity, so any future risk analysis must consider debris flows. This will allow better risk management in nearby population ~~centers~~ centres and a safer coexistence with the volcanic structures of the southern Andes.
