# Design and Application of a Multi-Hazard Risk Rapid Assessment Questionnaire for Hill Communities in the Indian Himalayan Region

Shivani Chouhan<sup>1\*</sup>, Mahua Mukherjee<sup>2</sup>

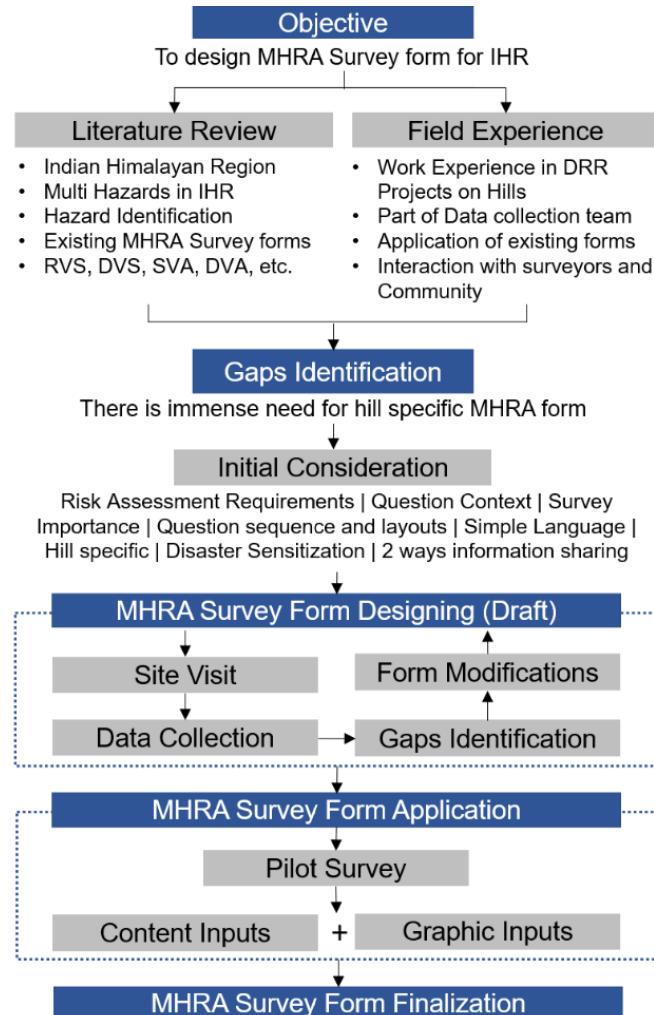
Figure 2: Methodology adopted *by author*

216 To gather beneficial and appropriate information related to multi-hazards in the Himalayan  
217 region, careful attention must be given to the design of the questionnaire that covers all the  
218 important contributing factors from various identified hazards and fulfills all the gaps identified  
219 from the existing survey form and field experience. Designing an effective questionnaire, it  
220 takes time, effort, and a variety of stages. The methodology to prepare the Multi-Hazard  
221 Survey form for Indian Himalayan Region is shown in Figure 2.

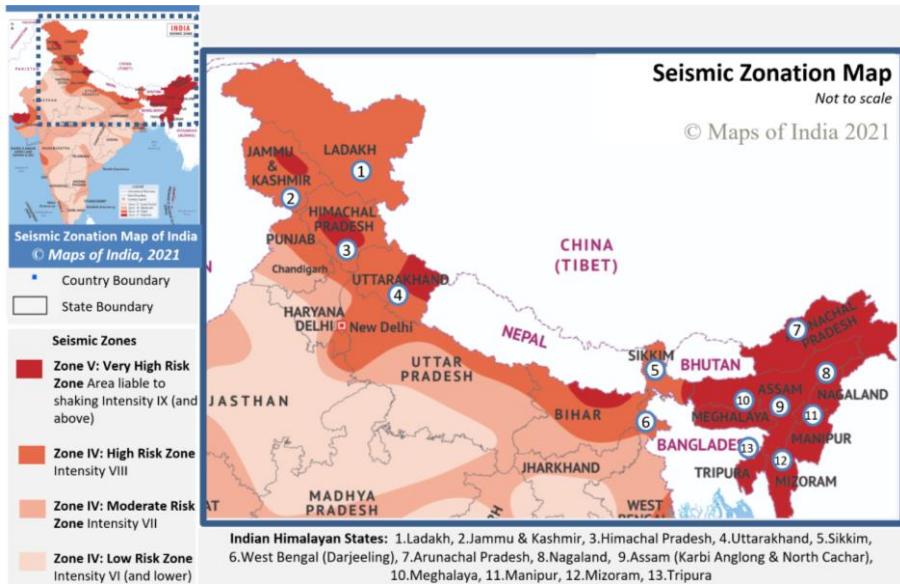
259  
260 Figure 3: Seismic Zonation Map of India, Source: adapted from (pp. Map of India, 2021)

253 The first seismic zoning map of India was published in 1935 by the Geological Survey of India  
254 (G. S. I.) (Figure 3) (A. K. Mohapatra, 2010). Based on the damage earthquakes caused in  
255 various parts of India, this map has undergone numerous modifications (IS-code1893-1, 2002)  
256 (Marcussen, 2017), (Khattri et al., 1984) since its original creation As per Seismic zonation  
257 map, India is divided into four distinct seismic risk zones shown here by colour (Dunbar, 2003)  
258 in Figure 3 below:

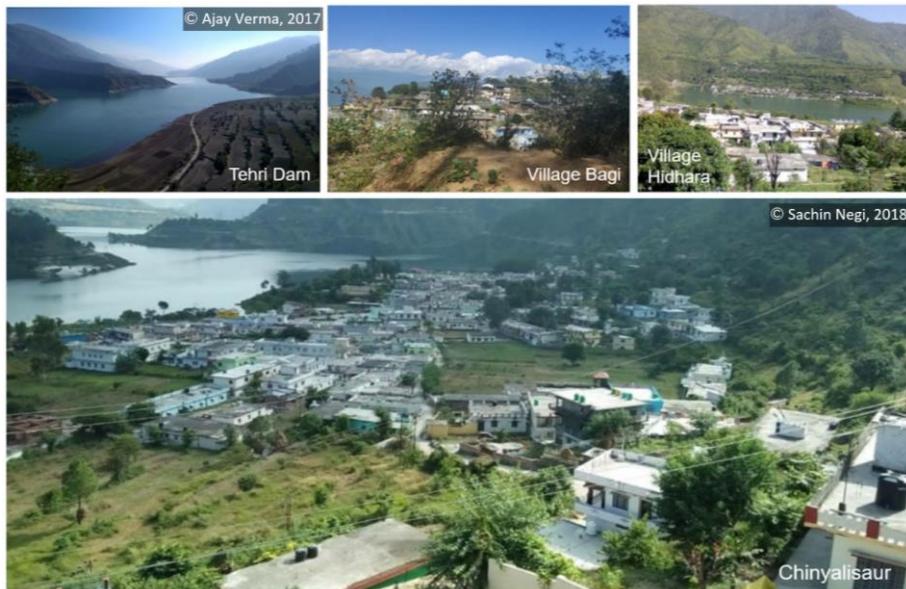
447 The Preliminary survey had been conducted at 5 Gram Panchayats of Chinalisaur sub-district  
448 in Uttarkashi, Uttarakhand, namely Chinalisaur, Dhanpur, Dharasu, Hidhara, and Bagi, in  
449 October and November 2019, using Draft MHRA Survey form. Some of the pictures of the visit  
450 are provided in Figure 5.

451  
452 *Figure 5: View of Site selected for Pilot Survey*  
453 The preliminary survey was conducted to determine (1) Whether the questions are clearly  
454 framed? (2) Does it cover all the requirements as per hill communities? (3) Is the wording of  
455 the questions correcting enough to lead to the desired outcomes? (4) Is the question as well  
456 options for answer suggested is hill specific or not? (5) Is the question positioned is in the most  
457 satisfactory order? (6) Surveyors and respondents of all classes understand the questions?  
458 (7) The questions and their options are self-explanatory or not? (8) The sections in the survey  
459 form cover risk assessment related questions for all identified hazards or not? (9) The  
460 questions are as per construction practices and construction materials available on hills or  
461 not? (10) Are there any need to add some Questions or specified, or some need to be

233 We have designed a draft MHRA survey form (Section 4.1) and applied it to some of the  
234 buildings in five villages in Uttarakhand (Figure 5). An initial pilot survey has been conducted  
235 at 10 schools (section 4.2) using the proposed survey form with content and graphical inputs.  
236 The results and observations relating to the Pilot survey are discussed in sections 4.2 and 4.5  
237 of this paper.

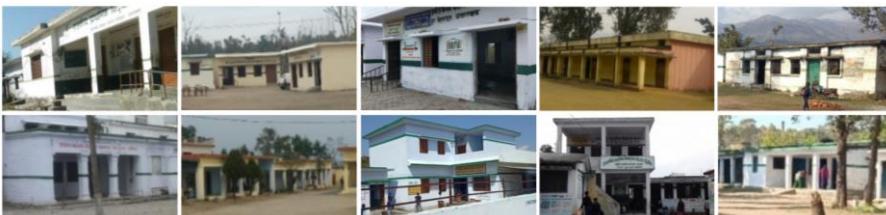
582 The photos of the 10 schools where pilot survey was conducted is shown in the figure below:

584 Figure 7: Photo of the 10 schools

631 Due to the region's strong earthquake zonation, RVS and NSRA data suggest high structural  
632 and non-structural vulnerability in almost all the 10 schools ([figure 7](#)), which assumes greater  
633 significance. On the other hand, Schools need to improve its fire safety measurement and  
634 trainings on the same. The high wind and flood pose a prominent moderate to high risk.  
635 Industry and landslides, on the other hand, pose no risk. The risk of fire arises from a shortage  
636 of fire safety equipment and structural issues such as the absence of an alternate staircase,  
637 the incorrect placement of fire-risk properties, etc. Fire disasters have the potential to be  
638 catastrophic, but this should be a top priority as we advance. The wind is a significant concern  
639 in this region because it is vulnerable to frequent windstorms. High-speed winds pose a risk  
640 in the form of hazard trees/ towers, flying objects weakly latched doors/windows.
