1                                   **Design and Application of a Multi-**  
2 **Hazard Risk Rapid Assessment Questionnaire for Hill Communities**  
3 **in the Indian Himalayan Region**

31 The main objective of this study is to design and apply a hill-specific risk assessment survey  
32 form that contains more accurate information for hill communities and hill-based infrastructure  
33 and allows for the surveys to be completed efficiently and in less time. The proposed survey  
34 form is described herein and is validated through a pilot survey at several locations in the hills  
35 of Uttarakhand, India. The survey form covers data related to vulnerability from Earthquake  
36 (Rapid Visual Screening), Flood, High Wind, Landslide, Industrial, Fire Hazard in the building,  
37 Climate Change and Non-Structural Falling Hazard. The proposed form is self-explanatory,

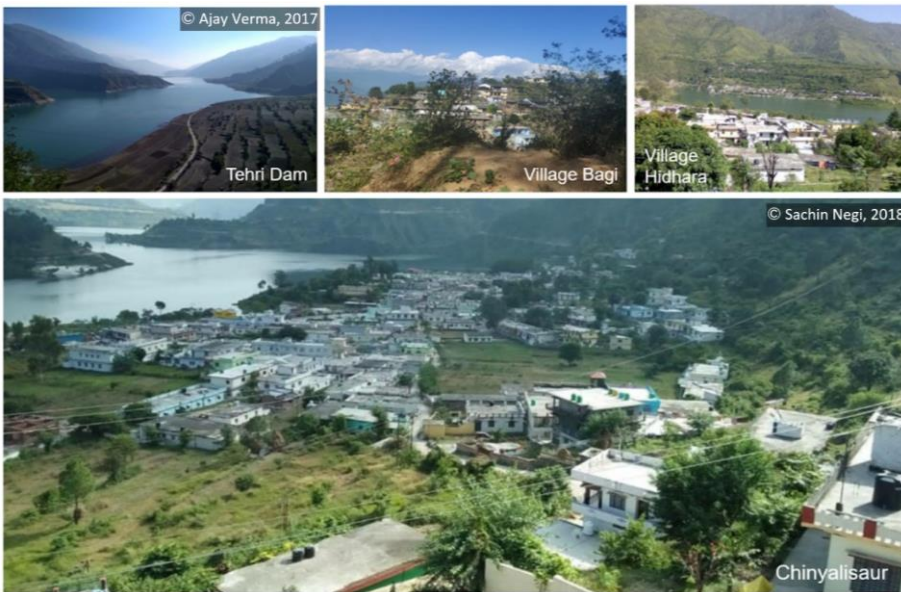
446 The Preliminary survey was conducted at 5 Gram Panchayats of Chinyalisaur sub-district in  
447 Uttarkashi, Uttarakhand, namely Chinyalisaur, Dhanpur, Dharasu, Hidhara, and Bagi, in  
448 October and November 2019, using Draft MHRA Survey form. Some of the pictures of the visit  
449 are provided in ig5.

*Figure 5: View of Site selected for Pilot Survey*

233 We have designed a draft MHRA survey form (Section 4.1) and applied it to some of the  
234 buildings in five villages in Uttarakhand (Fig. 5). An initial pilot survey has been conducted at  
235 10 schools (section 4.2) using the proposed survey form with content and graphical inputs.  
236 The results and observations relating to the Pilot survey are discussed in sections 4.2 and 4.5  
237 of this paper.

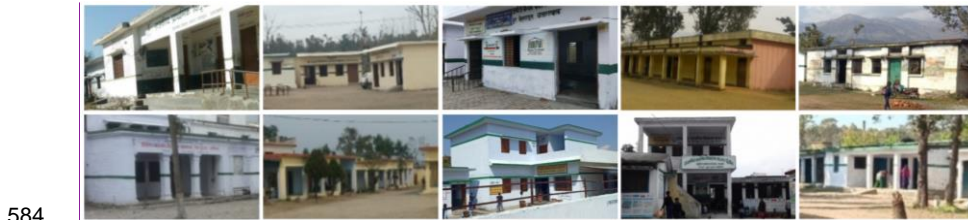
583 The photos of the 10 schools where pilot survey was conducted is shown in the Fig. 7 below:

585 Figure 7: Photo of the 10 schools

632 Due to the region's strong earthquake zonation, RVS and NSRA (Non-Structural Risk  
633 Assessment) data suggest high structural and non-structural vulnerability in almost all the 10  
634 schools (figure 7), which assumes greater significance. On the other hand, schools need to  
635 improve their fire safety measurement and trainings. High wind and floods pose a prominent  
636 moderate to high risk. Industry and landslides, on the other hand, pose no risk. The risk of fire  
637 arises from a shortage of fire safety equipment and structural issues such as the absence of  
638 an alternate staircase, the incorrect placement of fire-risk properties, etc. Fire disasters have  
639 the potential to be catastrophic, but this should be a top priority as we advance. The wind is a  
640 significant concern in this region because it is vulnerable to frequent windstorms. High-speed  
641 winds pose a risk in the form of hazard trees/ towers, flying objects weakly latched
