1 **Design and Application of a Multi-**
2 **Hazard Risk Rapid Assessment Questionnaire for Hill Communities**
3 **in the Indian Himalayan Region**

4 Shivani Chouhan^{1*}, Mahua Mukherjee²

5 ¹Research Scholar, Centre of Excellence in Disaster Mitigation and Management, Indian
6 Institute of Technology Roorkee, Roorkee, India

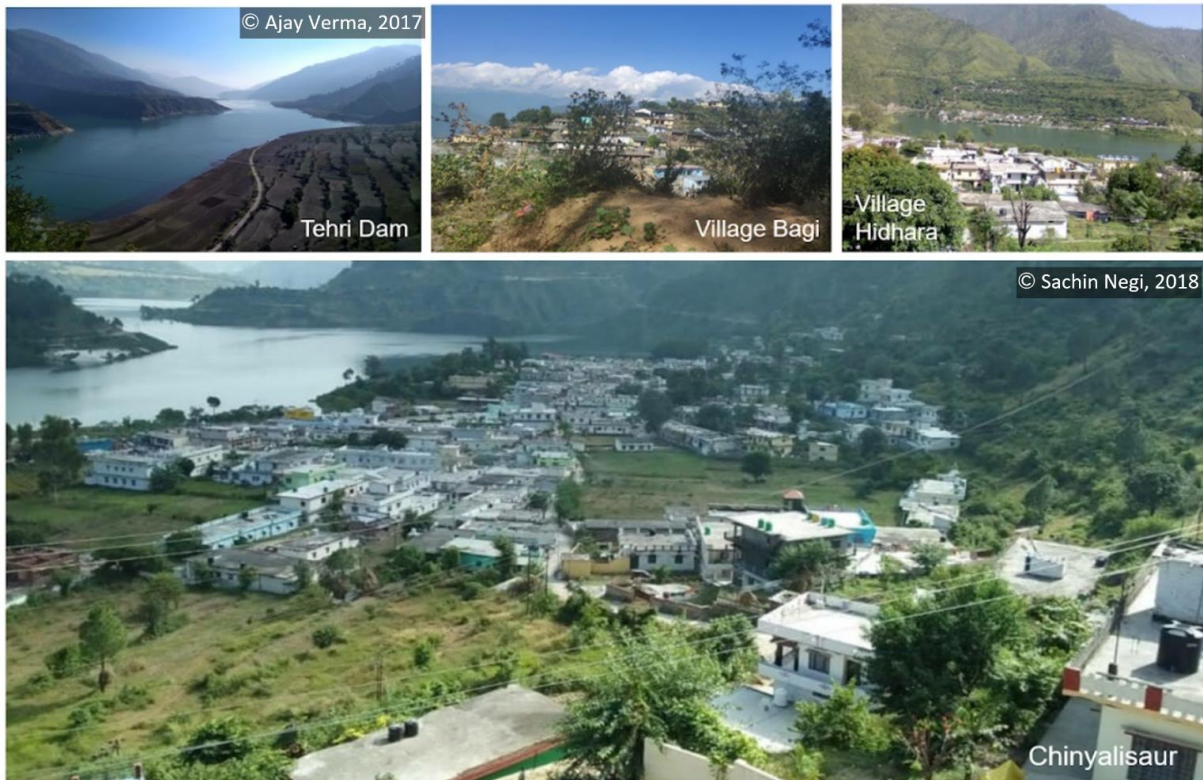
447 The Preliminary survey had been conducted at 5 Gram Panchayats of Chinyalisaur sub-district
448 in Uttarkashi, Uttarakhand, namely Chinyalisaur, Dhanpur, Dharasu, Hidhara, and Bagi, in
449 October and November 2019, using Draft MHRA Survey form. Some of the pictures of the visit
450 are provided in Figure 5.

233 We have designed a draft MHRA survey form (Section 4.1) and applied it to some of the
234 buildings in five villages in Uttarakhand (Figure 5). An initial pilot survey has been conducted
235 at 10 schools (section 4.2) using the proposed survey form with content and graphical inputs.
236 The results and observations relating to the Pilot survey are discussed in sections 4.2 and 4.5
237 of this paper.

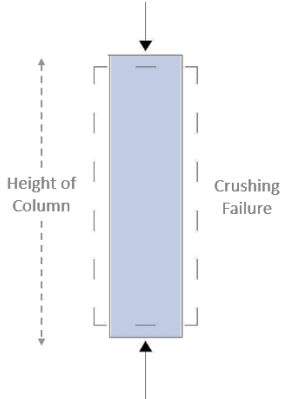
COLUMN						
97	Column available?	Yes			No	
98	If yes in Q.97, What is the type of Column?	Short Column			Long Column

<p style="text-align: center;">$X : Y \leq 1 : 12$ X: Area of Column Y: Height of Column</p>
