1 **Design and [Application](#) of a Multi-**
2 **Hazard Risk Rapid Assessment Questionnaire for Hill Communities**
3 **in the Indian Himalayan Region**

4 Shivani Chouhan^{1*}, Mahua Mukherjee²

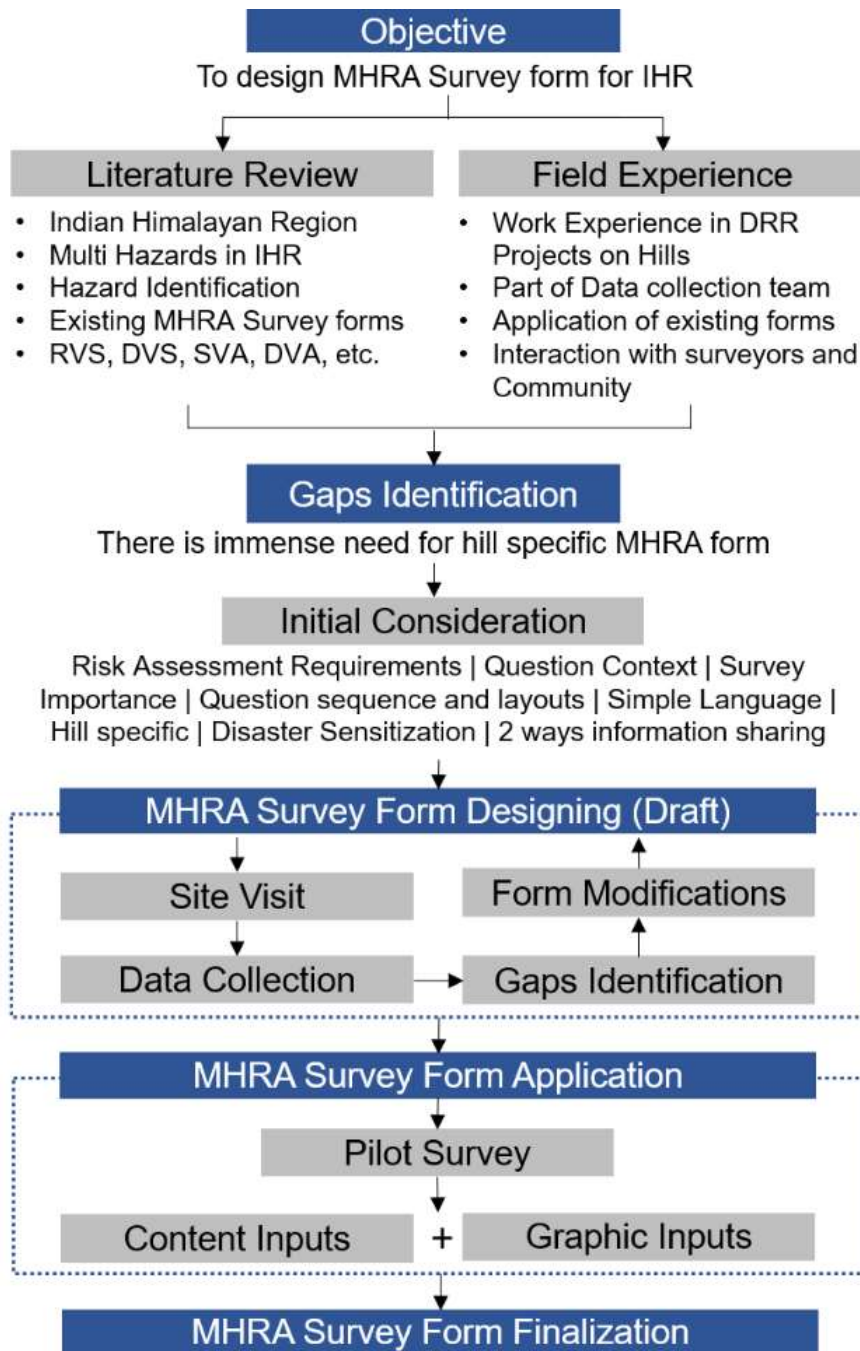
207 To gather beneficial and appropriate information related to multi-hazards in the Himalayan
208 region, careful attention must be given to the design of the questionnaire that covers all the
209 important contributing factors from various identified hazards and fulfils all the gaps identified
210 from the existing survey form and field experience. Designing an effective questionnaire, it
211 takes time, effort, and a variety of stages. The methodology to prepare the Multi-Hazard
212 Survey form for Indian Himalayan Region is shown in figure 2.

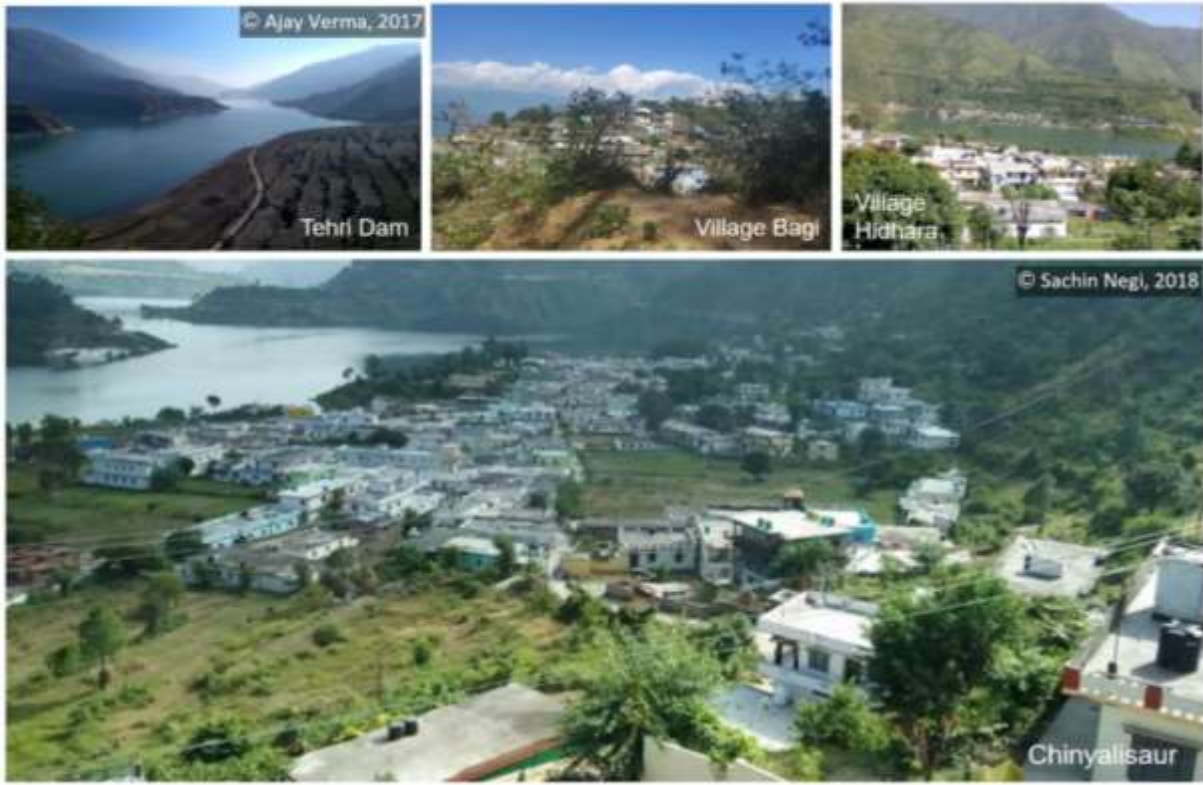
459 The [Preliminary](#) survey had been conducted at 5 Gram Panchayats of Chinyalisaur sub-district
460 in Uttarkashi, Uttarakhand, namely Chinyalisaur, Dhanpur, Dharasu, Hidhara, and Bagi, in
461 October and November 2019, [using Draft MHRA Survey form](#). Some of the pictures of the visit
462 are provided in Figure 5.

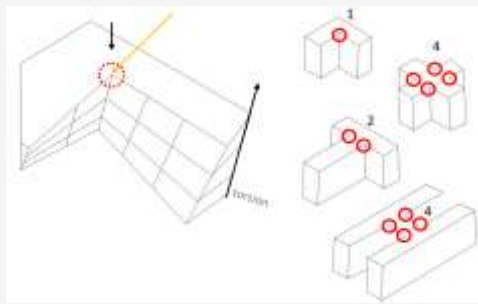
39	No. of Reentrants corner in Plan

40	Is extra strength available in reentrants corner?	Yes		No		
41	No. of Floors	only G	G+1	G+2	G+3	≥ G+4

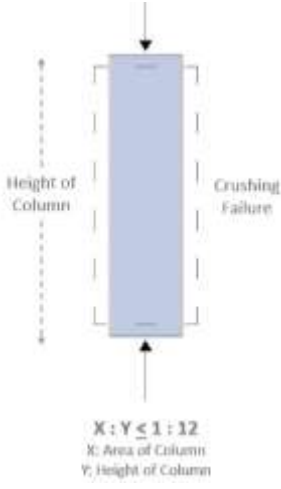
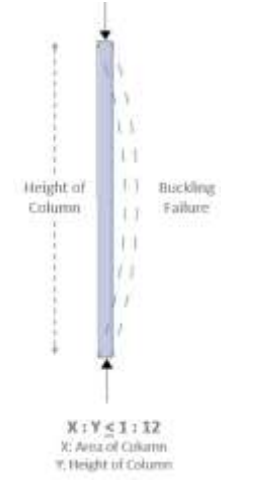
COLUMN						
97	Column available?	Yes			No	
98	If yes in Q.97, What is the type of Column?	Short Column			Long Column
