Design and Application of a Multi-Hazard Risk Rapid Assessment Questionnaire for Hill Communities in the Indian Himalayan Region

ABSTRACT

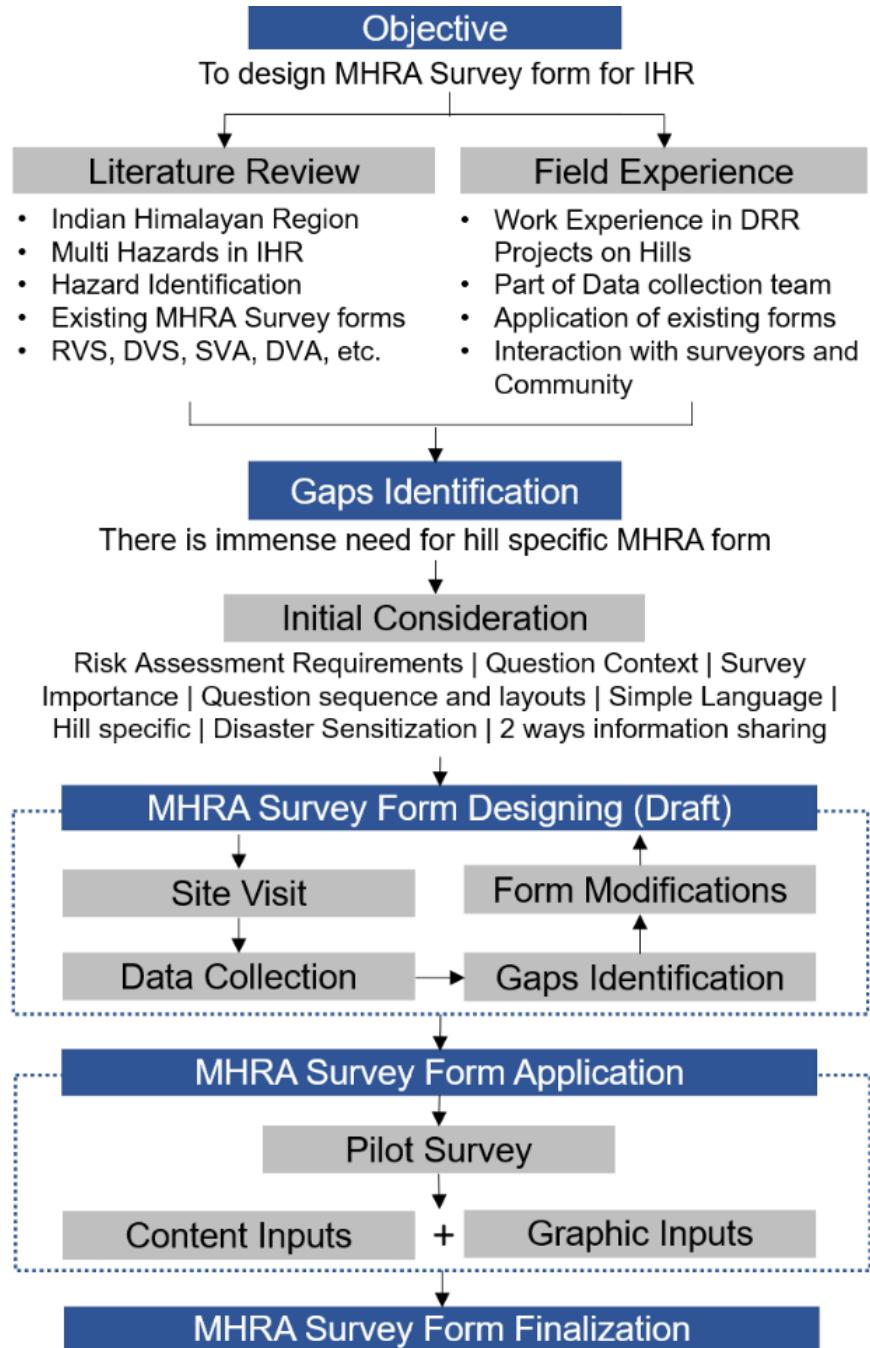
Figure 2: Methodology adopted by author

216 To gather beneficial and appropriate information related to multi-hazards in the Himalayan
217 region, careful attention must be given to the design of the questionnaire that covers all the
218 important contributing factors from various identified hazards and fulfils all the gaps identified
219 from the existing survey form and field experience. Designing an effective questionnaire, it
220 takes time, effort, and a variety of stages. The methodology to prepare the Multi-Hazard
221 Survey form for Indian Himalayan Region is shown in Fig. 2.

233 We have designed a draft MHRA survey form (Section 4.1) and applied it to some of the
234 buildings in five villages in Uttarakhand (Fig. 5). An initial pilot survey has been conducted at
235 10 schools (section 4.2) using the proposed survey form with content and graphical inputs.
236 The results and observations relating to the Pilot survey are discussed in sections 4.2 and 4.5
237 of this paper.

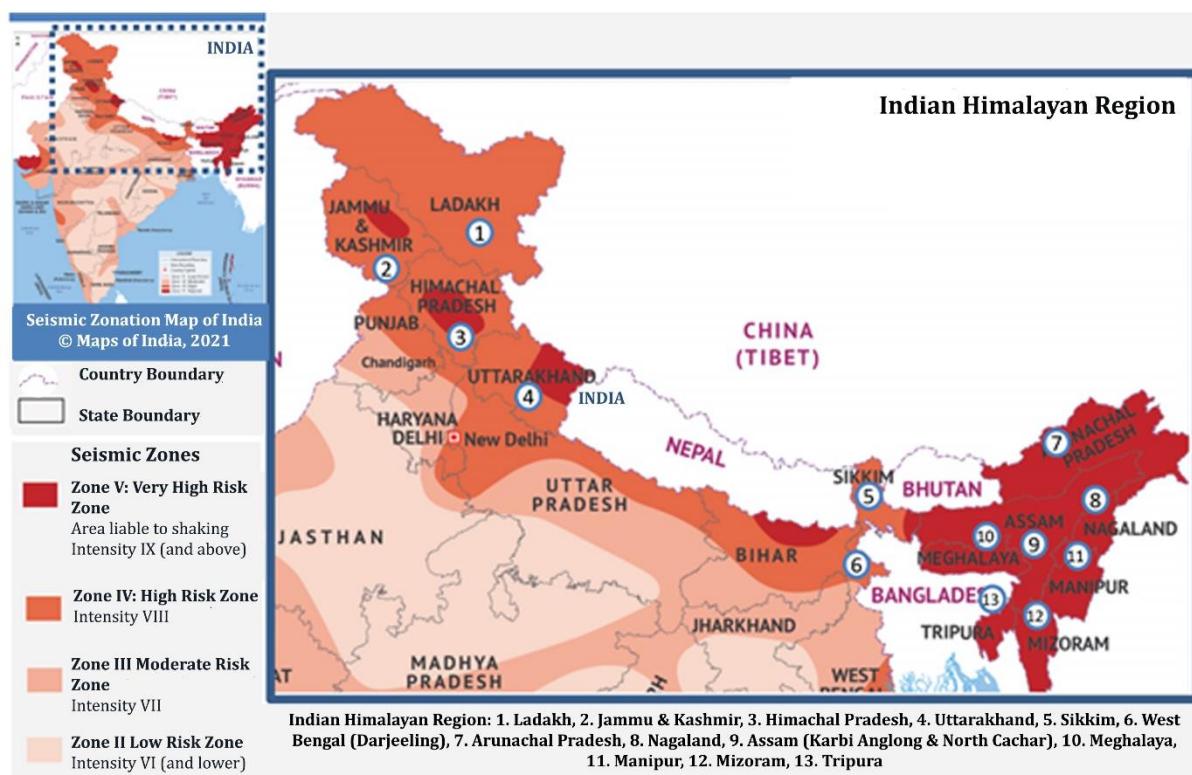
260 *Figure 3: Seismic Zonation Map of India, Source: adapted from (pp. Map of India, 2021)*

253 The first seismic zoning map of India was published in 1935 by the Geological Survey of India
254 (G. S. I.) (Fig. 3) (A. K. Mohapatra, 2010). Based on the damage earthquakes caused in
255 various parts of India, this map has undergone numerous modifications (IS-code1893-1, 2002)
256 (Marcussen, 2017), (Khattri et al., 1984) since its original creation As per the Seismic zonation
257 map, India is divided into four distinct seismic risk zones shown here by colour (Dunbar, 2003)
258 in Fig. 3 below:

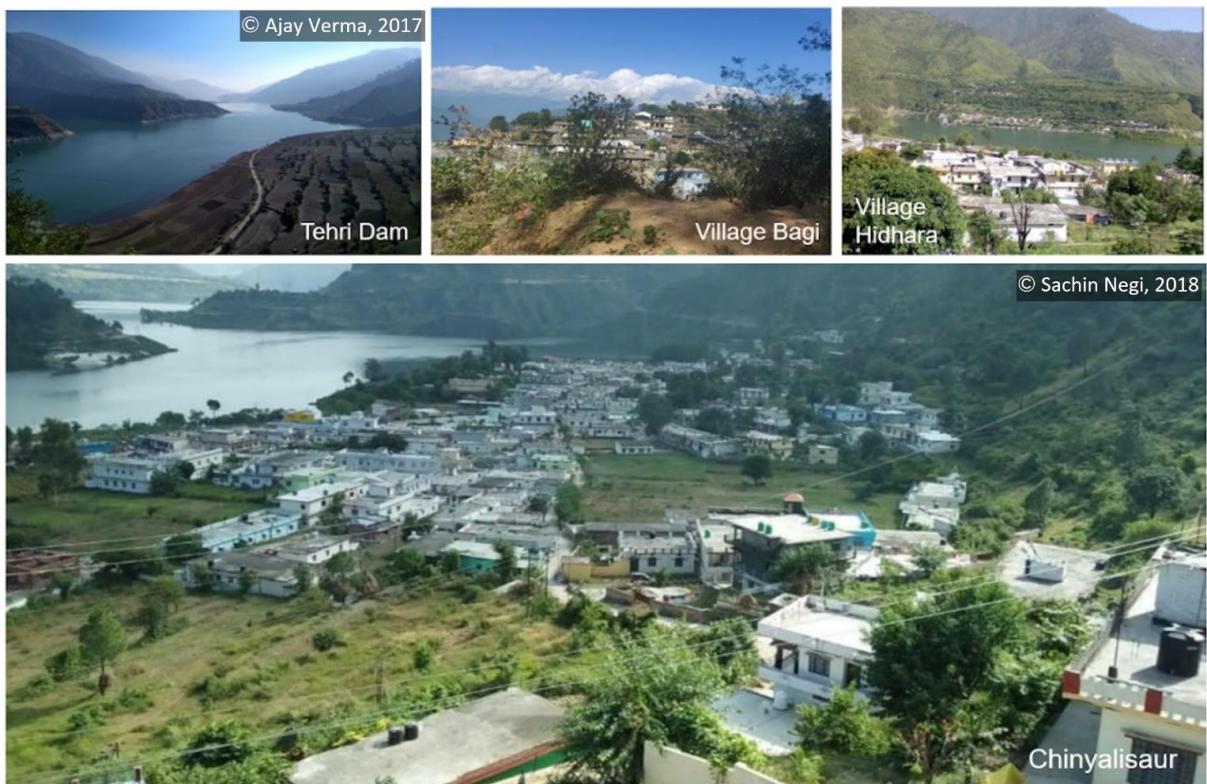
447 The Preliminary survey was conducted at 5 Gram Panchayats of Chinalisaur sub-district in
 448 Uttarkashi, Uttarakhand, namely Chinalisaur, Dhanpur, Dharasu, Hidhara, and Bagi, in
 449 October and November 2019, using Draft MHRA Survey form. Some of the pictures of the visit
 450 are provided in ig5.
