1 **Design and Testing of a Multi-**  
2 **Hazard Risk Rapid Assessment Questionnaire for Hill Communities in**  
3 **the Indian Himalayan Region**

4 Shivani Chouhan<sup>1\*</sup>, Mahua Mukherjee<sup>2</sup>

5 <sup>1</sup>Research Scholar, Centre of Excellence in Disaster Mitigation and Management, Indian Institute of Technology  
6 Roorkee, Roorkee, India

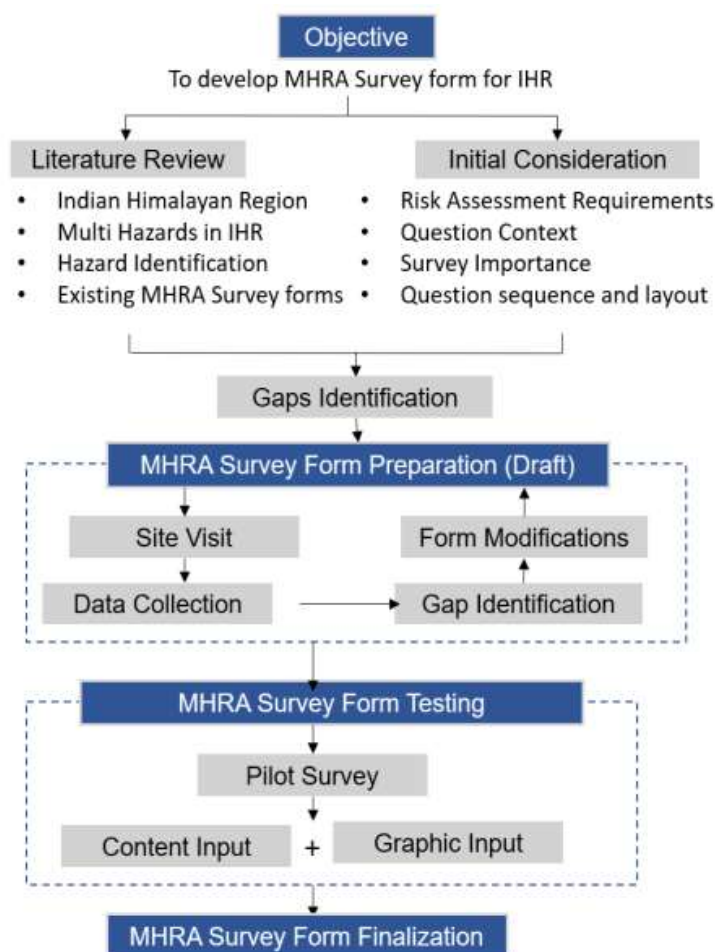
178 *Figure 2: Methodology adopted*

172 To gather beneficial and appropriate information related to multi-hazards in the Himalayan region, careful  
173 attention must be given to the design of the questionnaire that covers all the important contributing factors from  
174 various identified hazards and fulfils all the gaps identified from the existing survey form. Designing an effective  
175 questionnaire, it takes time, effort, and a variety of stages. The methodology to prepare the Multi-Hazard Survey  
176 form for Indian Himalayan Region is shown in figure 2.

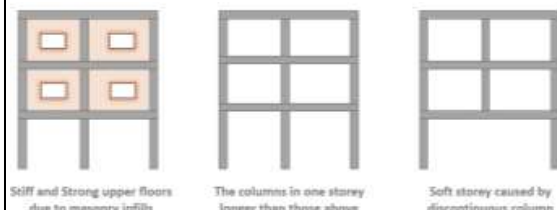
SOFT STOREY				
	<p>A soft storey building is a multi-story building in which one or more floors have windows, wide doors, large unobstructed commercial spaces, or other openings in places where a shear wall would normally be required for stability as a matter of earthquake engineering design.</p>
