# Reevaluating Flood Protection: Disaster Risk Reduction for Urbanized Alluvial Fans

Tamir Grodek<sup>1,2</sup>, Gerardo Benito<sup>2</sup>

**Abstract.** The deterioration of check dams and other flood prevention measures, combined with storms breaking historical records, has created an immediate risk of floods and debris flows breaching urbanized alluvial fans. In this study, we reevaluate these floods and sediment prevention measures and propose a different flood prevention paradigm.

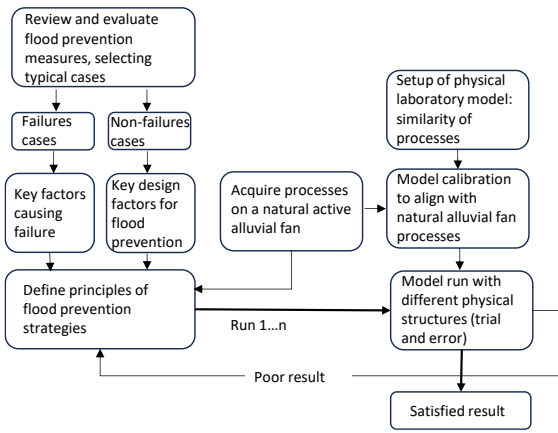
Figure 1: A schematic diagram of the methodology

125        The methodology consists of four main steps (flowchart, Fig. 1): (1) literature review and selection of case studies of natural and urbanized alluvial fans ~~in~~from different climatic regions based on landform characteristics (Table 1), (2) analysis of key factors contributing to both failure and non-failure (success) of the flood prevention measures, (3) investigation of the hydro-sedimentary dynamics of natural (non-urbanized) active alluvial fans to derive nature-based solutions for safer urbanization, and (4) development of a physical laboratory model to test these concepts, incorporating a nature-based design for sustainable urban development on alluvial fans.

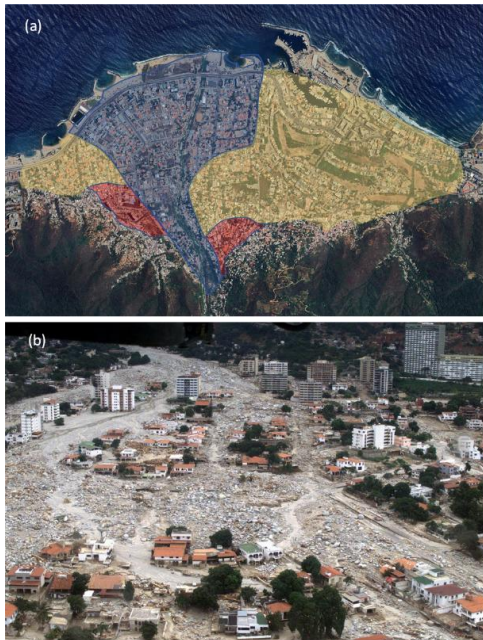
Figure 12: The 1999 Caraballeda flood. The debris flow impact 1.3 km<sup>2</sup> of the city. (a) flood deposits: blue, the 1999 flood; yellow, historic debris flow; and red, prehistoric deposits (Source: Wiczorek et al., 2001). (b) aftermath (source: Larsen and Wiczorek, 2006).

R=0.46, indicates the likelihood of both debris flows and fluvial processes. Historical records indicate 1–2 comparable events per century (Fig. 2a; 1798, 1912, 1914, 1938, 1944, 1948, and 1951; Salcedo, 2000, Lopez and Courtel, 2008), however, until the 1950s the area was mainly rural and less populated. Calculated the probability of the rainfall, estimated T>1,000–y (pre-event), and T=270–y thereafter (highest daily rainfall, 410–mm, has a T=150–y [Dec15, 1999]). Despite the exceptional event magnitude of these events, between 2001–2008, 24 mountainous streams were between 2001–2008, had been channelized and 63 dams had been built in the canyons (37 are closed-type and 26 are open-type dams). Up to date, the dams have been subject to a rapid sedimentation and significant downstream, significant bed erosion has been observed downstream due to the clear water, which has entrained more sediments. In summary, ~50% of the out of 63 dams have, ~50% lost their capacity, 7 have been destroyed and 13 are suffering damages.

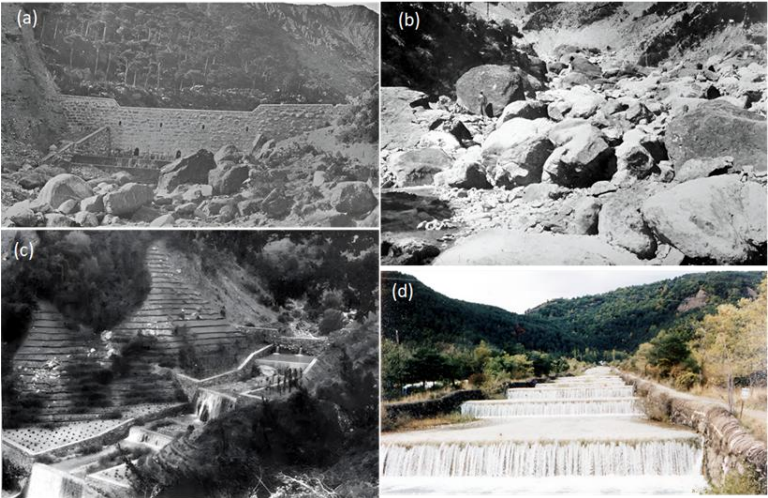
Figure 23: Types of flood control measures widely applied-used in the European basins disgorging-draining to urbanized alluvial fans. (a) Early check dams just after construction in, 1907; (b) after destruction, 1955; (c) check dams' revision and afforestation in, 1963; (d) the radial canal across the alluvial fan and the road, three years before the collapse of the 1996 event. Source: [https://www.inia.es/serviciosyrecursos/recursosdocumentales/forestales/fototecaforestal/Paginas/Imagenes.aspx?tema=\\*&provincia=HUESCA&municipio=BIESCAS#k=aras#l=3082](https://www.inia.es/serviciosyrecursos/recursosdocumentales/forestales/fototecaforestal/Paginas/Imagenes.aspx?tema=*&provincia=HUESCA&municipio=BIESCAS#k=aras#l=3082)

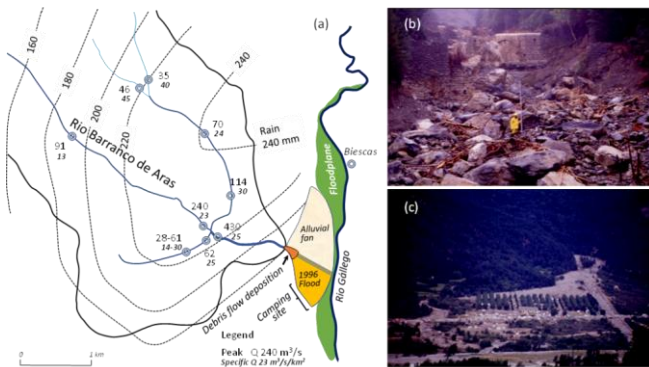
**Figure 34:** Biescas flood, Aug. 1996: (a) basin rainfall and flood discharges, (b) collapse of 32 check dams and remnant of the debris flow surge and (c) the camping site aftermath. Source: Benito et al., 1998.

Location: Central Pyrenees (Aragón, Spain; Table 2), August 1996 (87 deaths). The alluvial fan of the Rio Barranco de Aras was frequently prone to flooding. Between 1926 and 1943, 36 check dams were built in the steep basin (Fig. 23) to protect the road to France (N260–A136). In August 1996, >200 mm of rain fell in 2 h, producing a flood peak of >400 m<sup>3</sup> s<sup>-1</sup>, breaching a sequence of 32 out of the 36 retention-check dams and entraining 0.17 Mm<sup>3</sup> of 0.2 Mm<sup>3</sup> of suspended sediment (Fig. 34). The debris flow surge deposited at the fan-head blocked the constructed mid-fan canal. The flow spread laterally, covering a part of the fan, sweeping through a campsite and caravan park and dragging people and their caravan down to the Rio Gállego. The basin ruggedness,  $R=0.28$ , below the likelihood of debris flows (Melton  $R=0.28$ ), indicates that the collapsed check dams, probably caused the debris flow surge (García-Ruiz et al., 1996; Benito et al. 1998). Historical records indicate show two comparable events (1907, 1929).

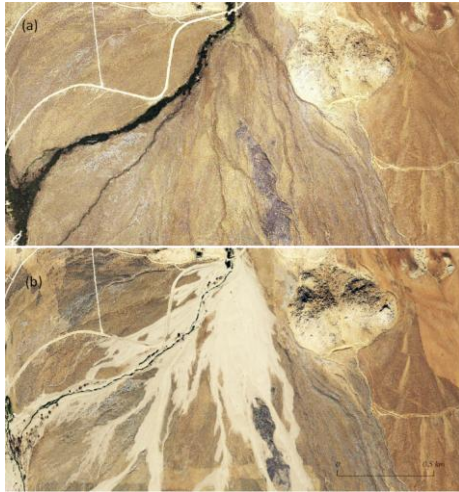
**Figure 45:** Oak Creek alluvial fan. (a) Dark desert patina indicating non-flooded surfaces for more than millennia (Liu and Broecker, 2000); (b) Post forest fire, a heavy storm on the feeding basin triggered debris flows down to the alluvial fan, deposited 1.5 Mm³ of sediment. Note, white surfaces indicate the recent debris flows. Source: ©Google Earth 7-2007 and 6-2009.

Location: Nevada, USA (Table 2), July 12, 2008. Although this example is less disruptive, this example is an illustration of the rule of rare events in arid regions that need to be considered. The alluvial fan of the Oak Creek River basin did not show evidence of flooding for millennia or so. This is evidenced indicated by the dark desert patina over the fan surface (Liu and Broecker, 2000) and the historic Mt. Whitney Fish Hatchery established in 1917 on the riverbank in 1917, which has never been on the riverbank and never flooded (Fig. 4a5a). On July 6, 2007, a forest fire impacts-affected the basin and on year later, on 12 July 2008, residual moisture from hurricane Bertha caused high-intensity rainfall ( $97 \text{ mm hr}^{-1}$ , 39 min). The following flood triggered  $1.5 \text{ Mm}^3$  of debris flows that spread over 7 km down the fan, damaging residences houses, including the fish hatchery (Fig. 4b5b). The debris flows surge (1–3 m in height), moved at estimated velocities of  $2\text{--}5.4 \text{ m s}^{-1}$  (Wagner et al., 2012).

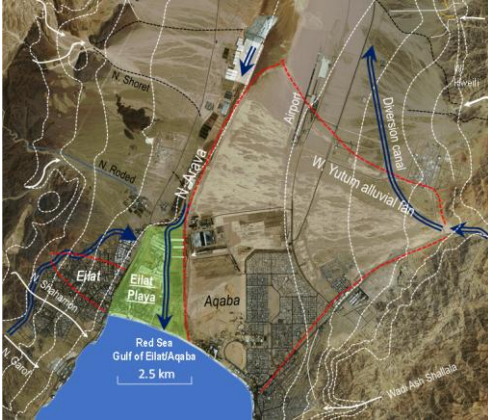
Figure 56: Visible active distributary channels on the Wadi Yutum alluvial fan. Since the picture was taken (2004), the city has grown without leaving short flowpath to the sea; instead, several retention dams are constructed to reduce sediments and diversion canal to bypass the city (Eom et al., 2011). The canal increases the flow path to the Red Sea from 8.5 to 27 km (slope drop from 2.4 to 0.7 % respectively), reducing sediments carrying capacity of flood. Source: ©Google Earth 2004.

Location: Aqaba-Jordan (Table 2). Situated on the shores of the Gulf of Eilat/Aqaba, the city covers a large part of the alluvial fan and is frequently inundated by desert flash floods disgorged from Wadi Yutum (Farhan and Anbar, 2014; Farhan, Y. and Anaba. 2016; Fig. 56). The basin covers ~4,000 km², mainly drains mainly to depressions, and only 1,720 km² is hydrologically connected to the fan (e.g., sub-basin W. Yutum El-Umrán sub-basin, 770 km²). The flood of 3 February 2006 is an example of an arid flash flood. While only 1 mm of rain was measured over the cities of Eilat and Aqaba (avg. 25–40 mm y⁻¹), heavy rain, 5–10 km to the east (500–1200 masl), covered a limited part of the basins (including W. Mubarak, s=5.3 %; A=65.1 km²). The flash flood ( $Q_p \sim 550 \text{ m}^3 \text{ s}^{-1}$ ) hit the city and further inundated the Eilat playa. The low  $R=0.05$  indicates fluvial processes. A similar type of storm inundated the cities of Aqaba, Ma'an and the Eilat playa on the night of 10–11 March 1966 (Schick, 1971). The flash flood of W. Mubarak destroyed the container port of Aqaba (located on a small alluvial fan,  $A=0.4 \text{ km}^2$ ). The discharge is unknown, but is estimated to be 140–270 m³ s⁻¹ (25–100-y flood probability, respectively).

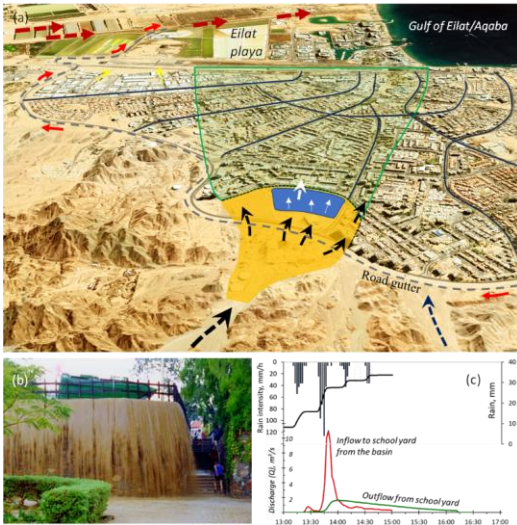
**Figure 67: Eilat, 1997 flood: (a) Flood disgorged from the canyon to the fan head (orange cone), depositing sediment and blocking the circumferential canal. By flooding the school compound (blue), the flow attenuated and spread between several four-lane roads (black arrows) without overtopping. Thus, the damage was minimal (b). (c) Rainfall and the attenuation of the flood discharge through the city (calibrated based on Nahal Yael hydrometric stations). Source (a): ©Google Earth 2024.**

The urban framework is criss-crossed by a road network (30 % of the urban area, including car parks; Fig. 6a7a). The 4–lane  
radial roads, which following the fan slope (3–7 %), efficiently transport floodwaters down to the playa. The orthogonal  
350 roads, parallel to the fan contours (slopes 0–0.5%), are often inundated during floods or urban runoff.

the fan head. The gated school, including a soccer field, acted as a retention pond and the flow was attenuated over 0.25 km,  
from an incoming peak discharge of 11 m<sup>3</sup> s<sup>-1</sup> to 1.6 m<sup>3</sup> s<sup>-1</sup> at the school gate, depositing most of the sediment (Fig. 6b7b-c).

360 Further downstream, the flow was split-divided by a complex of 4–lane road network and the peak discharge was further  
reduced to ~0.4 m<sup>3</sup> s<sup>-1</sup> per road, with limited overflow. Following these decades of experience with urban flooding, this flood  
prevention method was further investigated as an alternative to the total flood protection (Sourcesource: Grodek et al., 2000,  
Grodek, 2024).

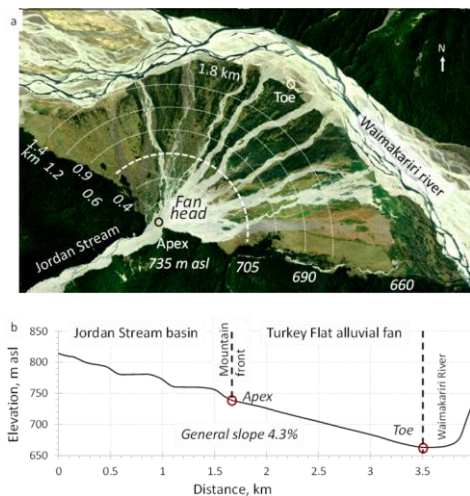
Figure 78: (a) Turkey Flat alluvial fan. Color ranges indicate relative time laps between floods: white, recent activity; grey, recently abandoned, partly weathered sediments, seasonal vegetation (<3 y); yellow – annual plant and beginning of shrub germination (>3<10 y); green – mature bush of matagouri plant, long periods without flooding (>10 years). Dashed lines (Table 2); the semicircle arcs for measure active channels (Table 3), (b) longitudinal profile, from the mountain river down to the fan toe and across the Waimakariri River. Image: <https://mapviewer.canterburymaps.govt.nz/>

sediment abrasion and lack of vegetation (Fig. 7a8a). Severe storms cover the entire fan head, (ii) below, the mid-fan (area=4 km<sup>2</sup>, 15 % are active), is characterize by 7–9 distinct individual shallow channels distributed radially from the fan head to the fan toe. Each channel has an average width of 50 m (total width, 400 m). The density and the size of the vegetation indicates the relative time interval between out-of-channel floods (Fig. 7a8a).

These important observations show that as the flow progresses down the alluvial fan, a progressively larger area remains unaffected by the flood (Table 23; Fig. 7). In general, the proportions of affected and unaffected areas are related to flood magnitude and basin/fan ratio (Table 1); the higher the basin/fan ratio, the larger is the active areas. The example of the Turkey Flat alluvial fan shows that while at the fan head 66 % of the area at the fan head is subject to flooding during a single event, only 15 % of the area at the mid-fan, only 15 % is occupied affected, meaning that 85 % of the mid-fan can be considered for safer zone design.

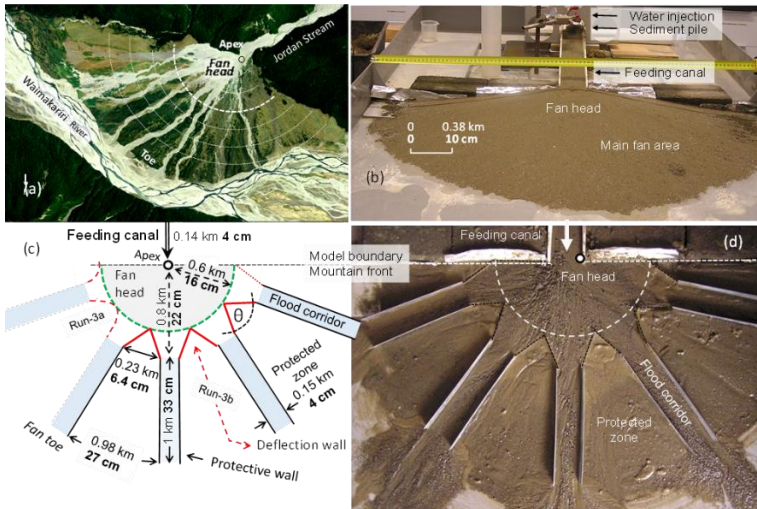
Fig. 89: (a) Turkey Flat alluvial fan; (b) Physical model setup (see section 2 Materials and methods Appendix B for details); (c) Sketch of the final model simulation, Run-3b (Run-3a in dashed). Dimensions: i. Normal letters, the proposed design, ii. letters in bold, the laboratory physical model. Angle of  $\theta < 45^\circ$ ; (d) View of the final physical model simulation (mixed sediment sizes; for the model parameters, see Table 1).

The first step in applying the analogue physical model was setting up the apparatus to achieve similarity of processes to the Turkey Flat alluvial fan (Fig. 9a-b; see section 5.2). The model was examined under fluvial conditions. The model setup is described in detail in the materials and methods, section 2Appendix B.

Once the calibration was established, control measures were introduced to the alluvial fan. A first attempt was made to test the feasibility of applying radial control canals from the fan apex and the fan head sector. These included (i) parallel canals down to the toe of the fan (Run2a-b); (ii) semi-circular alternating walls and gates, that divert flows to pre-defined corridors along the steepest slope (Run 2b). Both attempts failed to properly distribute sediment down the alluvial fan, resulting in immediate sedimentation and breaching of the floodwaters carrying sediment into the pre-defined safe zone. This consistent failure to control the flow at the fan head sector leads to the conclusion that this area should be preserved to allow natural processes to continue. Further attempts focus on the alluvial fan only, dividing the main fan area between alternating urbanization protection zones and flood corridors, replicating the natural flow observed on the Turkey Flat alluvial fan. The first attempt with a semi-circular deflector wall structure was disappointing as sediment accumulated in front of the structure and was frequently evacuated, threatening the protected zone (Run-3a; Fig 8e9c). The attempt with arrow-shaped deflector walls (0<45°), showed the best result of continuous evacuation of floods and sediments out of the alluvial fan (Run-3b; Hollingsworth and Kovacs 1981). 0 higher than 45°, cause sedimentation above the deflector wall. The-This result was confirmed using both, sorted sand and mixed sand and gravel (Fig 9c-d).

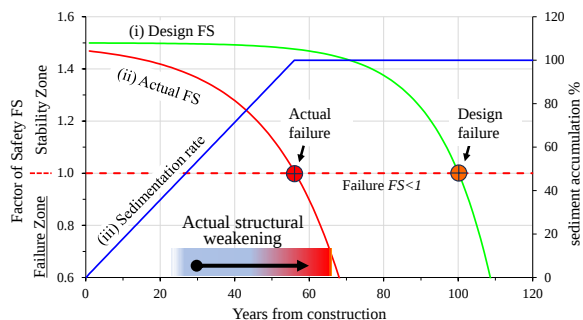
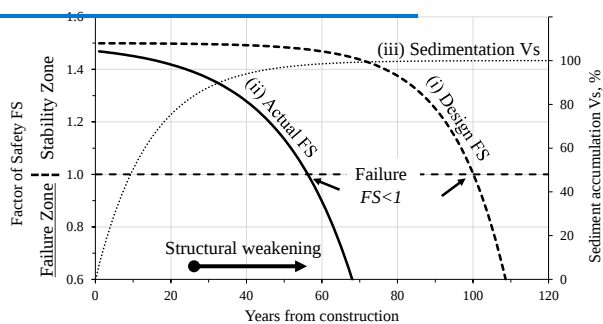
**Fig. 910:** Functionality of flood prevention measures in time as Factor of Safety, FS: (i) **e**Engineering design (generally  $FS=1.5$ ), (ii) **A**ctual-**a**ctual FS in time **a**s a result of sedimentation, water pressure and structural erosion and aging, and (iii) **F**fsSediment accumulation in the check damation-rate,  $V_s$  (%). **I**t should be noted that the designed safety factor for a 100 year service life is reduced to less than 60 years as a result of structural degradation (e.g. progressive deterioration of materials due to temperature/water changes, occurrence of extreme impacts, etc.). **F**or FS and  $V_s$  equations and calibrations, see Appendix B-2.1 and 2.2 respectively.

To illustrate the degradation of sediment control measures over time (e.g., check dams), we present Figure 10, comparing the design factor of safety (FS) with the actual FS as presented in the case study of Biescas, Pyrenees (discussed in Section 3.2):

155 piping, and the severity of the expected events. An  $FS < 1$  marks the point at which the structure is at risk of failure. Given the large number of parameters involved, physical calculations are complex and unreliable. Therefore, we demonstrate  $FS$  using the modified Gompertz-Makeham law of lifespan to model its progression over time:  $FS(t) = A - Be^{-\gamma t}$  where

$A$  represents the  $-FS$  engineering design (1.5),  $B$  is a  $-$ scaling constant for the age-dependent term (design: 0.0005 and actual: 0.03) and  $\gamma$  is the  $-$ exponential structural degradation ~~in~~over time (design: 0.069 and actual: 0.05). For the sedimentation rate of a check dam,  $V_s(t)$ , we assume a linear accumulation of sediments over time until the check dam reaches full capacity~~sedimentation rate of a .ss~~

The design of sediment control measures is typically based on the 100-y rainfall probability (Design FS, Fig. 910-i) and  
445 assumes a homogeneous event distribution. However, recent trends in climate change, characterized by record-breaking storms, raise concerns about the reliability of current recurrence interval practices. Examples include Caraballeda, Venezuela, with 900 mm of rainfall in 52-h, Biescas, Spain, with 250 mm in 2-h (sections 3.1-3.2), and Val Canale, Italy, with 285 mm in 4-h (390 mm total, Tropeano and Turconi, 2004). These catastrophic events raise questions about the reliability of predicting the next disaster (Davies and McSaveney, 2011) and suggest that flood control measures have often  
450 been implemented without adequate assessment for maintenance or prediction of the potential damage from their failure.
